REPORT No. 1944/25.

GEOLOGICAL REPORT ON THE COTTER DAM AND THE AGGREGATE
USED IN THE CONCRETE FOR THE DAM.

P.B. NYE - ASSISTANT DIRECTOR.
AND
H.B. OWEN - GEOLOGIST.

15 AUG 1944

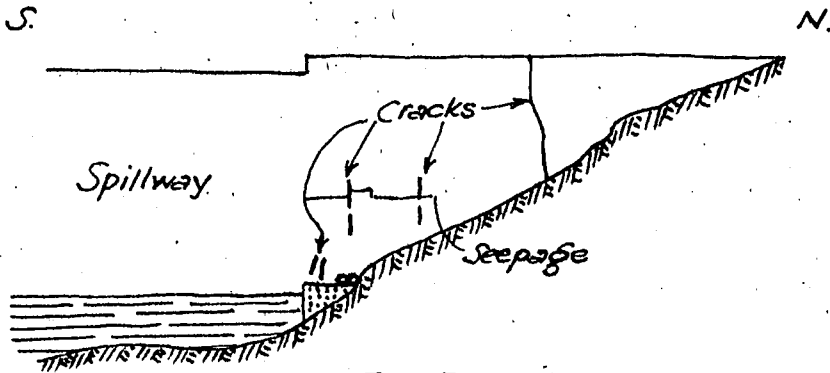
*Text Figure 1.
Sketch elevation of northern portion of
downstream face of Cotter Dam
Scale 1" = 40' (approx.)*

The most noticeable cracks are in the northern part of the dam. The most prominent of these trends almost at right angles to the dam and has a strike of 305° . It is visible under the water on the upstream side of the raised path and appears to have a maximum width of about half an inch at the surface of the dam, but much smaller at very shallow depths. Its course along the raised path

has been covered with cement mortar, but it is visible on the downstream face as a nearly vertical crack extending from the top of the face for a depth of about 30 feet to the rock forming the side of the gorge.

Several less prominent and less extensive cracks occur to the west of the main crack near the bottom of the downstream face (see text figure 1). On the lower part of this face there are incrustations formed of thin layers of a brownish-white substance. These incrustations have been formed by deposition from solutions that have traversed the concrete. There is little doubt that the substances deposited were derived largely from the concrete by percolating water.

The incrustations are most plentiful below a horizontal line about 20 feet above the outlet pipes. Water seeps slowly from this line which apparently represents the surface between two pourings of concrete. Most of the incrustation is derived from the water percolating through this and other horizontal joints, but some is derived from water percolating through the cracks.
