# Phaeton (1889) Wreck Inspection Report

**Date of Inspection:** 2/11/2004

OIC M. McCarthy (Department of Maritime Archaeology, WA Maritime Museum)

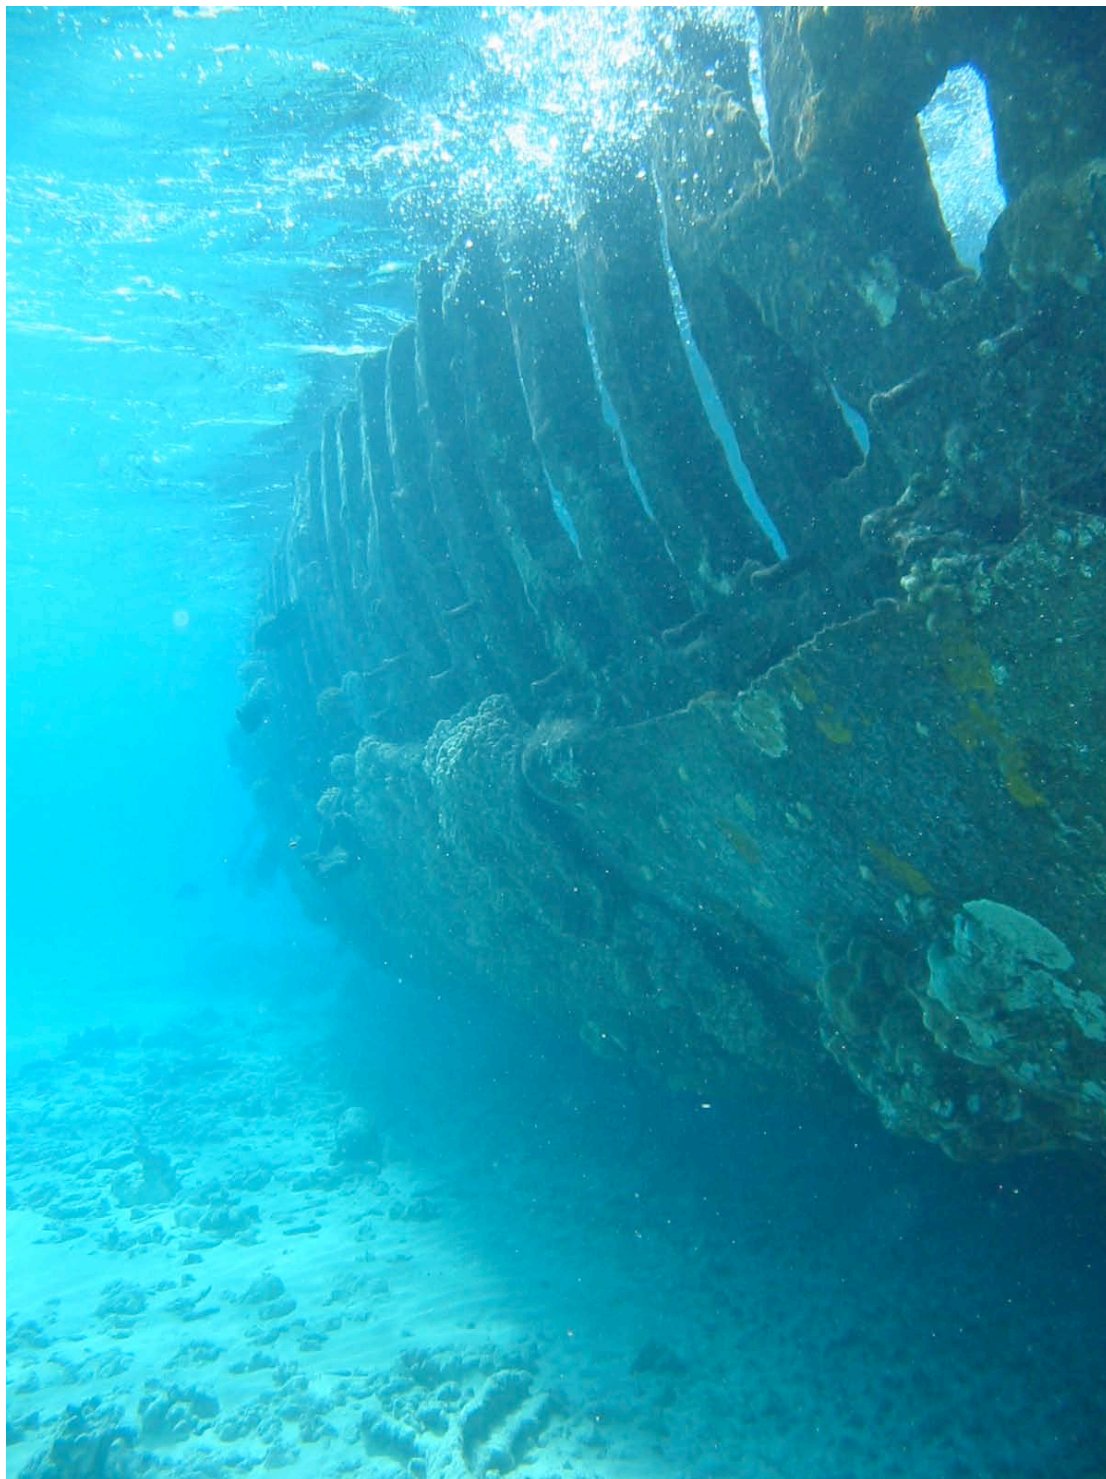
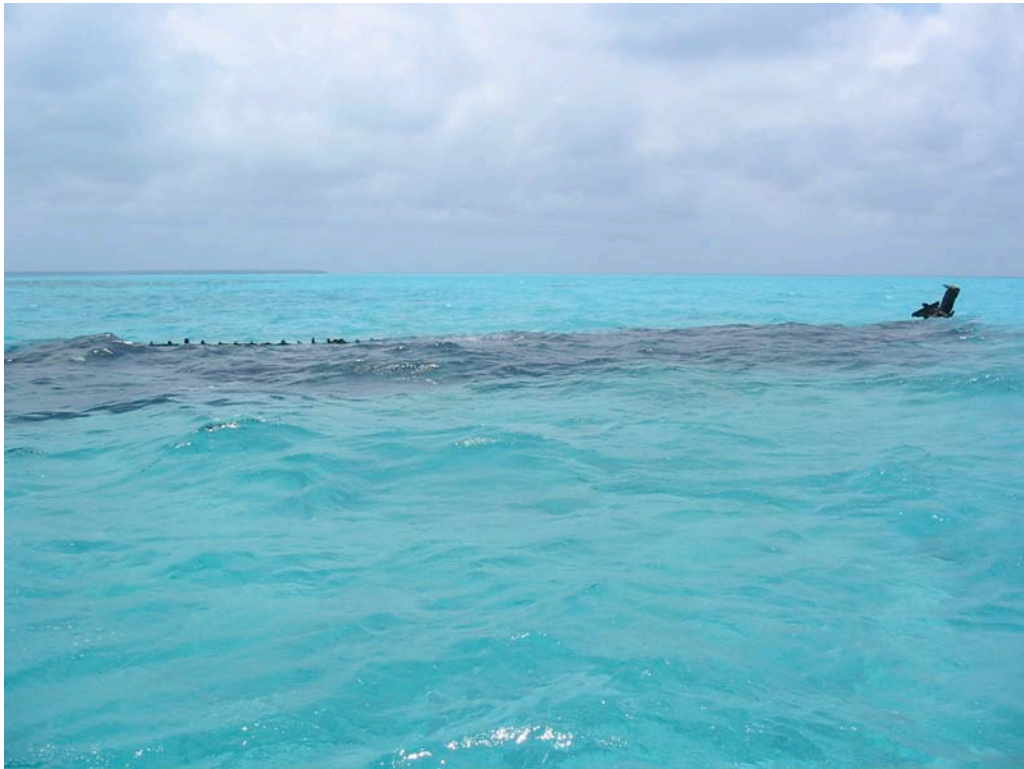
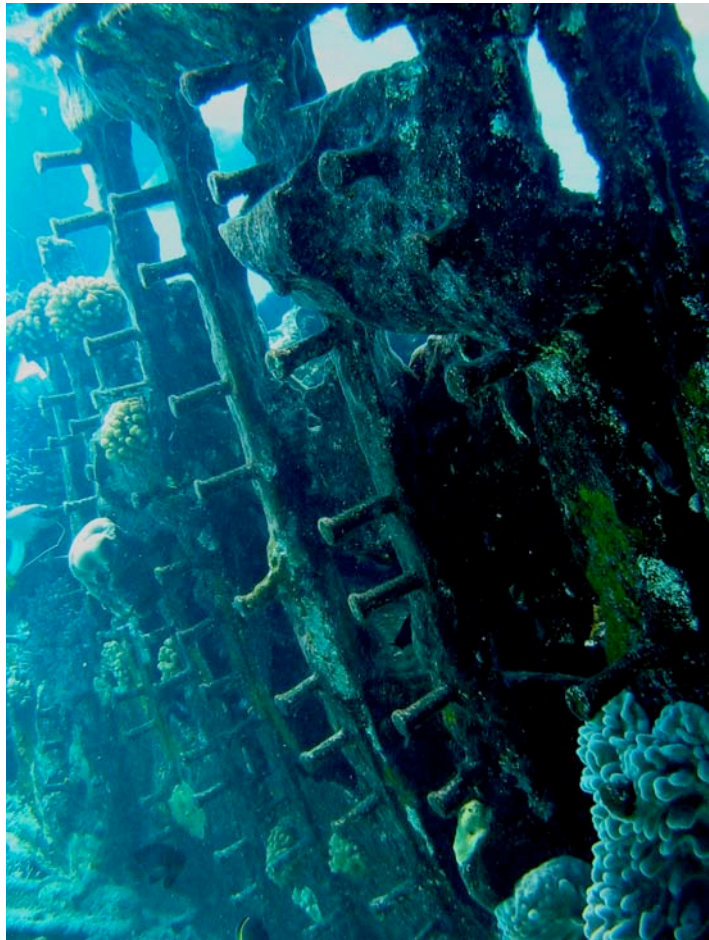
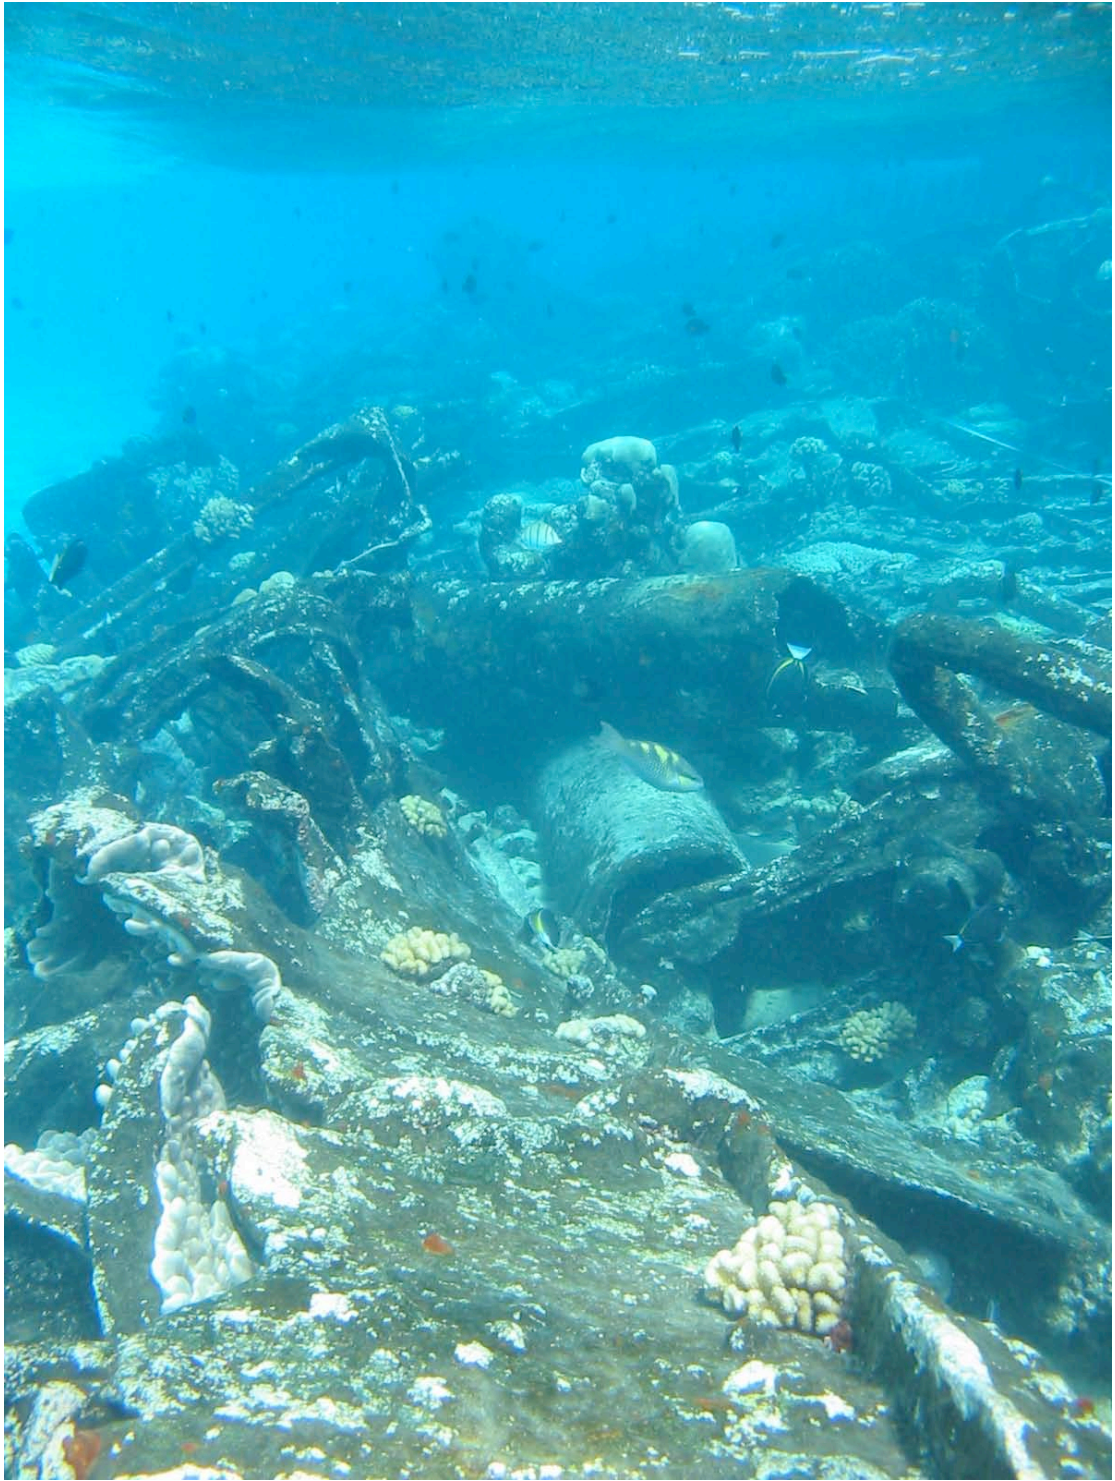
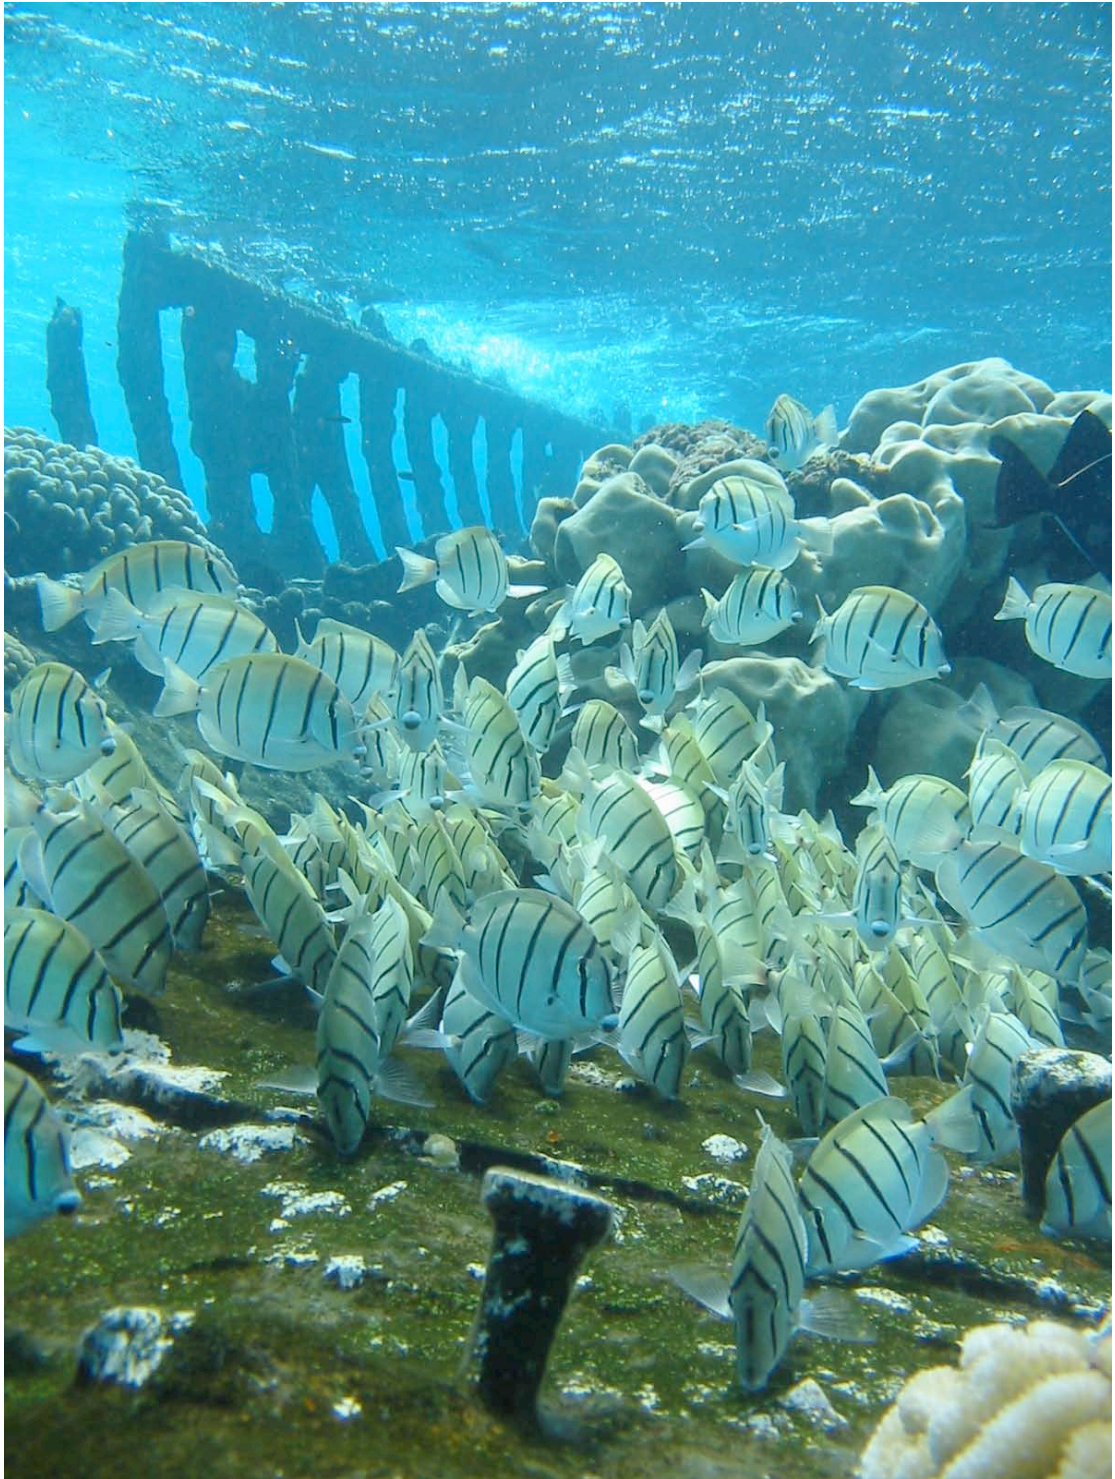
## **Images of the site ( By Robert Thorn)**

The fore-part and midships section aft to a break in the hull at the 40m mark from the bow are intact and are lying virtually upright on a sand bottom. The iron frames of the fore part of the wreck are all intact from the sea surface down to the keel, i.e. from around the turn of the bilge. This situation presents an immensely strong ‘cup’ or ‘vessel’ that is filled with cemented and concreted iron wreckage (anchor, chain, beams, mast sections &c).<sup>1</sup> Some wreckage lies outside the hull. Where exposed to the action of the seas, all the woodwork, outer and ceiling planking appear to have disappeared, leaving only their fastenings projecting from the iron frames. The iron stem projects above the surface, for example, and it carries large copper alloy through bolts that were set into the ironwork to secure the heavy timbers of the bow. These timbers have long-since disappeared. The frames immediately aft of the stem also carry lines of copper alloy bolts, each with a head and a thread on which a copper alloy nut is hove down, but again each is devoid of the timber planking they once secured. Further aft and closer to the keel, the copper-alloy sheathing is intact, and possibly some of the timbers underneath the sheathing may remain.

Aft of this intact section lies the stern, which, in contrast with the bow and midships section, is completely disarticulated and lying flat on the seabed. Adding to the problems in this section, each of the elements comprising the stern were difficult to recognise out of context in the short time available on this inspection. Preliminary indications are that this area has been torn apart with considerable force, to lie scattered on the sand bottom.
