Direction Island Unidentified (Cocos Keeling Islands) Inspection Report

Technical Data

Site Name: *Direction Island unidentified.*

Date of Inspection: 2/11/2004

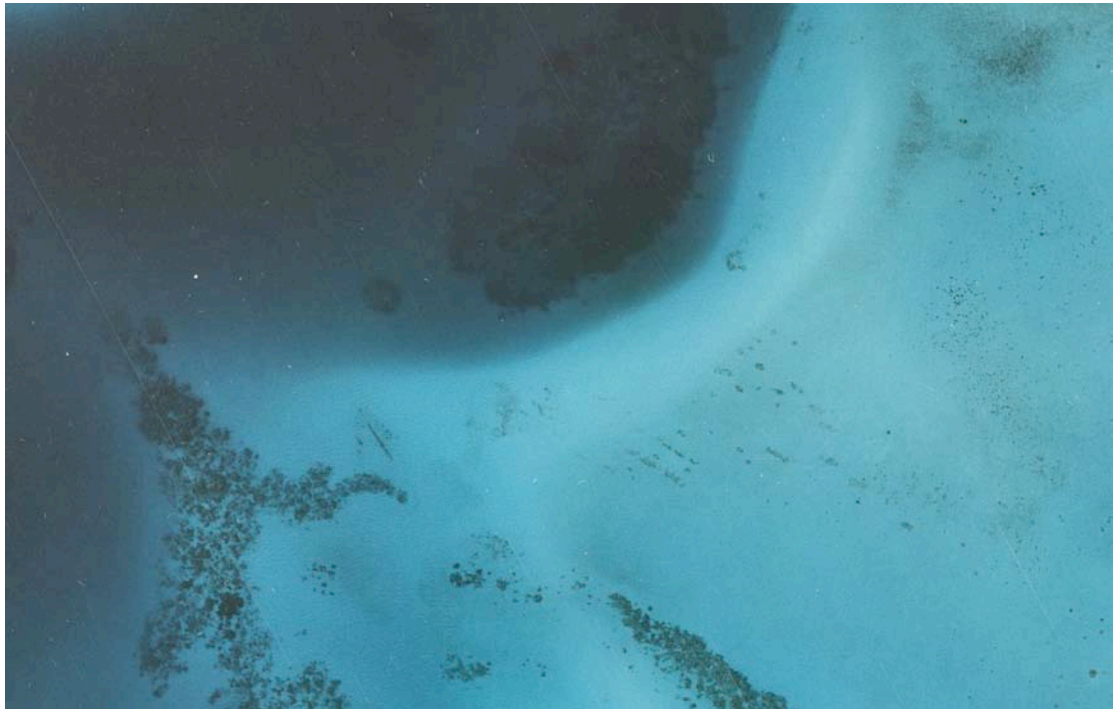
Air photo image of the wreck site (1987). Courtesy Parks Australia

metres away from the line of the keelson, certainly provide some hint of further buried materials. These are expected to be the remains of frames. The aerial view below also provides indications of further remains.

Note: The line of the keelson is clearly visible as a distinct dark line on the seabed. The cause of the inverted 'V' shape at the top of the line is unknown at present. (See recommendations)

3. A wreck map and information pamphlets on this and on other maritime sites in the region should be produced.
4. A test excavation in order to ascertain the full extent of the remains could be performed. The cause of the 'V' shape apparent in the air photo image above needs also be ascertained. Further analyses (timber type and dimensions, fastening sizes and composition &c) would also be conducted in order to assist in better identifying the site.

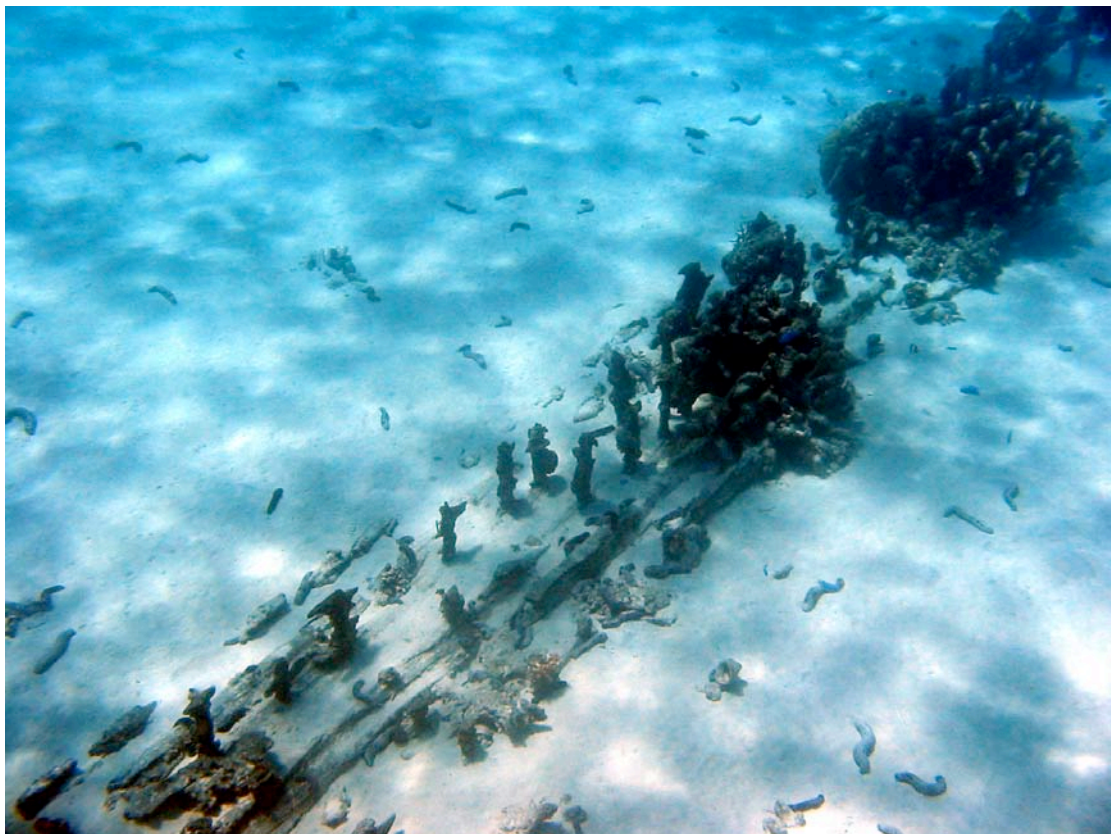
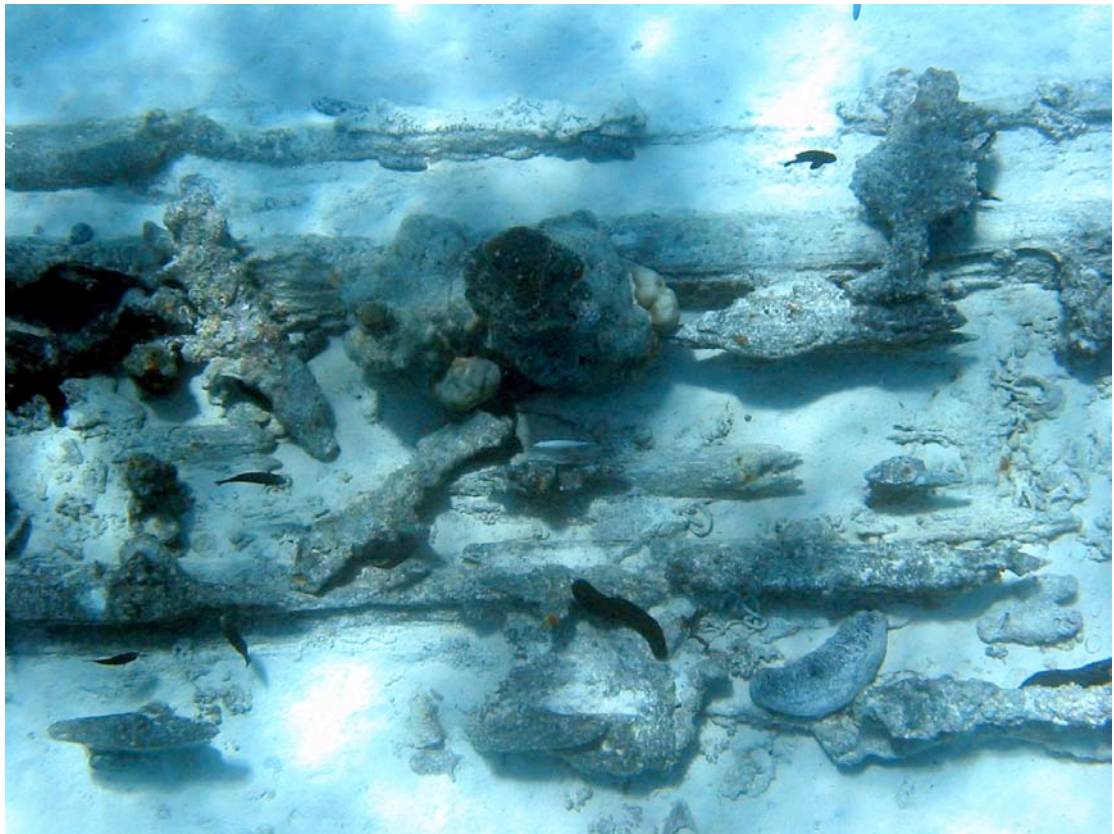
Views of the Site (R.Thorn)

This wreck is visible from the surface on a clear day, appearing as a distinct NW/SE line on the sandy bottom just south of Direction Island. Underwater it appears as six rows of concreted iron keel/keelson bolts in 3.8m of water running across hard compacted sand. The bolts, projecting upright through the sand are all of iron and are in lines of three pairs each, all running for 40 metres. One is a central pair rising c.30cm above the sand and others either side of it each rising c.10cm from the sand. Some are colonised by coral,

Appearing at first glance as the remains of an old jetty or similar structure, they are on closer investigation those of a keelson, once supported by sister-keelsons either side. Hand fanning to reveal buried structure adjacent the keelson(s) was difficult due to the hard and compacted nature of the sediment. Nonetheless, there are indications of some floor timbers and a wide, but thin (c. 2 inches thick), planking, alongside the keelson. Being of scantlings too small for ceiling or outer planking in vessels of this size, this timber is possibly a limber strake—a removable plank fitted next to the keelson to clear debris collecting in the bilge. Two timber samples were taken, one of this strake and the other of what appears to be a frame, albeit with considerable difficulty. Across the sand, there were surface indications of more timber under the sediments, though this was not adequately tested, given the difficulties of test excavation without water dredge or airlift equipment. No other clues were visible above the sea floor, though disturbances in the natural contours of the seabed a few
