UPPER COTTER DAM SITE INVESTIGATIONS

Dam Site C.

Progress Geological Report and Proposed
Drilling Programme.

L. C. Noakes

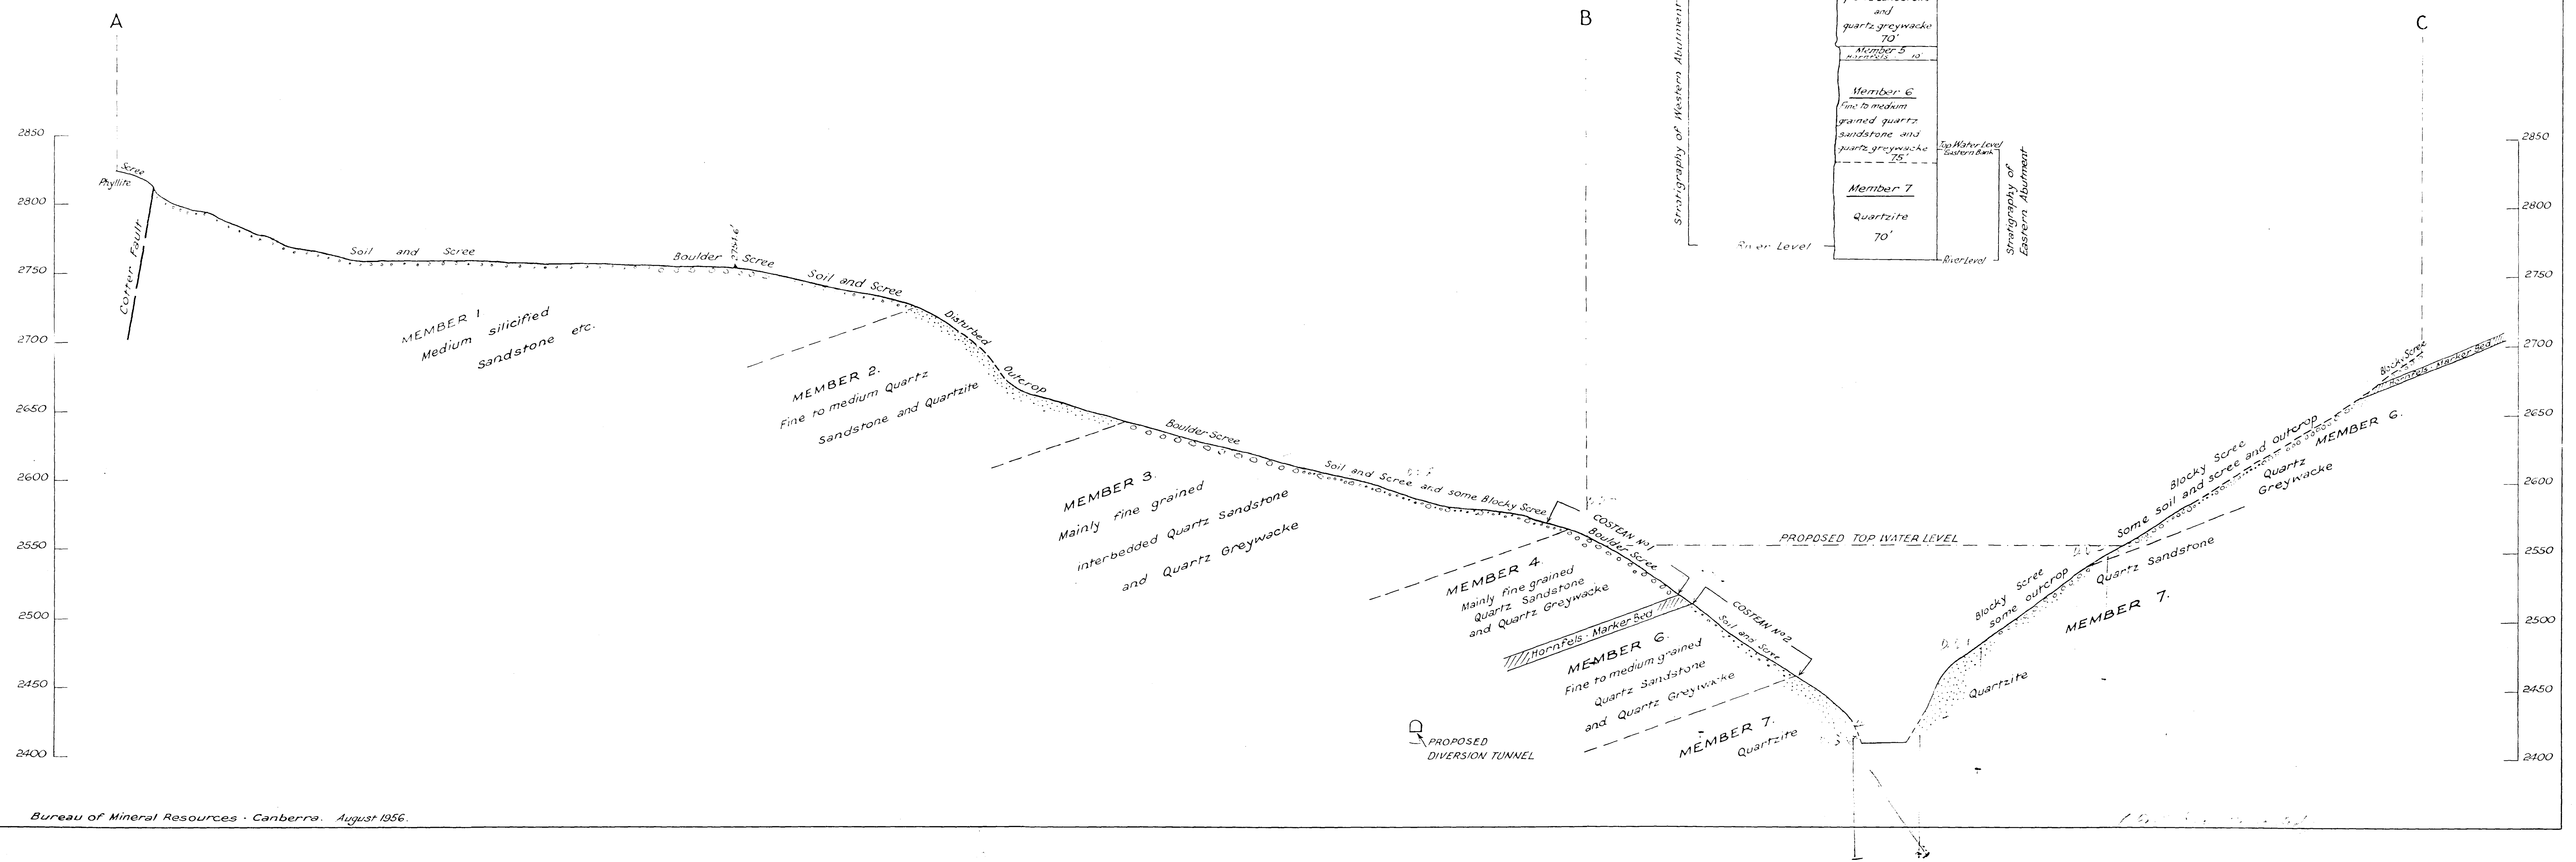
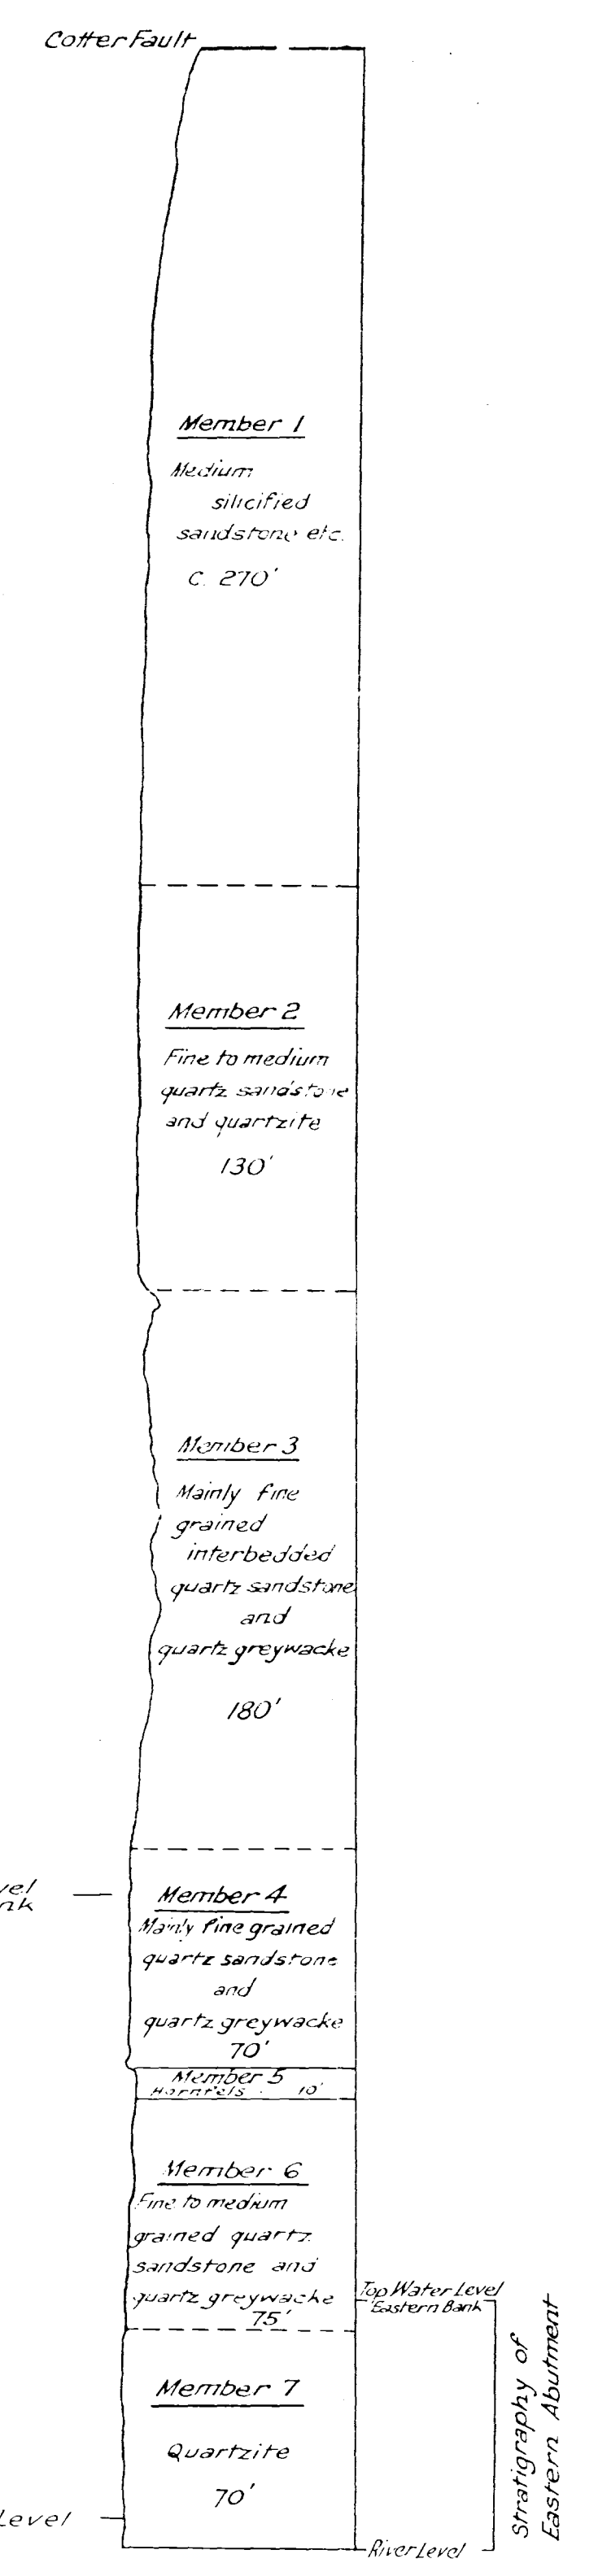
Section A-B-C along Proposed Wall
(Looking North)
and
Stratigraphic Section - Tidbinbilla Quartzite
(From Fault Saddle to Cotter River)

Beds of the Tidbinbilla Quartzite at the dam site show a general meridional strike with dips ranging from 18-25° to the west. The stratigraphic succession from the fault saddle in the west to the eastern abutment has been worked out and, for ready reference, has been divided into informal "members", as shown on Plate 2. More detail will be available when costeans have been completed.

The marker bed has been traced without displacement across the line of the proposed wall on both abutments and its position in the section across the river (see Geological Section) leaves no room for a major displacement between the two abutments.

A tentative diamond drilling programme has been worked out and the approximate location of holes is shown on the accompanying plan and section. This programme is a minimum one and is likely to be changed as sub-surface data become available. The holes have been numbered in order of importance according to present geological information. The total footage of the tentative drilling programme is approximately 750 feet.
