RECORDS 1956, No.91

SEISMIC REFRACTION SURVEY AT BLACK BOB'S DAM SITE,
NEAR OUSE, TASMANIA

W.A. WIEBENGA, D.F. DYSON and M.J. O'CONNOR

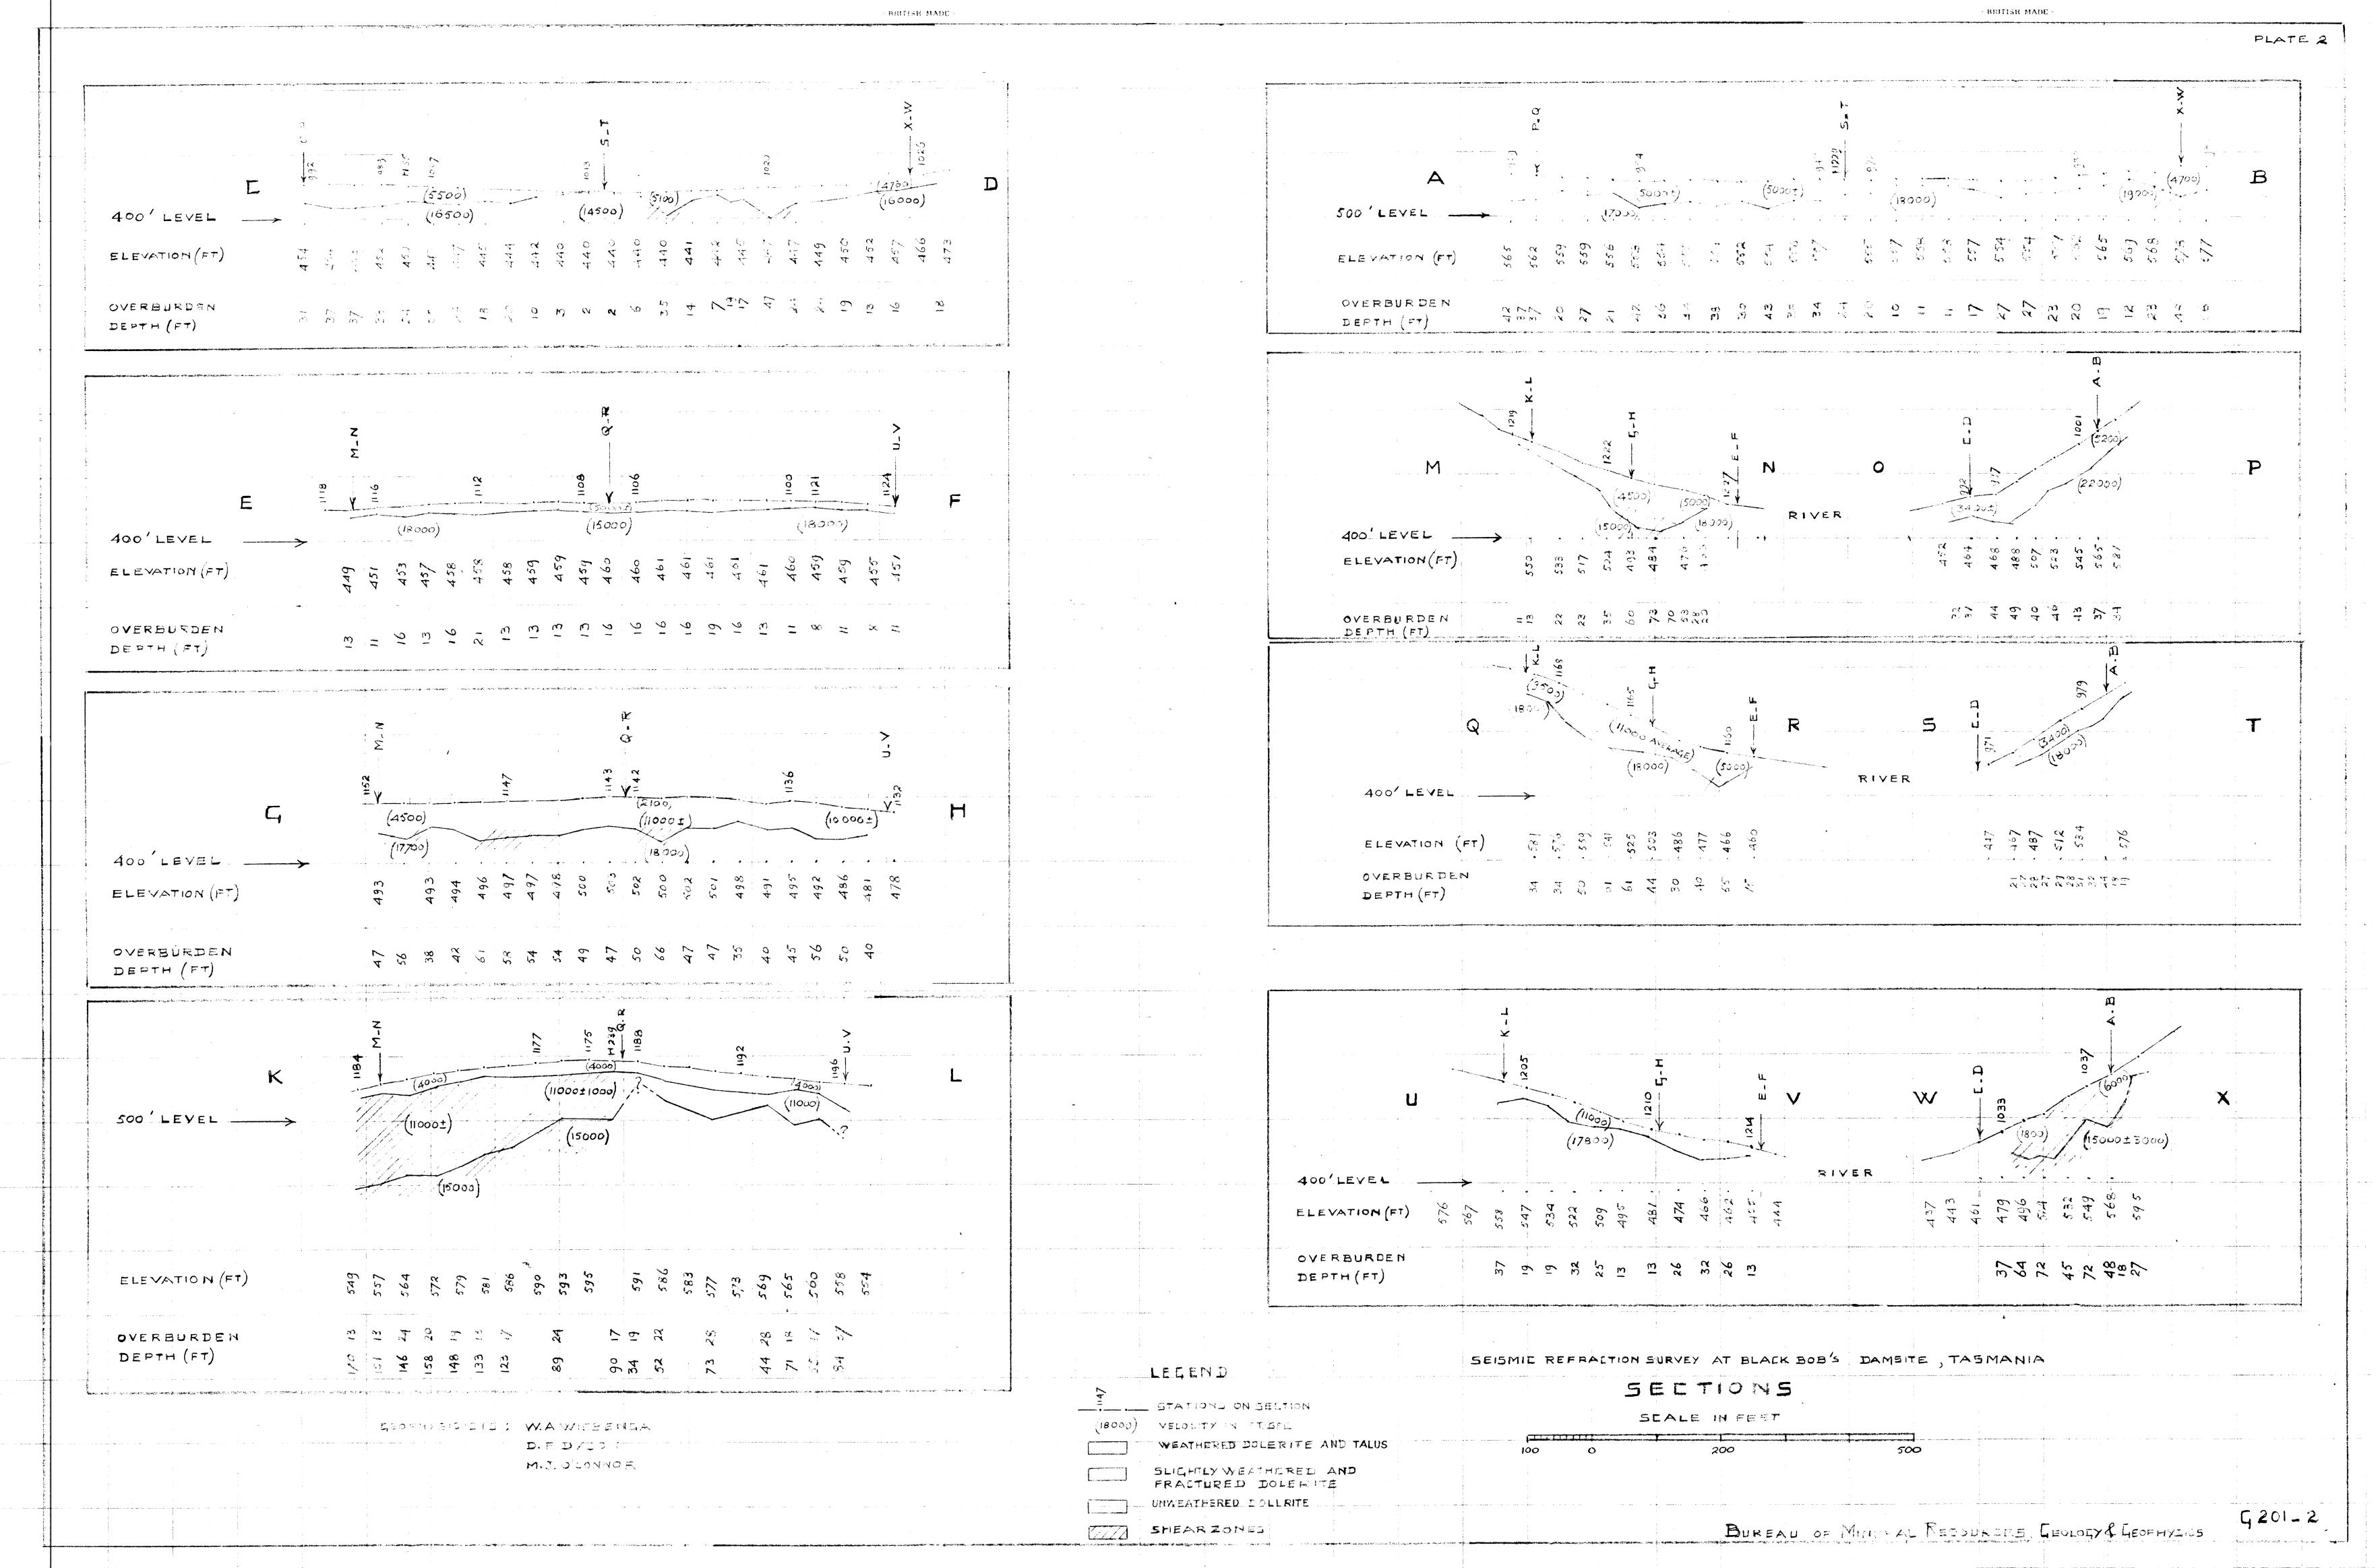
2. Cross-sections along traverses.

On traverse G-H, near station 1141 (Plate 2), the weathering shots gave velocities of 2,100 and 6,200 ft/sec. and the normal shots 12,300 and 18,000 ft/sec. for the deeper layers. To compute the depth to unweathered dolerite near station 1141, an average velocity of 11,000 ft/sec. was used.

Between stations H239 and 1184 on traverse K-L, the seismic data indicated an intermediate layer between the 4,000 and 15,000 ft/sec. layers. The velocity in this intermediate layer could not be accurately evaluated, and the depth estimates are therefore unreliable.

In cross-sections O-P, Q-R, and W-X, the lateral change in the nature of the overburden is well shown by the lateral change in the overburden velocity. Such changes render difficult the interpretation of the data.

The cross-sections show that the overburden thins out rapidly towards the centre of the valley and is probably non-existent in the river bed. It is possible that erosion is proceeding at the same rate as the weathering of the dolerite.

Shearing in the dolerite is indicated on section A-B near station 984, on C-D near 1016 and 1020, on 3-H west of 1150 and possibly between 1140 and 1142 and 1145 and 1149, on K-L west of 1188, on M-N near 1224 and on W-X between 1034 and 1039. The location of the sheared dolerite is shown by the shaded areas on Plate 1. On the northern bank both the seismic and drilling results suggest a main shear zone striking easterly and situated as shown on Plate 1.

In the area surveyed, the line Q-R-S-T may be favoured by engineers as the most likely site for a dam. Shearing appears to be unlikely along this line and the thickness of overburden is less than along MN and WX.
