RECORDS

1957, NO.24

SEISMIC SURVEY OF THE SOUTHERN ABUTMENT OF DAM SITE "A",
UPPER COTTER RIVER, A.C.T.

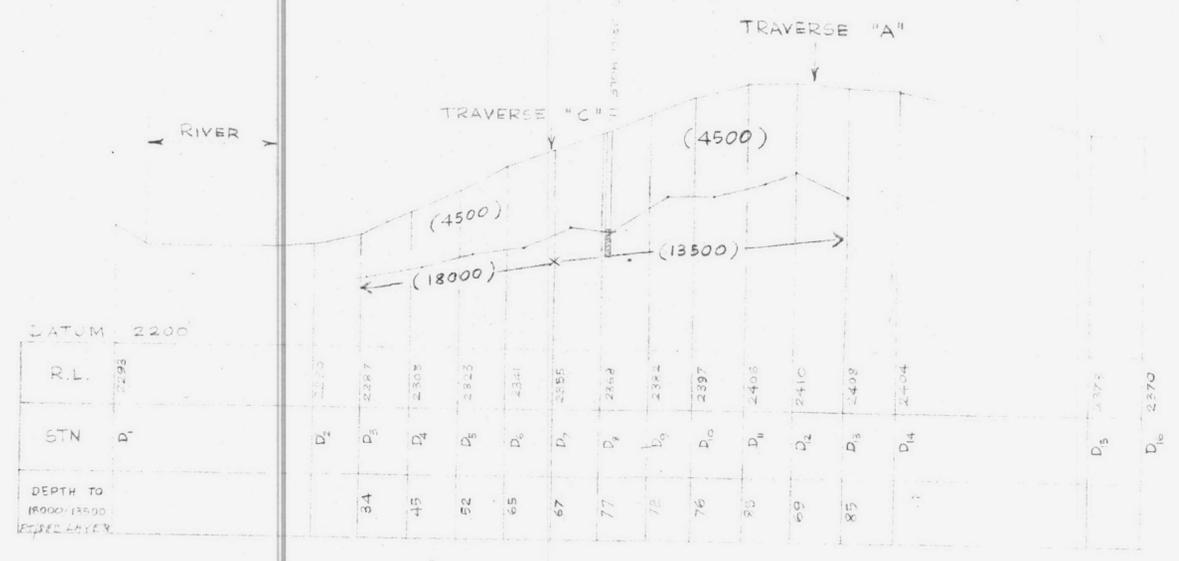
TRAVERSE "D"

Traverse D is located on the quartzite spur. The depths to bedrock computed from the seismic results range between 34 feet at station D3 and 83 feet at station D11, the average

depth being 66 feet. The log of diamond drill hole No.11, near station D8, shows a depth of 76 to 82 feet, to weathered granite with quartz veins, below weathered quartzite. The seismic determinations at D8 show a depth of 77 feet to bedrock of 13,500 ft./sec. velocity. This would indicate that the 13,500 ft./sec. velocity corresponds to weathered granite with quartz veins at the quartzite/granite contact. However, unweathered, slightly jointed quartzite could have the same velocity.

Between stations D3 and D7, the bedrock velocity is 18,000 ft./sec. and may indicate either unweathered granite, or quartzite with joints cemented by quartz. The overburden along traverse D has an average velocity of 4,500 ft./sec. and consists of brecciated and weathered quartzite.

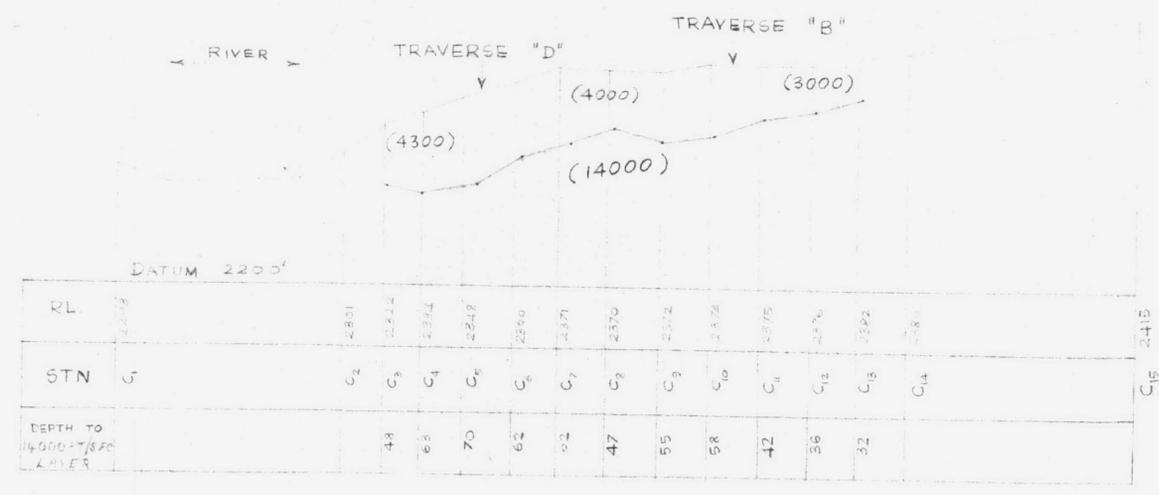
TRAVERSE "C"

Traverse C is located across the quartzite spur and extends eastwards over the area of granite outcrop. The average depth to bedrock is 52 feet, ranging from 60 to 70 feet over the quartzite spur to 32 feet at station C13. An inclined diamond drill hole, D.D.H.9, shows weathered, silicified granite, underneath weathered, silicified quartzite and quartzite breccia, at a depth of 55 feet below the surface at a point about 36 feet downhill from station C7. The seismic determination at C7 is 62 feet to bedrock of velocity 14,000 ft./sec., which is therefore assumed to be partly weathered, silicified granite. The average velocity in the overburden along traverse C ranges from 4,300 ft./sec. in the jointed and weathered quartzite over the quartzite spur to 3,000 ft./sec. in the very weathered granite near station C13.

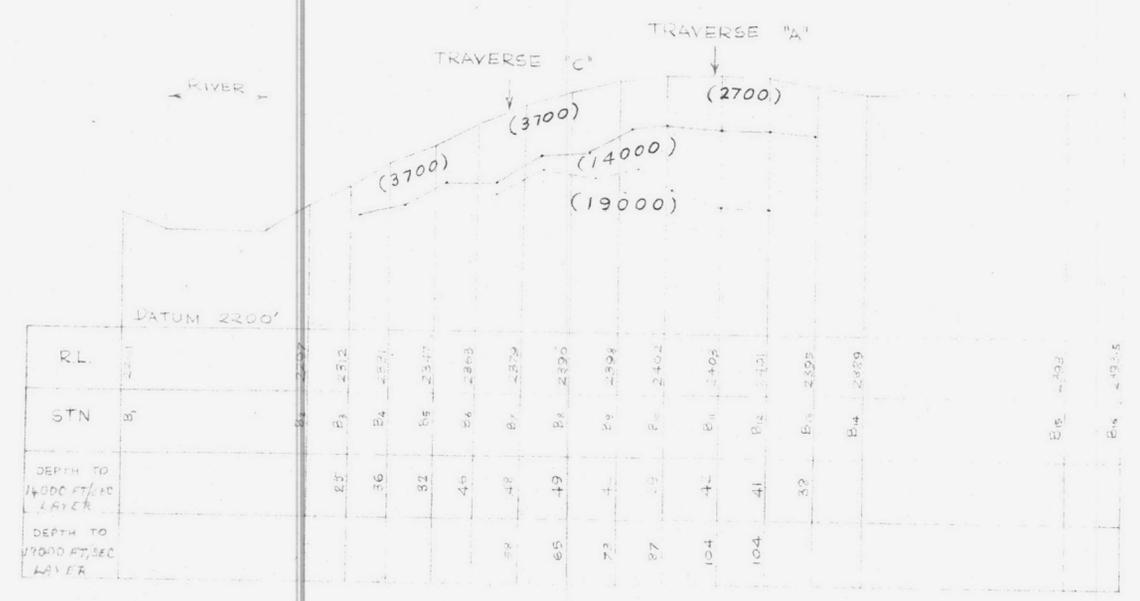
TRAVERSE "B"

Traverse B is located on weathered granite to the east of the spur and is approximately parallel to traverse D. The depth to bedrock of 14,000 ft./sec. velocity ranges from 25 feet at station B3 to 49 feet at B8, the average depth being 40 feet. A layer with a velocity of 19,000 ft./sec. was recorded from below the 14,000 ft./sec. material, and appears to represent unweathered granite underlying partly weathered granite. The partly weathered granite thins out towards the northern end of the traverse. The average velocity through the overburden along traverse B ranges from 2,700 ft./sec. in very weathered granite on the saddle of the ridge, to 3,700 ft./sec. near traverse C. The latter velocity may indicate very weathered granite and scree.

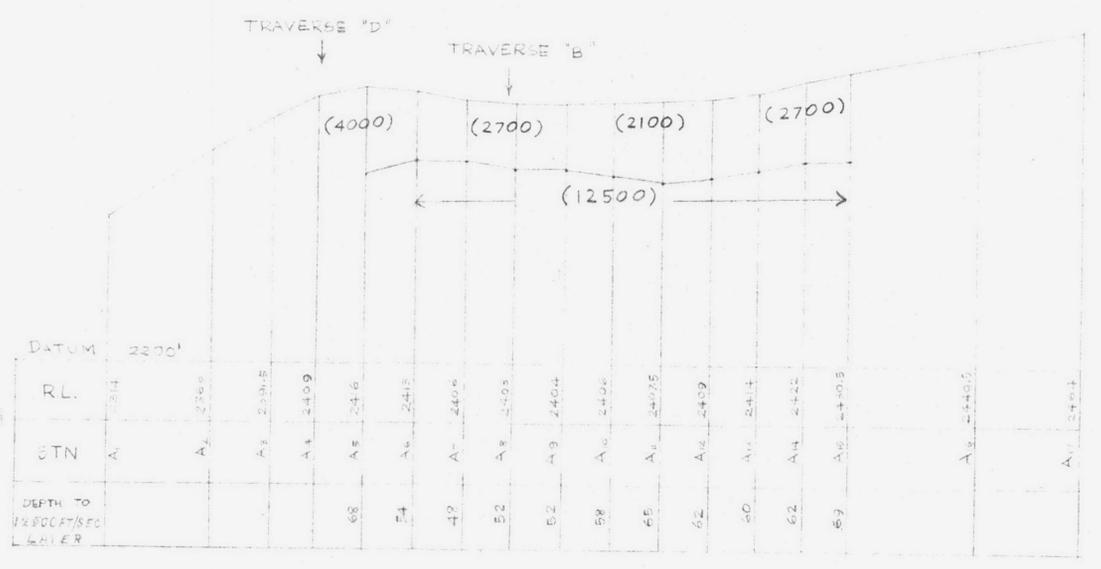
TRAVERSE "A"

Traverse A trends south-easterly through the saddle of the ridge. Between A6 and A15 the depth to bedrock of 12,500 ft./sec. velocity ranges from 48 to 69 feet, the average depth being 59 feet. This velocity of 12,500 ft./sec. represents partly weathered granite. The average velocity through the overburden along traverse A, near the quartzite outcrop at station A5, is 4,000 ft./sec., and represents jointed and weathered quartzite. The 2,100 to 2,700 ft./sec. velocity on the saddle represents very weathered granite.
