A GEOLOGICAL EXAMINATION OF ELDORADO MINE,  
TENNANT CREEK, NORTHERN TERRITORY

RECORDS 1958/76

LEVEL PLANS  
ELDORADO MINE  
TENNANT CREEK, N.T.

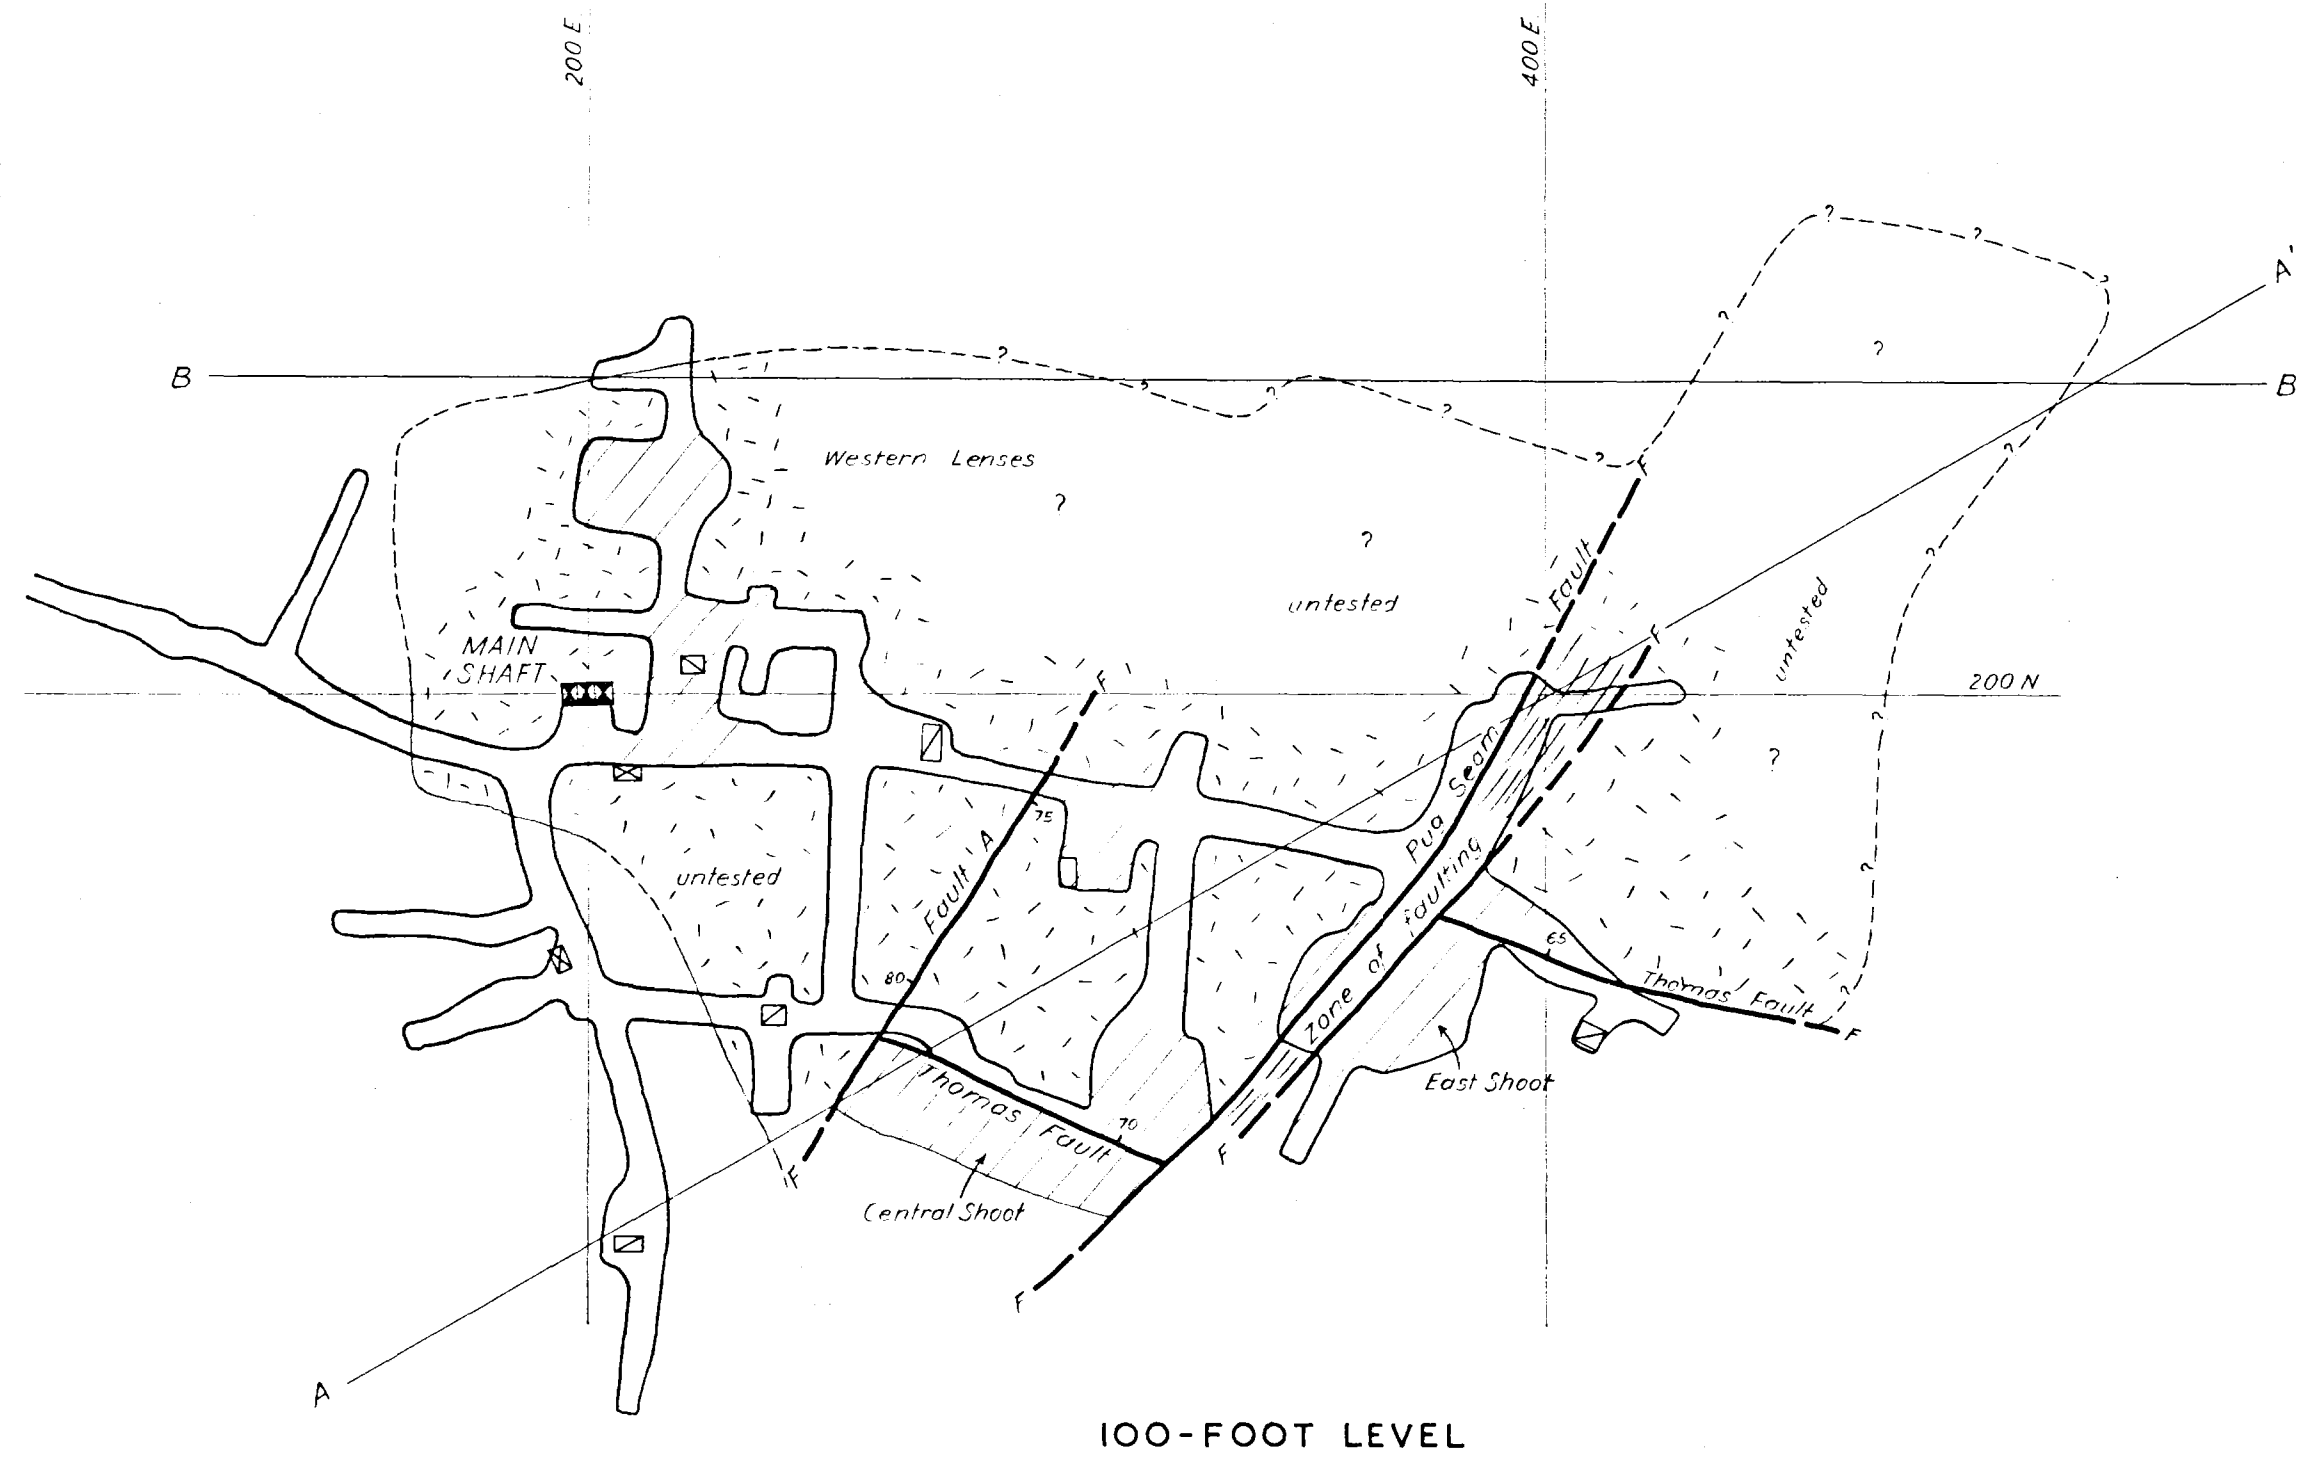
100-FOOT LEVEL

1) 100-foot level. At the north-east corner of the mine the Pug Seam Fault is 25 feet wide and has yielded more than the usual number of high assays (Plate 4). From Plate 2 it may be seen that the Pug Seam Fault could continue in ore for perhaps 100 feet to the north and possibly considerably further.

1) The continuation of the Pug Seam Fault to the north at the 100-foot level and the block of material to the east of this. At this level in the mine the possibility of loss of grade due to the entering of the primary zone can be ignored. The area is readily accessible for exploration from both the 100-foot level and the 200-foot level. A rise from the 200-foot level encountered 22 feet of ore averaging 35 dwt. per ton east of the East Stope (Plate 4).

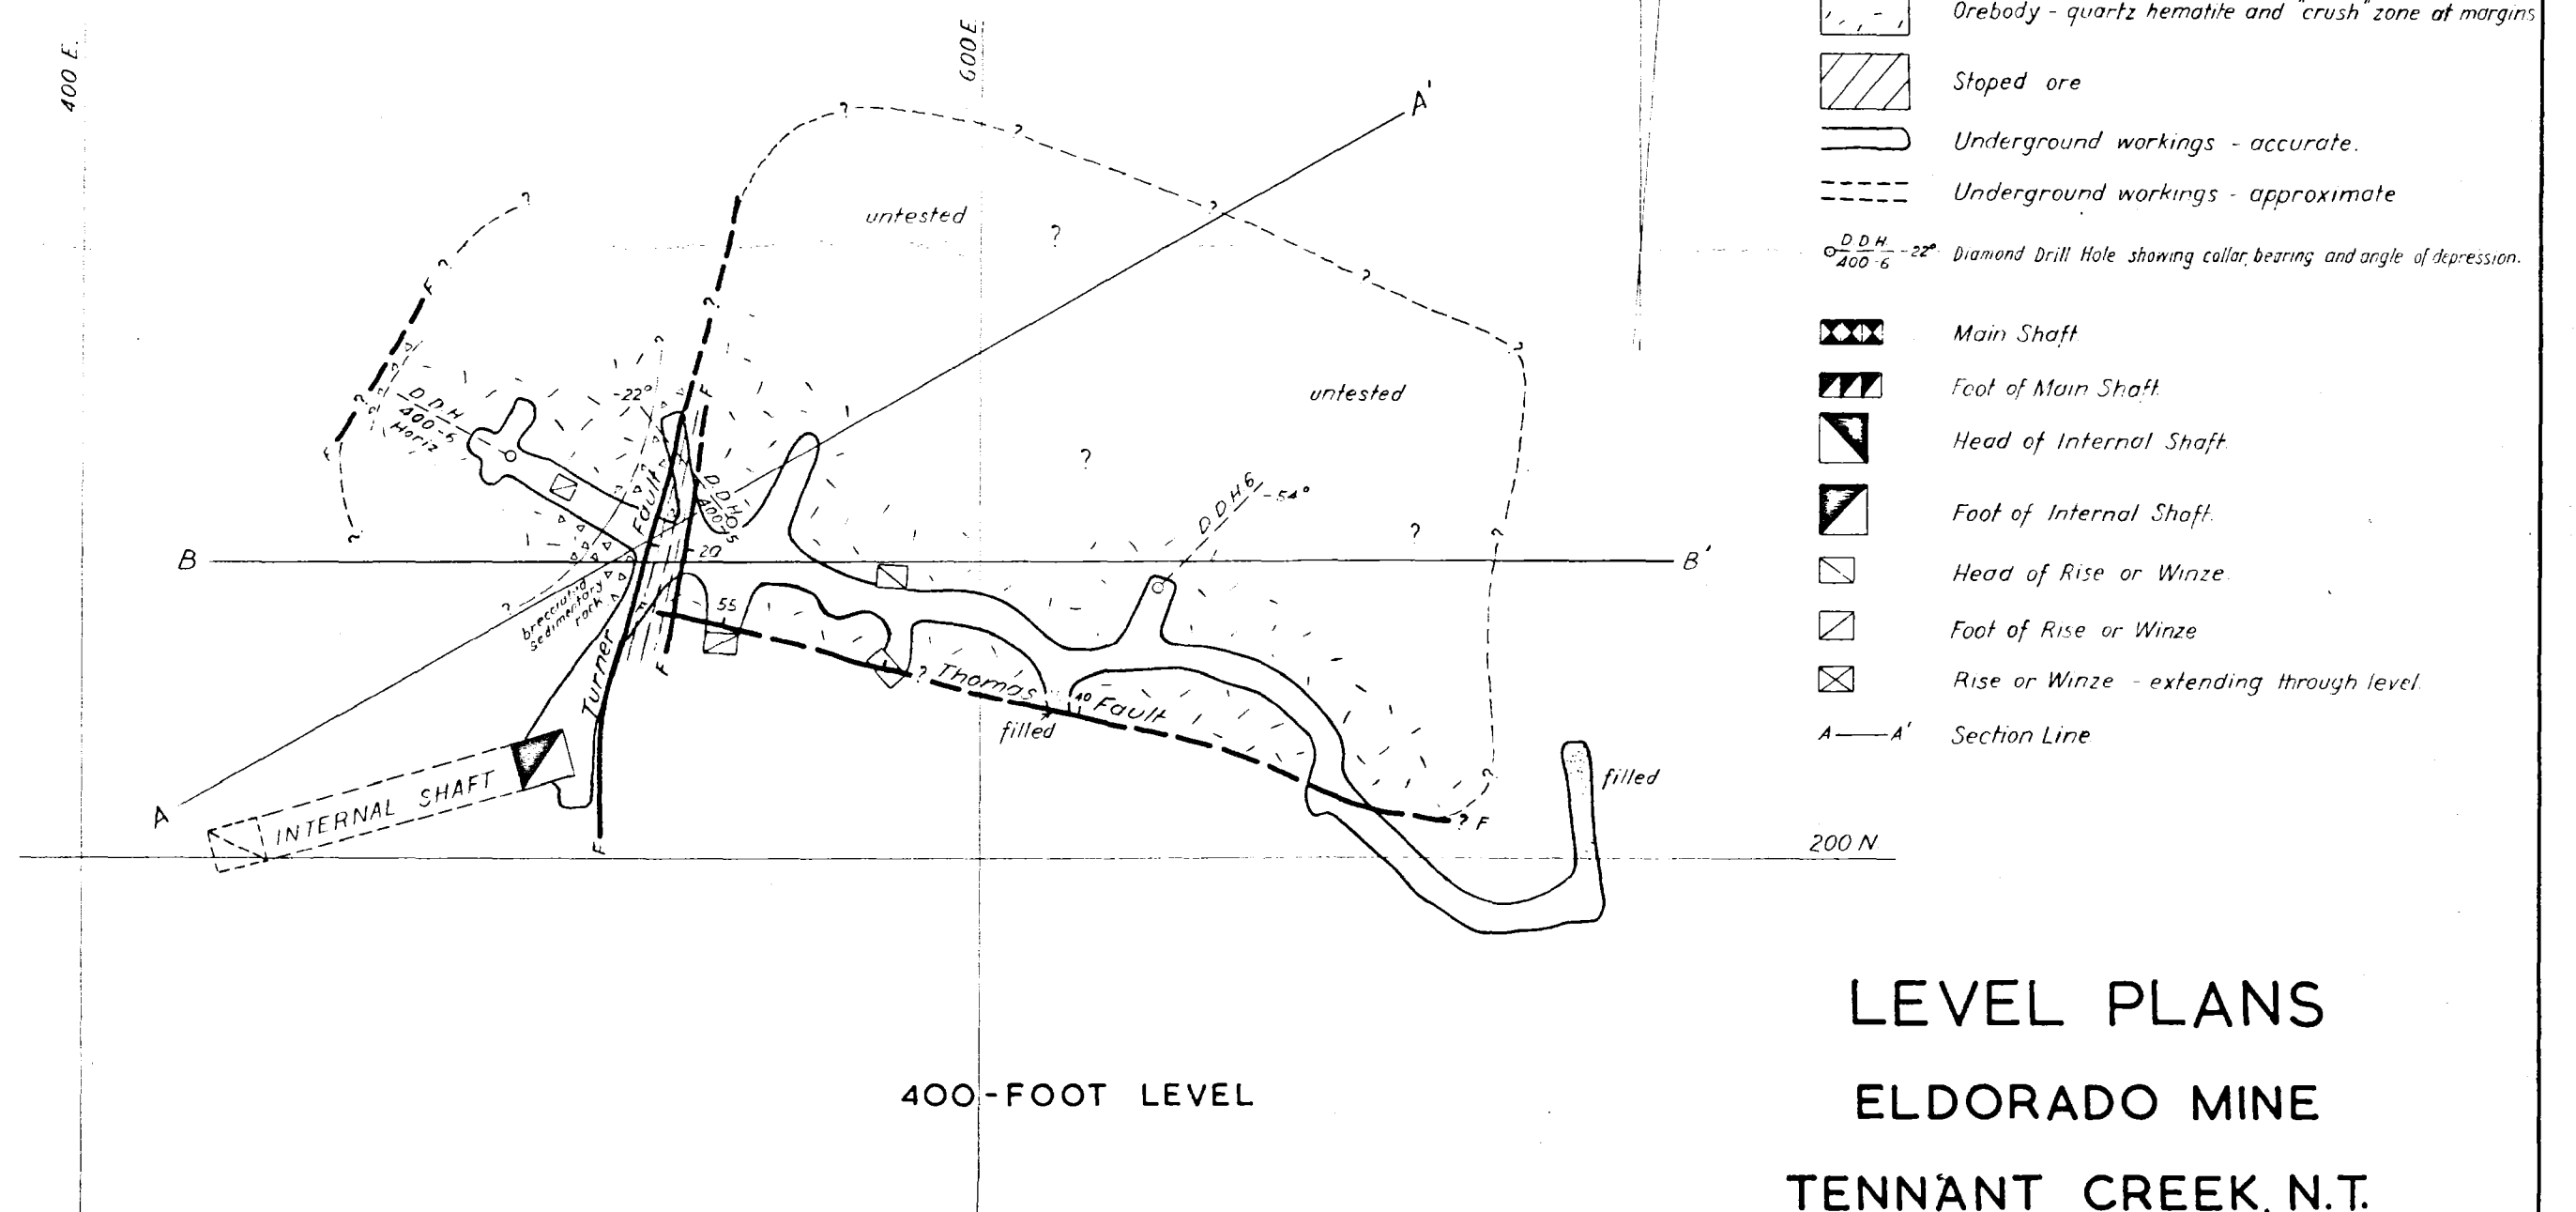
400-FOOT LEVEL

3) 400-foot level. No attempt has been made to locate the Pug Seam Fault west of the West Stope at this level (Plate 5). As good grade ore has been associated with this fault throughout the mine, this omission is difficult to understand. Some very good assays have been obtained in the West Stope, and the gold content may increase towards the Pug Seam Fault.

4) 400-foot level. Better than average assays have been obtained in the ironstone body underlying the Turner Fault in the west drive at this level. The extent of this body is unknown. (Plate 5.)

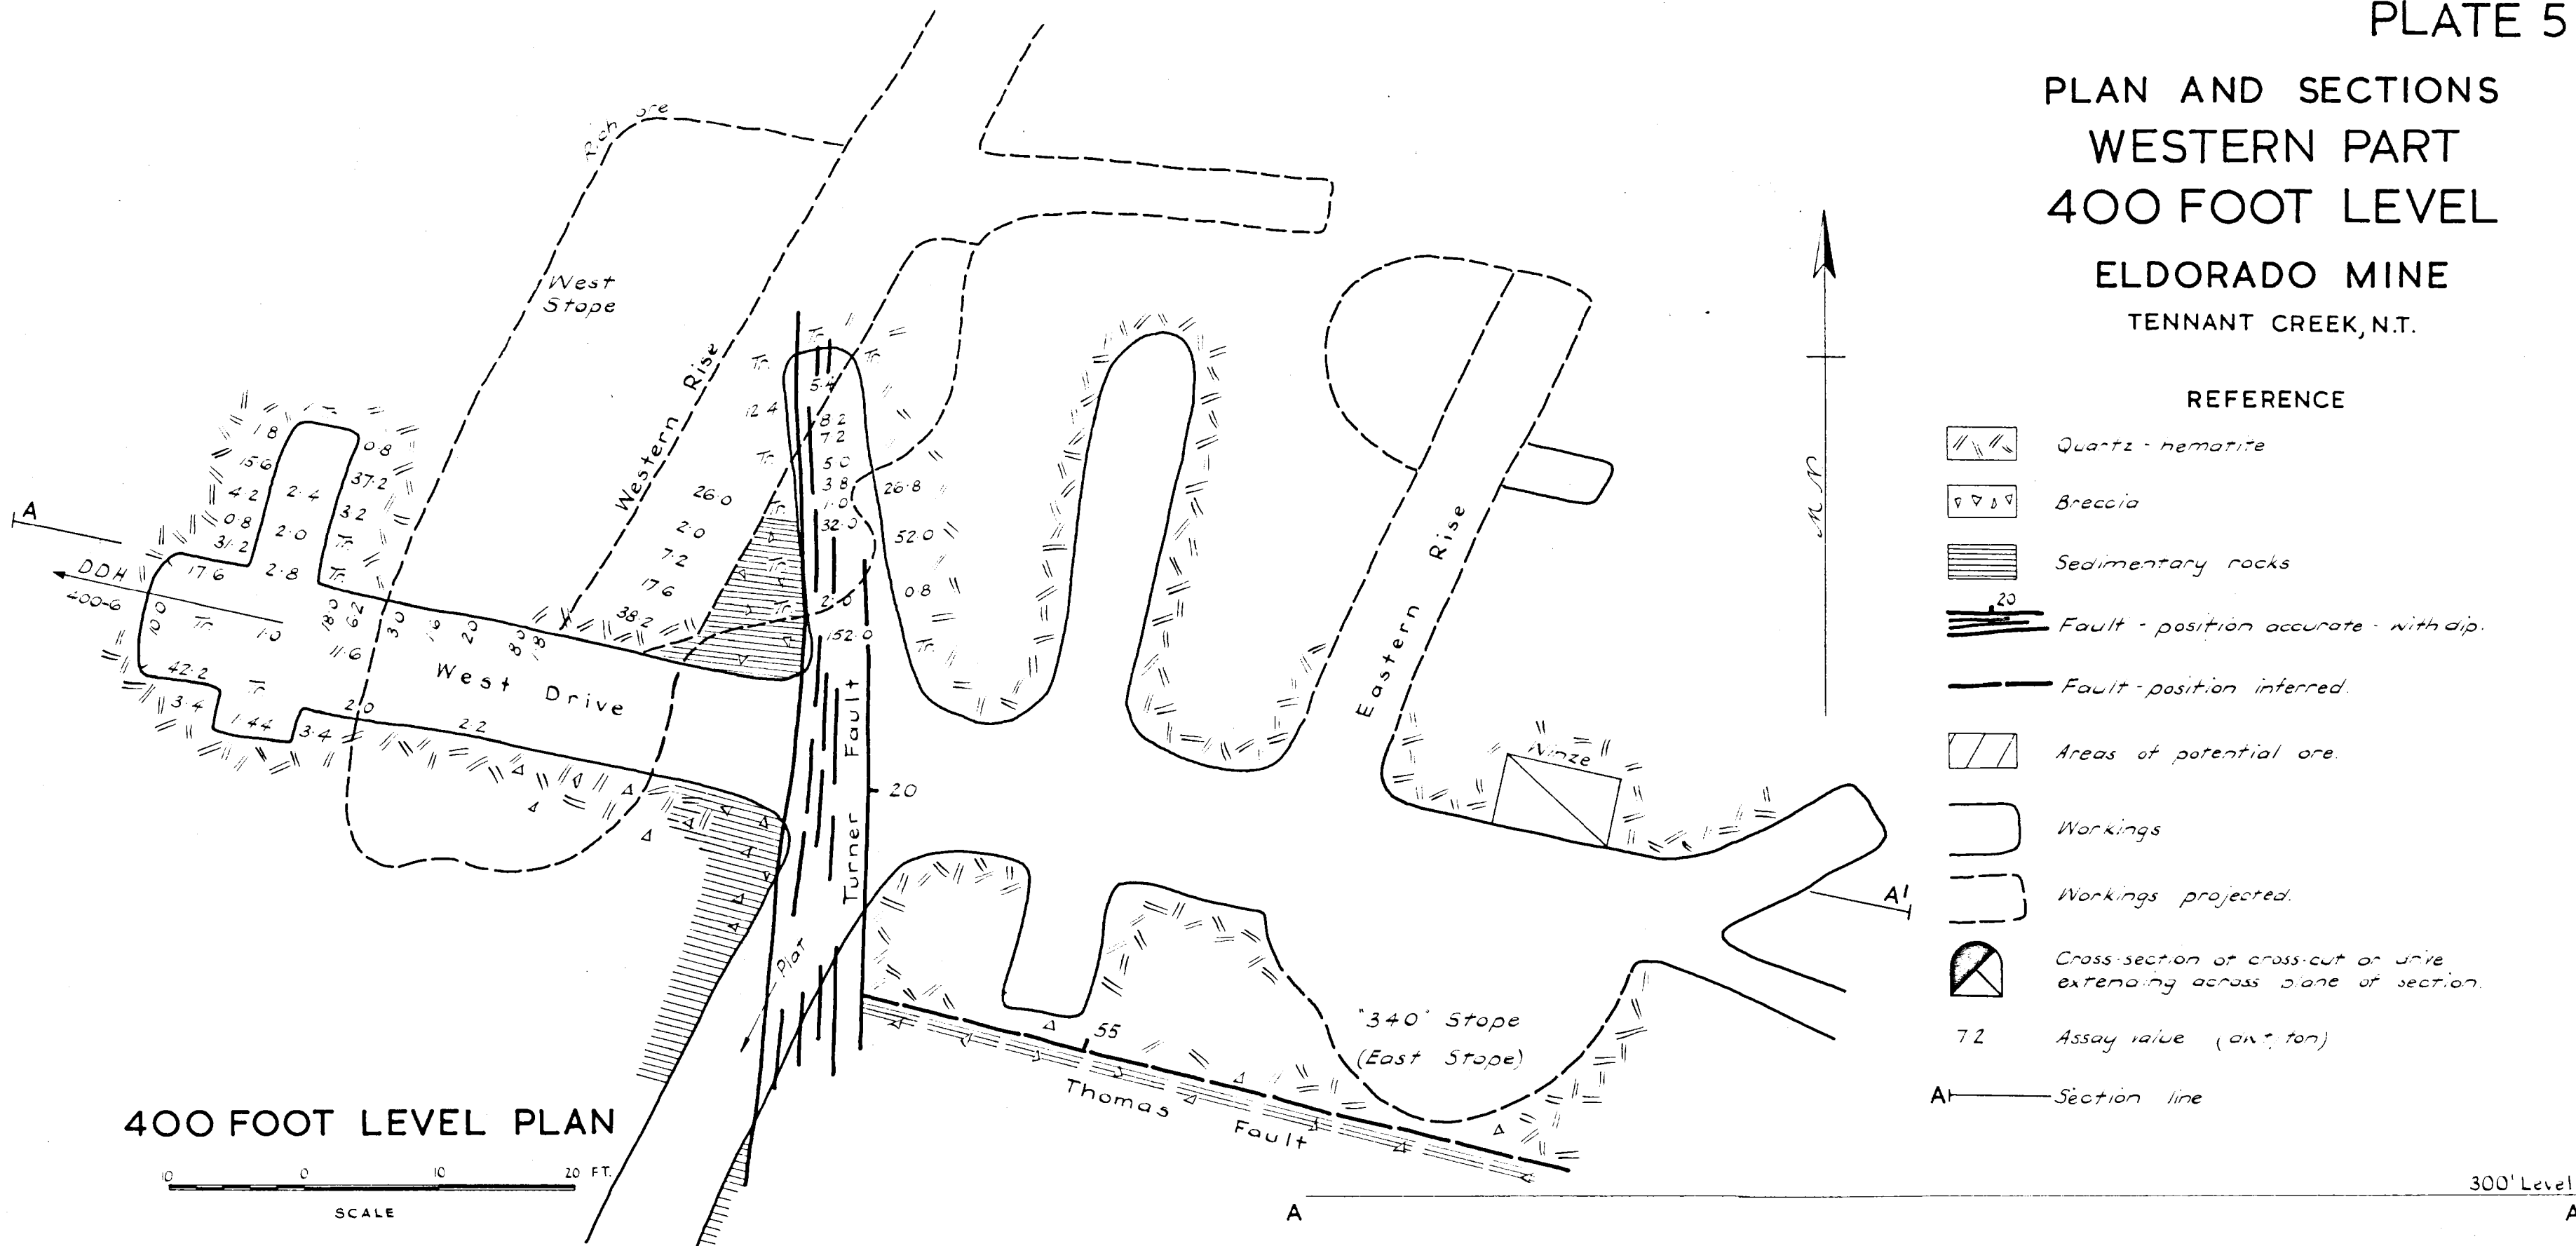
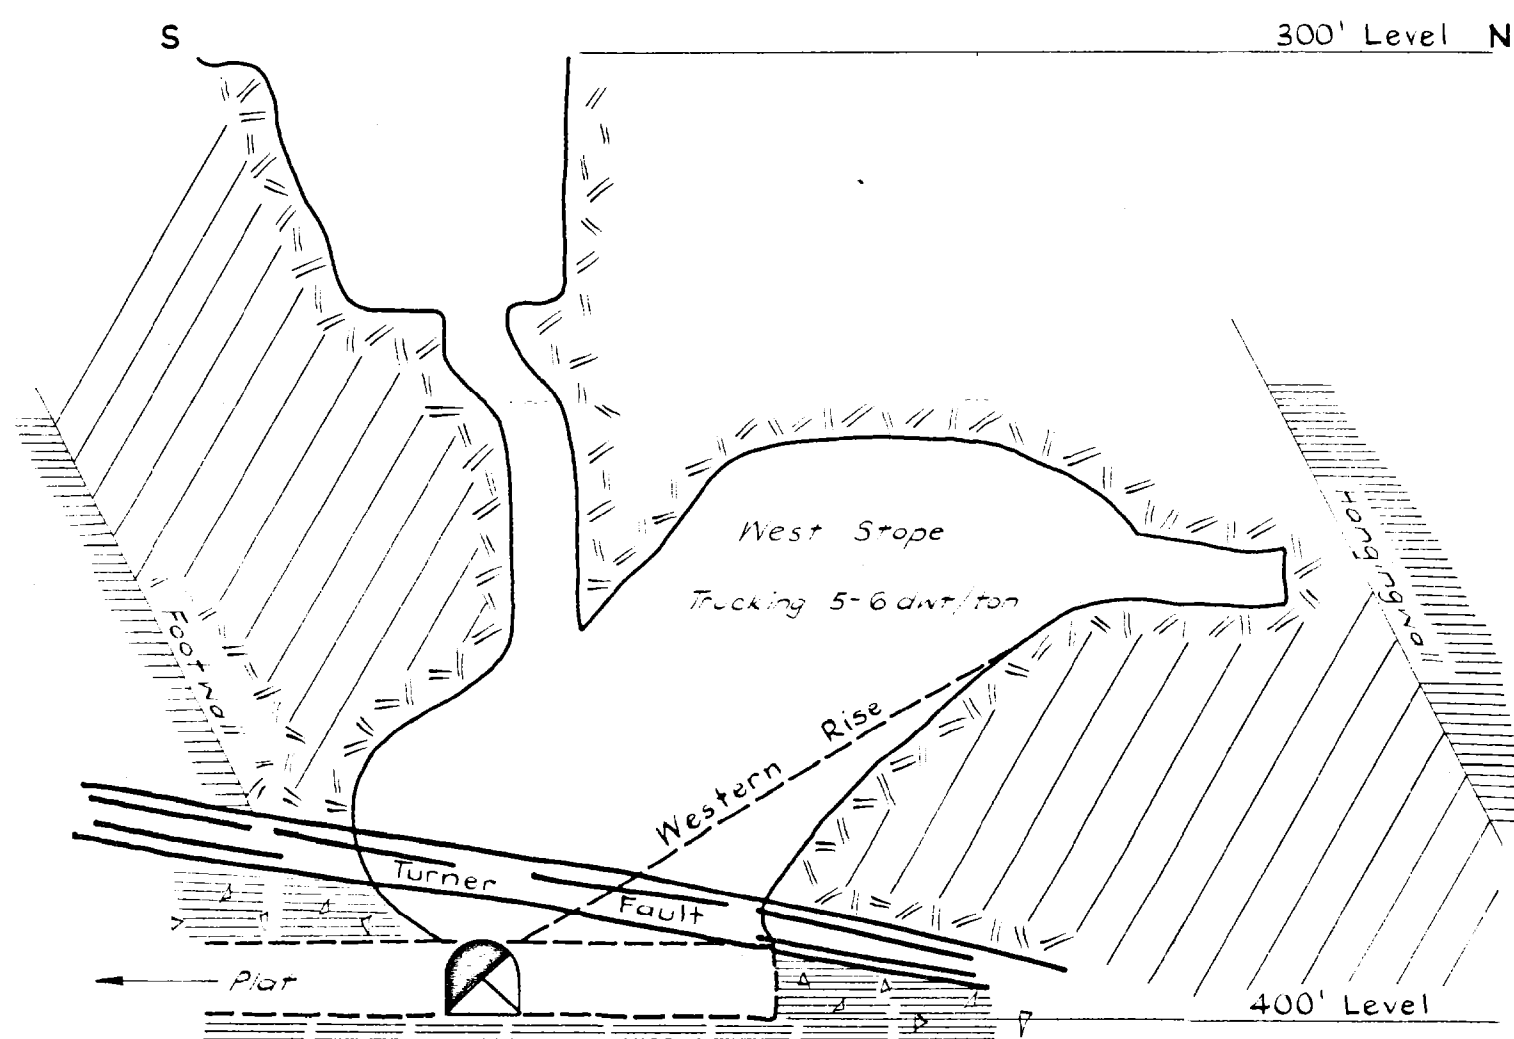
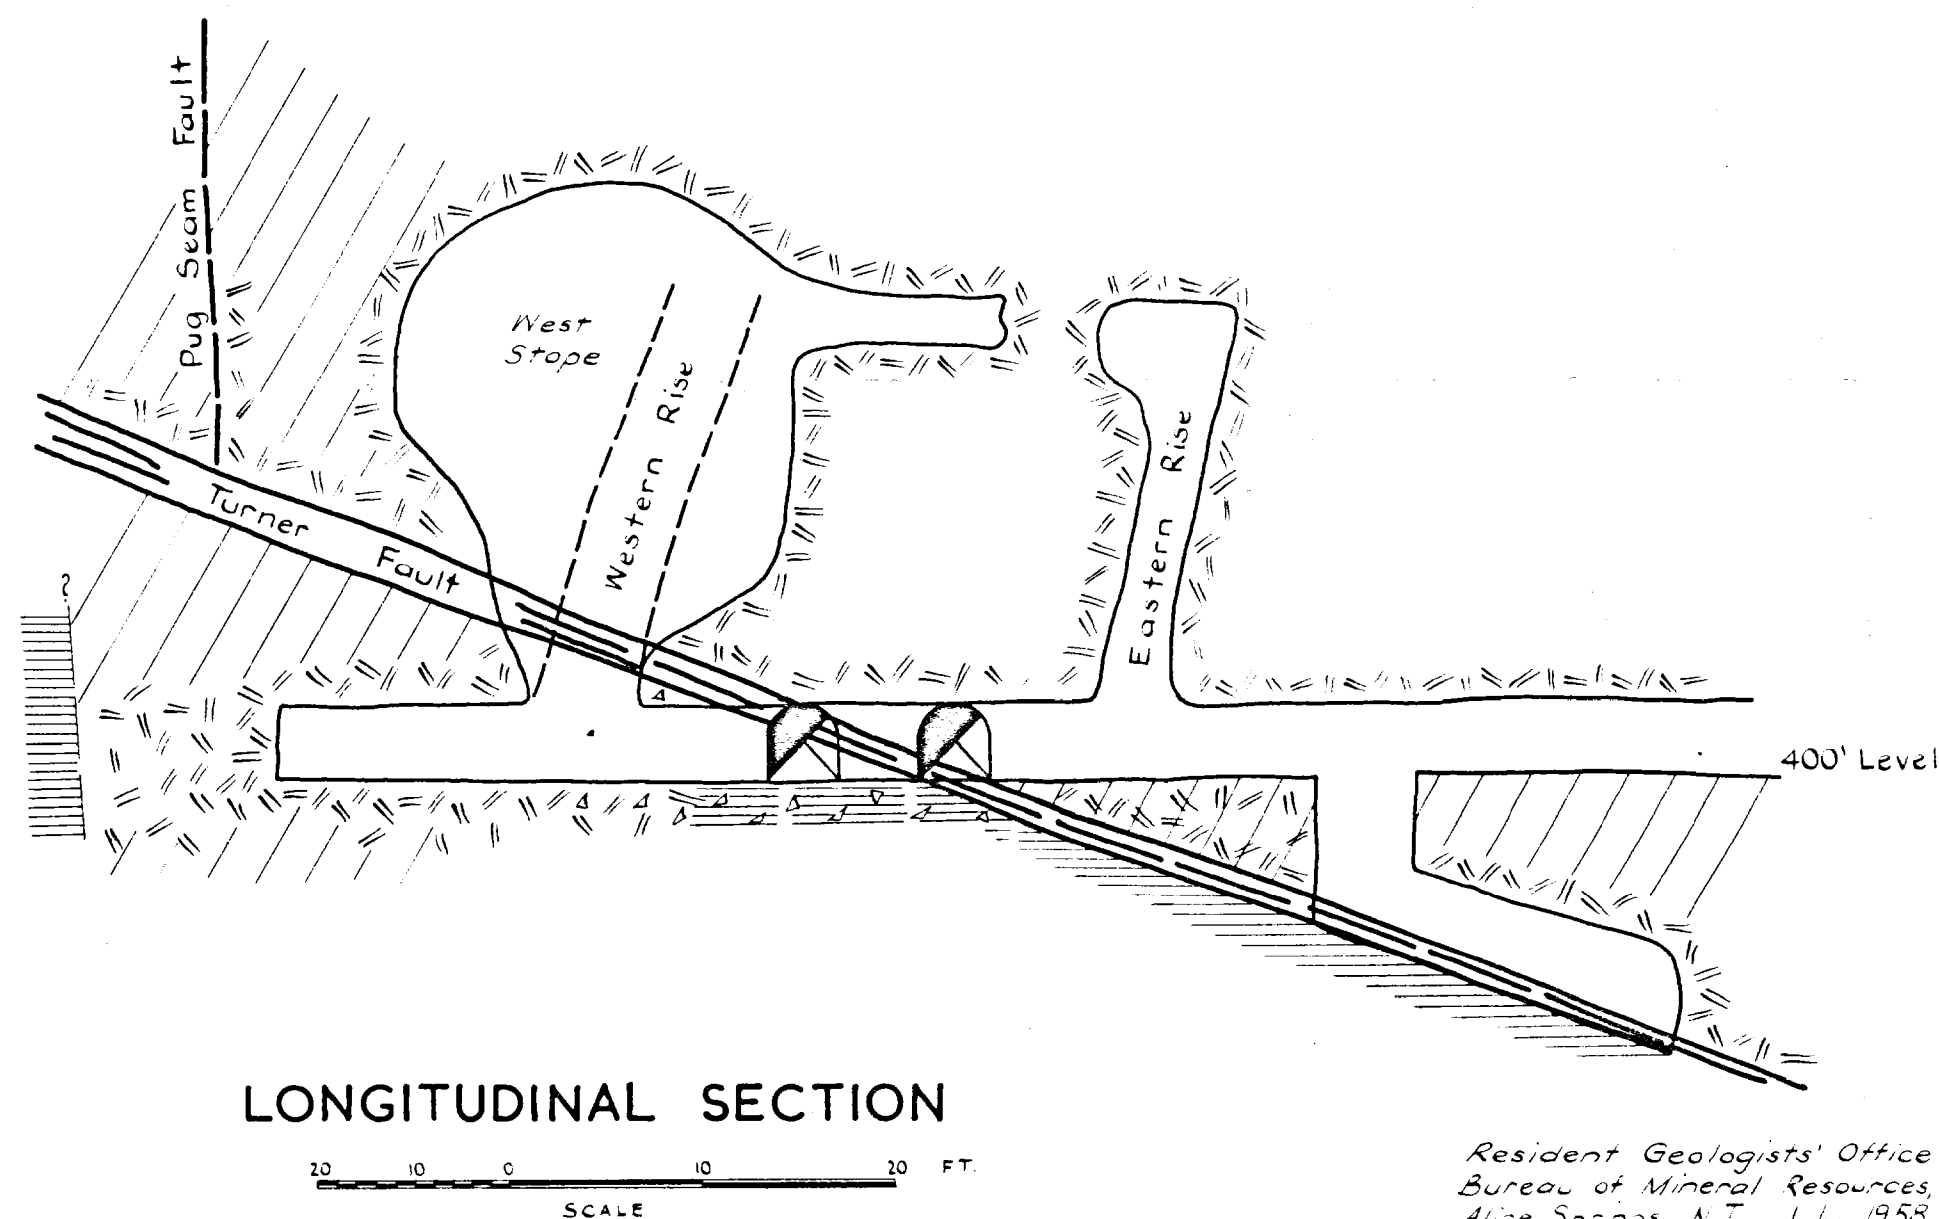
PLAN AND SECTIONS  
WESTERN PART  
400 FOOT LEVEL  
ELDORADO MINE  
TENNANT CREEK, N.T.

2) 300-foot level. Two diamond drill holes were put into the footwall of the orebody in the East Stope between the 300-foot level and the 400-foot level (Plate 5). Some very high assays were returned. Although the grade in this section

- 7) Eastern and northern section of 400-foot level - untested.
- 8) Below 400-foot level and above Turner Fault. A winze to the Turner Fault from the level averaged 10 dwt. per ton for the first 10 feet below the level (Plate 5). The fault was struck at 16 feet in the winze.

2) The footwall of the ironstone between the 300-foot level and the 400-foot level above the western end of the 400-foot level (Plate 5). Two diamond drill holes entered the footwall zone in this area and encountered very high but erratic values. This zone appears to be structurally favourable to the deposition of gold and may also be a locus for secondary enrichment.
