# DEPARTMENT OF NATIONAL DEVELOPMENT. BUREAU OF MINERAL RESOURCES GEOLOGY AND GEOPHYSICS.

RECORDS 1959/21

# GEOLOGICAL RECONNAISSANCE OF THE LALOKI RIVER HYDRO-ELECTRIC PROJECTS - PORT MORESBY

D.E. Gardner and L.C. Noakes

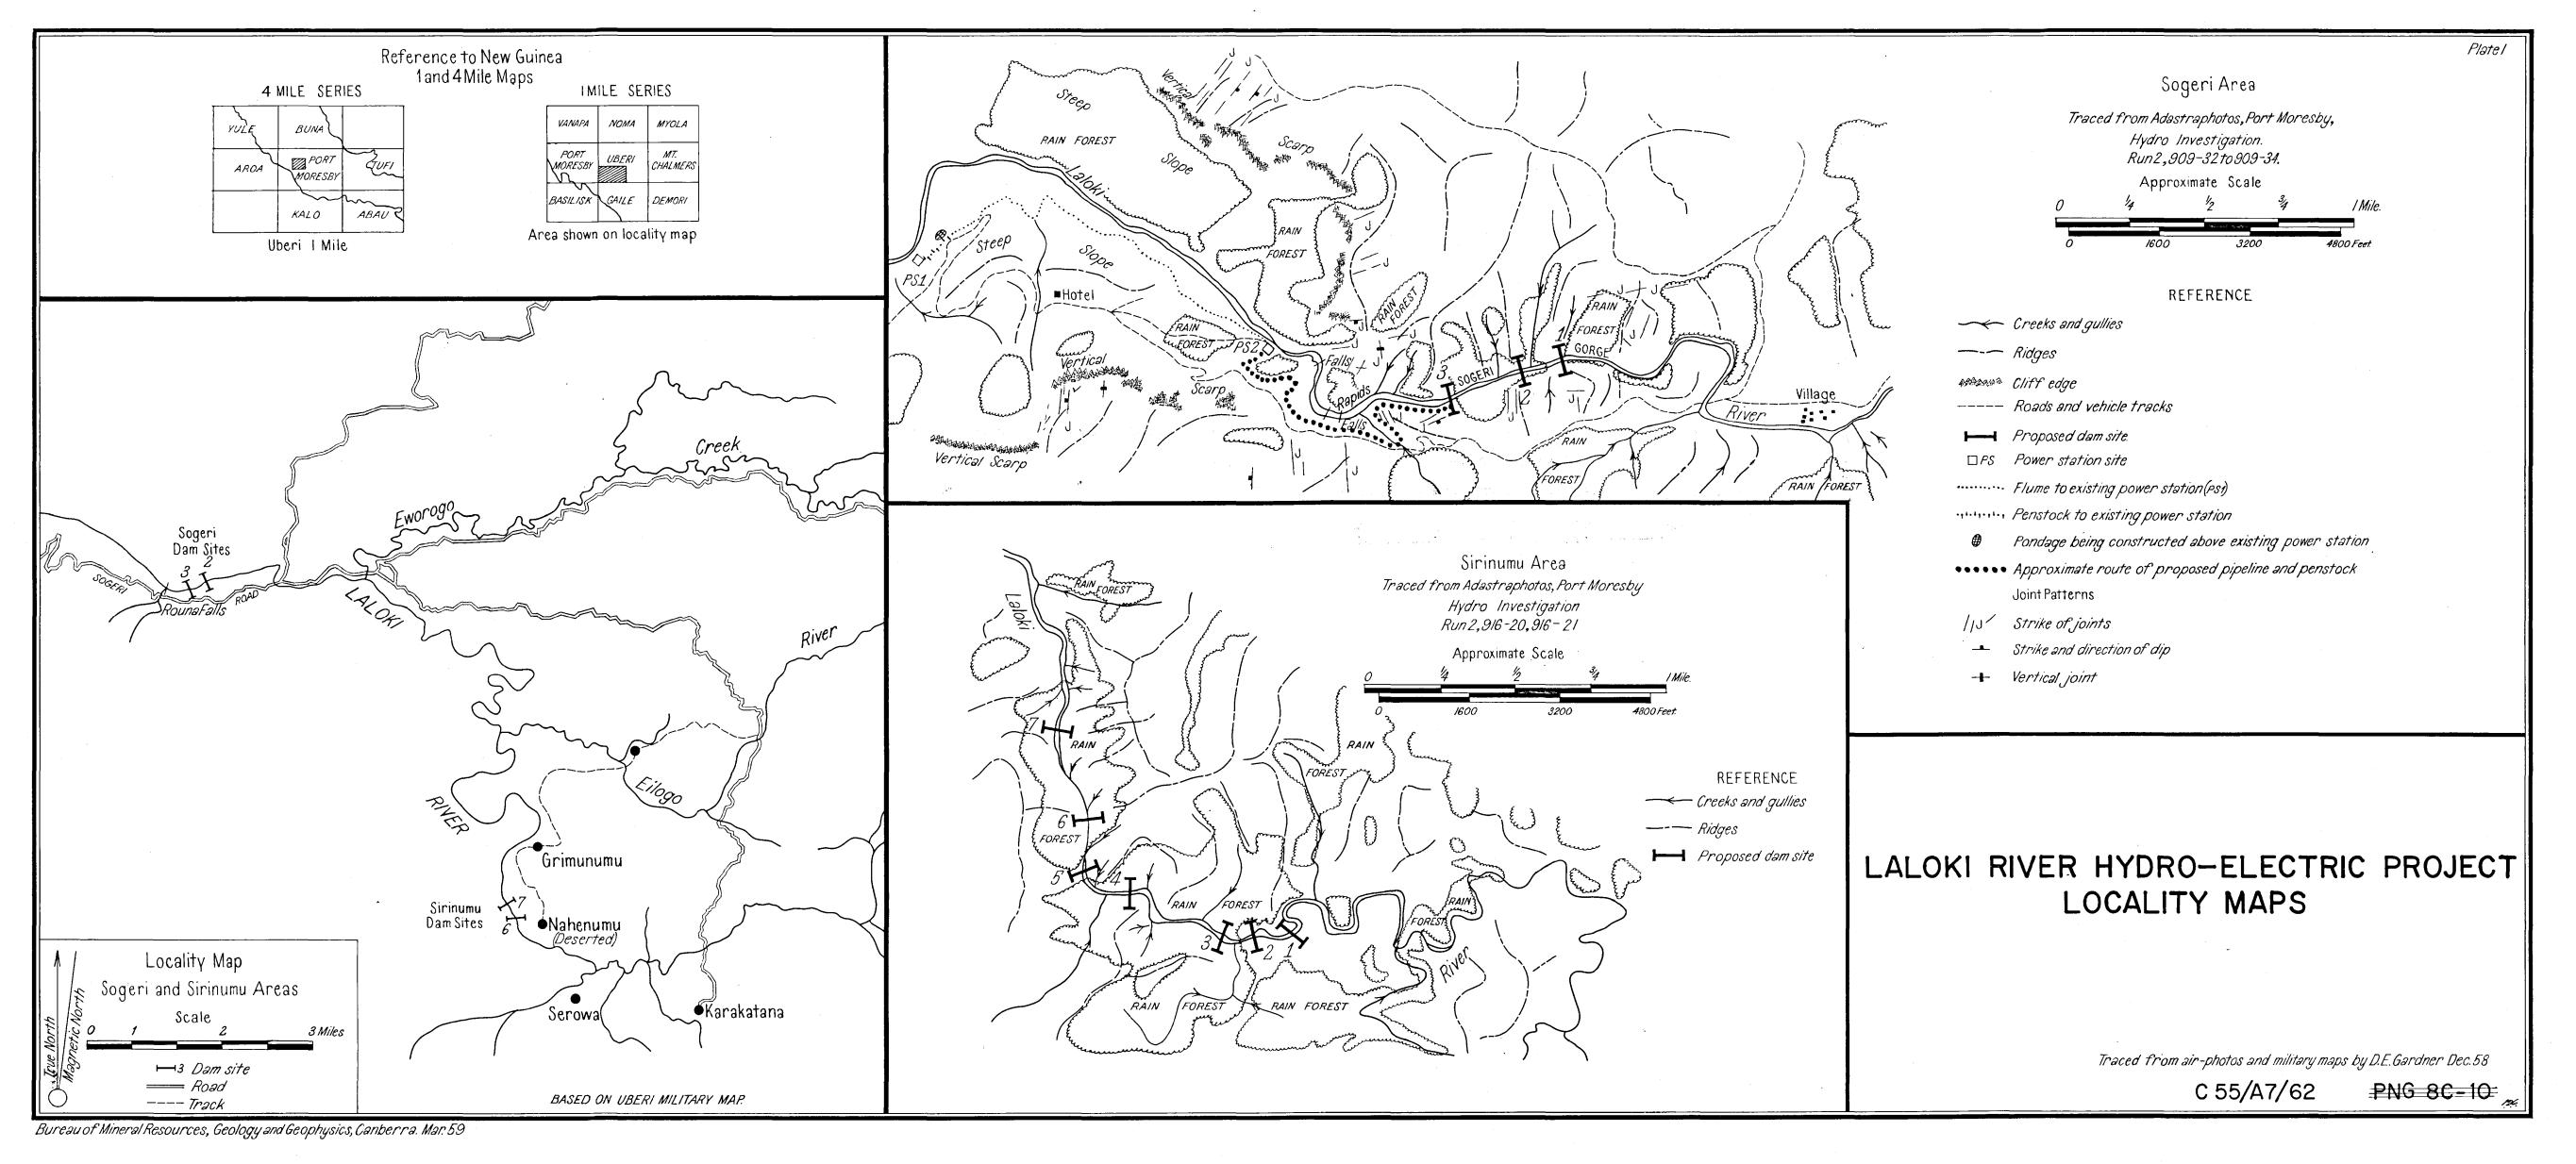
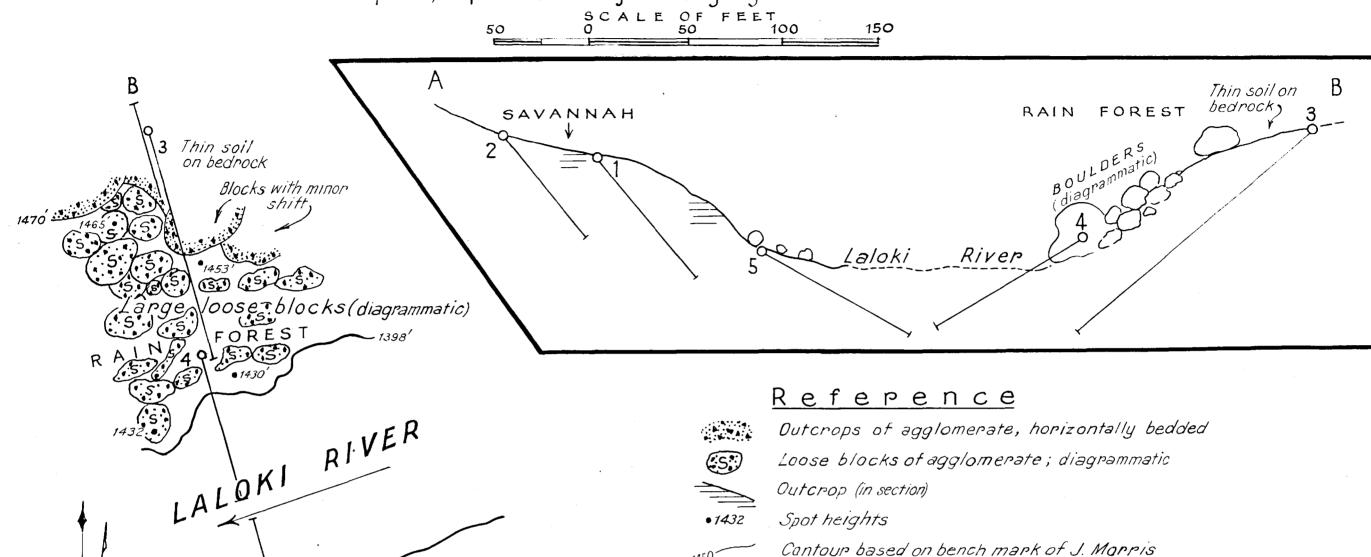
# SOGERI No2 DAM SITE

Sogeri No.2 Dam Site is shown in plan and sections in Plate 2. Levels are based on B.M. 3 shown on a survey plan by J. Morris. Contours are approximate and the loose blocks of agglomerate at the right abutment are shown diagrammatically.

On the right abutment at a distance of 120 feet from the river, where the elevation is 70 feet above the river bed, the valley wall appears to be formed of solid bedrock, in part covered by thin soil. Between this point and the river the terrain consists of a confused mass of slipped and fallen blocks of bedrock, up to 50 feet in diameter. This ground is difficult to traverse because in most places the normal fill of soil and fine detritus has been cleaned out of the revices by river and slope erosion.

The bedrock consists of the horizontally-bedded tuff and agglomerate already described. In the left abutment it is exposed in two definite outcrops; a number of small exposures appear to be in situ. In the right abutment, bedrock is exposed in the large outcrop mentioned under "Topography", 70 feet above river level and 120 feet back from the margin of the river. Over much of the left abutment the surface is underlain by soil and clay. However, the benched profile of the site and the occurrences of small exposures likely to be in situ suggest that the superficial cover may not exceed 5 - 10 feet up to 50 feet above river level. It is expected that the bedrock will have adequate strength for foundations for a dam at a depth of a few feet below its surface.

Parallel joints and shearing which might indicate structural weakness at the site were not observed although some nearsurface cracking due to unloading of the strata would be expected.

The preliminary geological survey indicates that further investigation of dam site No.2 and ultimate construction work would be more costly than at No.3 site. It is suggested that the level of the river bed at each site should be checked to establish accurately the loss of hydraulic head between the two sites. This will guard against any error having been made in recognition of the bench marks during the geological survey. It could well be that by comparison of profiles alone, the Department will favour Site 3 without further investigation of Site 2. Should additional work be undertaken, however, it is suggested that No.2 site be tested initially by diamond drilling and later, if the drilling results are satisfactory by carrying out routine mechanical tests on samples of bedrock.

Two drill holes, No.1 and No.2 aggregating 140 feet of drilling are recommended to test the left abutment. The right abutment presents considerable difficulty in access. It will be necessary to remove large loose blocks and drill the bedrock beneath them, or alternatively to do sufficient blasting and filling of holes to provide a track to move the drilling plant up to solid bedrock, where a platform may need to be cut for it. This latter method is recommended. Hole No.3, which is 160 feet long can then be drilled through the bedrock beneath the loose blocks approximately parallel to the slope of the valley wall. The river bed should be tested by drill holes 4 and 5, each 90 feet long, put down from either bank.

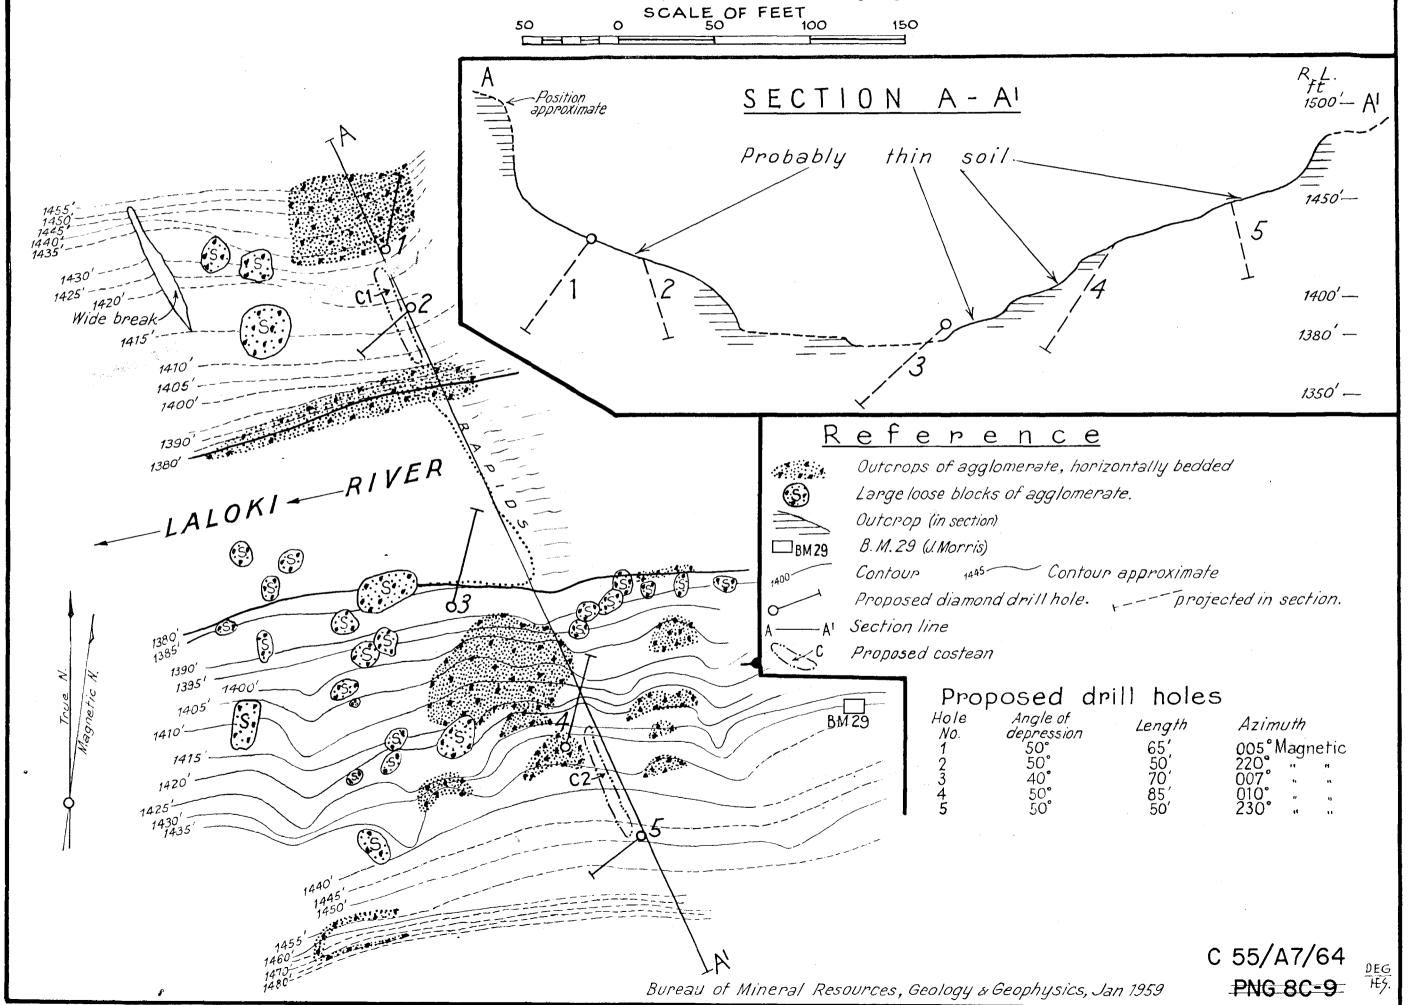
PRELIMINARY GEOLOGICAL INVESTIGATION

Sogeri No.3 dam site is shown in planand section in Plate 3. Levels are based on B.M. 29 shown on the survey plan by J. Morris. Contours on the southern or left hand side of the river are reasonably accurate within the limits of the 5 foot contour interval. On the northern side a few points were plotted accurately in the vicinity of the possible weir-axis and contours were sketched in. The profile at the dam site is symmetrical and the surface consists of outcrop or bedrock beneath a thin cover of soil. Vegetation is sparse. The left abutment is in a steep slope that extends at least 200 feet down-stream and a similar distance up-stream. The right abutment is in a steep slope consisting mainly of bare rock, that extends approximately 200 feet parallel to the river. Both down-stream and up-stream from the probable axis the contours recede sharply in areas of broken and probably gullied rock covered by dense rain forest. The river bed, formed of bare rock covered by shallow water, is 80 to 100 feet wide. At 50 feet vertically above it the valley width is less than 300 feet and at 100 feet above it the valley width is

As is the case at No.2 site, the bedrock consists of horizontally-bedded tuff and agglomerate which probably has adequate strength for foundations at a depth of a few feet below its surface. Where bare rock does not crop out at the surface, the soil cover appears to be thin; it is probably less than 2 feet thick over the greater part of the area and may have a maximum thickness of about 5 feet. No large loose blocks are present along the probable axis of the site.

Some vertical channels a couple of feet wide cross the river bed approximately parallel to the contour that marks the edge of the rapids shown in Plate 3. These have probably formed through erosion along a direction of jointing.

It is suggested that No.2 site be investigated initially by diamond drilling and costeaning. Later, if the results are satisfactory, samples of bedrock could be obtained from the cores and subjected to routine laboratory tests of their mechanical properties.

The suggested drill holes are sited at an angle to the weir axis in order to intersect possible major joints or fractures parallel to the erosion channels seen in the river bed. Hole No.1 is intended, in addition, to test the bedrock slightly up-stream from the right abutment, in the locality where the contours recede from the river. Hole No.2 is approximately parallel to the valley wall at the right abutment. Hole No.3 is to test the river bed in the vicinity of the rapids. If this hole is satisfactory it is doubtful whether testing of the river bed below the solid right abutment is warranted. Hole No.4 on the right abutment is for the purpose of checking the soundness of the bedrock between and below the nearby outcrops. Hole No.5 is located at the 1450 foot contour in order to investigate the bedrock below the cliff that follows the 1460 foot contour.

It is recommended that the bedrock beneath the grassy slopes on or above each abutment be exposed in costeans C1 and C2, shown in Plate 3.
