GEOLOGICAL REPORT ON DAM SITE NO. 6, SIRINUMU

UPPER LALOKI RIVER,

Central District, Papua.

Record 1960/7

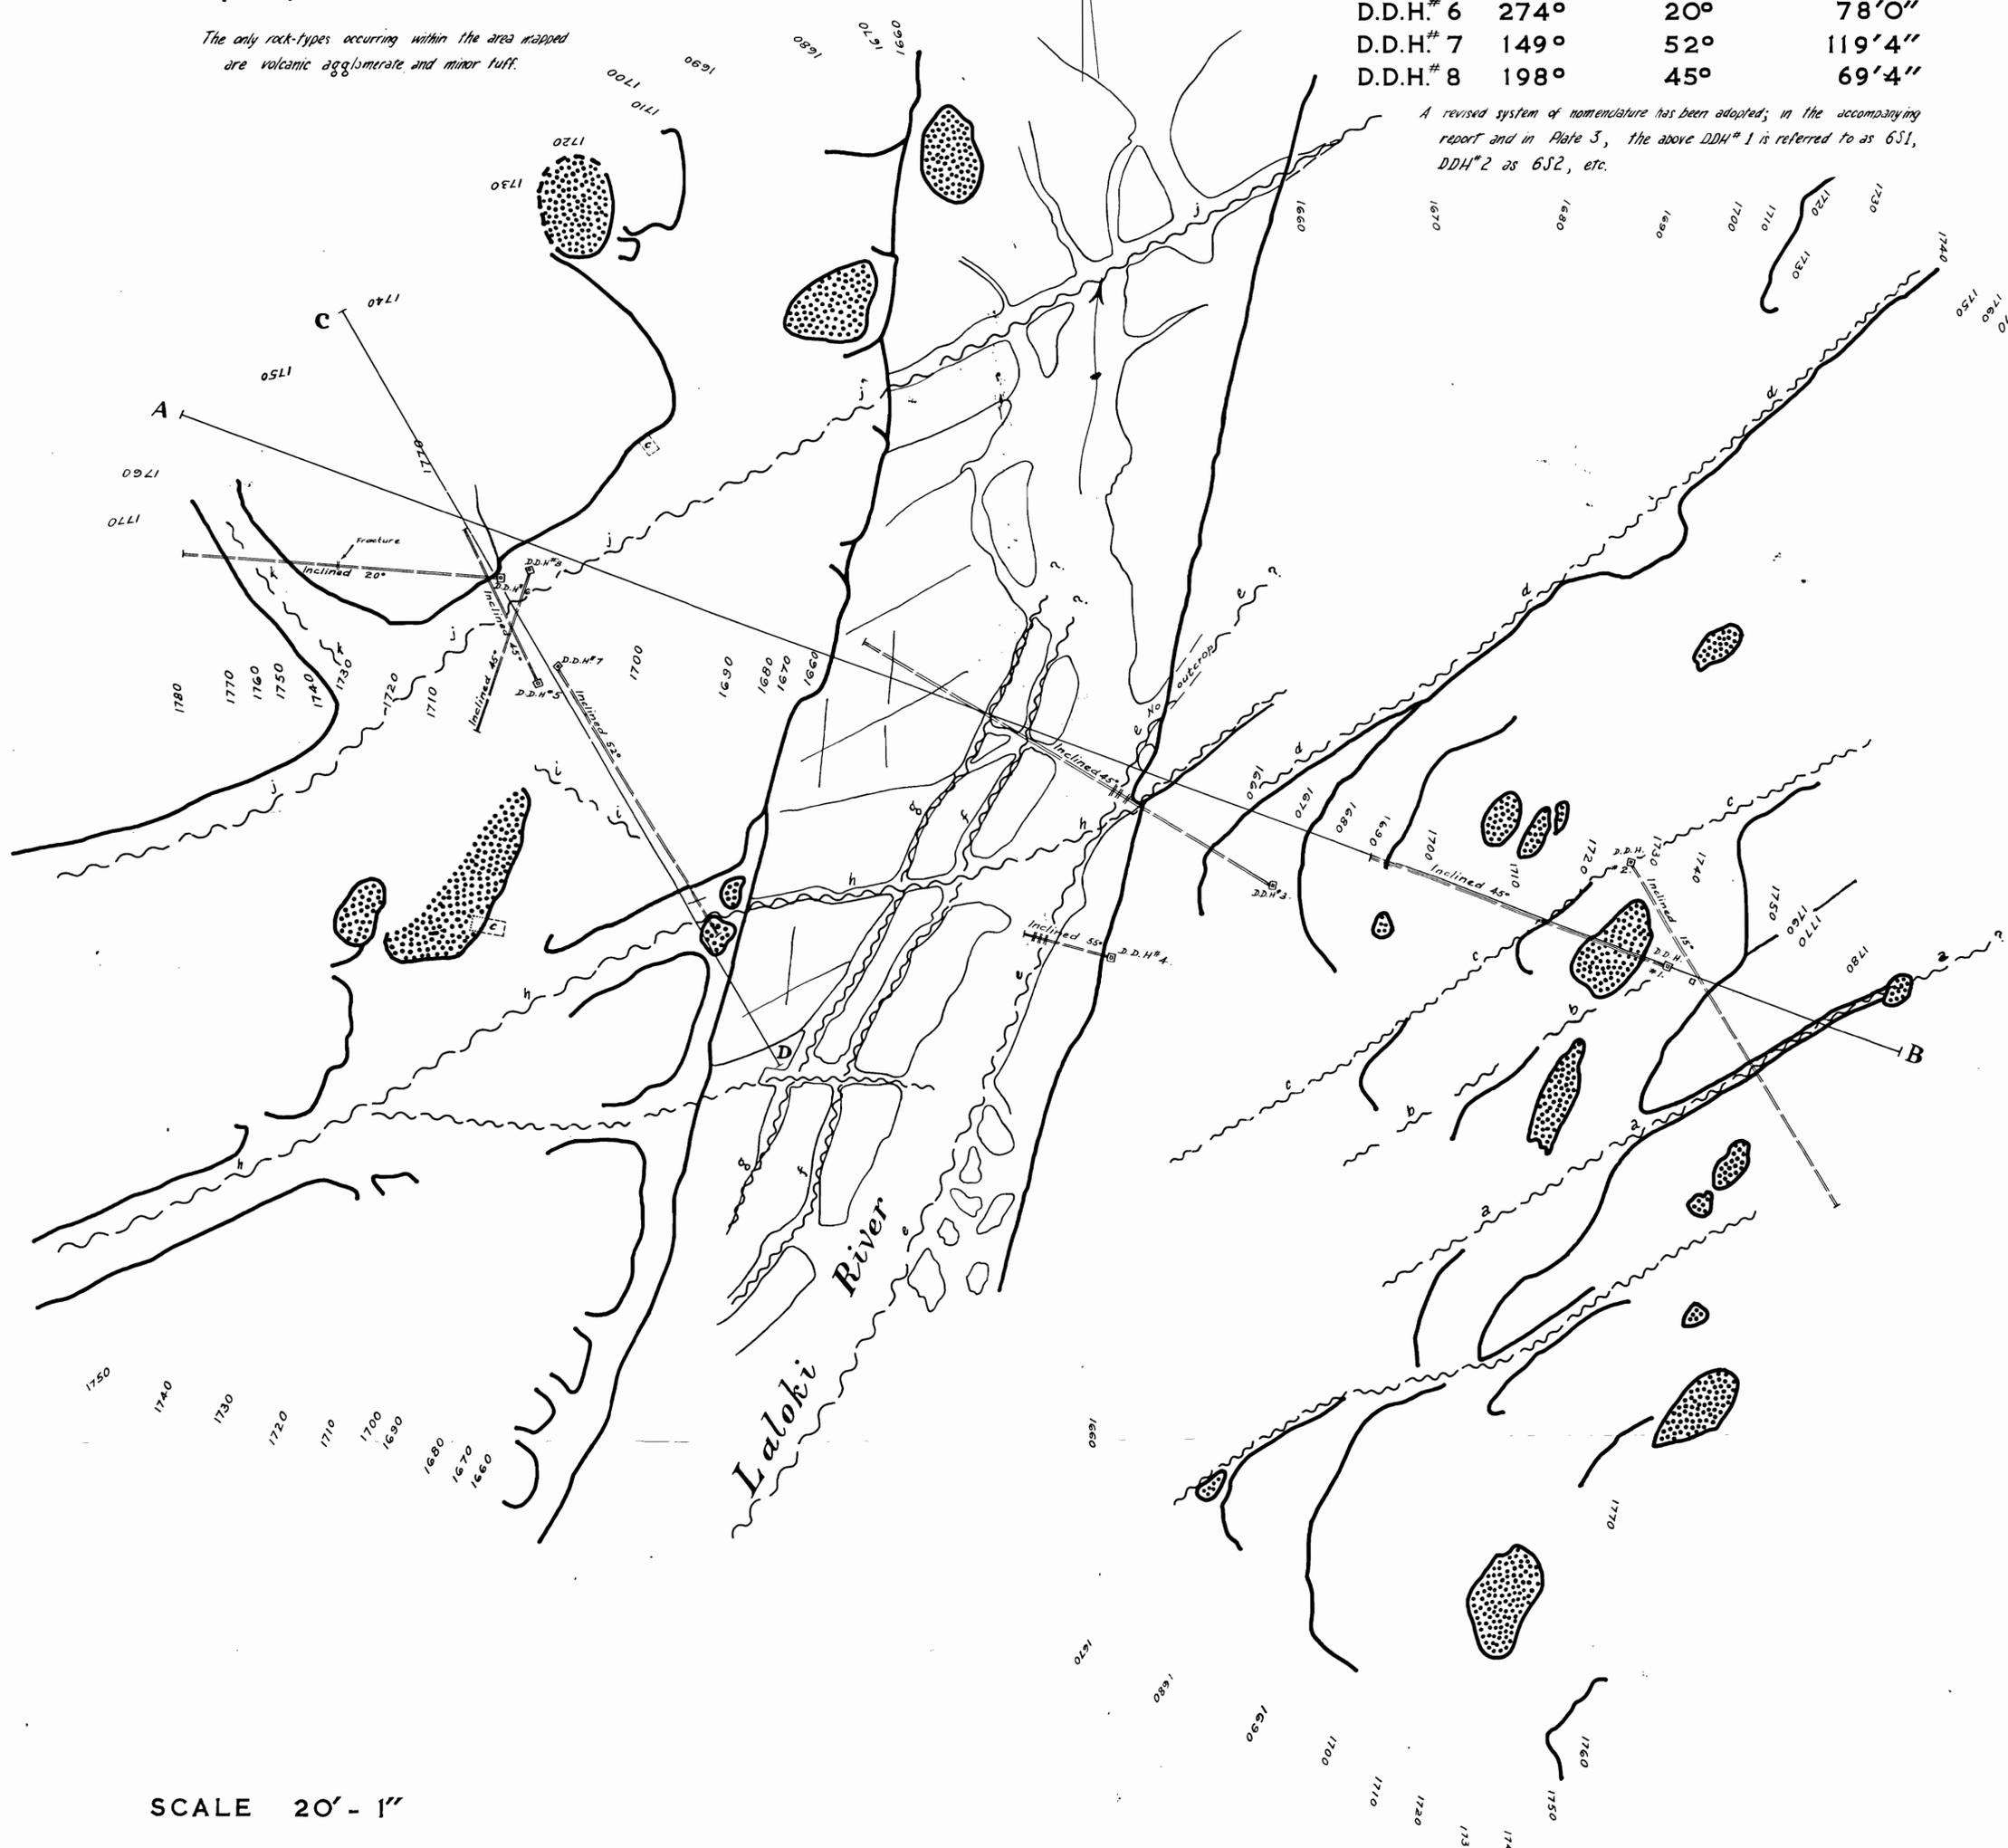
SIRINUMU N°6 DAM SITE

The only rock-types occurring within the area mapped are volcanic agglomerate and minor tuff.

A revised system of nomenclature has been adopted; in the accompanying report and in Plate 3, the above DDH# 1 is referred to as 6S1, DDH# 2 as 6S2, etc.

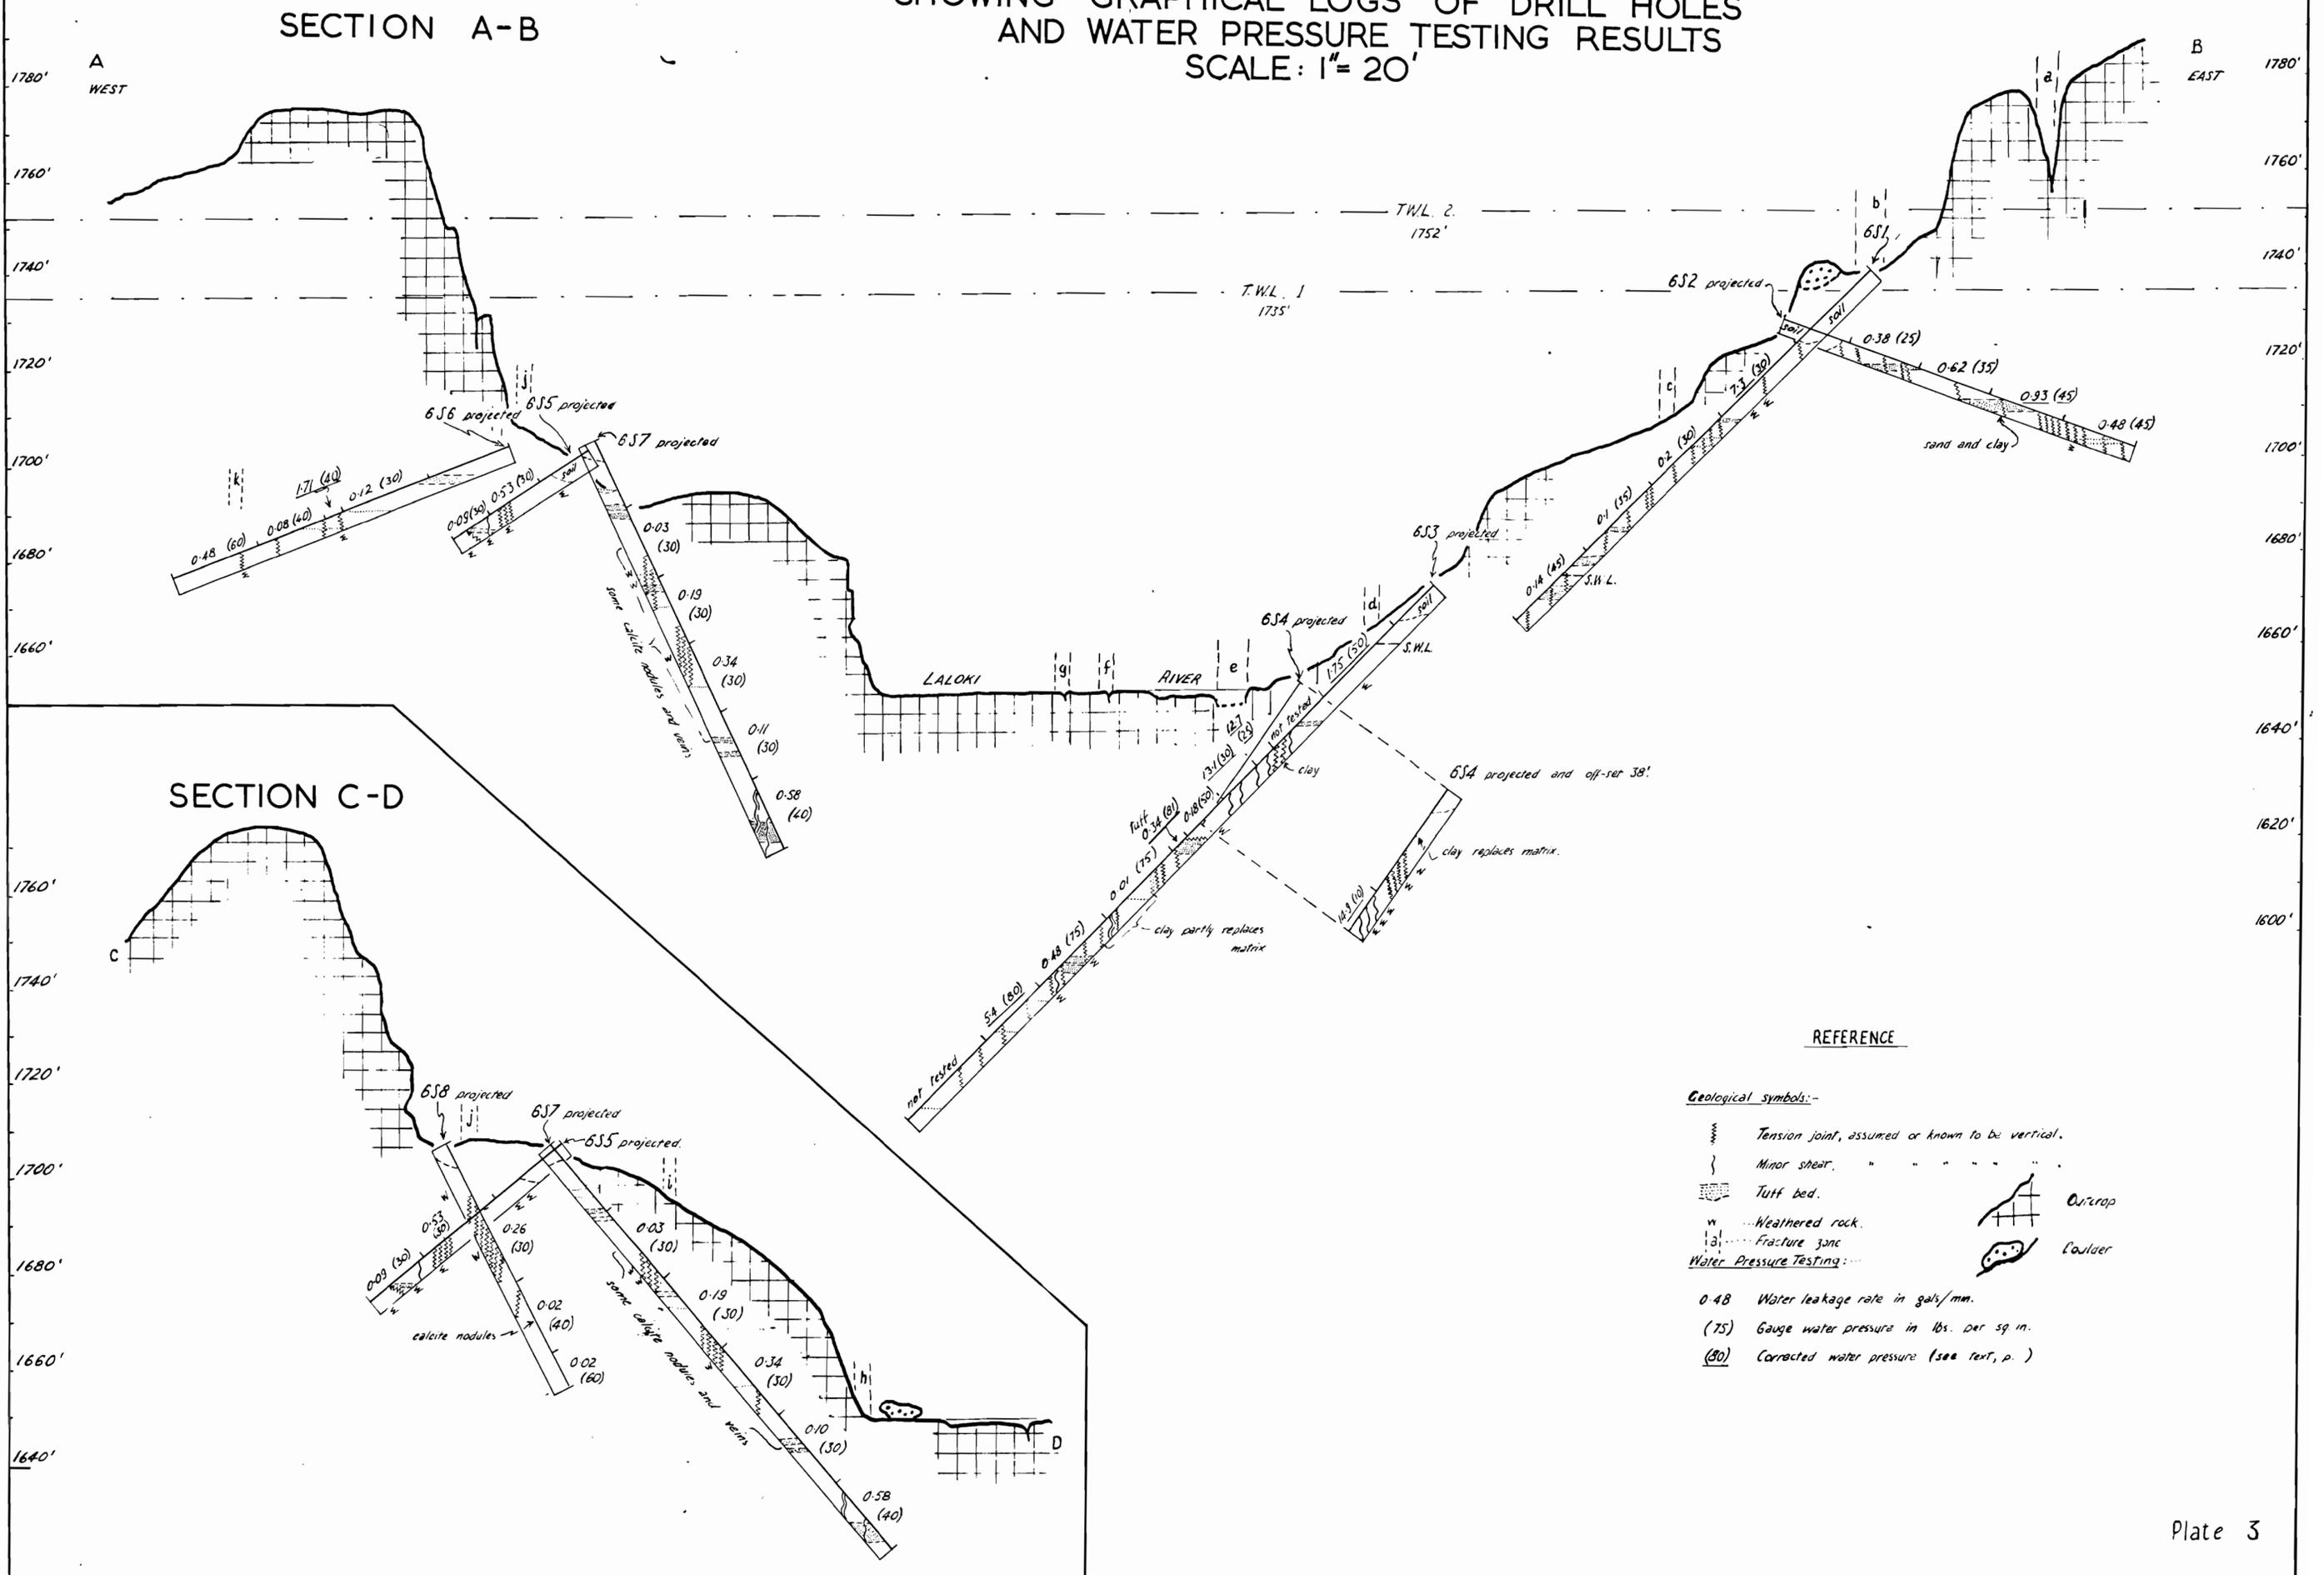
SECTIONS — SIRINUMU DAMSITE No.6

Lateral variation in grain-size within any one bed makes it difficult to relate the stratigraphic succession at one point to that at another. Some tuff beds are lenticular suggesting old stream beds or ponds. However, horizons in which tuff predominates can be recognized. The most conspicuous of these is that exposed at between RL 1705' and RL 1715' on both abutments and in DDH 6S2, whilst others occur at RL 1670' and RL 1620' approximately (see Plate 3).

SHOWING GRAPHICAL LOGS OF DRILL HOLES AND WATER PRESSURE TESTING RESULTS
