1960/102

GEOLOGICAL REPORT ON DESIGN INVESTIGATION OF SIRINUMU DAM  
AND SPILLWAY AREA, UPPER LALOKI RIVER, NEAR PORT MORESBY, PAPUA.

J.E. Thompson

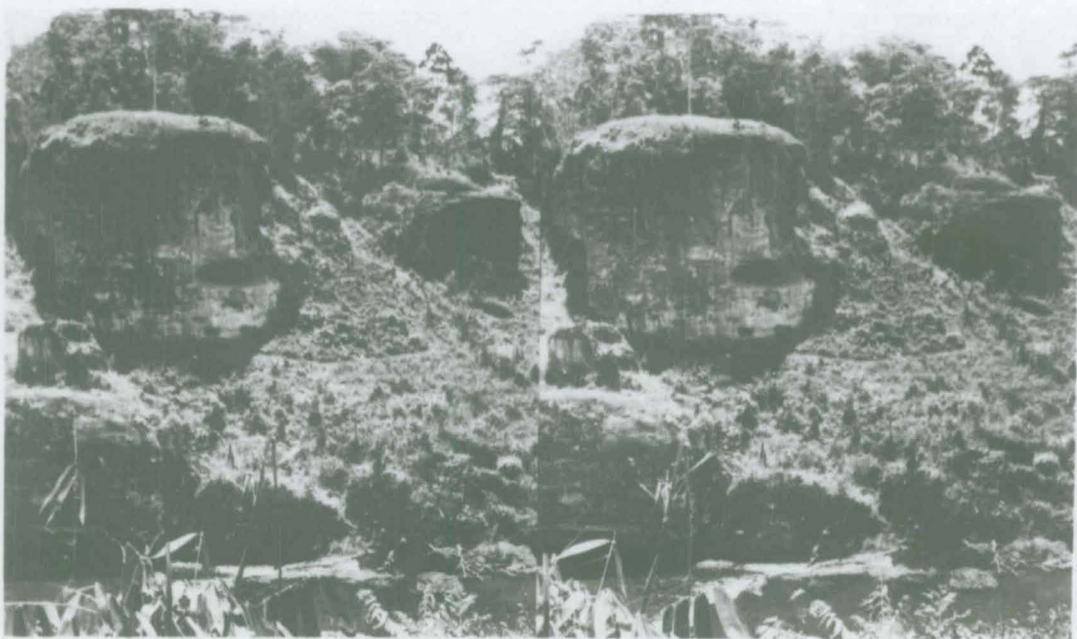
Fig. 2 . Stereo pair of photos showing right abutment  
for the dam .

The prominences, on both sides of the river, which provide the abutments for the dam are bounded by near-vertical joint faces and are cut into several rocky bluffs by valleys which have obviously developed along a fracture system that strikes about  $050^{\circ}$  magnetic.

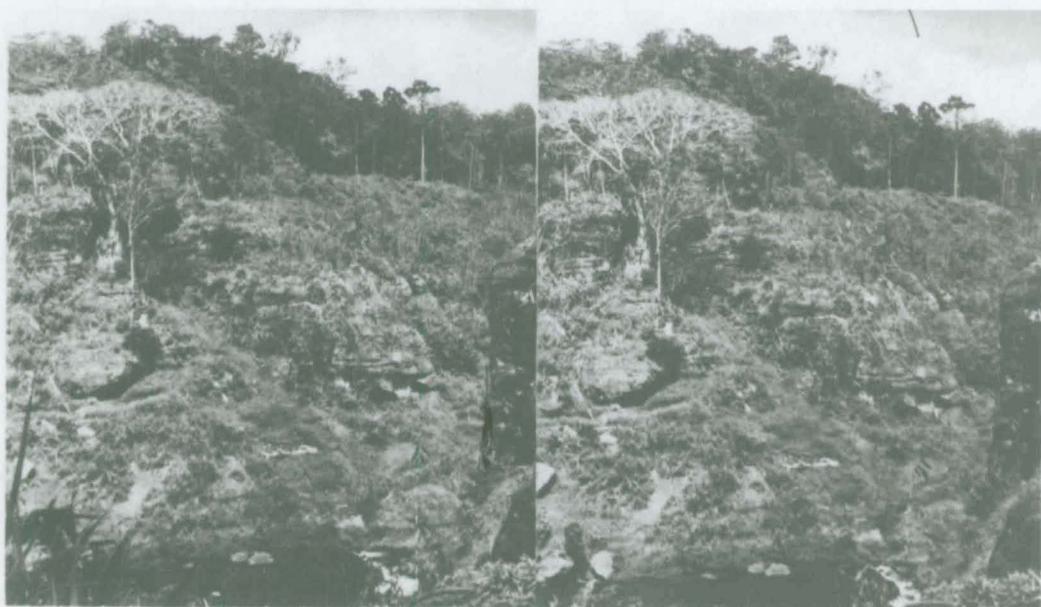
Fig. 3. Stereo pair of photos showing left abutment  
for the dam.

On the left bank, deepest overburden is at the base of the abutment cliffs, particularly near the principal joints. Diamond drill hole SDD 3, located over the large tension joint near the left abutment, passed through 18 ft 6 ins of overburden before entering the decomposed rock layer, and an auger hole nearby penetrated to 13 feet. Except near the base of the cliffs and over the deeply weathered joints, overburden ranges in thickness from 3 ft to 8 ft. Large slumped blocks of agglomerate are littered over the surface of the left bank foundation area.

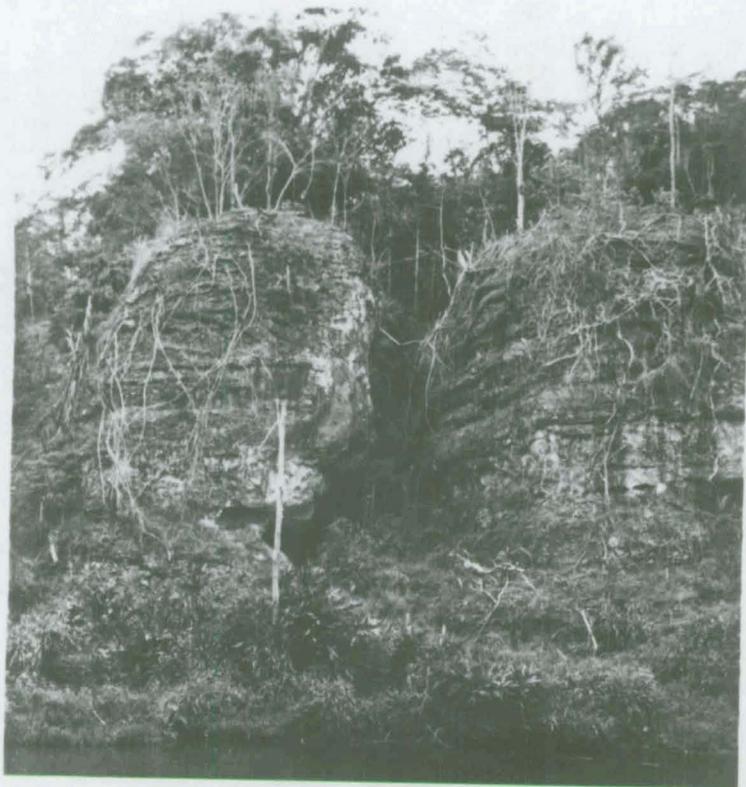
Fig. 4. Steep gully in left bank upstream from the upstream toe of the proposed dam, formed by erosion of a joint.

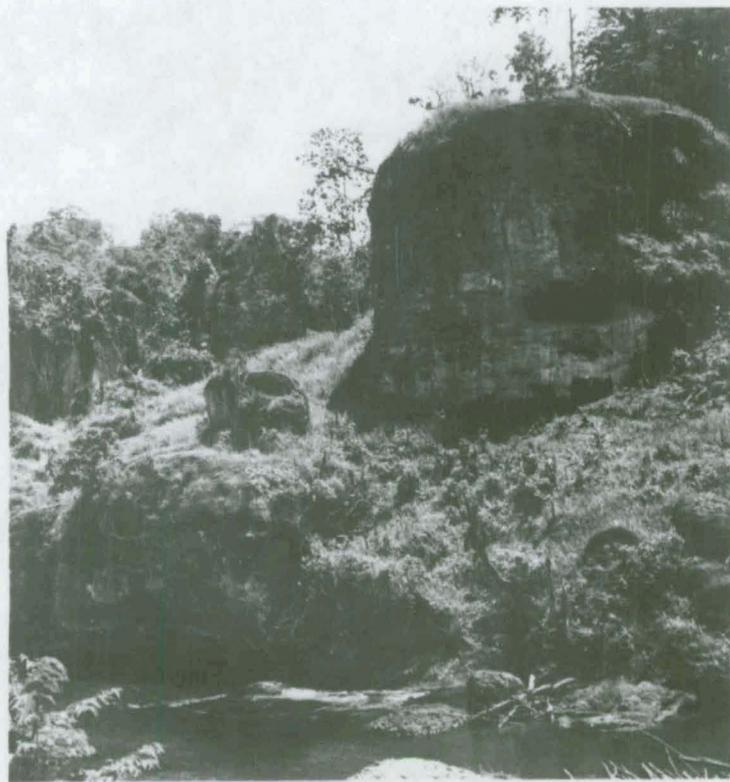
In the abutment cliffs, particularly on the right bank, several small caves and scour holes have been formed by river erosion of loosely aggregated patches of agglomerate and tuff

Fig. 5. Right abutment of the proposed dam showing scour holes in a tuff bed at the base of the cliff.

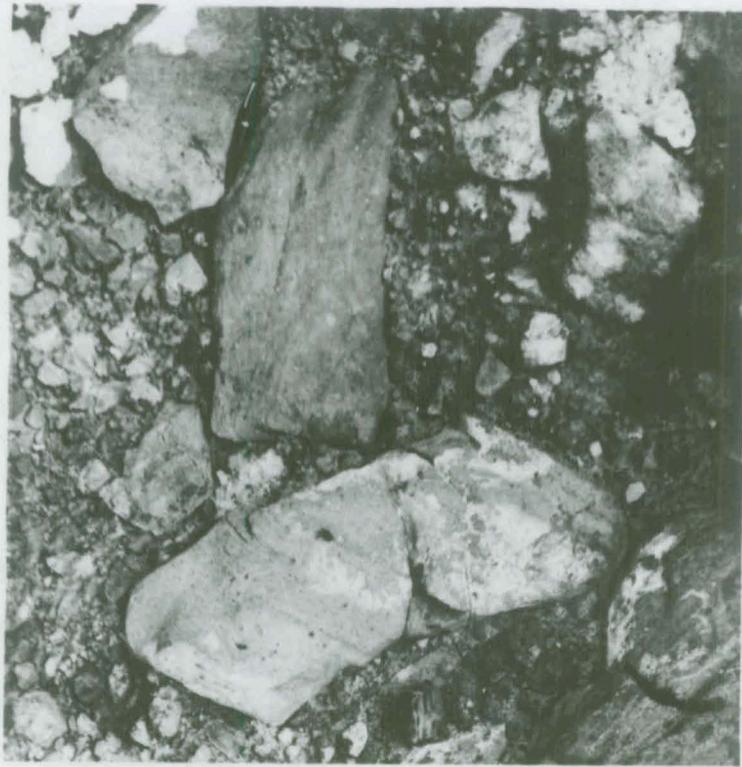
Fig. 6. Poorly-sorted coarse-grained agglomerate of the Astrolabe Agglomerate. Scale is indicated by the pen.

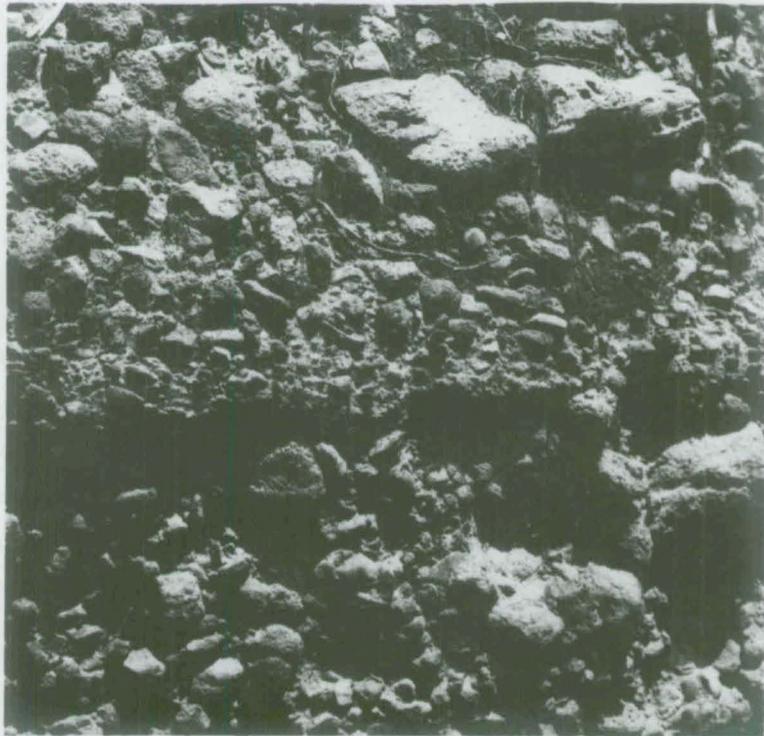
Fig. 7. Medium-grained Astrolabe Agglomerate. Note the relief produced by the preferential weathering of the matrix.

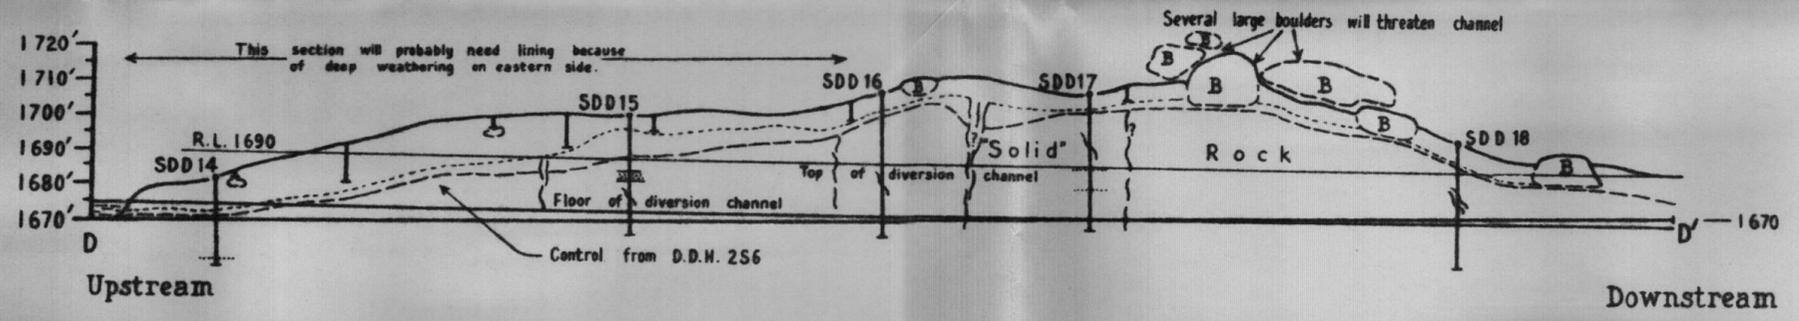
3A. ALONG AXIS OF DIVERSION CHANNEL ON RIGHT BANK

\* The following correction to Plate II should be noted: Plate II, Fig. 3A - From a point about 15 feet upstream of SDD 18 to the right side of the figure the "very weathered" - "weathered" rock boundary should be less than 2 feet above the "solid" rock boundary.

Vertical diamond drill holes SDD 14, 15, 16, 17 and 18 were drilled along the axis of the proposed diversion channel line on the right bank to determine the "bedrock" profile and examine the underlying rock in which the channel will be cut. The inclined diamond drill hole 2S6, which was drilled during the early investigation to intersect a possible fracture, passed through the diversion channel line midway between SDD 14 and SDD 15.
