DEPARTMENT OF NATIONAL DEVELOPMENT.
BUREAU OF MINERAL RESOURCES
GEOLOGY AND GEOPHYSICS.

REPORT ON EXPLORATORY DRILLING,
UPPER RAMU HYDRO-ELECTRIC PROJECT.

JUNE 1963

J.K. Hill

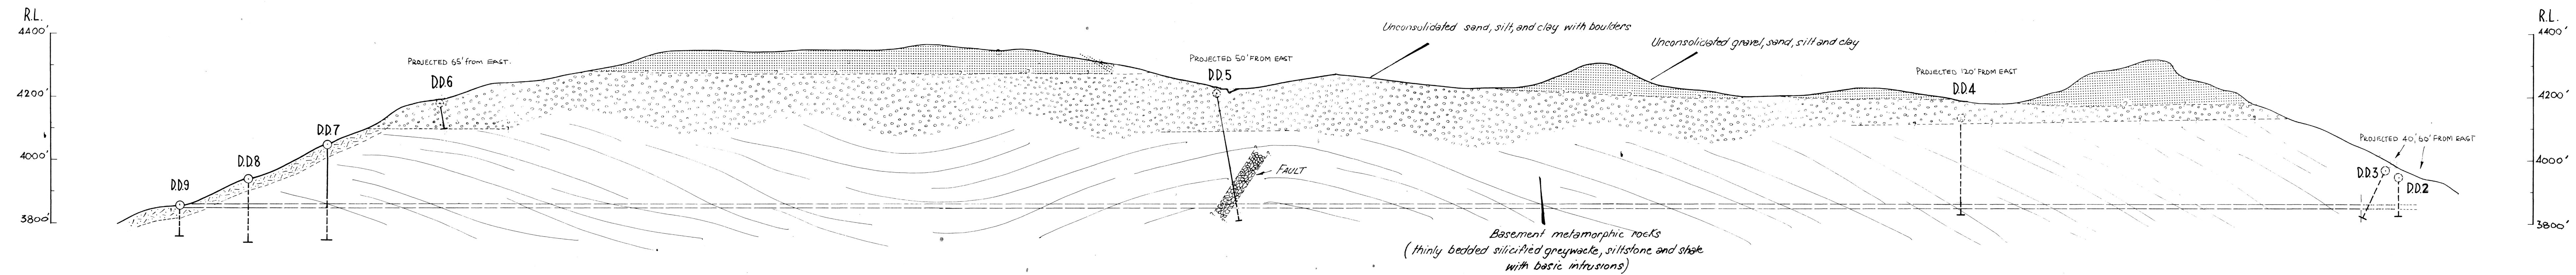
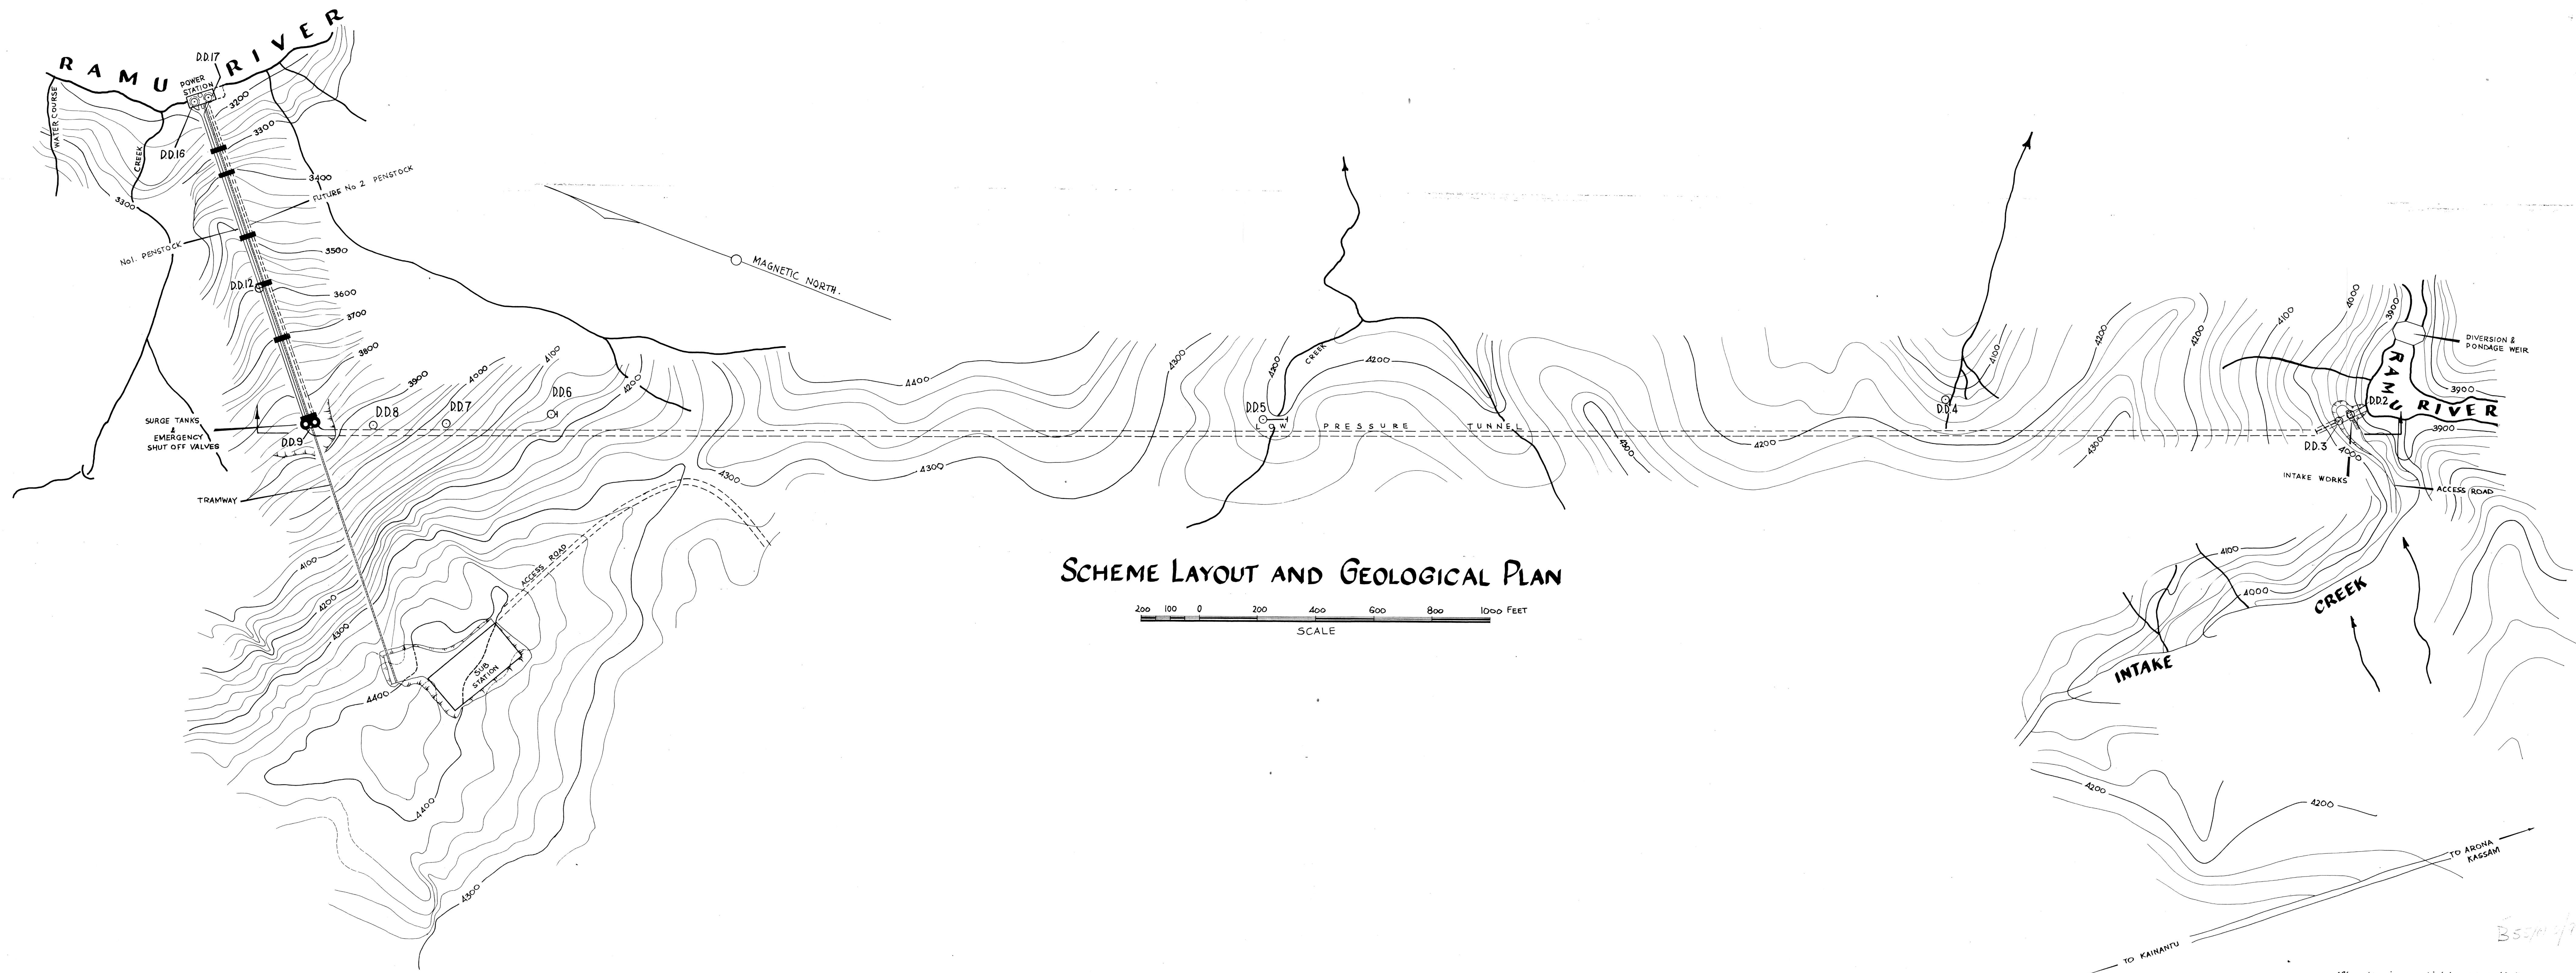
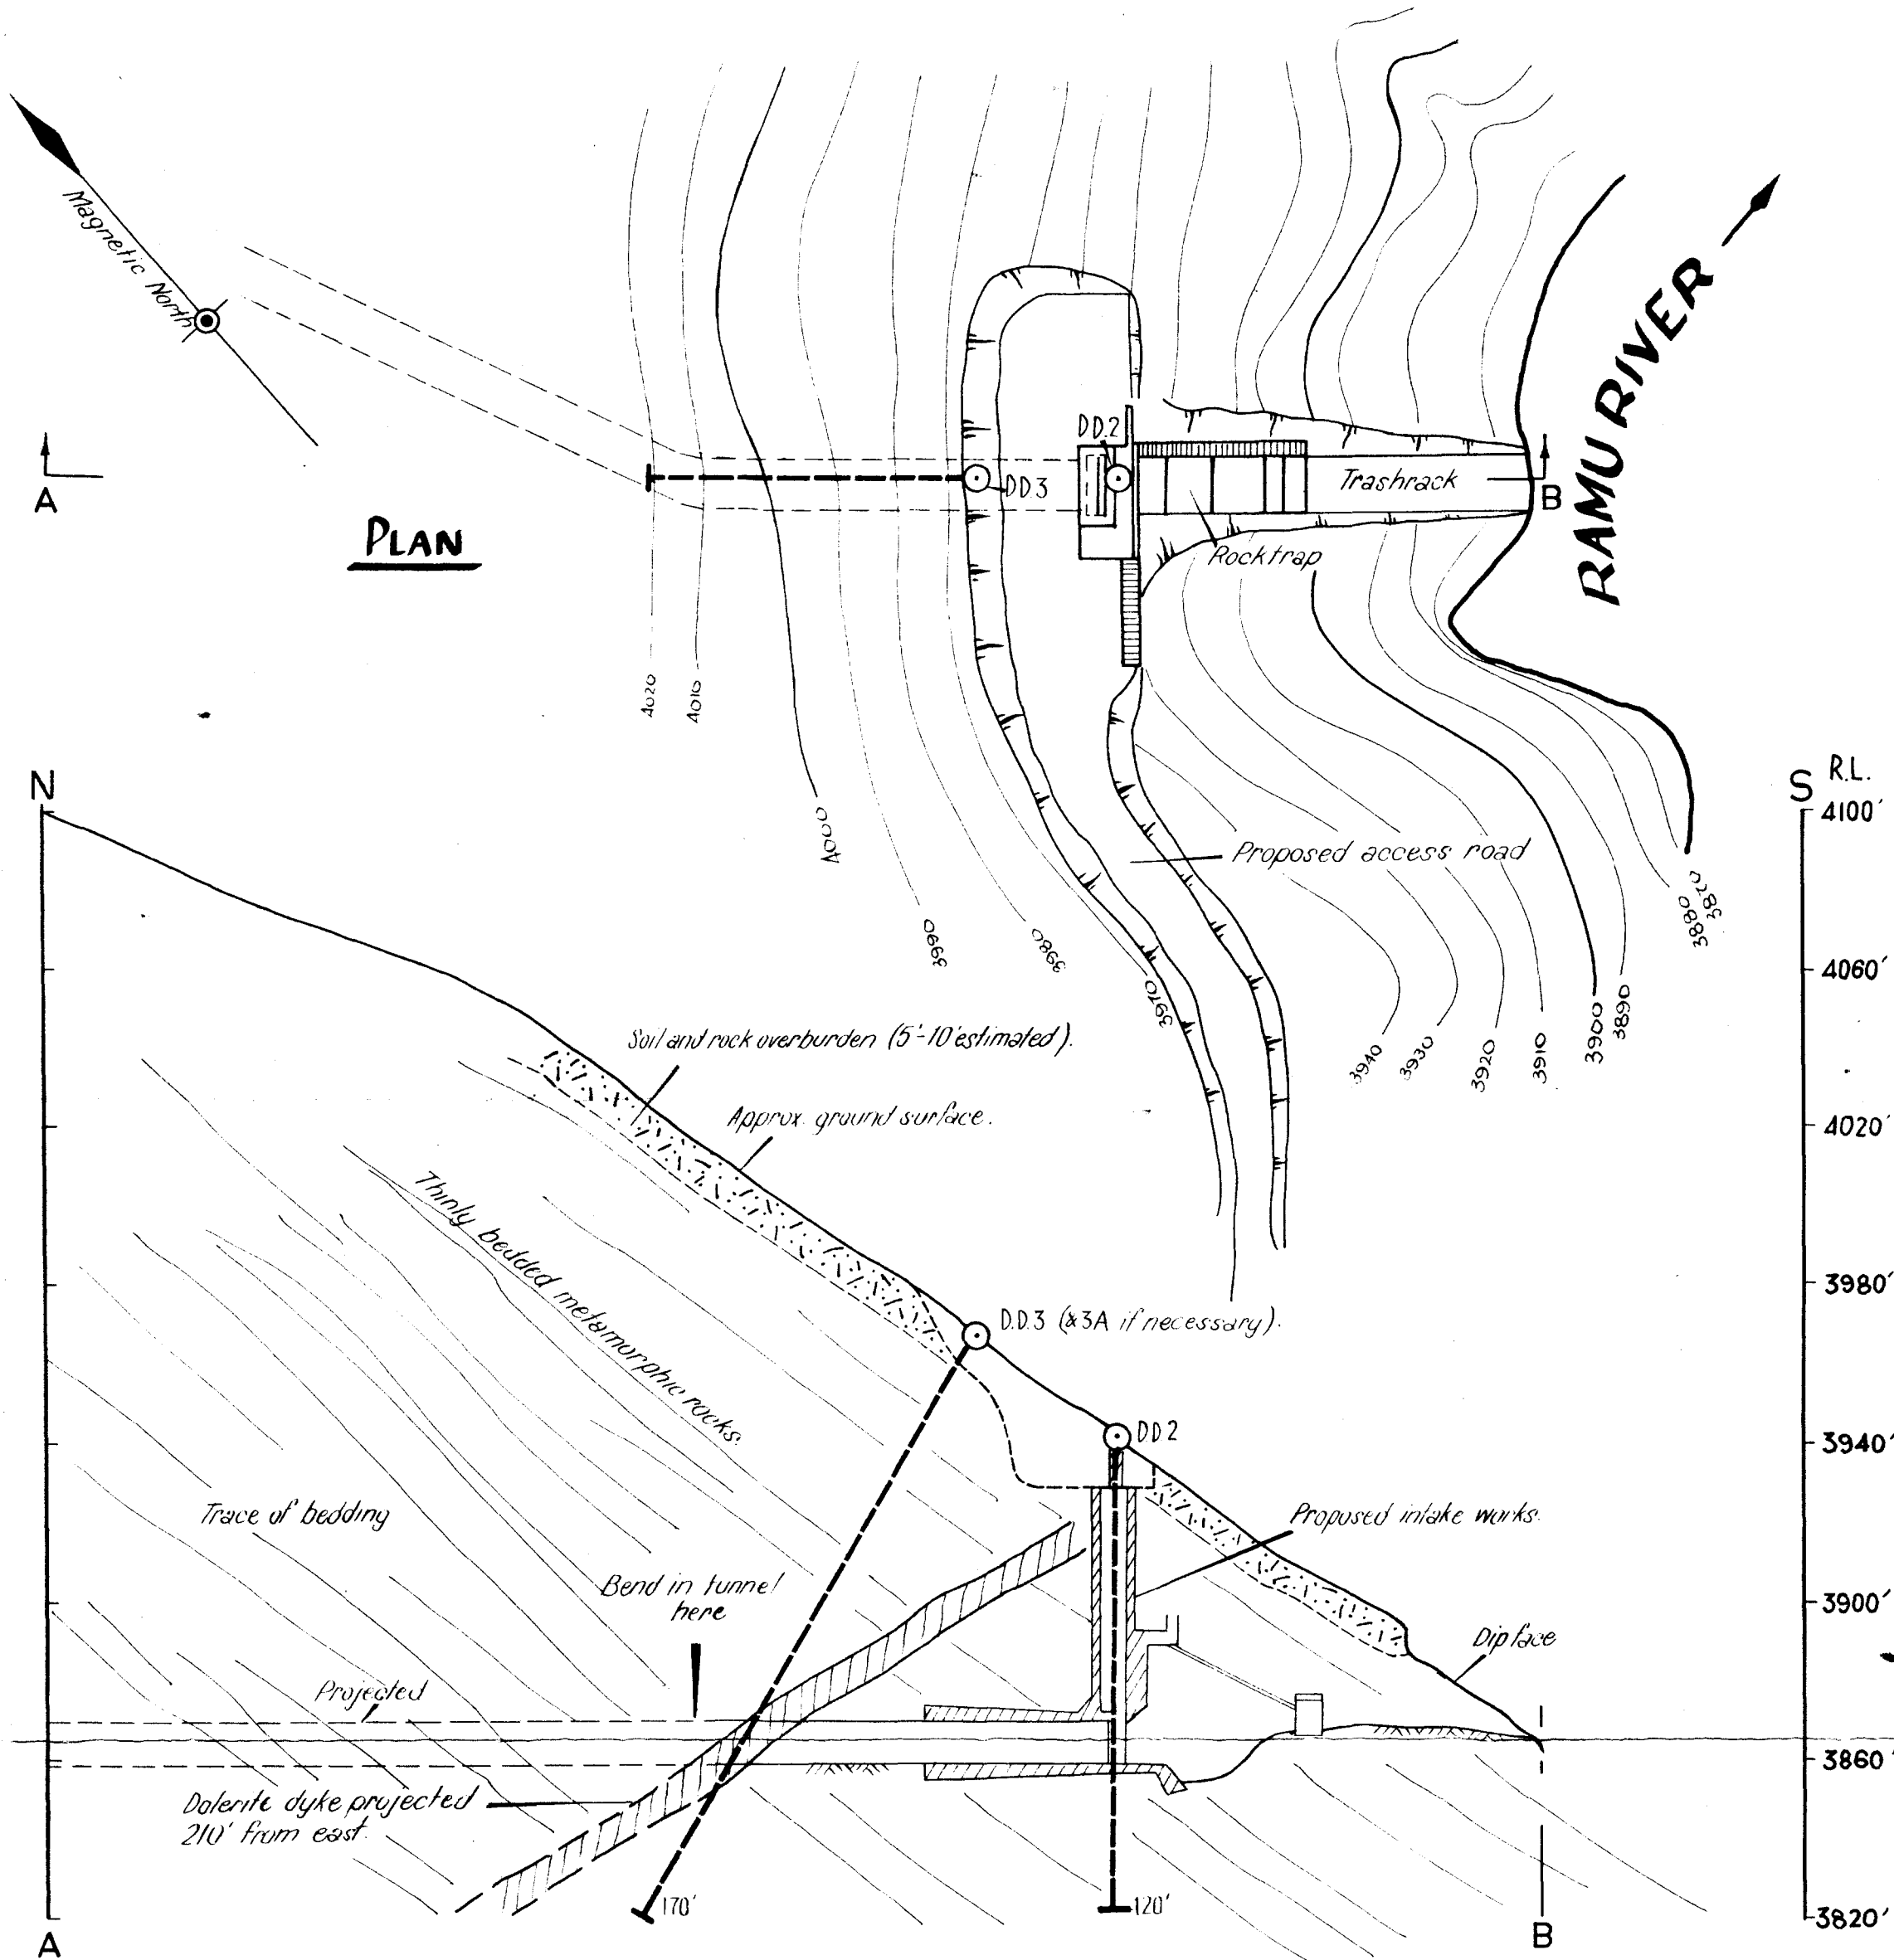
GEOLOGICAL MAP AND LONGITUDINAL SECTION OF PROPOSED TUNNEL LINE SHOWING POSITIONS OF NEW DRILL HOLES

A new site (chainage 6500') has been chosen for D.D.7, (see sections and plans). The new position is planned to be below the bottom of the sedimentary beds or away from the faulted zone, whichever interpretation is given to results from D.D.6. The hole will be vertical and it is expected that the only difficulties to be encountered will be in penetrating the soil and

D.D.8 has also been resited to chainage 6754' and deepened for similar reasons. It is not proposed to drill D.D.8A at this stage.

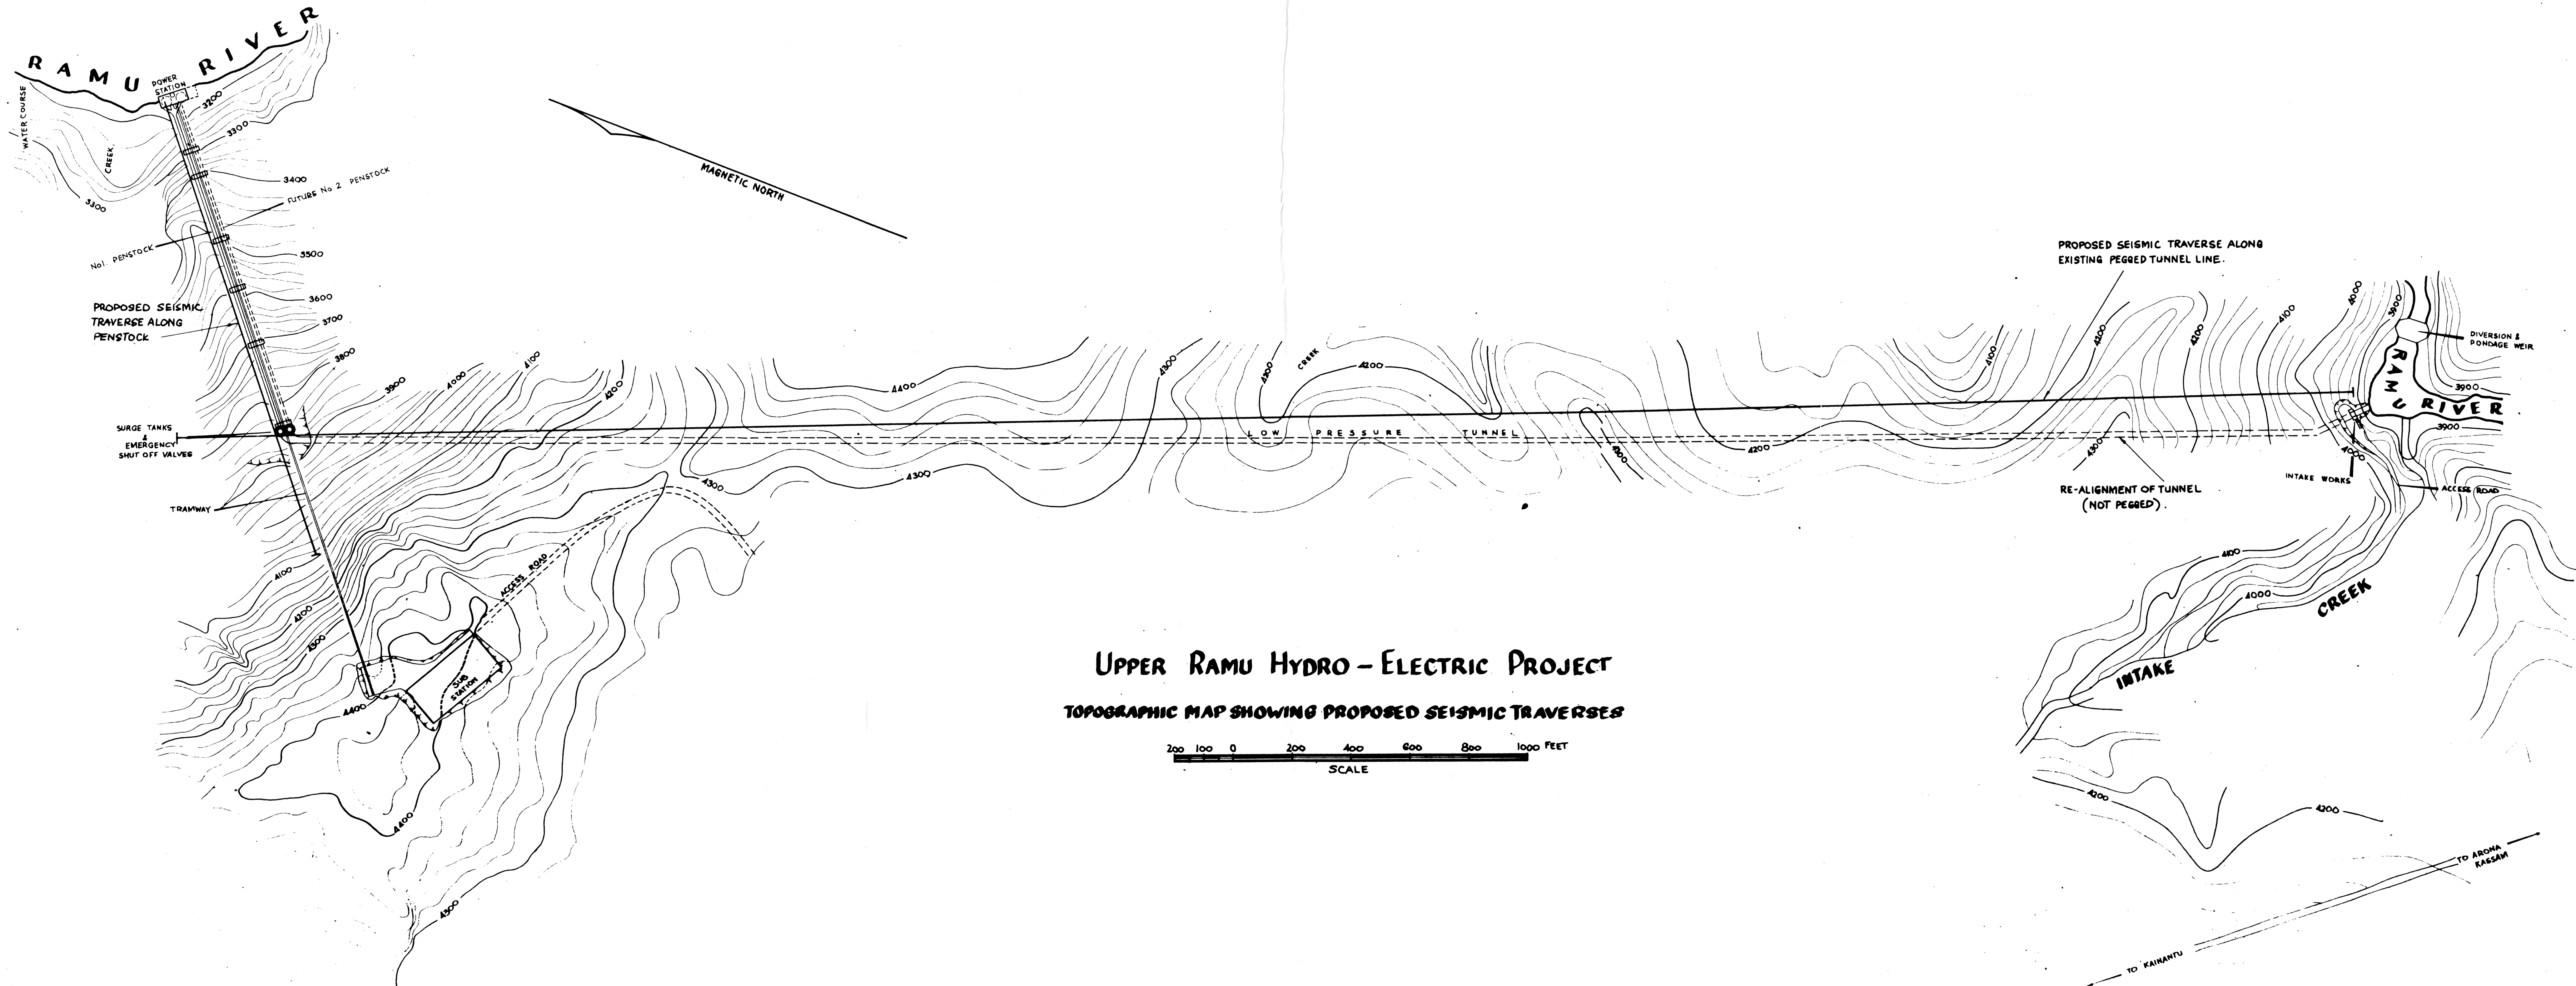
INTERPRETATIVE GEOLOGICAL SECTION AT INTAKE SHOWING PROPOSED DIAMOND DRILL HOLES

D.D.2, 2A, and 3 will be re-located because of a change in the alignment of the proposed tunnel at the intake structure, (see new specifications, sections and plans).
