1965/15

PRELIMINARY GEOLOGICAL INVESTIGATION OF LOWER WARANGOI RIVER HYDRO-ELECTRIC SCHEME, NEW BRITAIN, T.P.N.G.

AUGUST-NOVEMBER, 1964

J.R.L. Read

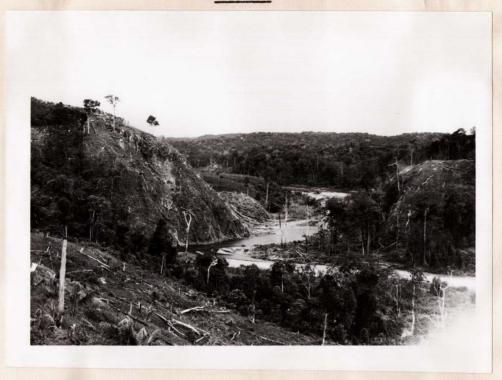
Fig. 1: Warangoi damsite, view looking downstream, October, 1964. The distance between the abutments at river level is about 300 feet and the top of the ridge at the left of the photograph is about 400 feet above river level.

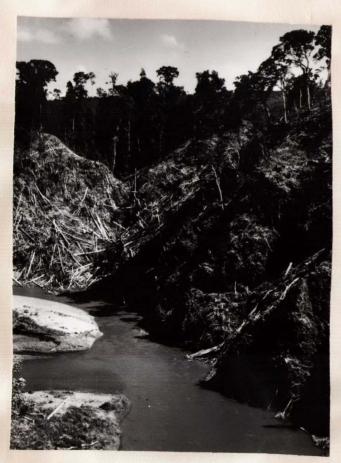
Fig. 2: Upstream from left abutment viewed from the right abutment, October, 1964.

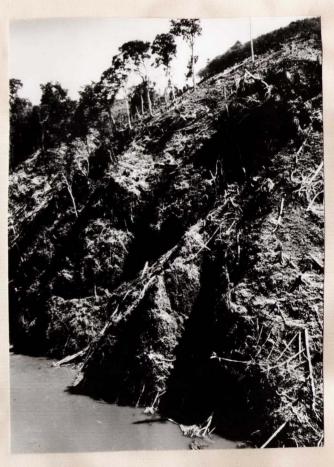
Fig. 3: Upstream face of left abutment, viewed from right abutment, October 1964.

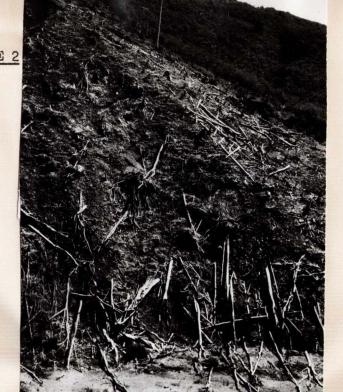
Fig. 1: Axis of left abutment viewed from right abutment, October, 1964.

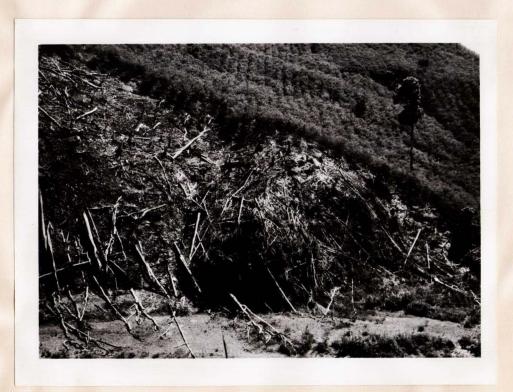
Fig. 3: Downstream from left abutment, viewed from right abutment, October, 1964.

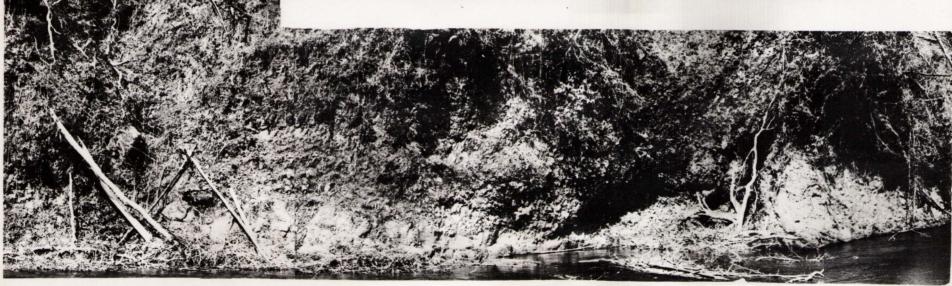
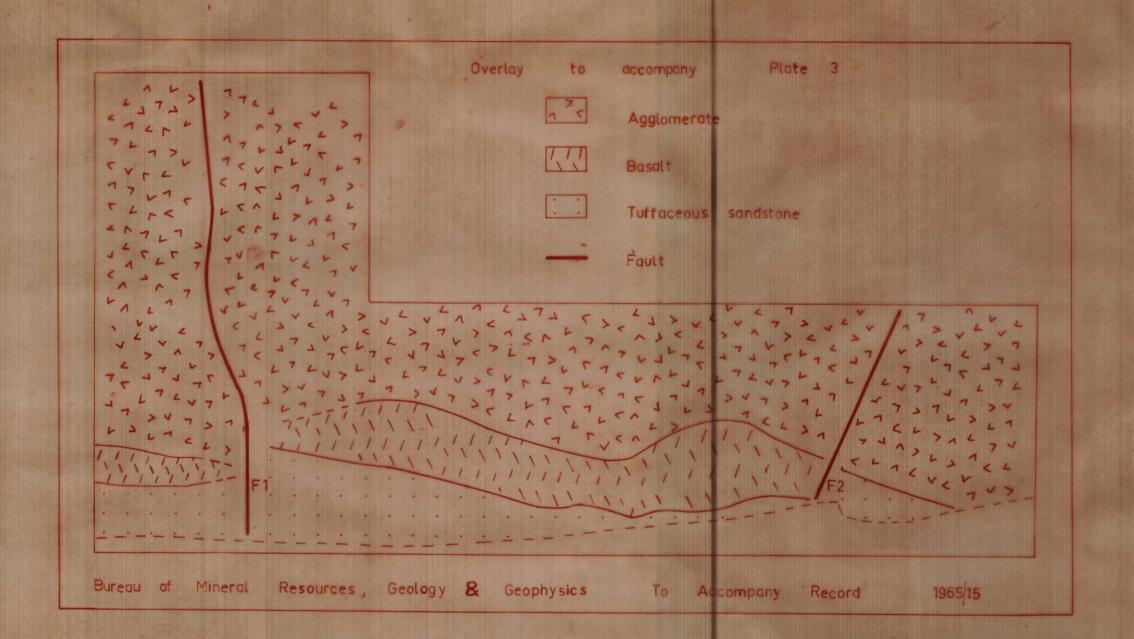
- Fig. 3: Downstream from left abutment, viewed from right abutment, October 1964.
- PLATE 3 : Upstream face of left abutment at river level, with overlay to show the displacement of strata between faults F1 and F2. Note the cave opening along the plane of fault F2.

Note cave opening along the plane of fault F2.

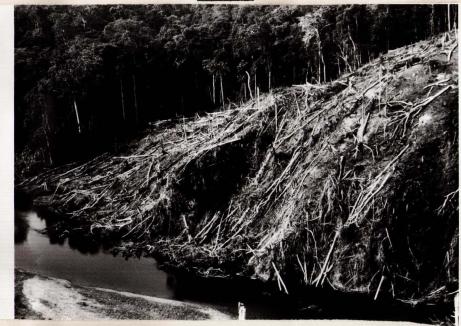
With the exception of outcrops of coral which conformably overlie agglomerate on the downstream side of the abutment (Plate 4, Fig. 1), rock exposed in the right abutment is entirely agglomerate. No interbeds of tuffaceous sandstone were observed; the agglomerate is otherwise identical with that in the left abutment. The exposures are particularly massive and the only indication of bedding was obtained from the outcrops of coral, which dip 35° to the south-east.

Fig. 1: Downstream face of right abutment, viewed from left abutment, October, 1964. Coral crops out slightly left of centre of photograph.

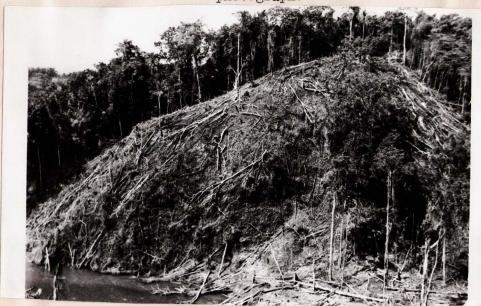
Scree deposits of agglomerate occur at the base of the north face of the abutment; most of the detritus has been supplied by the spall-tog of large blocks of agglomerate from the face, which is very steep and clean-cuts. (Plate 4, Figs. 2 and 3).

Fig. 2: Right abutment, viewed from left abutment, October, 1964.

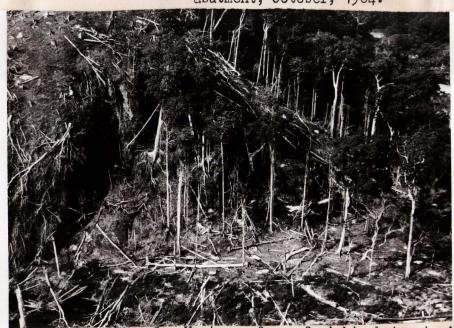
Fig. 3: Upstream face of right abutment viewed from left abutment, October, 1964.
