DEPARTMENT OF NATIONAL DEVELOPMENT
BUREAU OF MINERAL RESOURCES
GEOLOGY AND GEOPHYSICS

1965/155

PRELIMINARY GEOLOGICAL INVESTIGATION OF NO. 1 DAMSITE,
RAMU RIVER, UPPER RAMU HYDRO-ELECTRIC SCHEME, T.P.N.G.

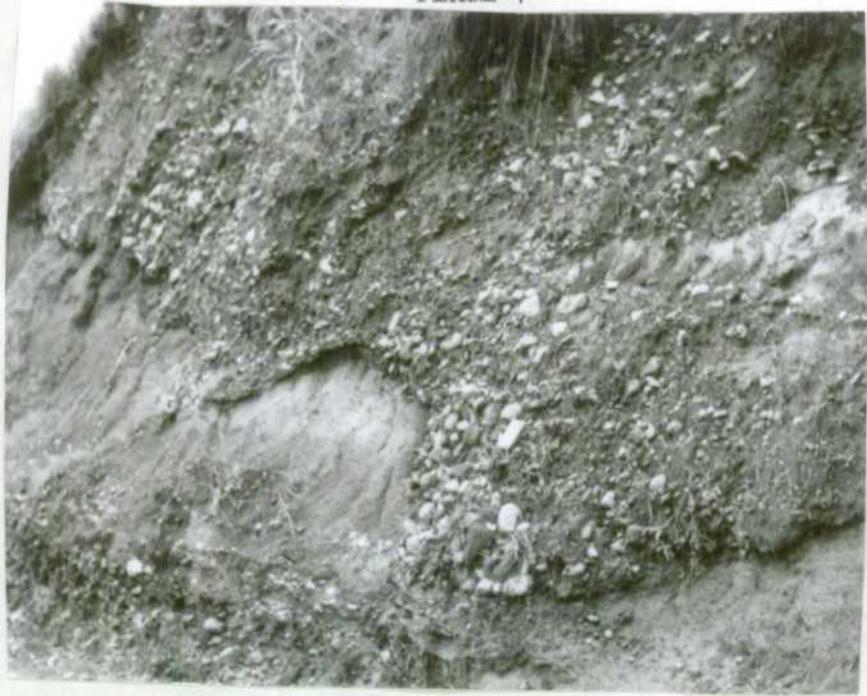
On the left abutment, costean 1 was excavated from a road cutting on the Highland's Highway to a bench at a reduced level of 4,115 feet. The combination of the road cutting and this costean gives a complete succession between RL 4,010 feet and RL 4,115 feet. In this section grey clay which weathers brown in colour is interbedded with conglomerate, which consists of rounded pebbles of igneous and metamorphic rocks up to ten inches in diameter in a matrix of sandy clay. Between RL 4,061 and RL 4,065 feet there is a band of fine brown sand with some clay; Sample 6 was taken from this level. The contacts between the various strata are roughly horizontal but there is an erosional disconformity at approximately RL 4,035 feet, where a thick band of conglomerate and some fine sand lenses have been deposited in wash-out channels in the underlying clay band (Plate 1A). Sample 4 was taken from the conglomerate in one of the channels above the disconformity. The lower part of the succession consists of conglomerate and minor clay bands; Sample 5 was taken from the conglomerate about ten feet below the disconformity. In this area considerable lensing was noted in the conglomerate (Plate 1B).

- A. Erosional disconformity between conglomerate and clay; road cutting, left abutment.
- B. Erosional disconformity and lensing of conglomerate; road cutting, left abutment.
- C. Detail of erosional disconformity of conglomerate on clay; road cutting, right abutment.

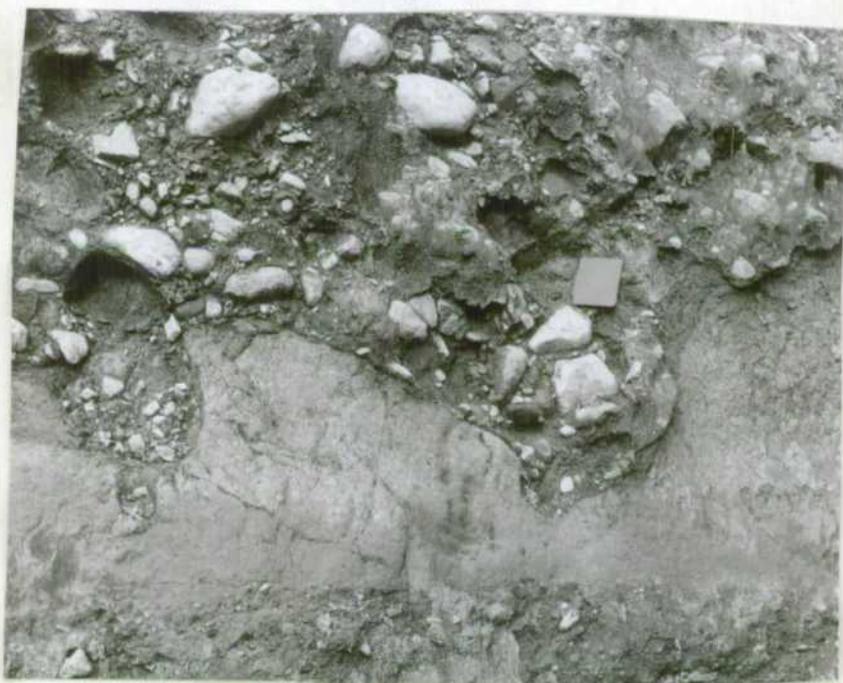
C.

At about RL 4,024 feet there is an erosional disconformity similar to that found in Section 1, at the base of a layer of conglomerate with interbands of fine sand (Plate 1C); Sample 2 was taken from a sand lens. The sequence of deposition and erosion is clearly revealed in the road cutting (Plate 6).

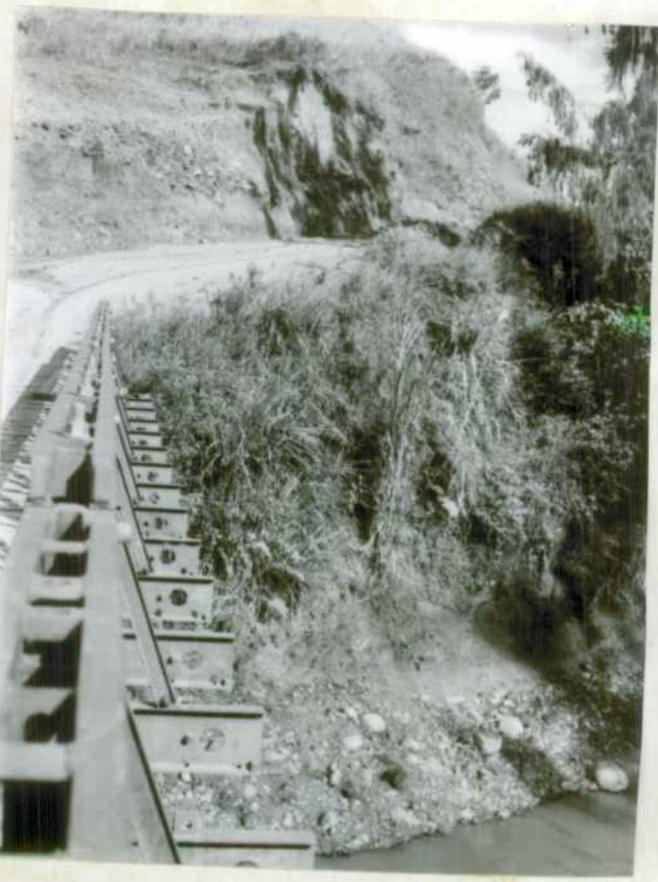
B.

Between the disconformity and river level conglomerate with sandy clay has been sampled in two places; Sample 1 is from RL 3,995 feet and Sample 5 from the lowest level exposed above the river (Plate 2B).

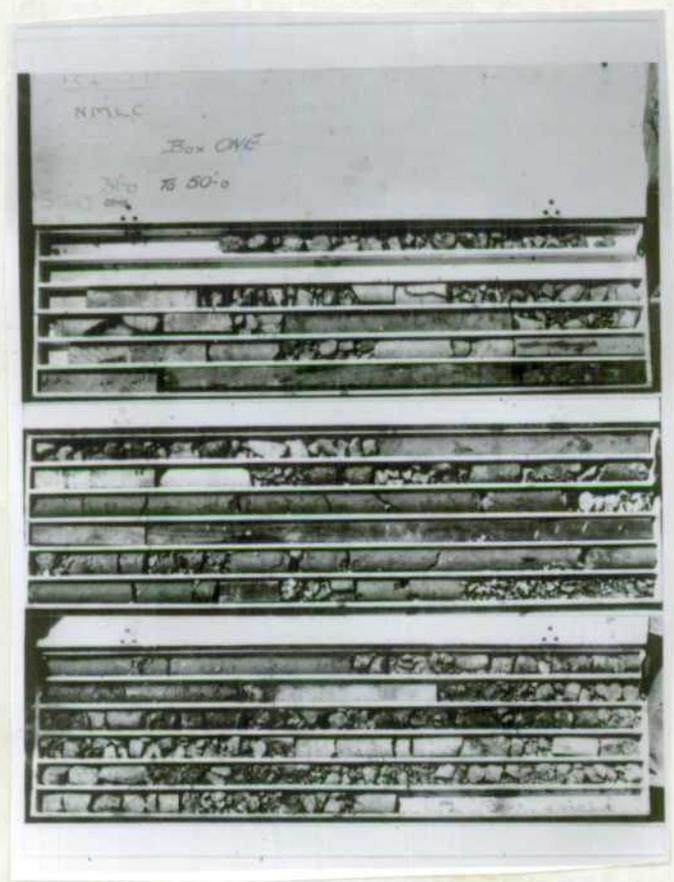
C.

Below river level the succession encountered in the diamond drill is similar to that exposed at the surface (Plate 2C). Unfortunately most of the matrix in the conglomerate was lost owing to washing out by the drilling water. Sample 7 is taken from sand recovered in the barrel and Sample 8 from sludge recovered from the drilling water. The drill encountered bedrock, which consists of completely to highly weathered dolerite, at a depth of 58 feet 6 inches (RL 3,950 feet) and continued in the dolerite to RL 3,900 feet, where drilling was suspended.

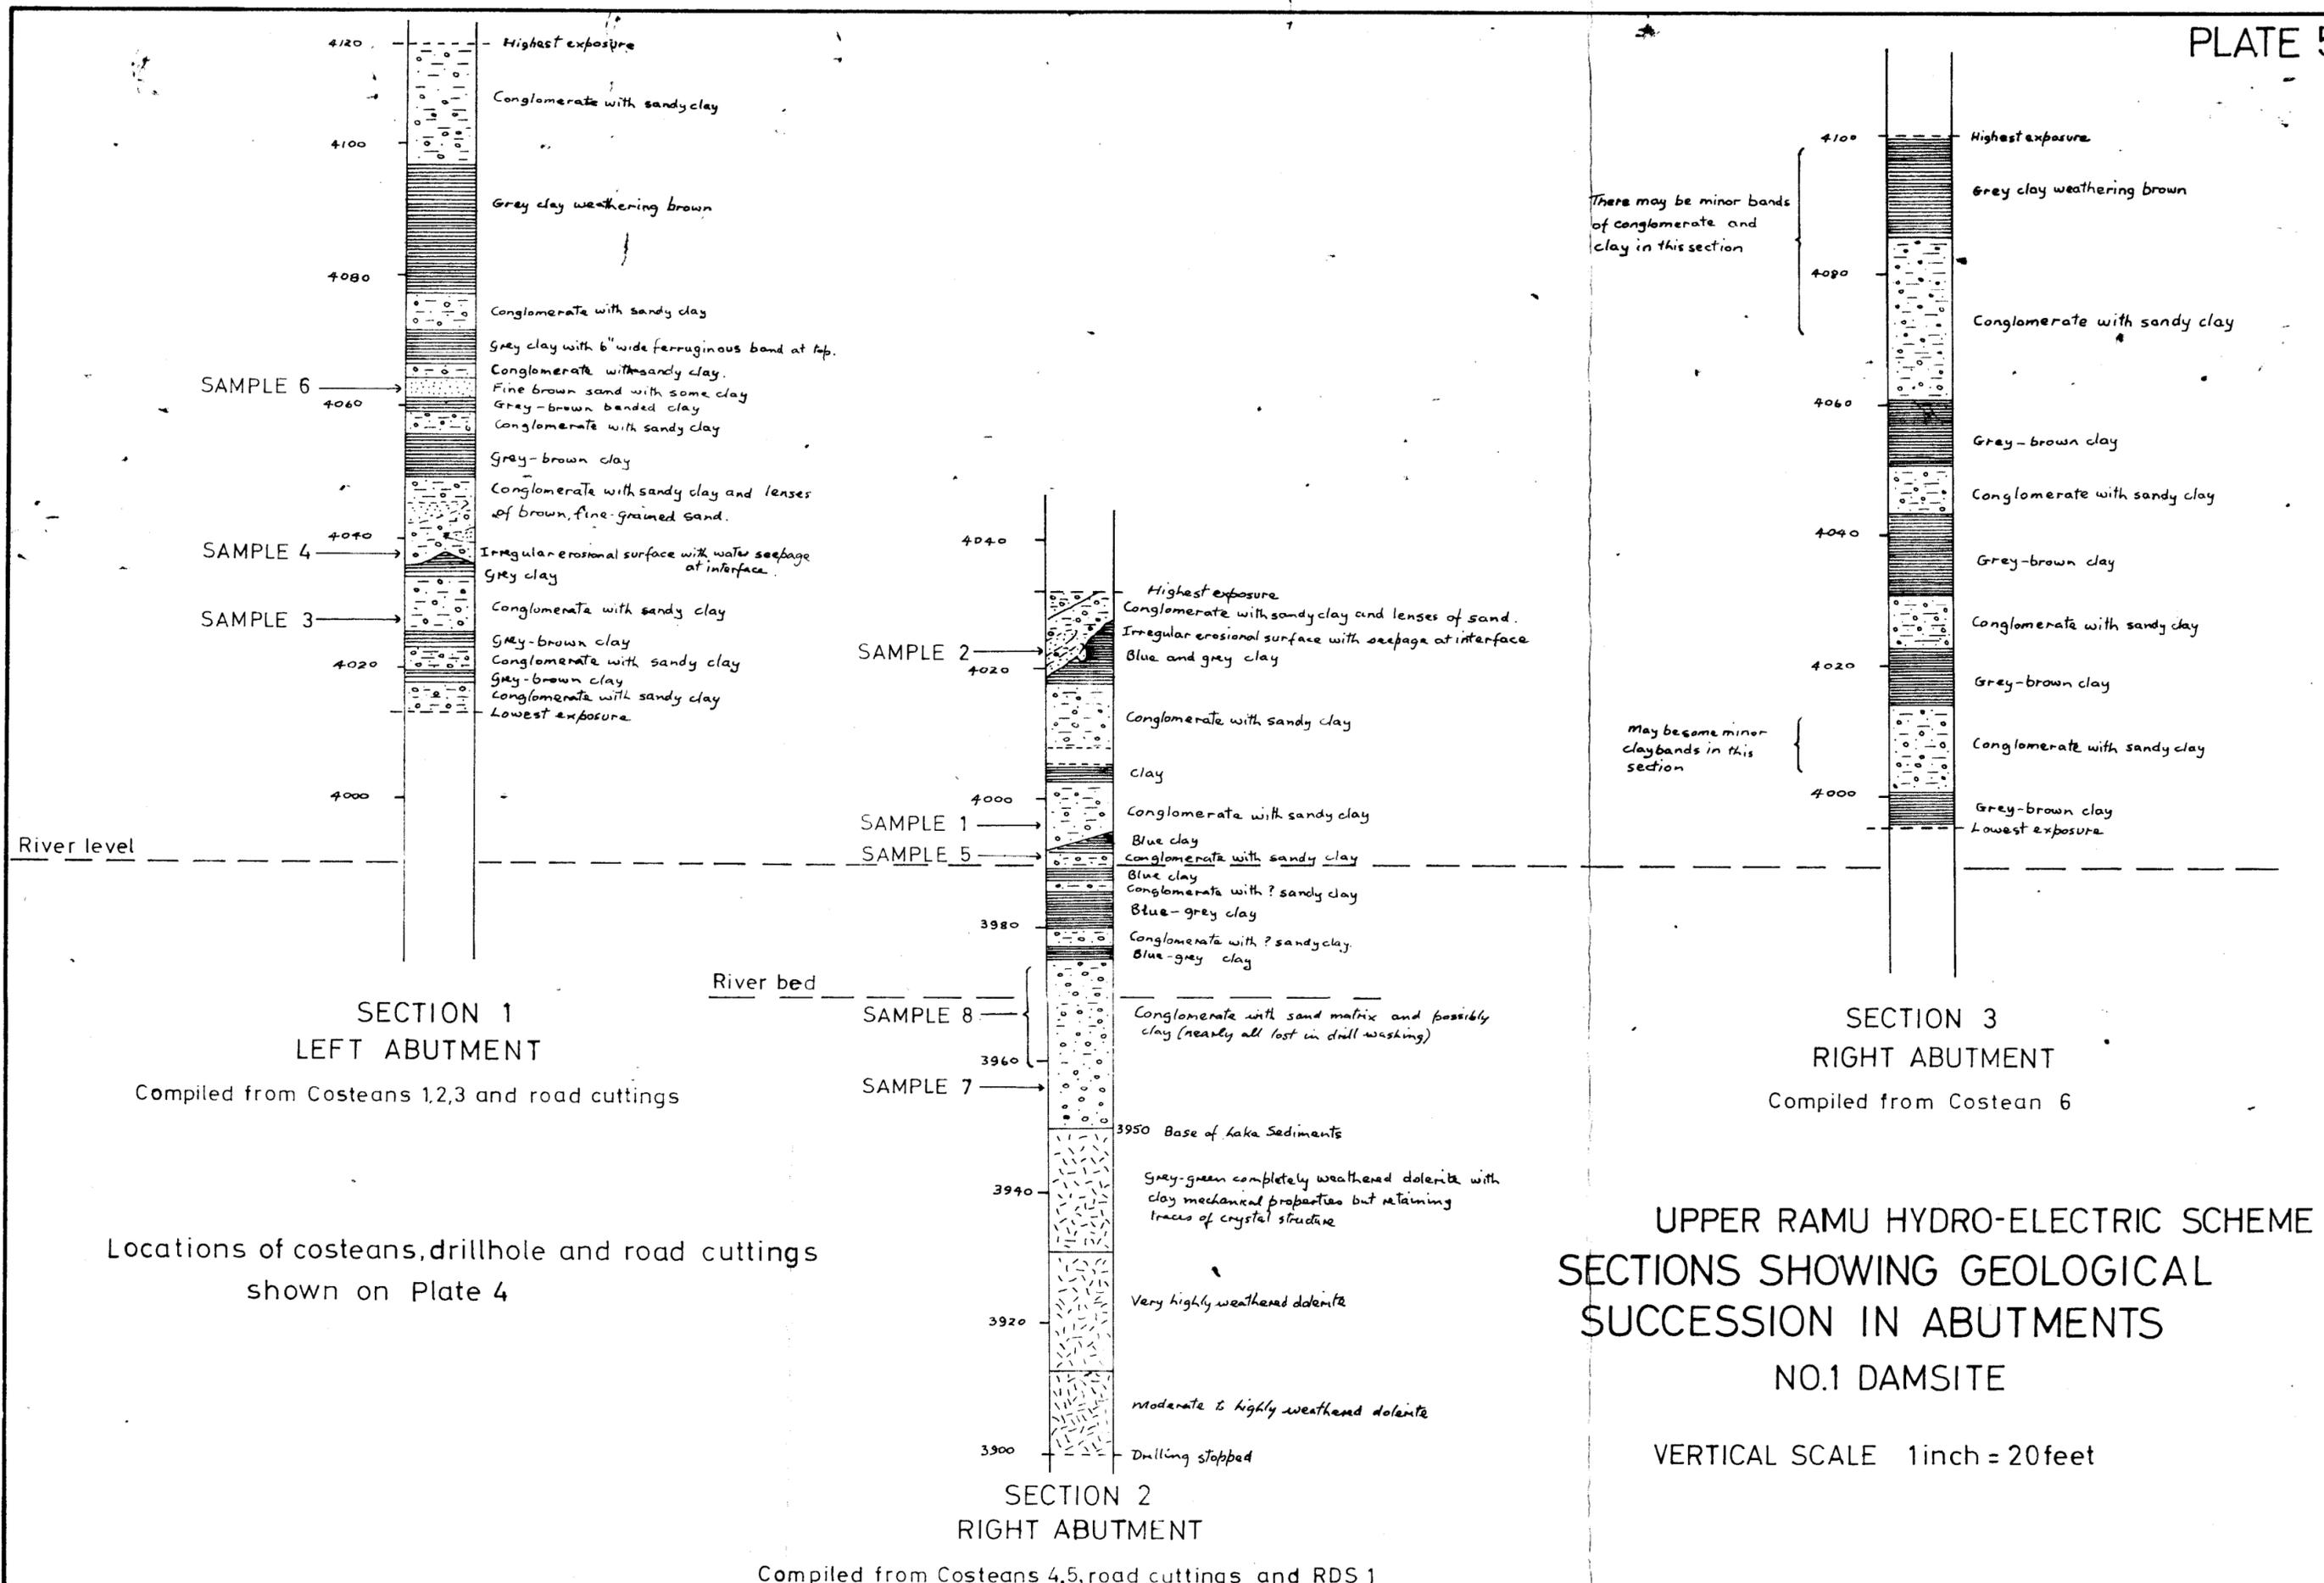
UPPER RAMU HYDRO-ELECTRIC SCHEME
SECTIONS SHOWING GEOLOGICAL
SUCCESSION IN ABUTMENTS

The position of the costeams, road cuttings and drill hole are shown in Plate 4. The succession as found in the investigation is indicated on Sections 1, 2, and 3, in Plate 5.

Section 2 has been compiled from exposures in the right abutment just upstream from the bridge and from information derived from the drill hole RDS 1. It gives an almost continuous succession from a level of RL 3,900 feet to RL 4,032 feet. The succession is again one of interbanded conglomerate and grey clay.

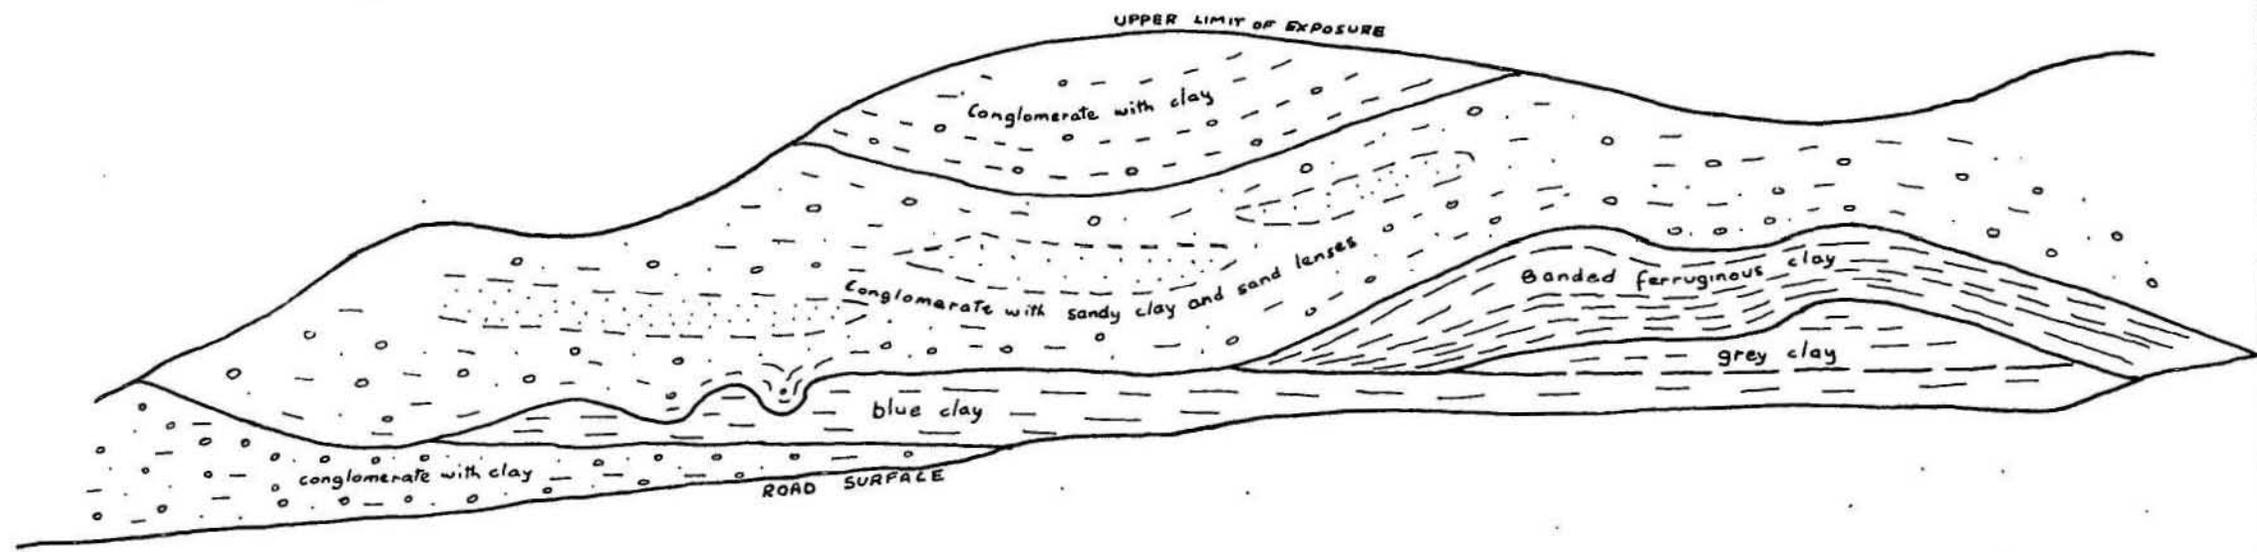
PLATE 6

UPPER RAMU HYDRO-ELECTRIC SCHEME
SKETCH SHOWING EROSIONAL DISCONFORMITY
IN ROAD CUTTING, RIGHT ABUTMENT NO 1 DAMSITE
