INVESTIGATIONS FOR THE TOWN WATER SUPPLY FOR DARU,

WESTERN DISTRICT, PAPUA

J.P. MacGregor

Records 1967/21

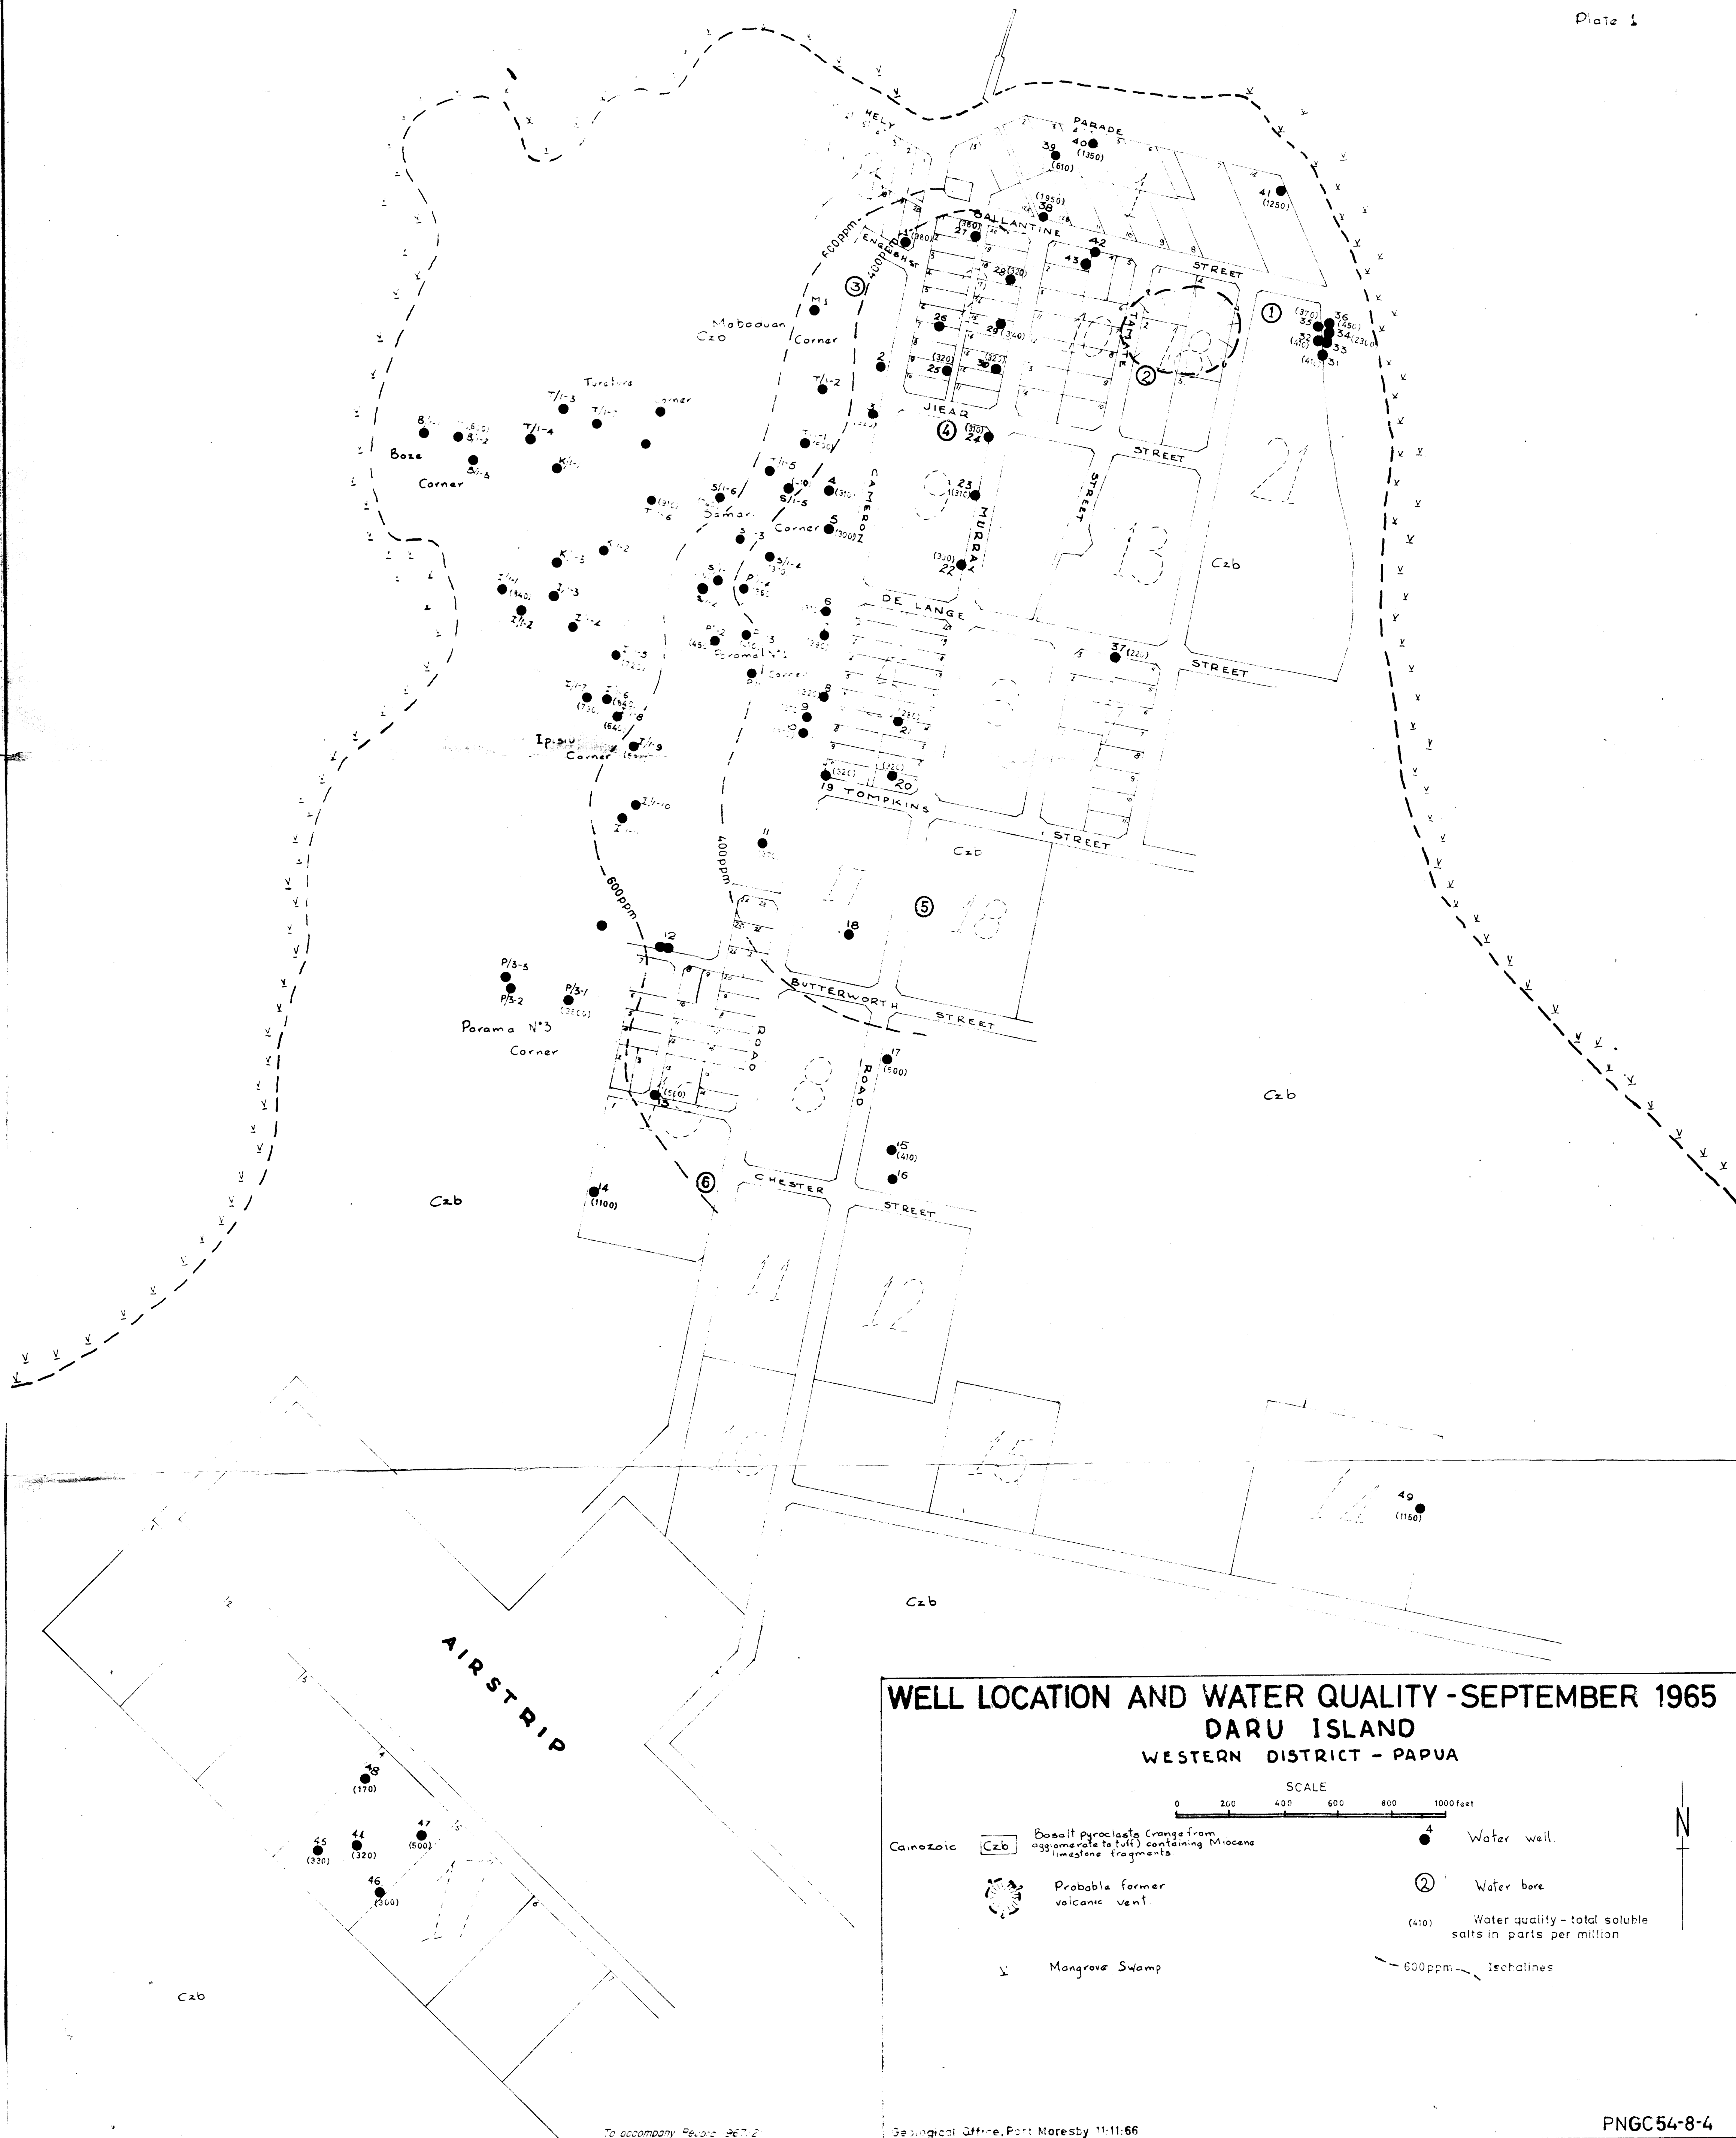
Plate 1 - Well location and water quality, September, 1965.  
Scale 1 inch : approx. 260 feet.

The hospital is at present partially supplied by low capacity electric pumps fitted on wells Nos. 6, 9, 22 and 23 on Plate 1. These wells supply good quality water but not in sufficient quantity for the hospital's needs.

The chemical quality of the water from shallow wells in the centre of the Daru Island as indicated on Plate 1 is considerably better than that produced from the bores, and is quite acceptable as drinking water. It seems, however, that because of the number of wells which would be required to cope with the estimated demand, and the cost of reticulation, that a town supply solely derived from shallow wells is not an economic proposition. Further investigation would be needed to establish whether enough water is contained in the shallow aquifer and whether the recharge rate of the aquifer is sufficient to cope with the demands of the developing town.

1. Examination of the wells and bores on Daru island has shown that a tuffaceous sandstone aquifer is present at shallow depth.
2. In an area in the centre of the island good quality water can be obtained from wells throughout the year (Plate 1.)
3. The flow from the sandstone aquifer into the wells is slow.
4. Most wells are poorly constructed and polluted.
5. Pollution of the wells comes from nearby latrines and from surface contamination.
6. A properly constructed, protected and positioned well would provide an ample supply of water for a low capacity pump.
7. Further investigation is required to prove whether there is sufficient good quality water in the aquifer for a reticulated town supply.

1. Several Standard Sanitary Wells as specified in P.H.D. drawings should be constructed as soon as possible and fitted with hand-pumps.
2. These wells should be sited in an area with good quality groundwater in the dry season (see Plate 1).
3. The wells should be sunk to the base of the sandstone layer regardless of water level.
4. All latrines and other wells within 100 yards radius of the new wells should be filled in and well sinking in this area should be prohibited.
5. Consideration should be given to the piping of water from some of the wells to central storage tanks in villages close to the coast, to provide drinking water.
6. Villagers should be encouraged to use the water from the wells and either fill in their present wells or use them for washing only.
