Macquarie Island  
Geophysical Observatory,  
Annual Report 1966

E.J. MUIR

RECORD NO. 1968/41

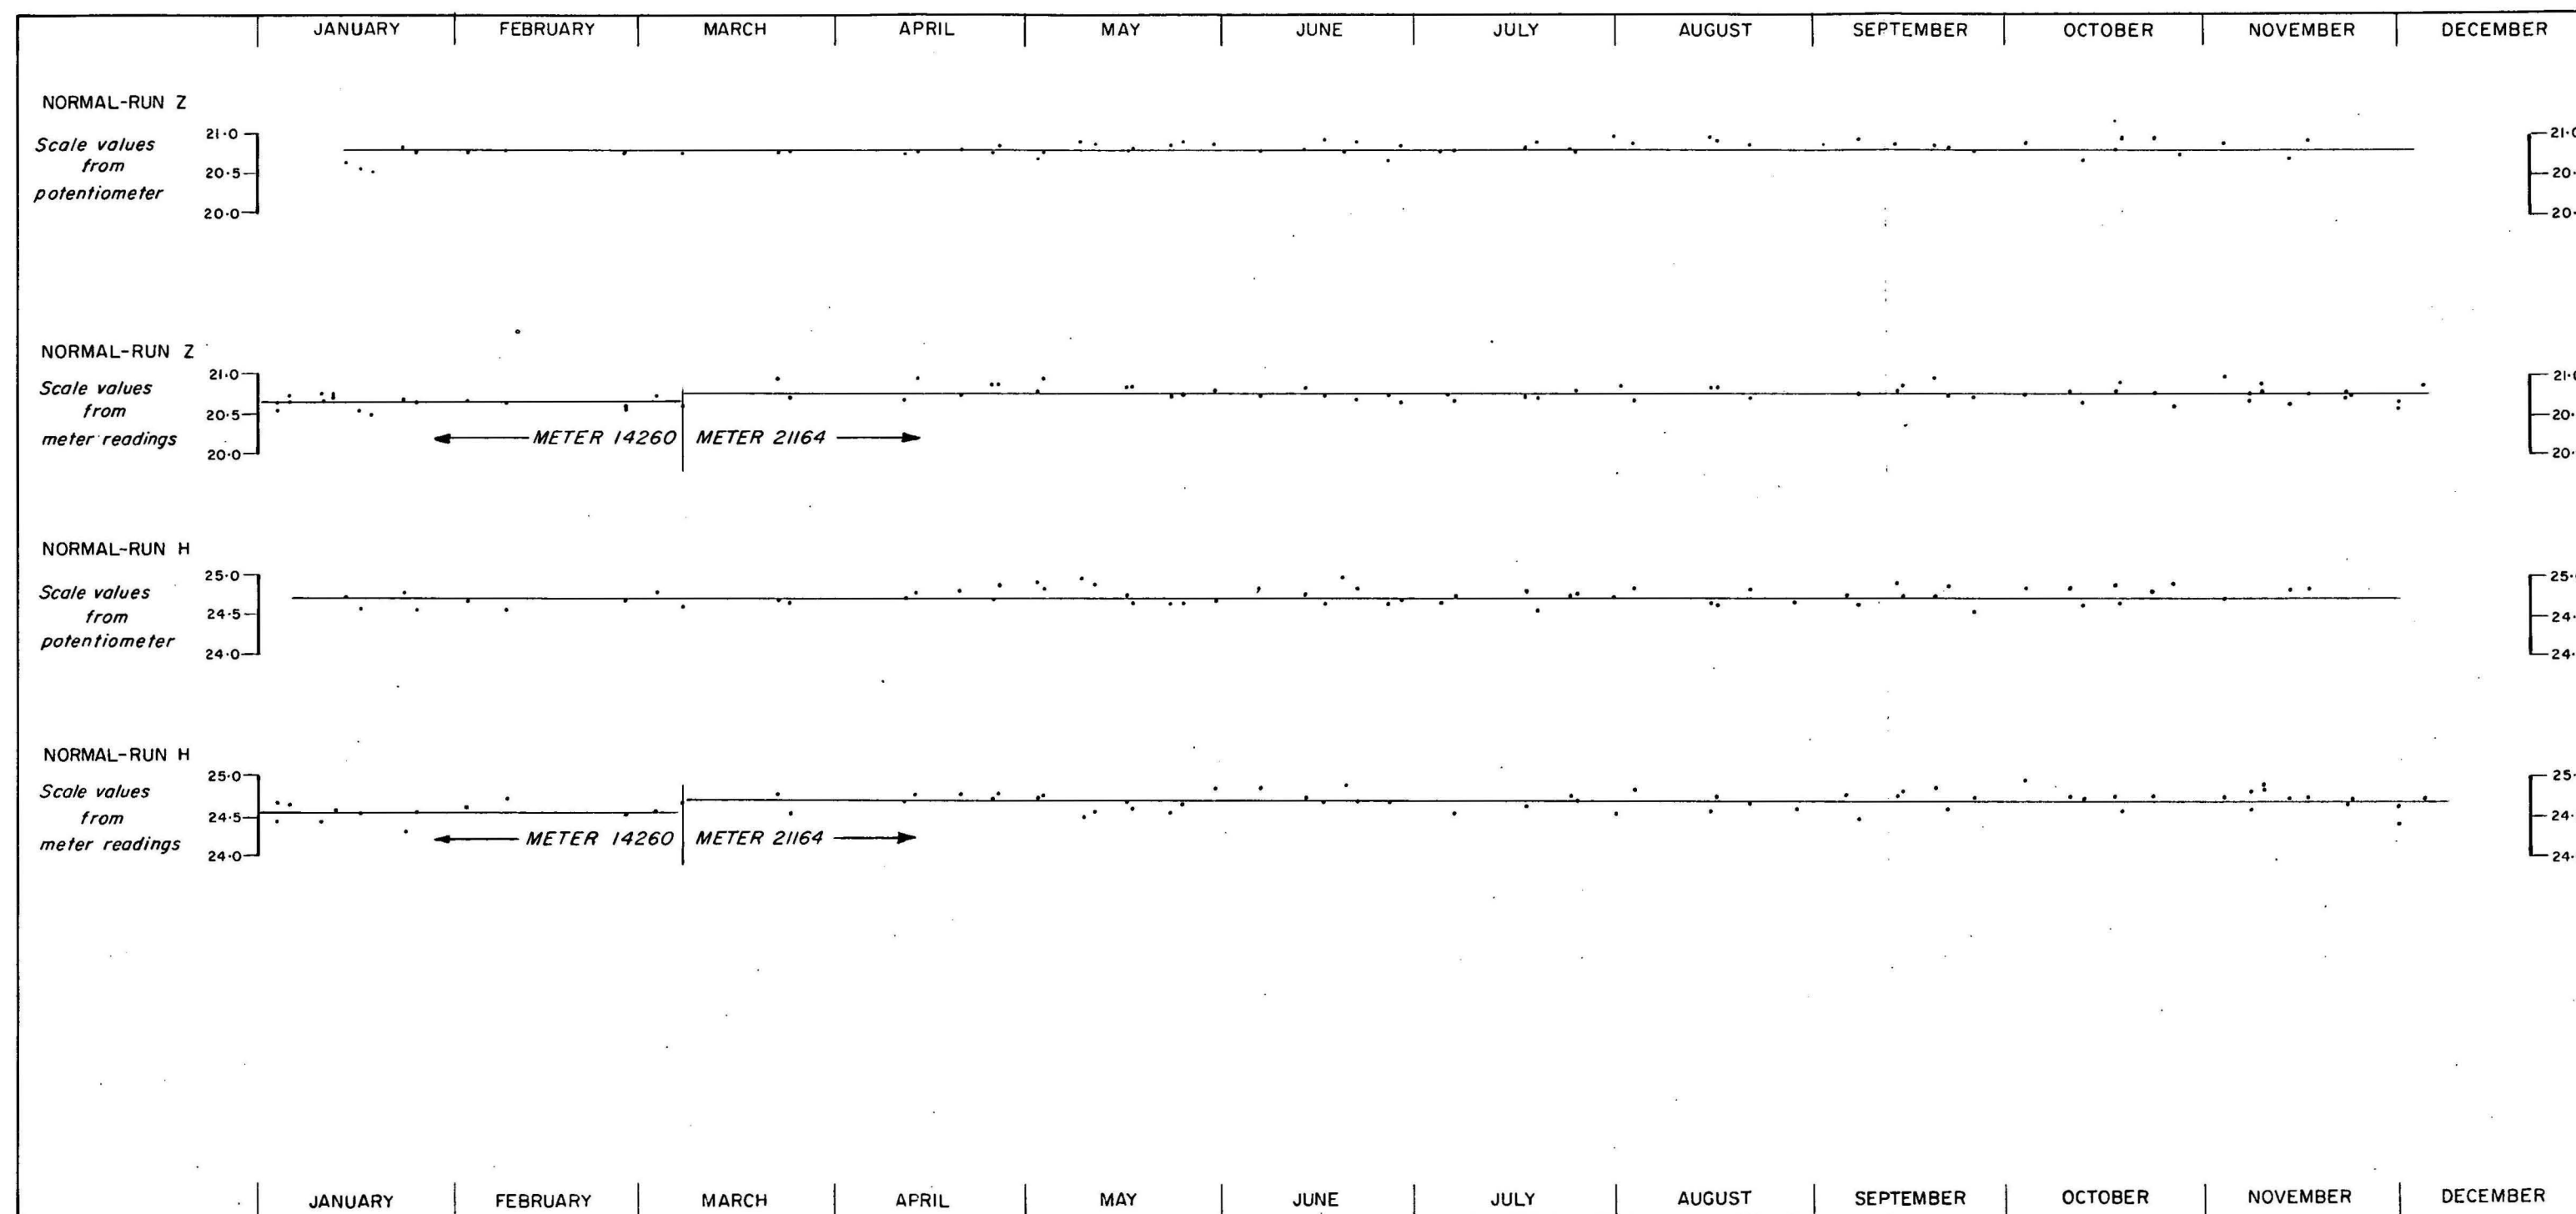
NORMAL-RUN SCALE VALUE ADOPTIONS

Control observations. Normal-run scale value and absolute observations were made twice weekly. Rapid-run scale values were determined monthly. From these results, scale value and baseline values were adopted. Plots of scale values showing adopted values appear in Plate 1. The industrial standard meter VML 14260 previously used for measuring scale value currents was returned to Melbourne for calibration. Meter VML 21164 was used from March onwards.

FROM SCALE VALUES DETERMINED WITH POTENTIOMETER,

ADOPT:-  $S_z = 20.8$

$S_H = 24.7$

FOR WHOLE YEAR

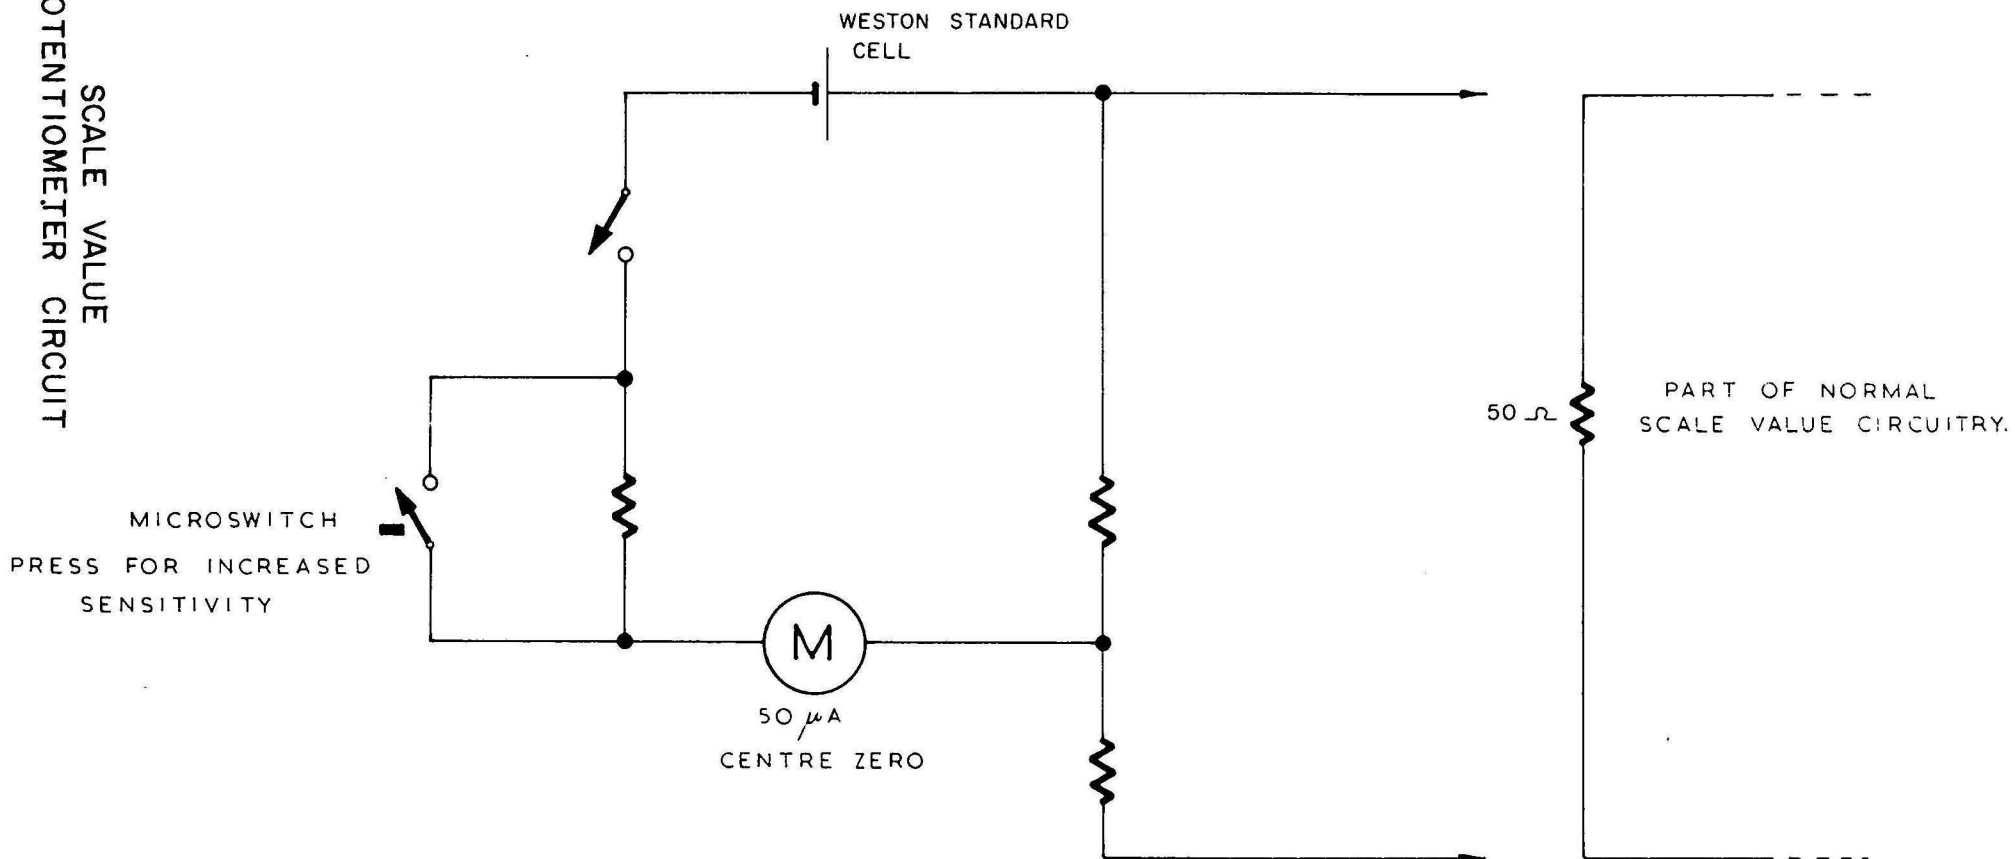
# POTENTIOMETER CIRCUIT SCALE VALUE

In order to check on the consistency of the scale value meter, a potentiometer incorporating a Weston standard cell was constructed and used to monitor the scale value observations. The circuit is given in Plate 2. The null indicator of the potentiometer was a 50-microamp centre zero meter. The proximity of this meter to the normal-run variometers led to small steps in D and H baseline values when the potentiometer was installed on January 14 and removed on November 18. The potentiometer increased the H baseline by about 4 gammas and decreased the D baseline by about 0.2 minute. This potentiometer was returned to Australia in December 1966, and has since been calibrated and found to null at a current of  $(62.82 - 0.035T)$  mA where T is the temperature in the range 0-20°C. All scale value adoptions have been based on this, which is why the 1966 scale values appear to be somewhat higher than those adopted for 1965.

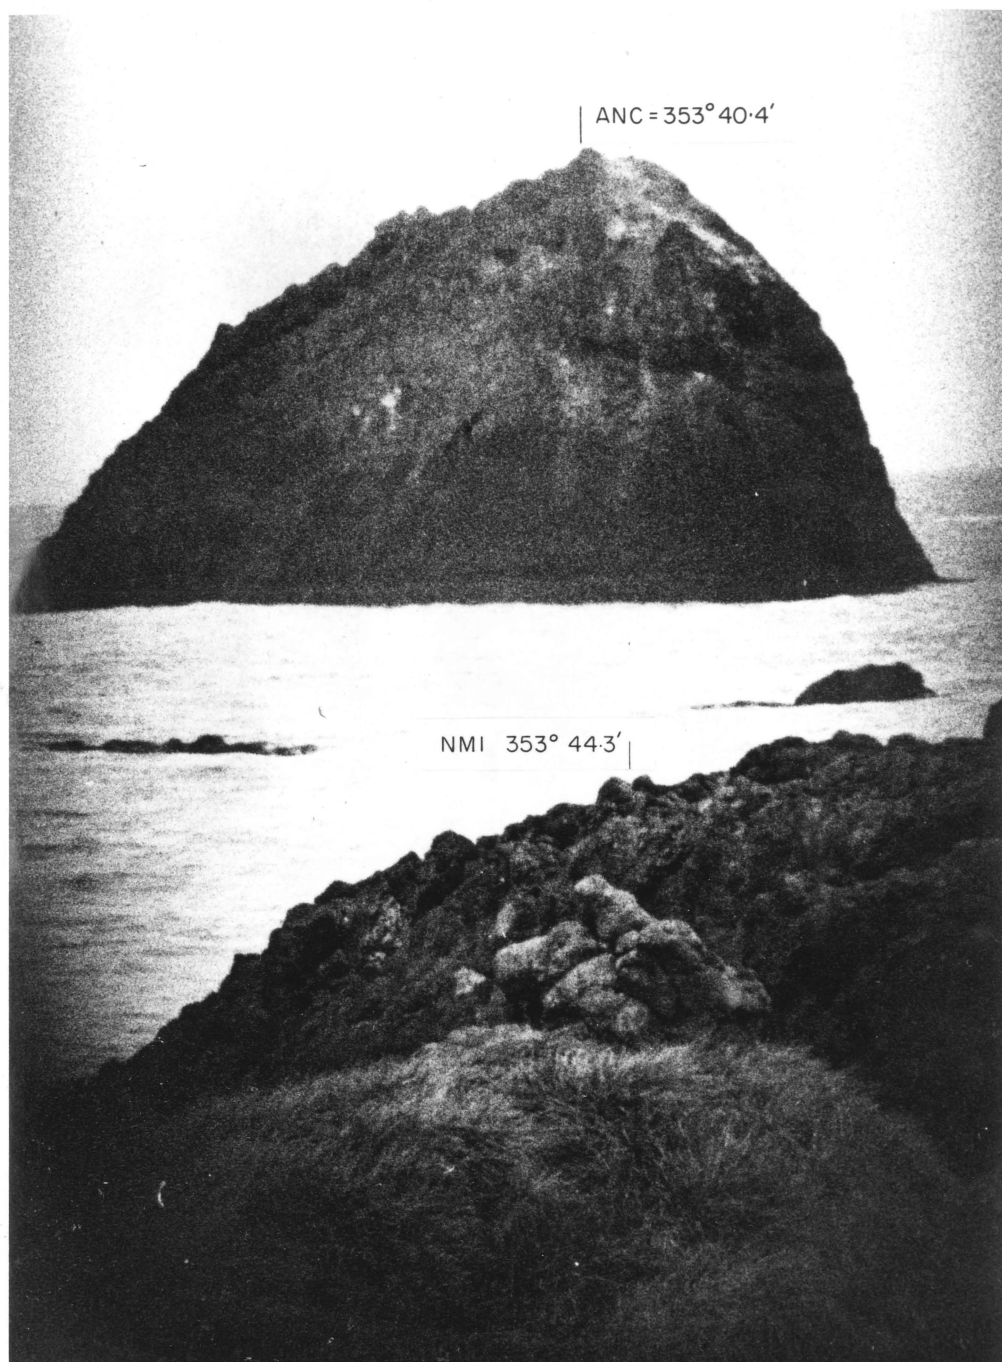
MACQUARIE ISLAND  
ANCHOR ROCK  
SHOWING AZIMUTHAL MARKS

Early in the year a fibre was broken in the Askania declinometer. The replacement fibre was made of tungsten. Difficulty in the identification of azimuthal reference marks was experienced owing to the lack of proper diagrams, so a photograph of Anchor Rock with the azimuthal references clearly marked is shown in Plate 3.
