RECORDS 1968/88

GEOLOGICAL INVESTIGATION OF TENNENT DAMSITE,
GUDGENBY RIVER, A.C.T. 1966-1967

D.A. Buchhorn

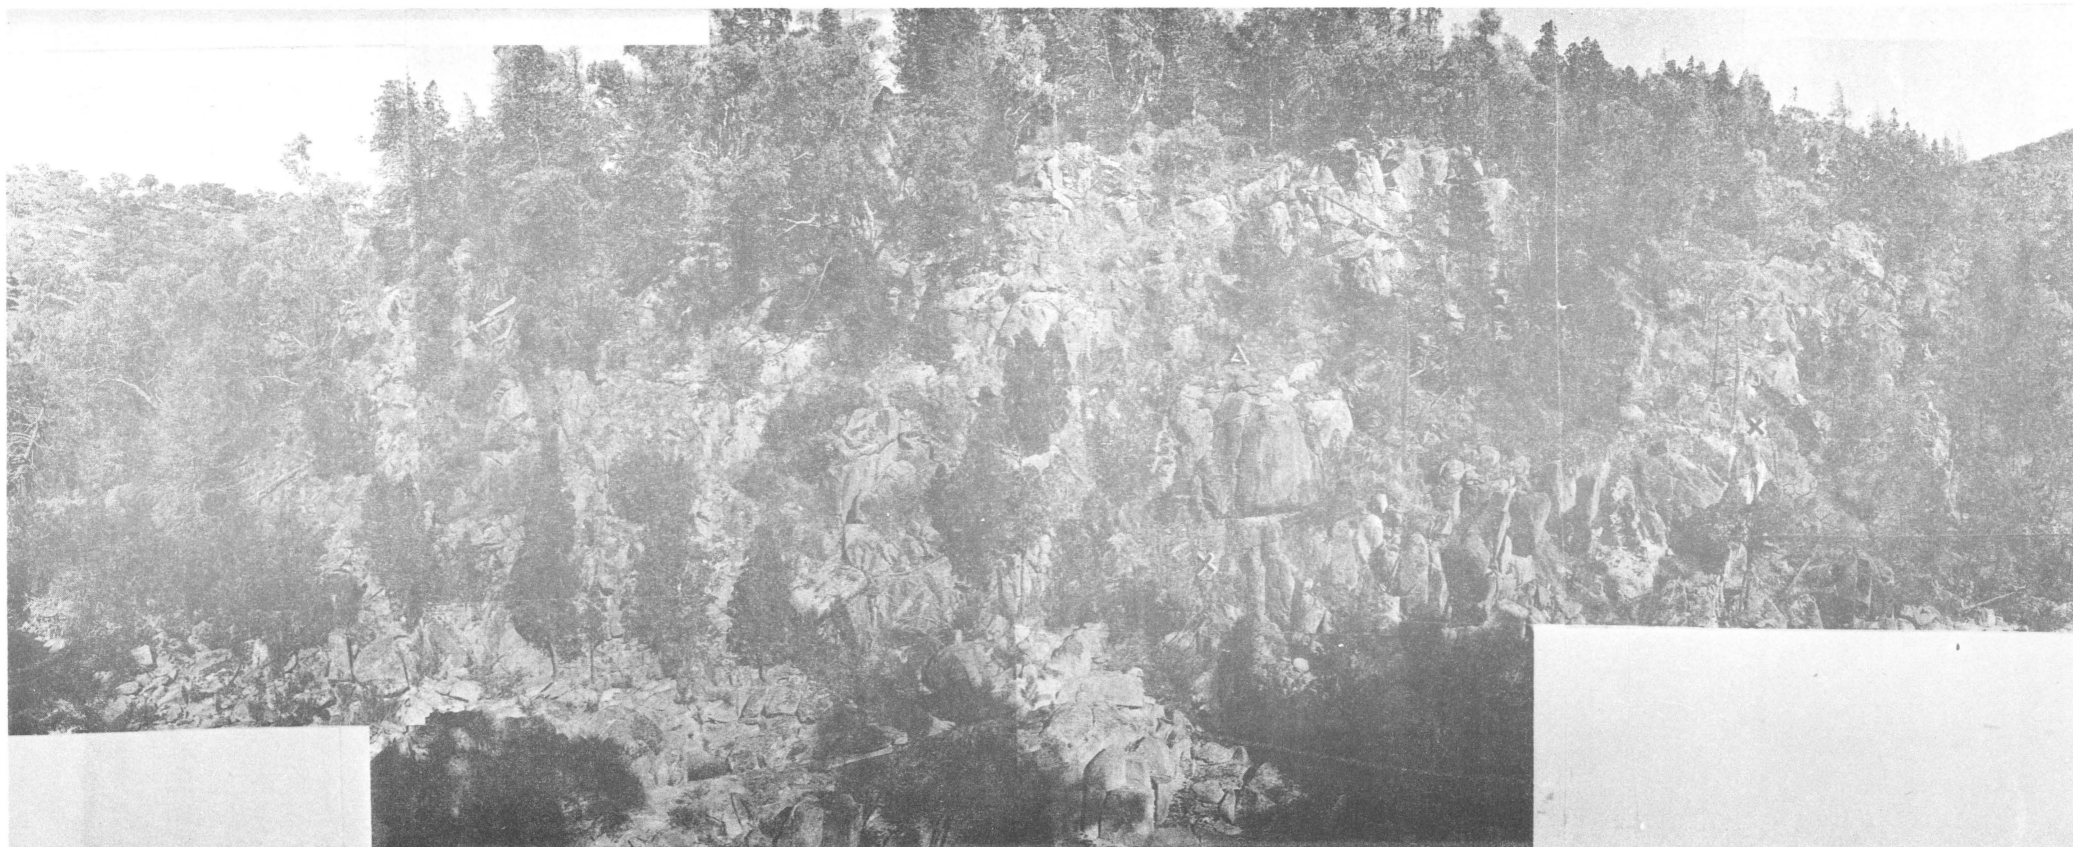
WEST BANK UPSTREAM

Fig. 1. From 19050/85720 (near station 791) looking West. Station 779 near centre; large dipping joint marked by crosses at each end.

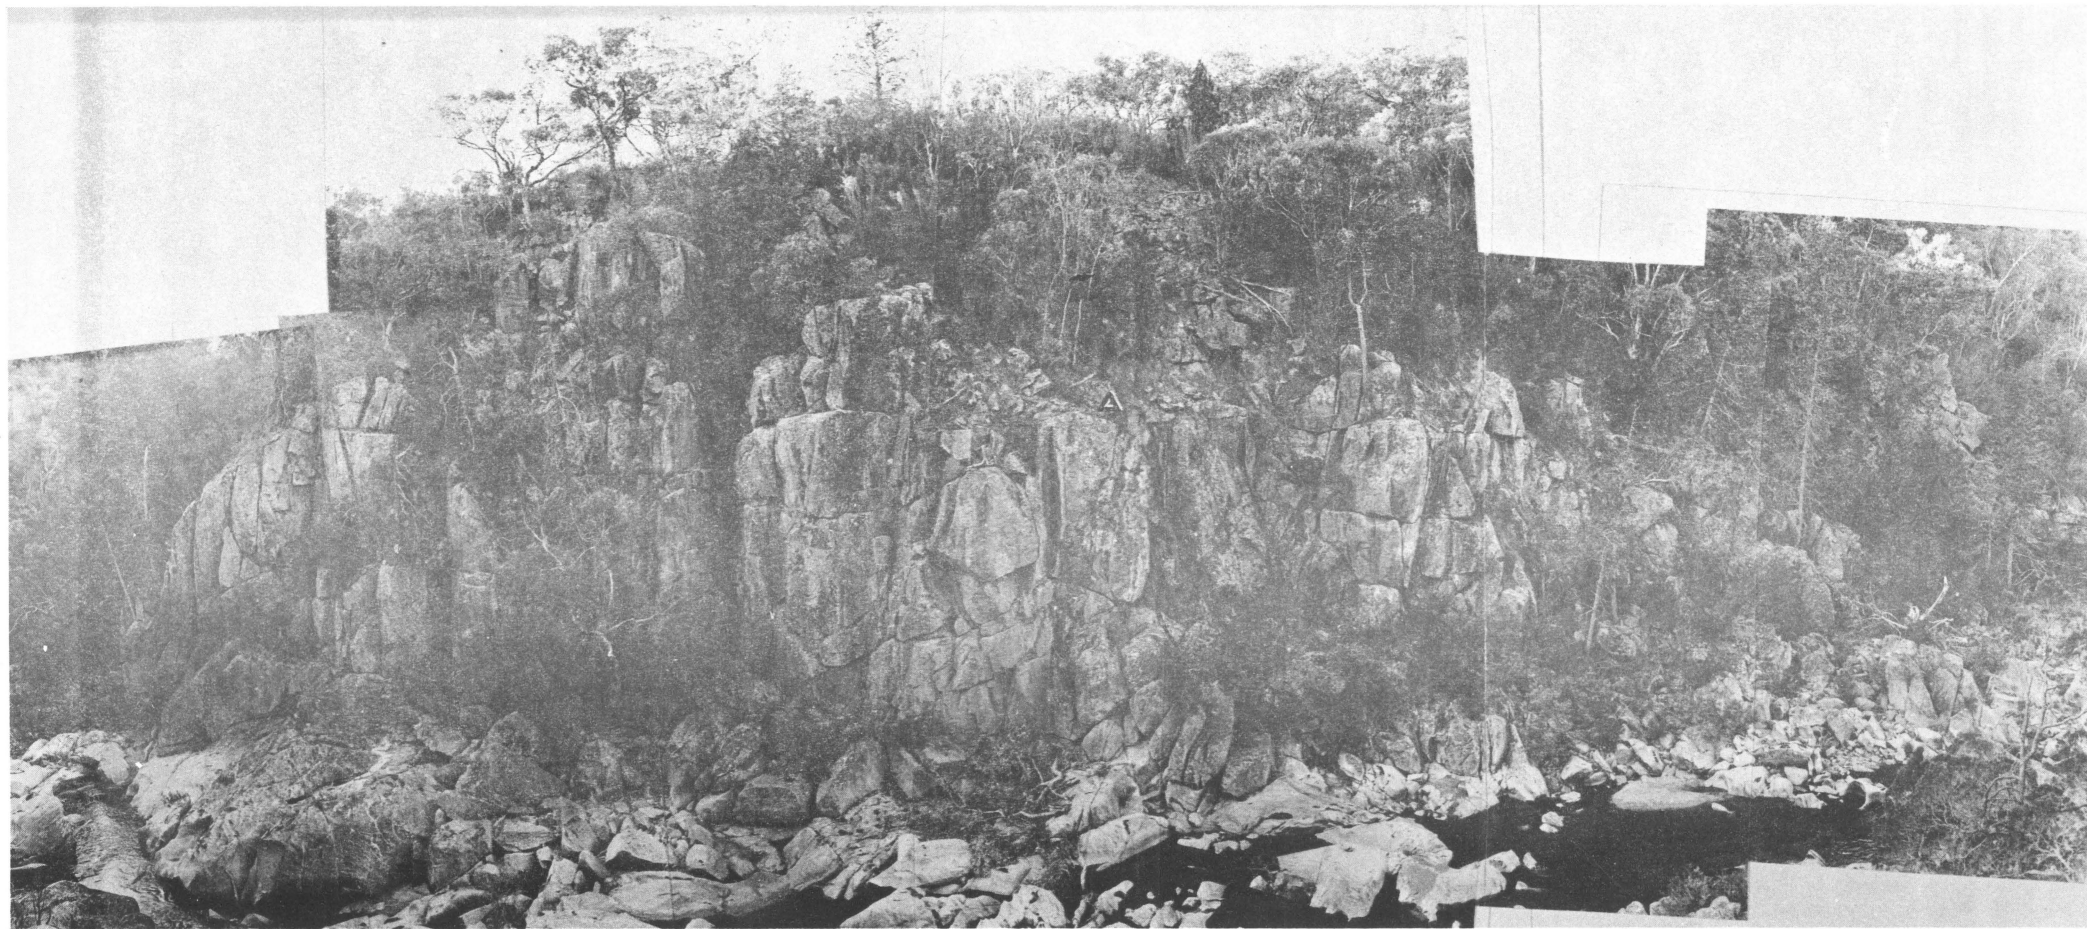
EAST BANK UPSTREAM

Fig. 2. From 18930/85870 (Station 779). Station 766 near centre. Cliffs are up to 60 feet high; steeply-dipping joints are predominant, but there are some horizontal and gently-dipping joints.

Set 4 joints Generally horizontal joints. They are type 1 and are believed to be sheeting joints. Many are irregular in shape, especially on the east bank upstream. (Fig. 2).

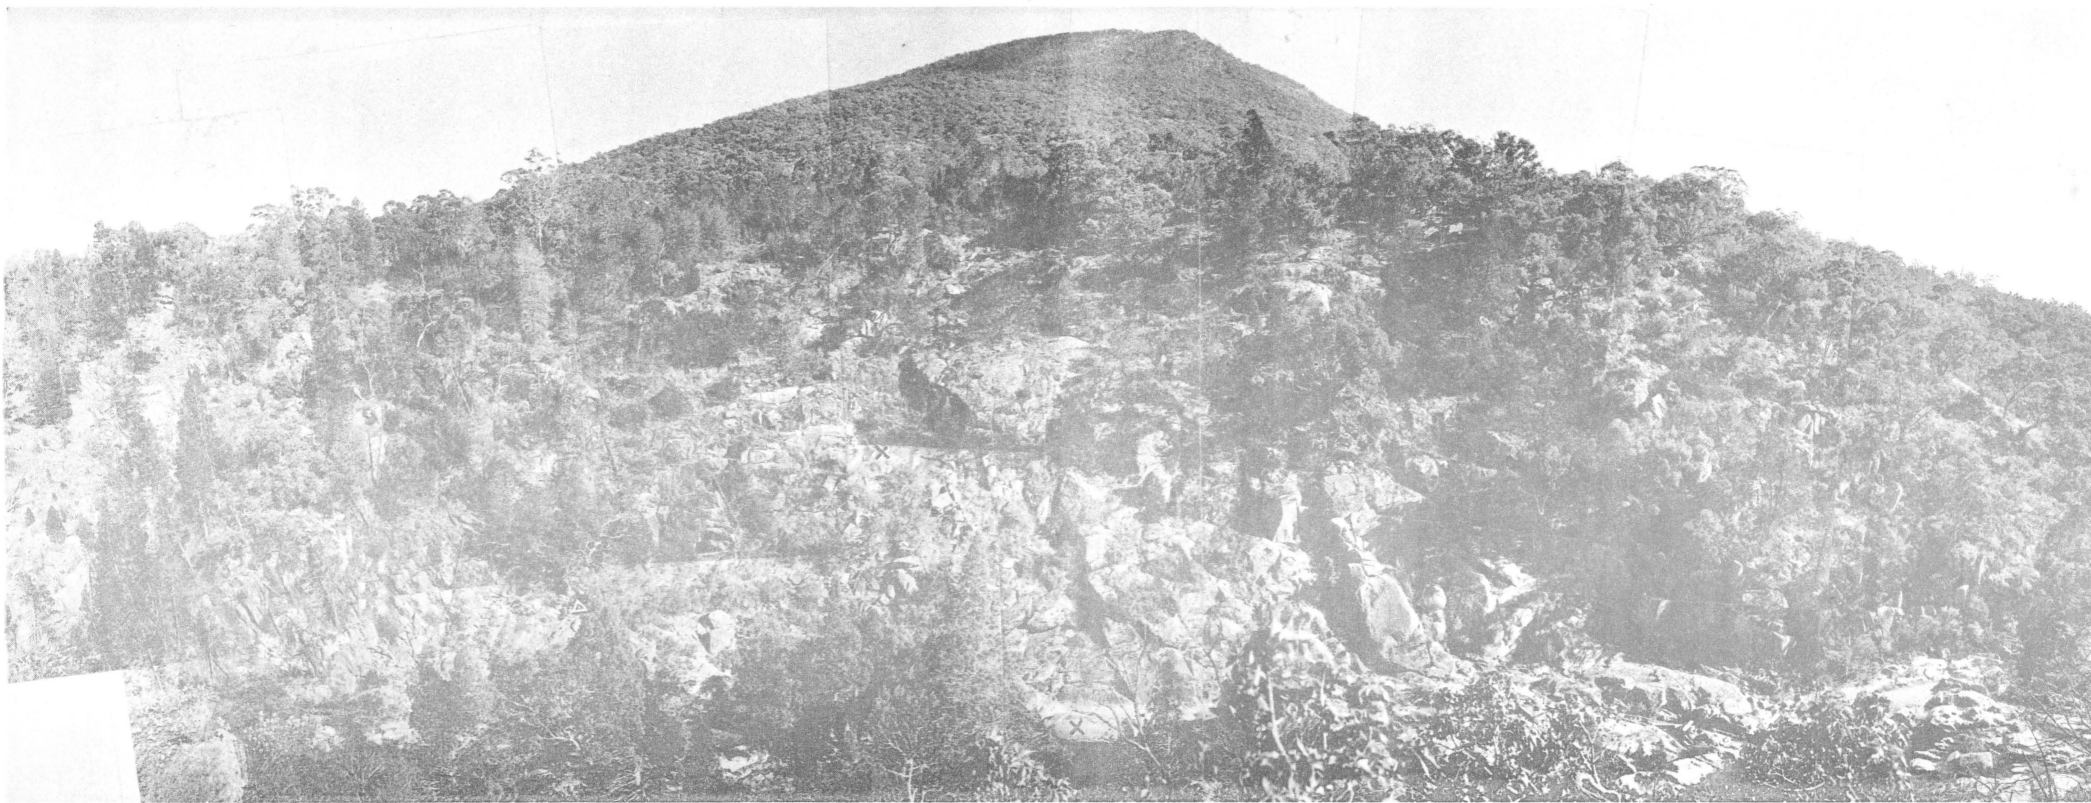
WEST BANK DOWNSTREAM

Fig. 3. From 18830/85500 looking West. Station K at lower left. Mt. Tennent in the distance. The slope of this bank is controlled to a large extent by easterly-dipping joints which often appear as "dip slopes"; two of these are marked by crosses.

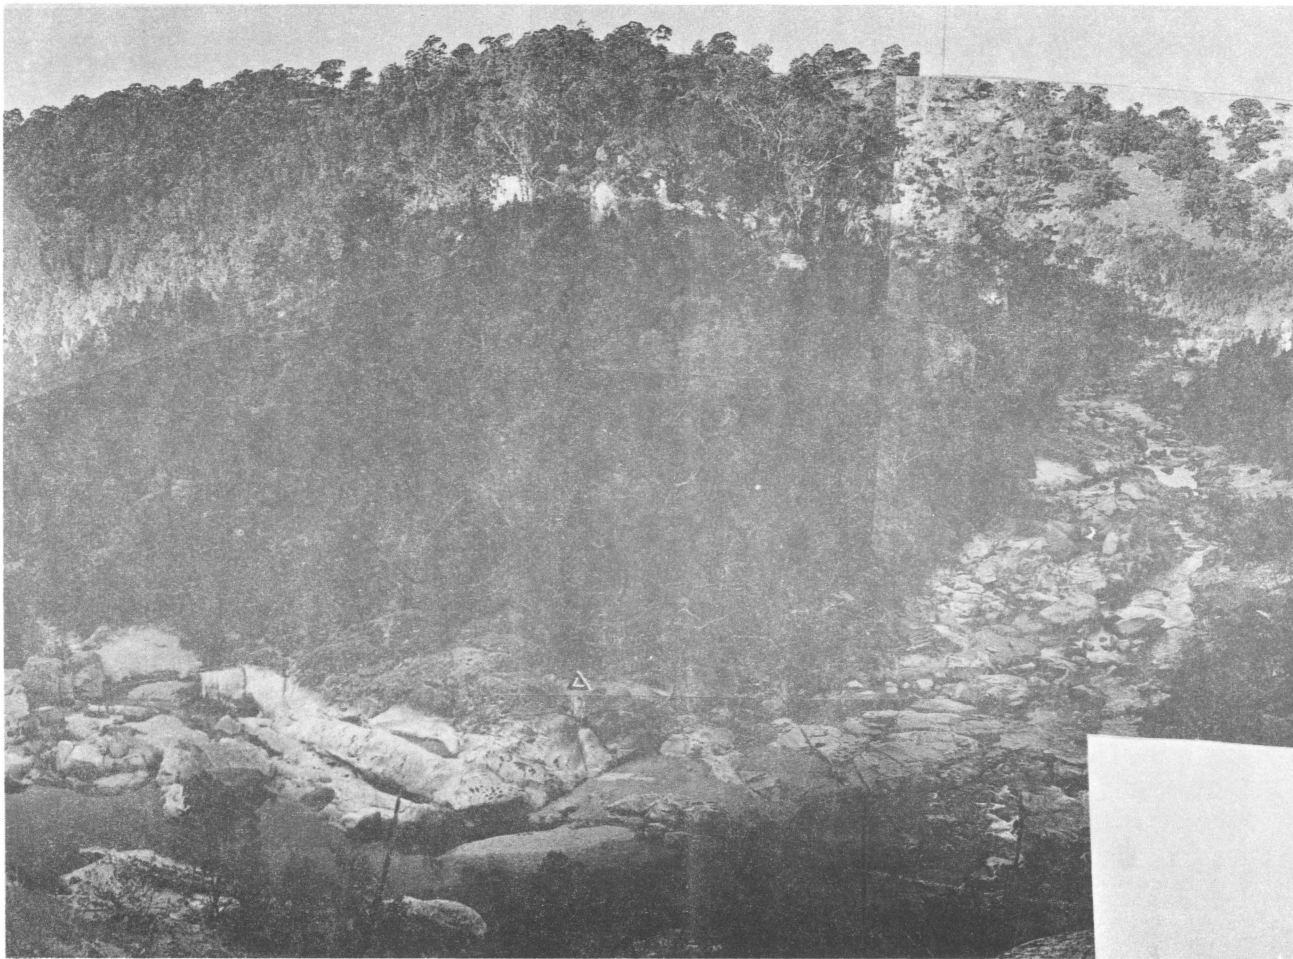
EAST BANK AND NARROW RIDGE

Fig. 4. From 18450/85610 looking East. Station R marked. River flows from right to left. Note rocky riverbed, high cliffs upstream, and lack of outcrop on East Bank Downstream.

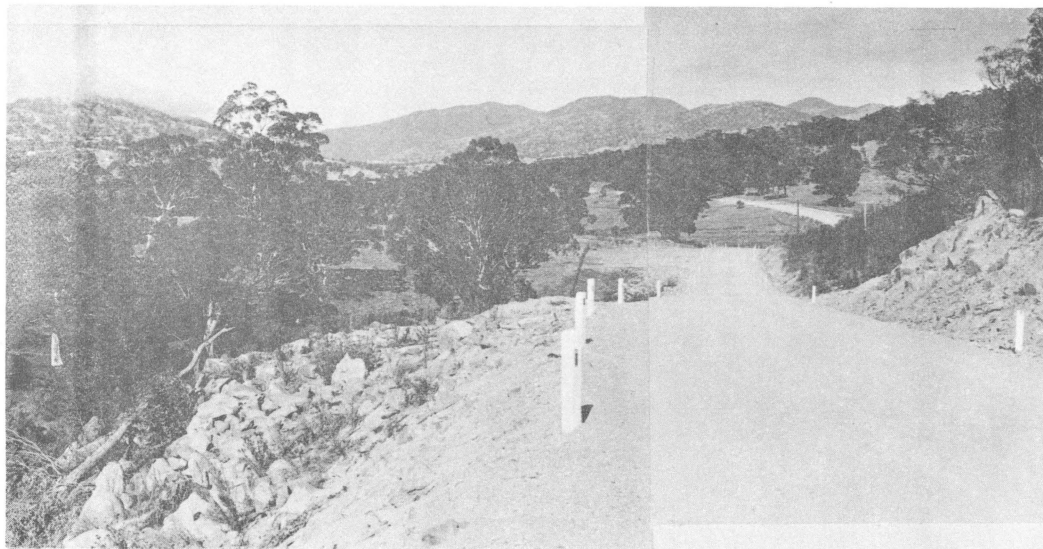
Fig. 5. From 18020/84670 looking South. Naas Road and reservoir area; a spillway running from the saddle down the small valley at the left is proposed.

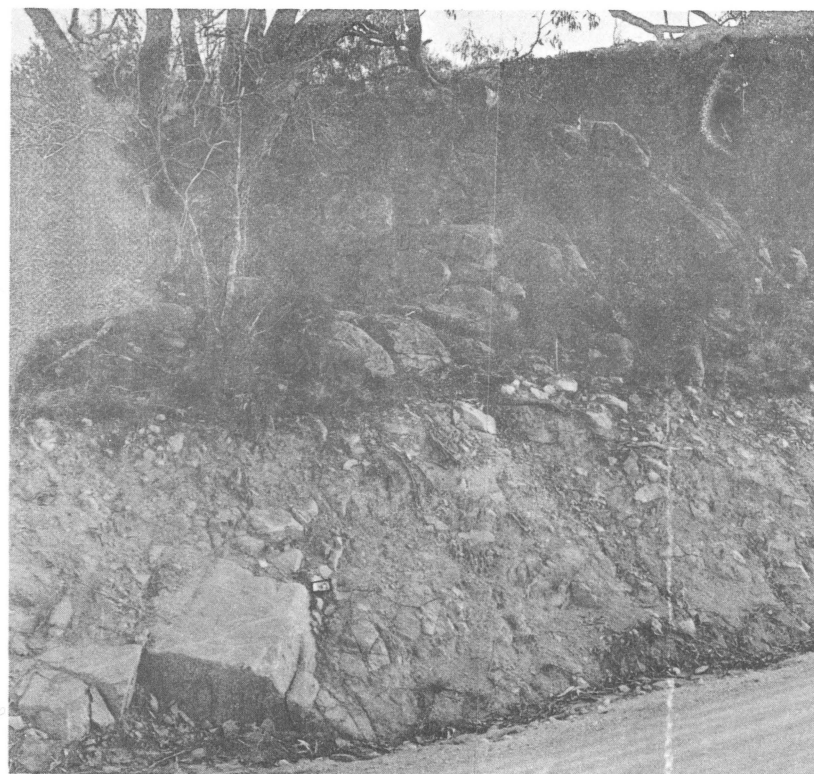
Fig. 6. From 17860/84310. Road-cutting showing depth of weathering near a large outcrop. \$2 note for scale.

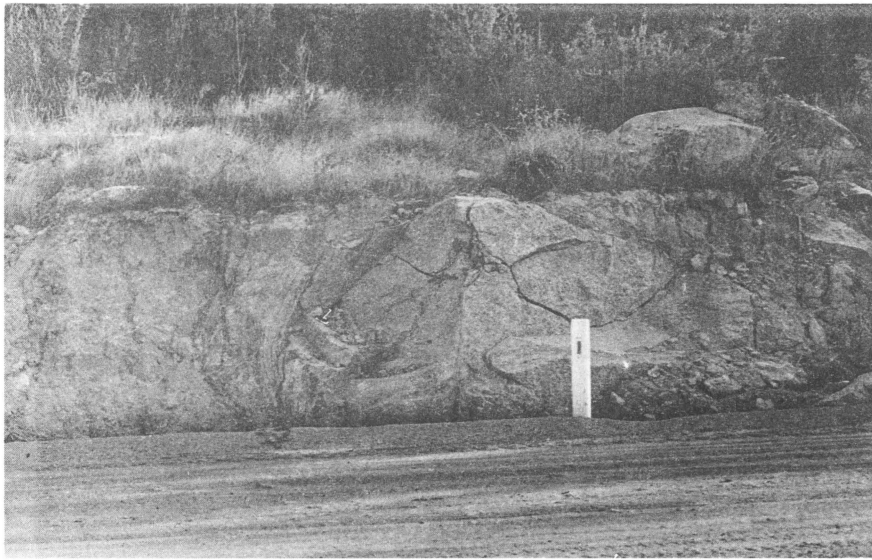
Fig. 7. (Above left) From 17750/84250. Road-cutting showing weathering. Note sharp boundary between completely-weathered and unweathered rock, and rounding of the rock-body by weathering. Hammer at left end of boulder gives scale.

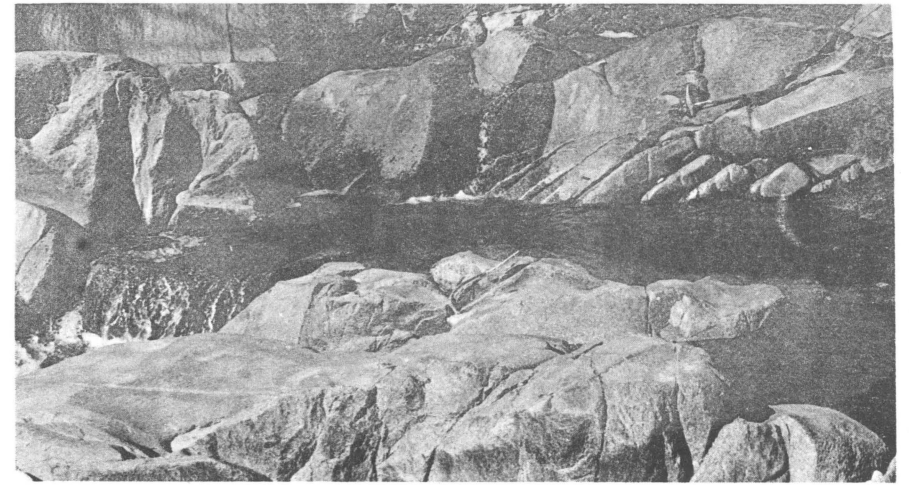
Type 4. Closely-spaced parallel joints, moderate size, within a horizontal zone, and having the orientation of set 3 joints, i.e. strike 152° magnetic and dip 37° east. The joints occur between two horizontal planes about 4 feet apart. An example is shown in Figure 8; the photograph shows how readily the joints are eroded by the river. These joints are exposed in the downstream portion of the gorge between R.L's 1930 and 1955 and have also been found in DG1 between the same elevations. In DG2 a set was found between R.L's 2076 and 2079. The areal extent of a particular zone is large. For example, the zone which has its lower surface at R.L. 1955, is mostly eroded but occurs at E18620/S85300, E18690/S85210 and E18750/S85220 and thus may have had an areal extent of greater than 2600 square feet.

Fig. 8. (Above right) From 18740/85200. Multiple joints, analogous to current-bedding: parallel closely-spaced dipping joints restricted to a horizontal zone a few feet thick. In the foreground a horizontal surface representing the lower extremities of these joints ("bottom-set beds"). Hammer gives scale.

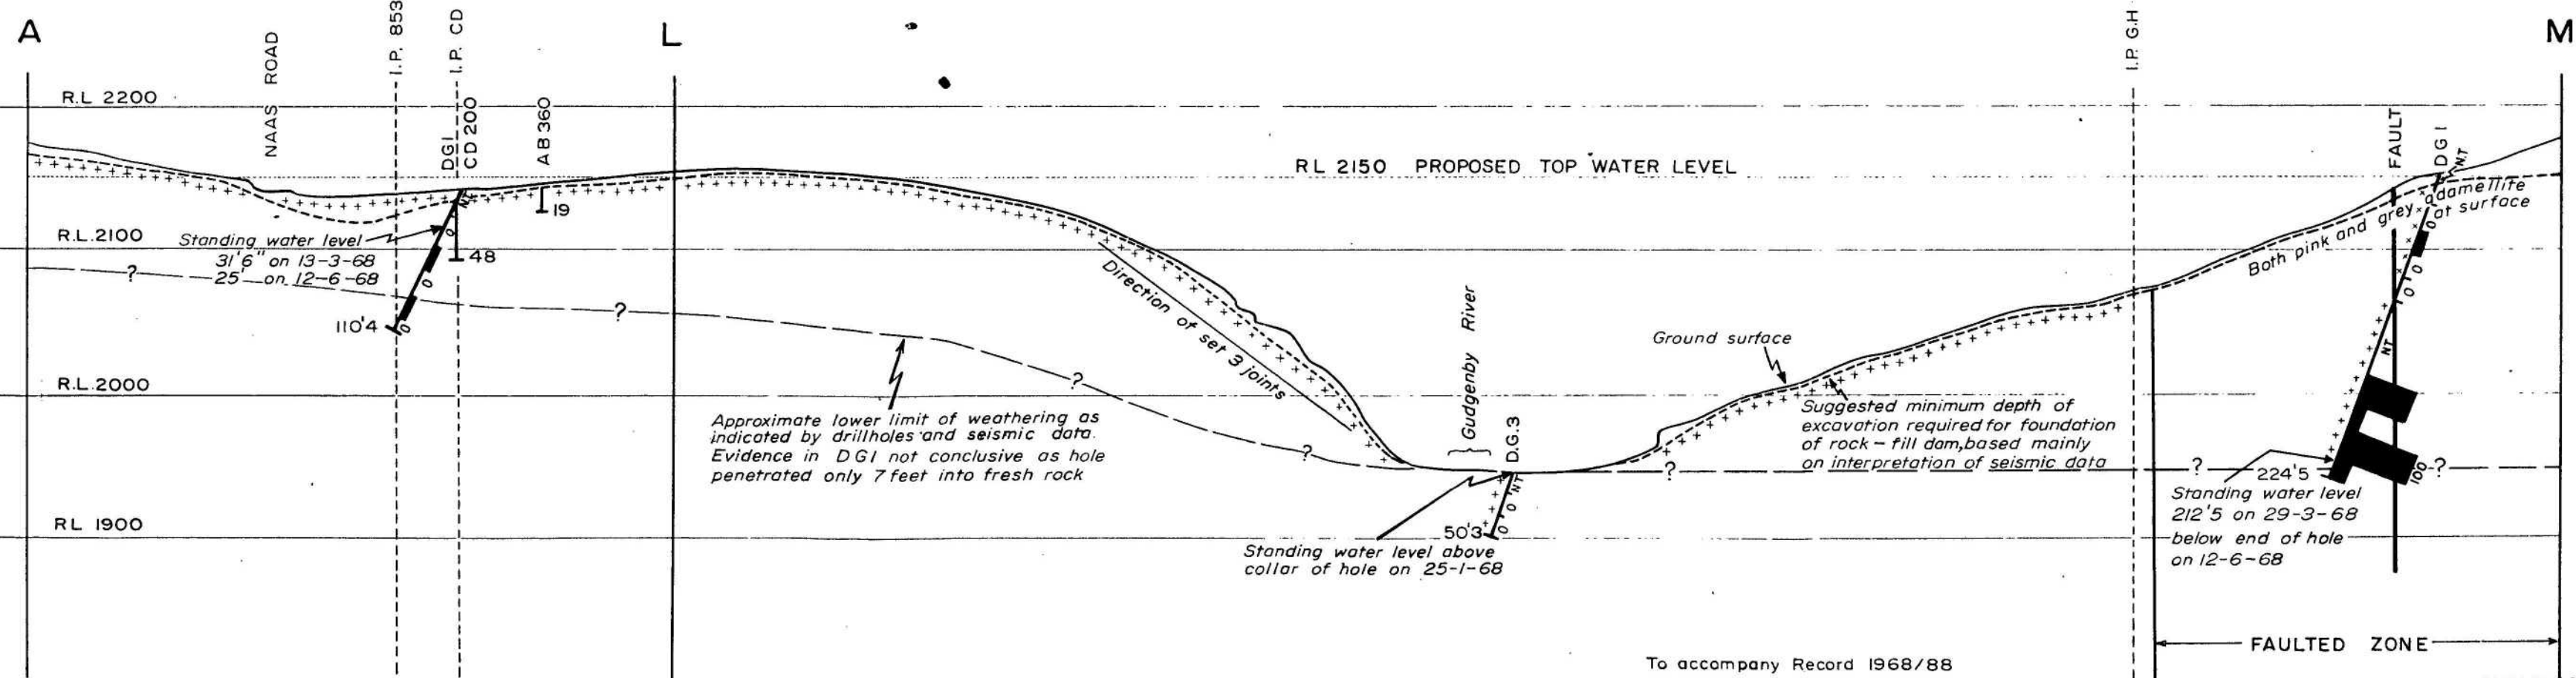
SECTION ALM, POSSIBLE DAM AXIS, LOOKING NORTH (DOWNSTREAM)

Plate 4 shows a possible excavation profile. It is based on the very limited data obtained so far and should only be regarded as a guide for present estimating and planning purposes. Much further investigation work is still required to determine the foundation profile. Localised deeper excavation, especially on the east bank, will doubtless be required below the profile presented.
