Record No. 1968 / 90

Wilkes Geophysical Observatory,  
Annual Report 1966

*F.J. Taylor*

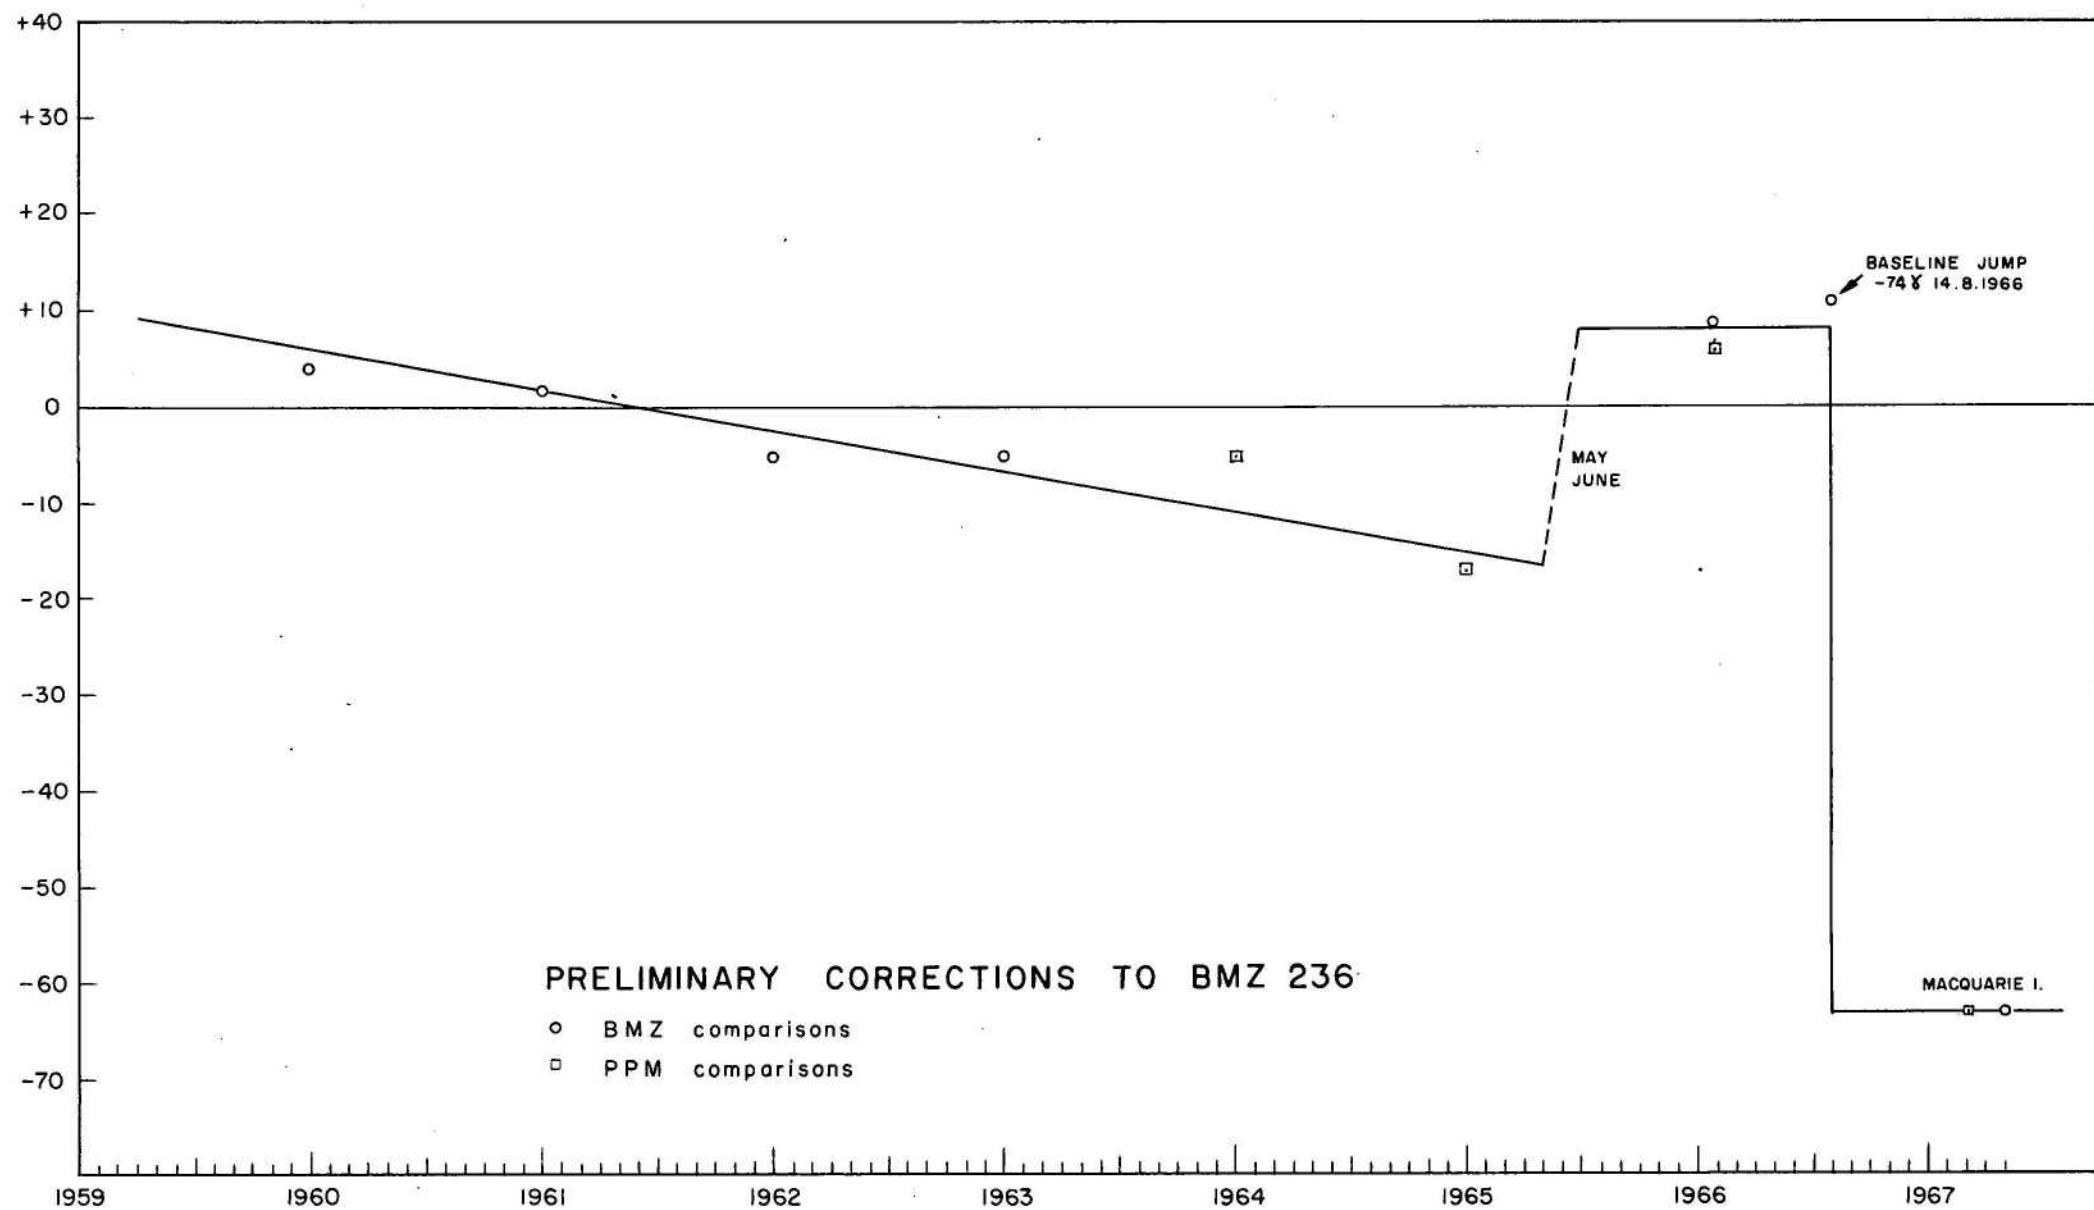
Intercomparisons made at the 1966 changeover between BMZ 236, a PPM, and long-range BMZ 221 were of doubtful reliability. Because of PPM failures an accurate station difference was not determined and that measured in 1965 has had to be used. For these reasons BMZ 236 corrections have been derived from analysis of all available comparisons and of baseline value changes during 1965 and 1966. The results are shown in Plate 1.

Corrections prior to 1965 show a steady drift. The abrupt changes occurring in 1965 and 1966 are based on the following evidence:

- (a) 1966 and 1967 comparisons show a change of correction of about 71 gammas.
- (b) Eight observations on 14 August 1966 revealed an apparent baseline value change of 74 gammas. Detailed analysis of magnetograms proved that this was a BMZ effect; possibly the instrument was moved unclamped on 3rd or 13th August.
- (c) May-June 1965 baseline values changed about 25 gammas during a period when the BMZ neutral division changed a corresponding amount (Browne-Cooper, 1968). Confirmation that this change took place in the BMZ was obtained by comparing selected quiet day ordinates, observed baseline values, and the amount of secular change.

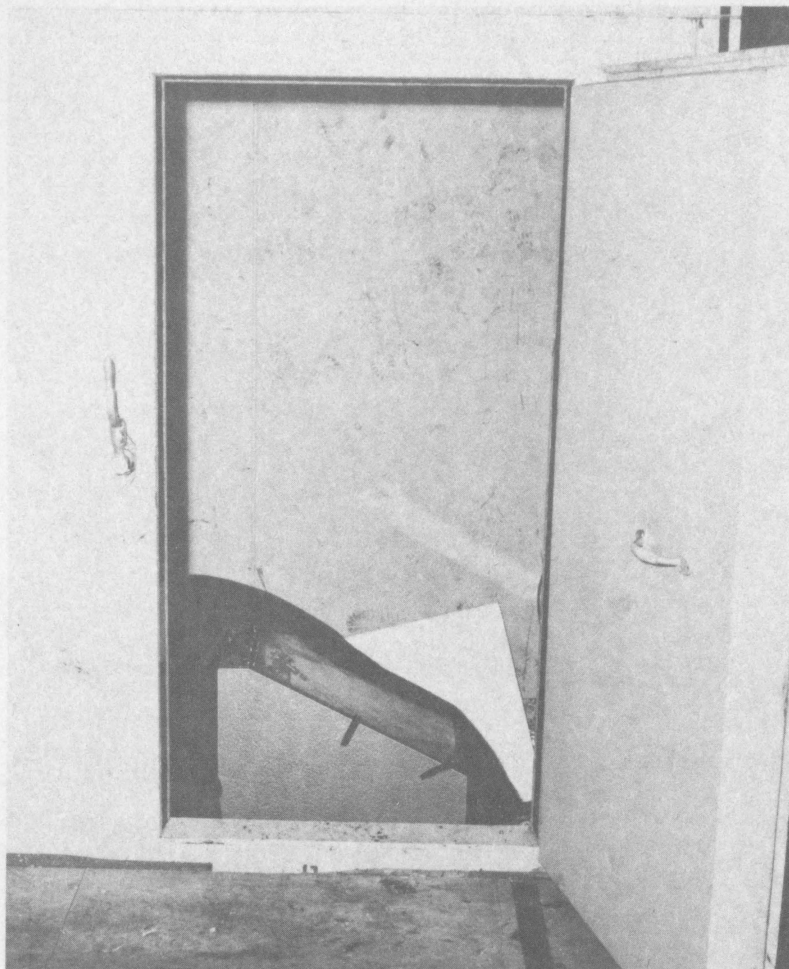
(a) ENTRANCE TO VAULT

- (1) Three new heaters were installed in the recording room (Plate 4). These heaters were made from 500 and 240-watt, 240-volt stove elements; two elements were wired in parallel and clamped on a long strip of No. 8 gauge steel. Three sets were made and, when installed, were operated on two 110-volt phases. Initially attempts were made to control the temperature of the recording room with the aid of a thermostat. However, this created more drifting and hence one of the heaters was allowed to remain on continuously.
- (2) The concrete base of the vault was lined with sisalcraft on the inside (the term 'vault' is used for the inner hut which houses the seismometers). This prevented drifting snow from entering the vault and also helped to maintain a steady temperature.

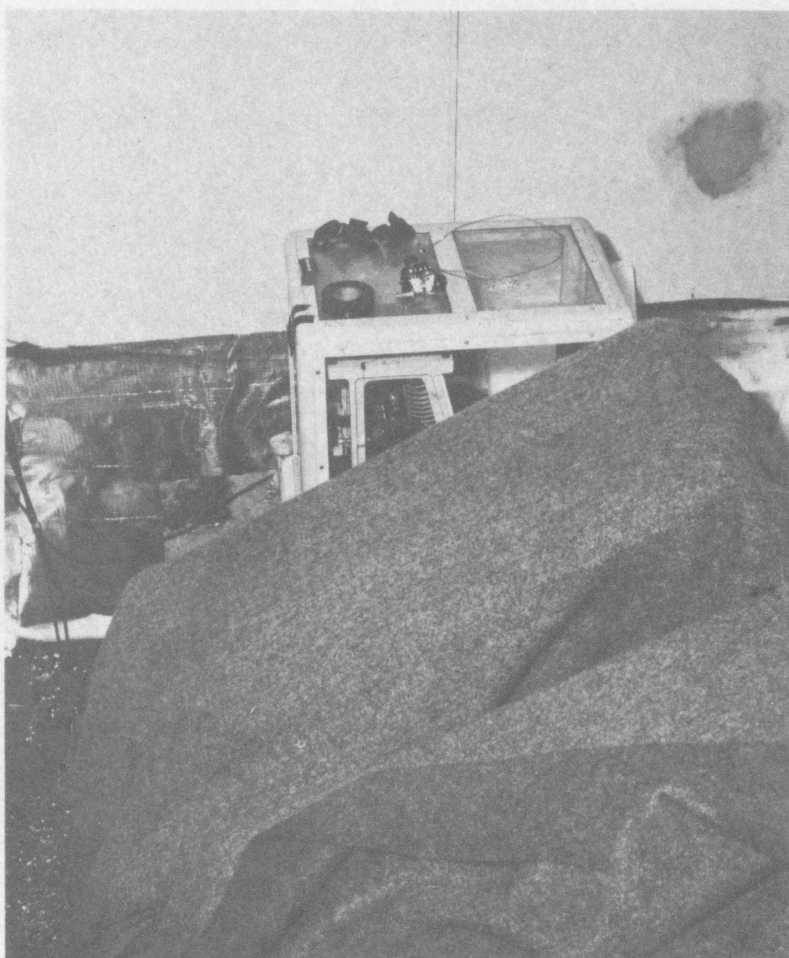
(b) INTERIOR OF VAULT

- (3) The three perspex lids of the seismometer covers were removed and hinged at the upper end. This provided ready access to the seismometers.
- (4) All switches and attenuators were placed in a metal box, which was then installed on the galvanometer pier. Calibrating circuits for the galvanometers were also included in this box.

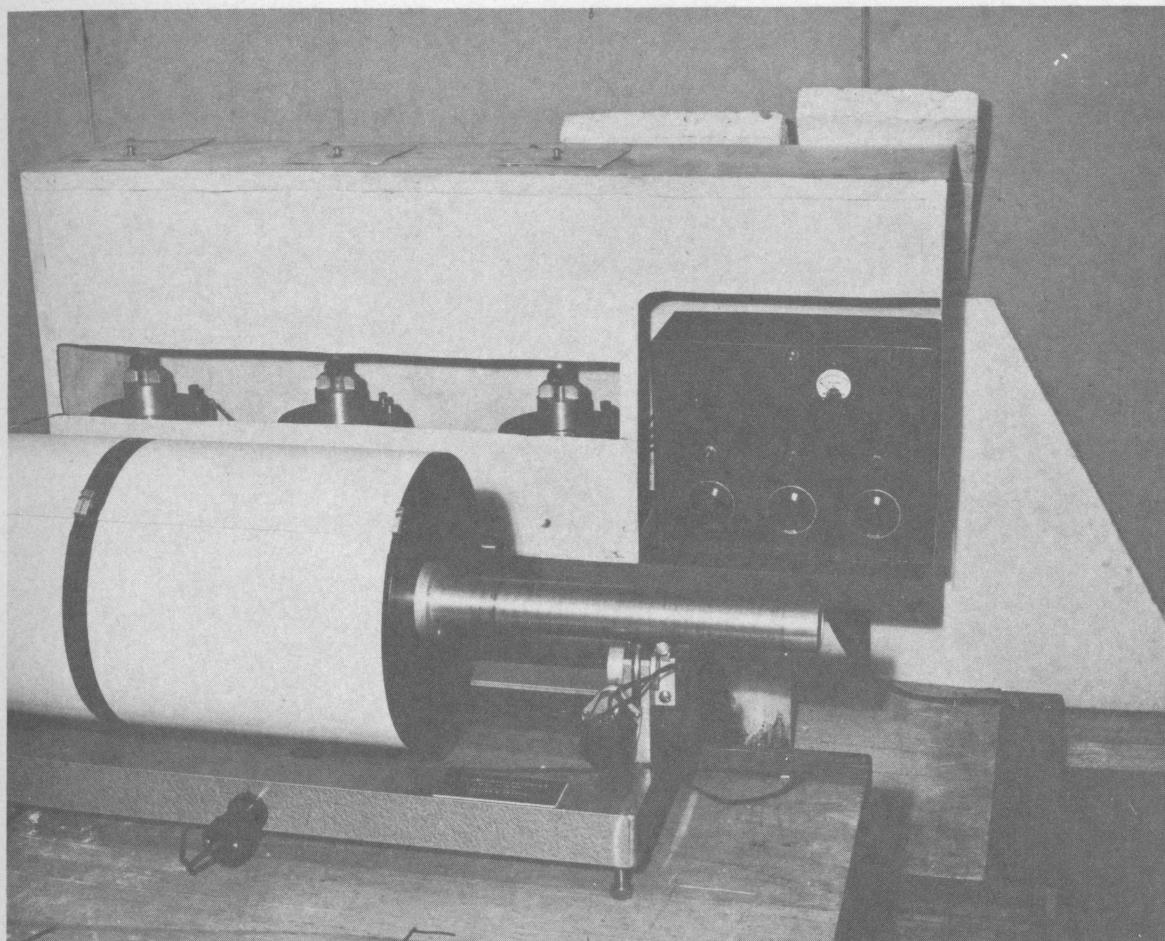
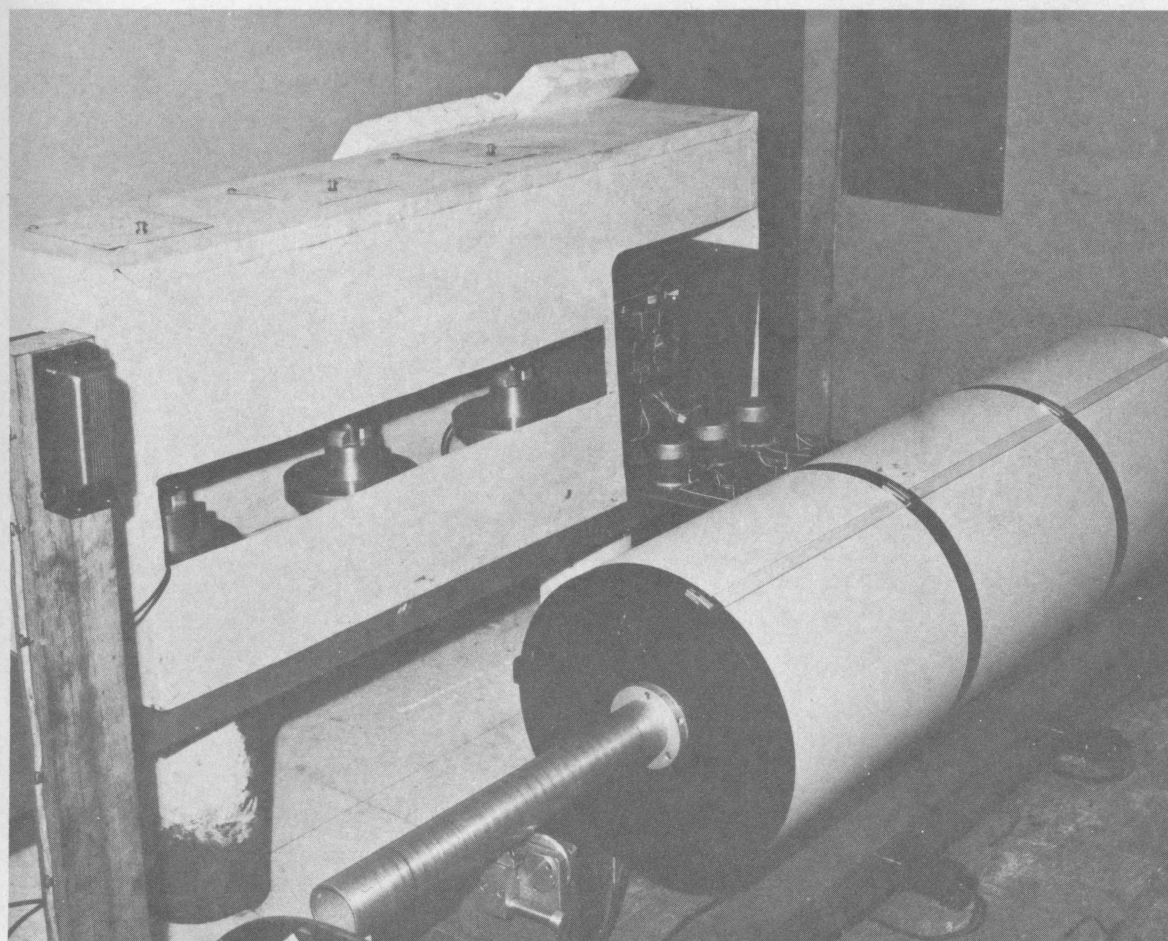
GALVANOMETERS AND RECORDING DRUM

- (6) Polyurethane insulation was placed over the concrete well which surrounds the galvanometer piers (Plate 3) and also around the concrete base of the vault.

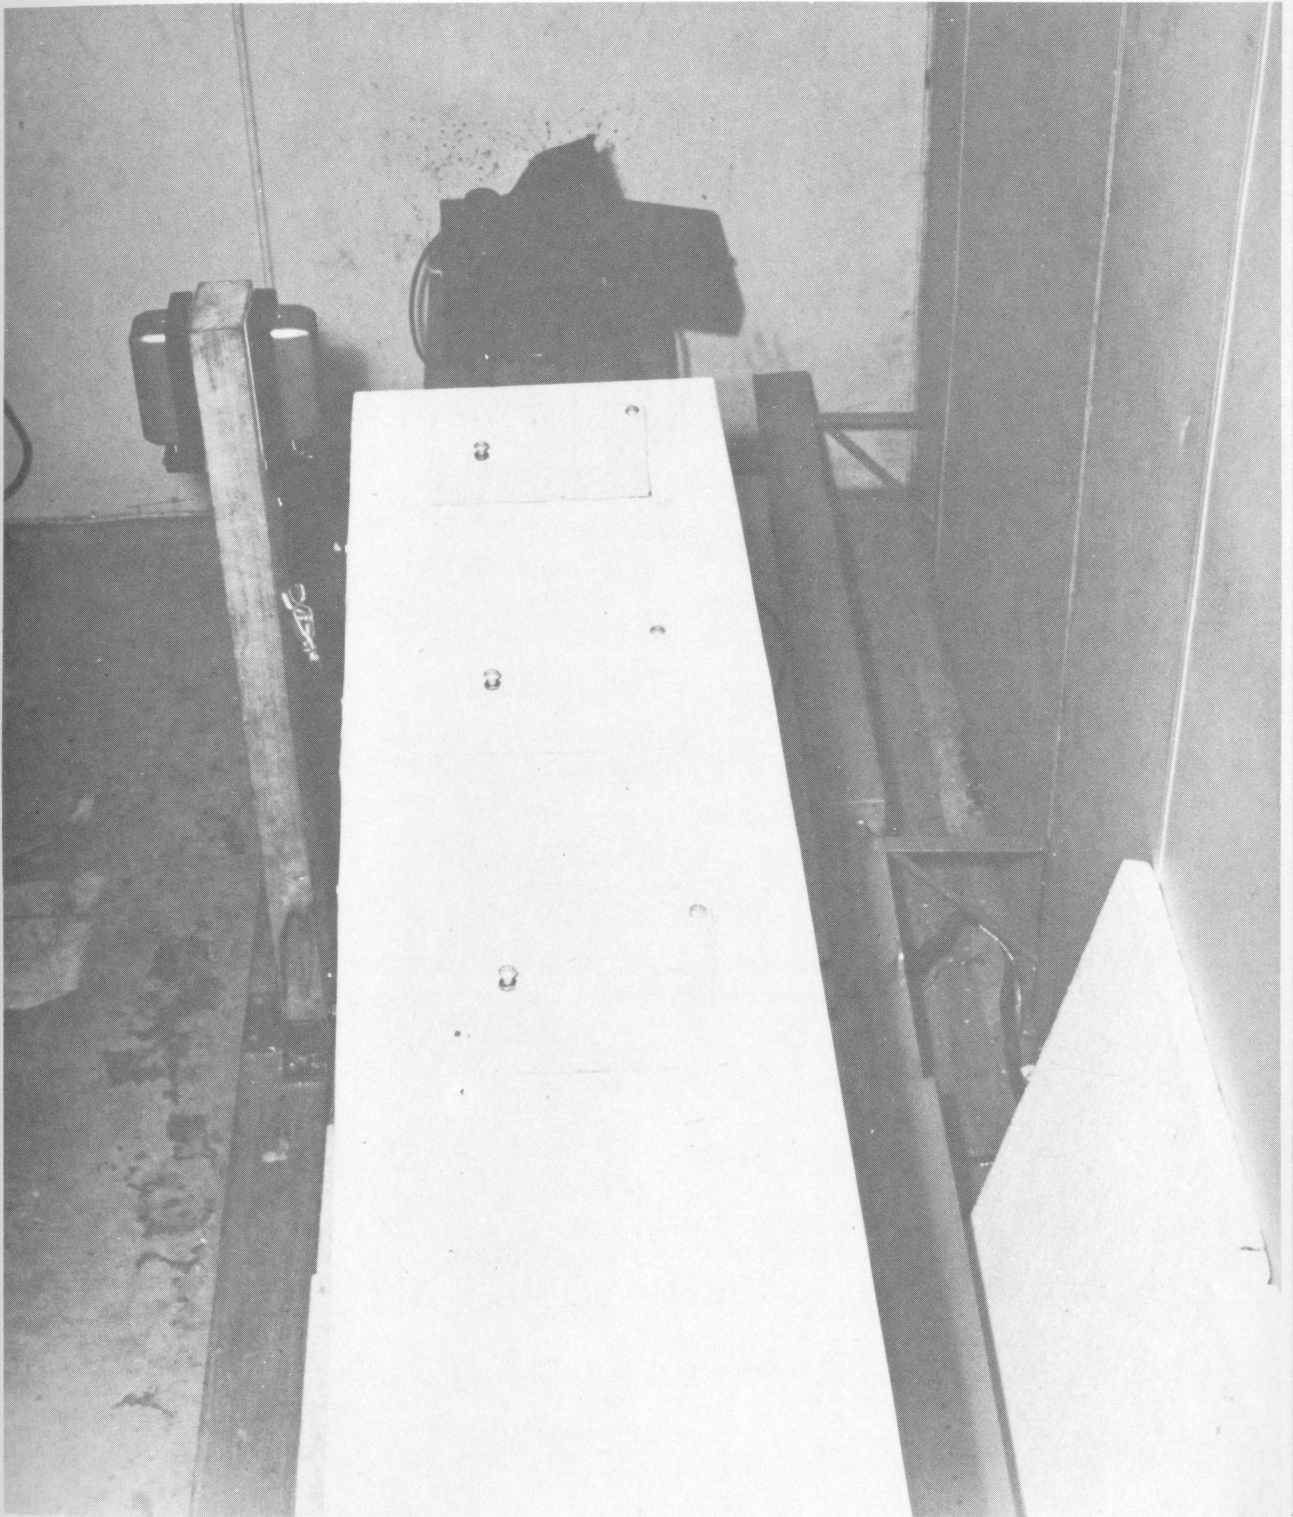
GALVANOMETER COVER AND ELECTRIC HEATER

- (5) A zincanneal cover, painted flat white, was installed over all three galvanometers and the control panel. This was part of an effort to control the temperature in the vicinity of the galvanometers.

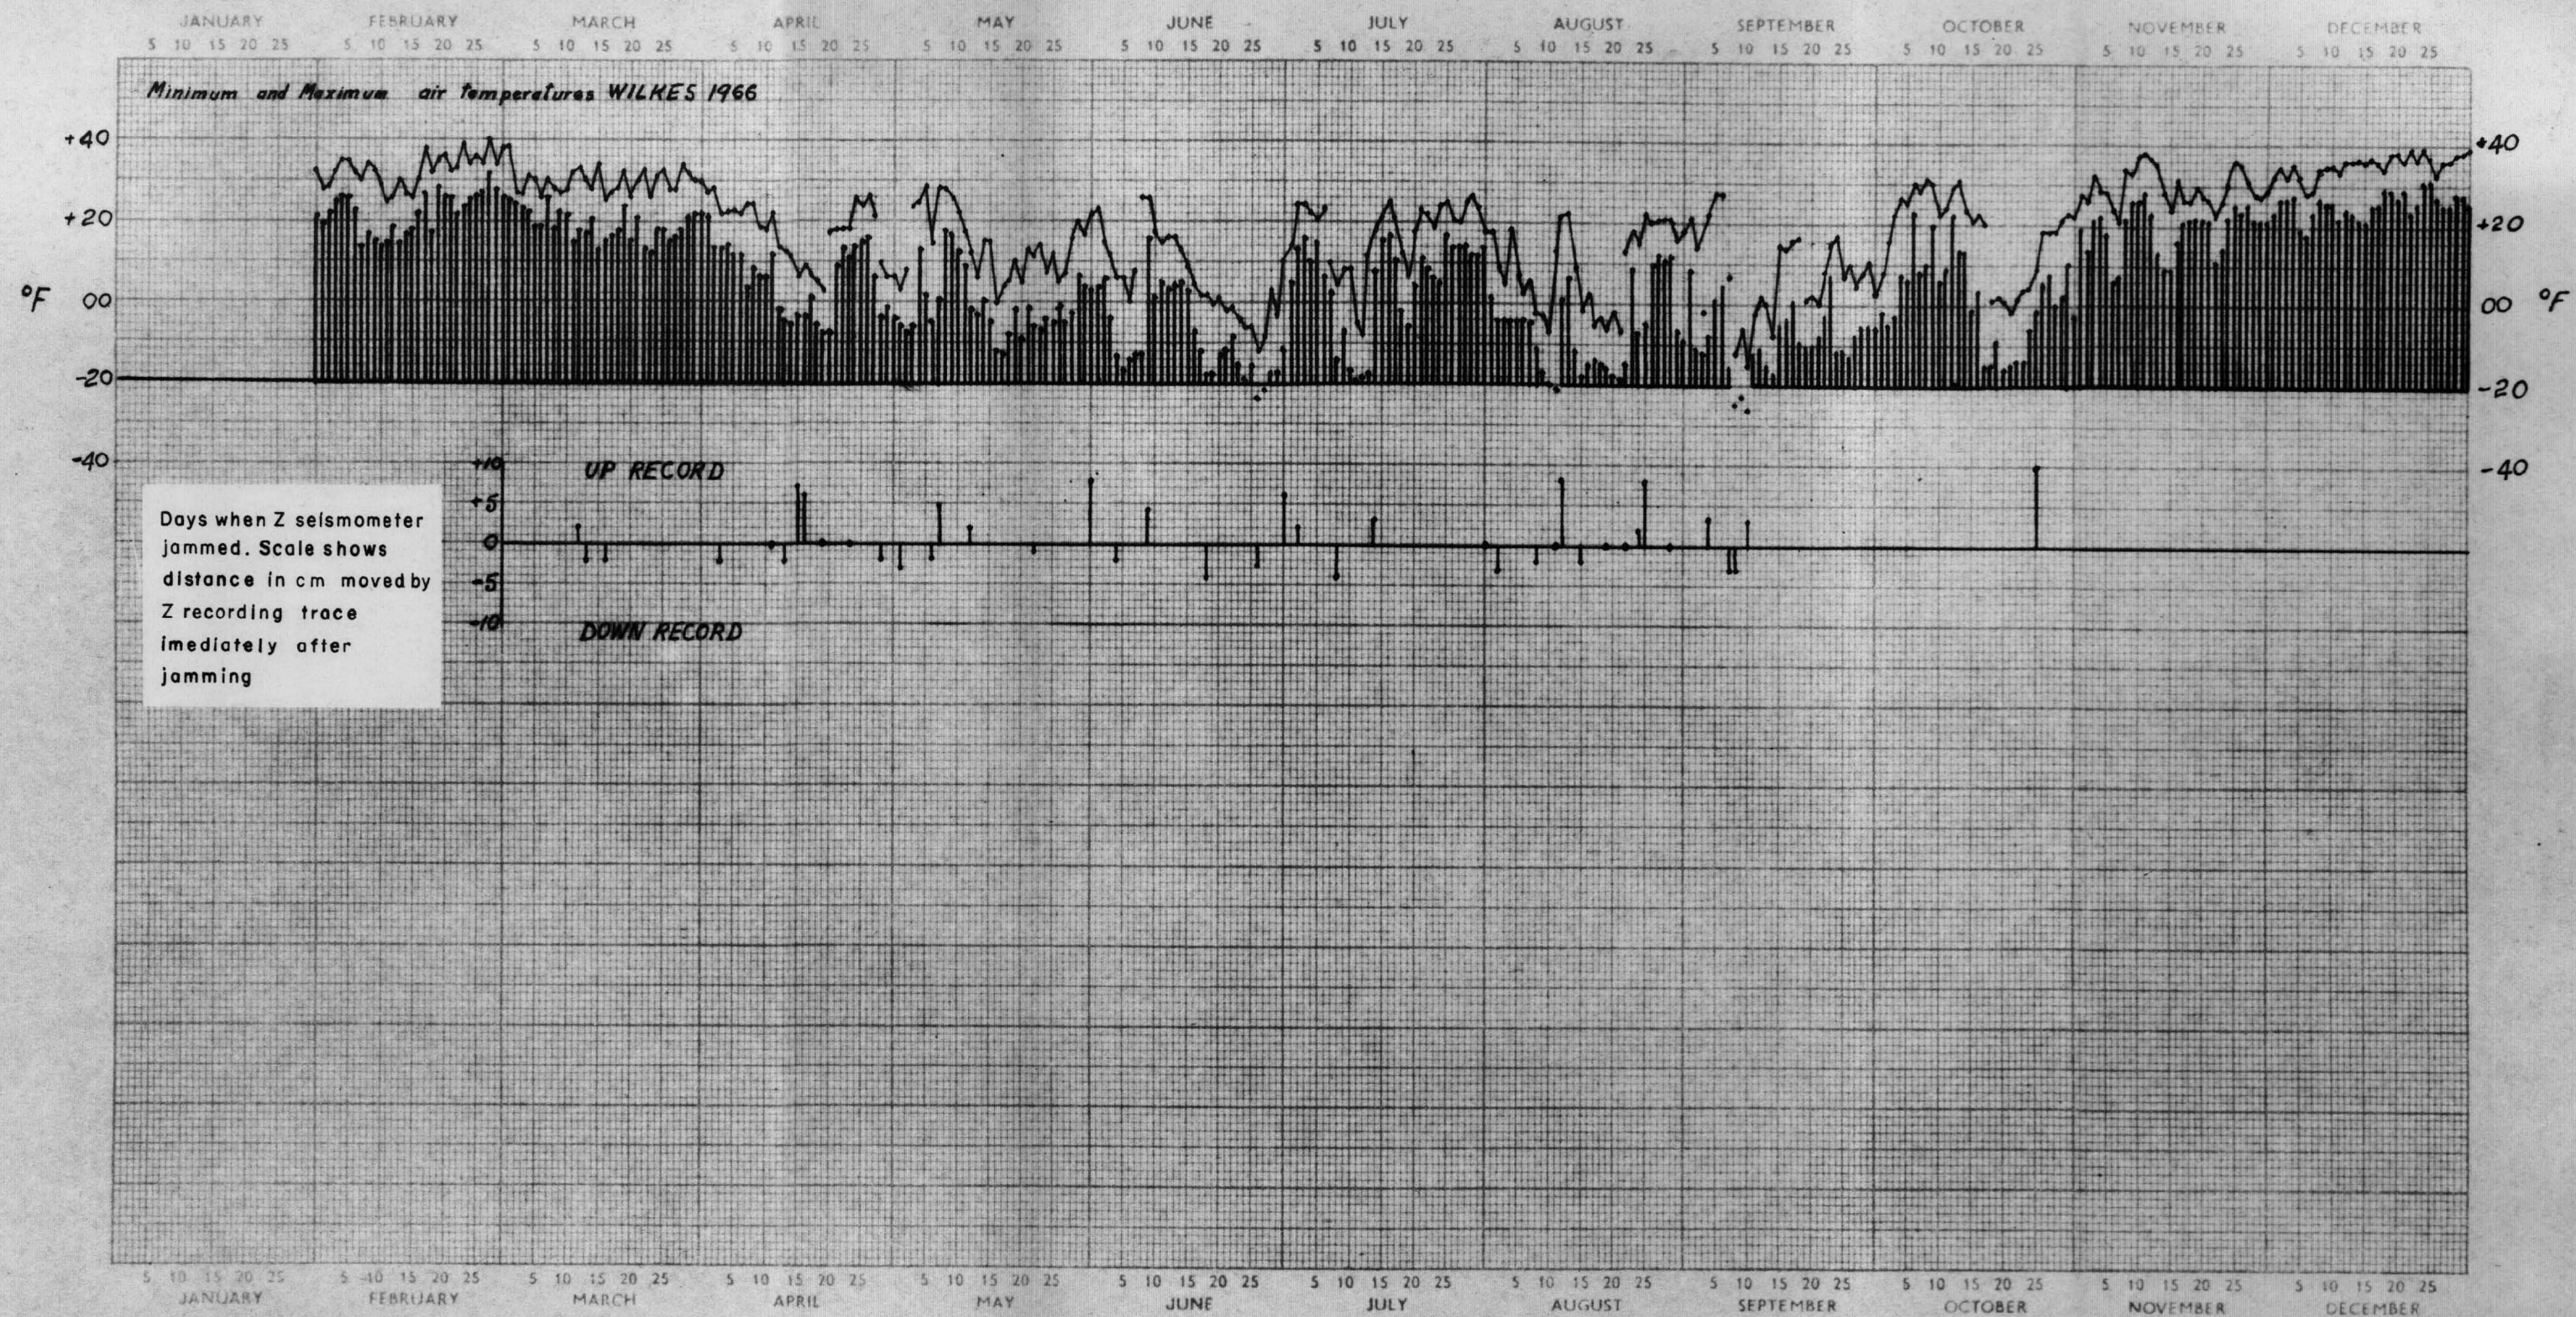
DAILY EXTREMES OF AIR TEMPERATURE  
AND JOINING OF LONG PERIOD Z SEISMOMETER

From evidence available at the present moment it appears that temperature variation is the originator of about 90 percent of the above faults. However, the author wishes to point out that thermo-electricity does not account for all of these effects.

Plate 5 shows a plot of minimum and maximum air temperatures recorded at Wilkes in 1966. Below this plot are shown the days on which the Z seismometer jammed and the distance moved (cm) by the Z recording trace immediately after jamming. Sudden temperature changes, e.g. those associated with high winds cause the mass of the Z seismometer to move up or down. If the temperature change is continuous then the mass of the seismometer will continue to move until it hits either the upper or lower stop. Thus, the d.c. current produced by continuous movement in the same direction will suddenly cease and hence the recording trace will show some sharp movement immediately after jamming. In general there is some correlation between the direction of movement of the recording trace and the sign of the temperature change. However, the picture is complicated by other factors such as humidity and static charges.

Because it is desirable to have the seismometers in a room separate from the galvanometers and recorders, and because it is impossible to prevent drifting by thermostatic control, then both the recording room and the seismometer vault must be placed underground. This suggestion was advanced by G. Dewart as far back as 1957, when drifting proved to be a serious problem during the first year at Wilkes. This task is not as difficult as it may appear. The problem would be to blast a shaft in the side of a steep slope and then seal the entrance with a concrete wall. The usable space inside the shaft would need to have the dimensions 8 ft high, 12 ft wide, and 24 ft long. Temperature changes inside such a shaft would be very small and the establishment of two rooms inside the shaft would not set up serious temperature gradients. This idea of course is simply a replica of such seismological stations as Mundaring and Toolangi.
