RECORDS 1968/109

GEOLOGICAL INVESTIGATION OF THE
PROPOSED KUMUSI RIVER-KOKODA ROAD, T.P.N.G., JULY, 1967

J.C. Braybrooke

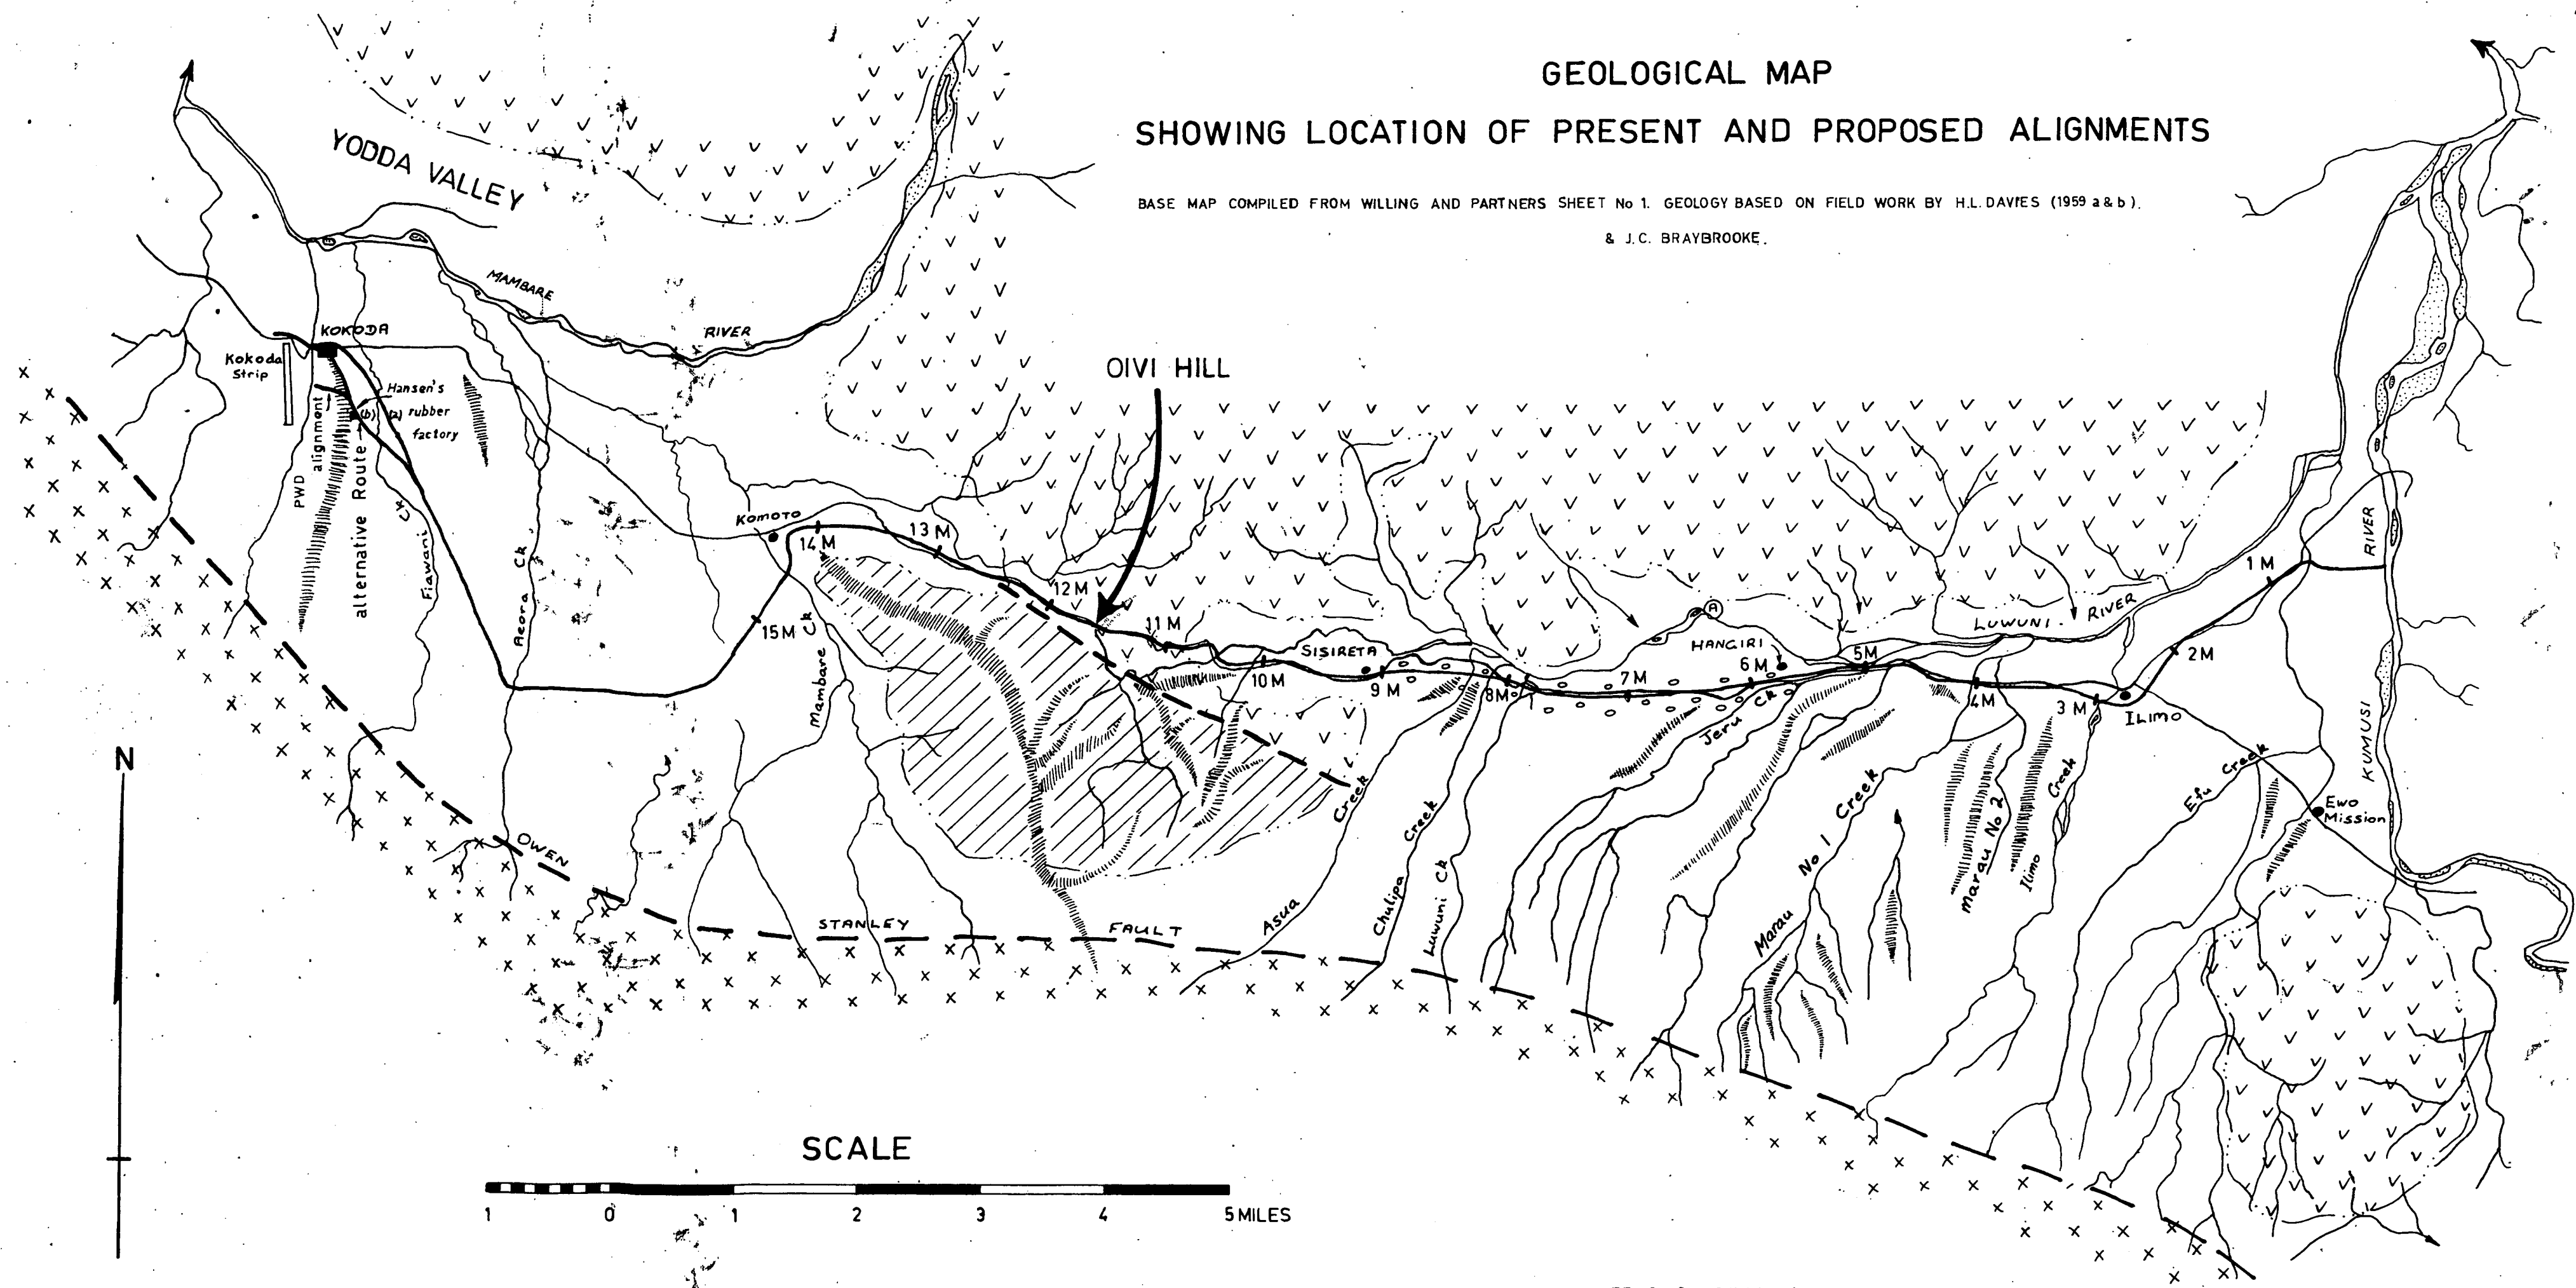
PLATE 1

GEOLOGICAL MAP SHOWING LOCATION OF PRESENT AND PROPOSED ALIGNMENTS
