Record 1971/129

MACQUARIE ISLAND  
GEOPHYSICAL OBSERVATORY,  
ANNUAL REPORT 1970

J.R. Meath

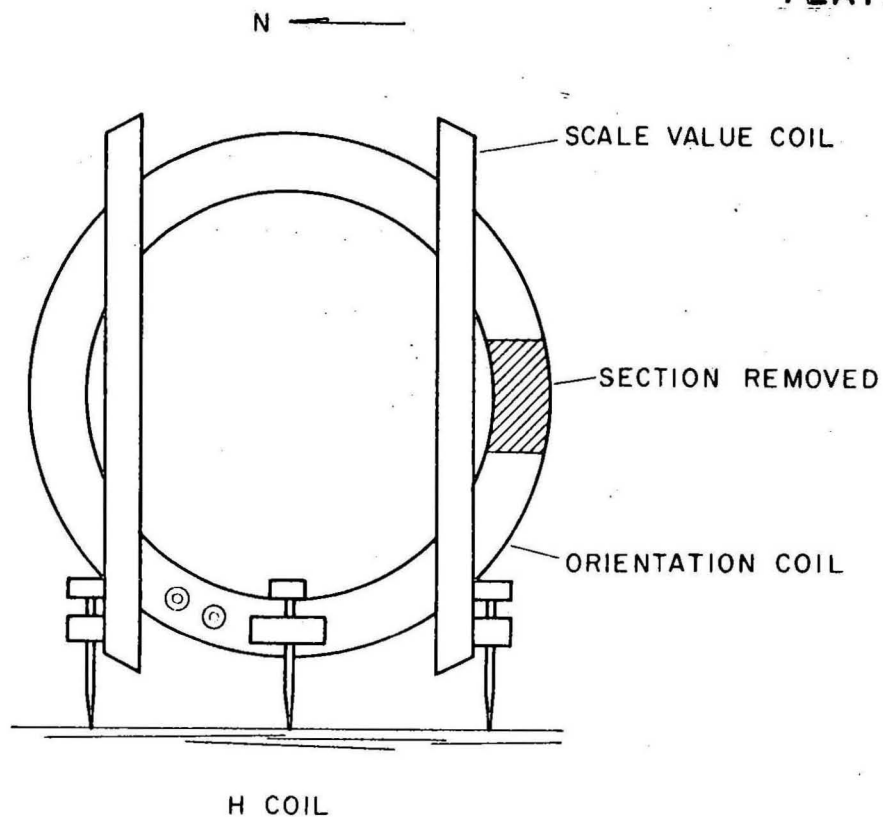
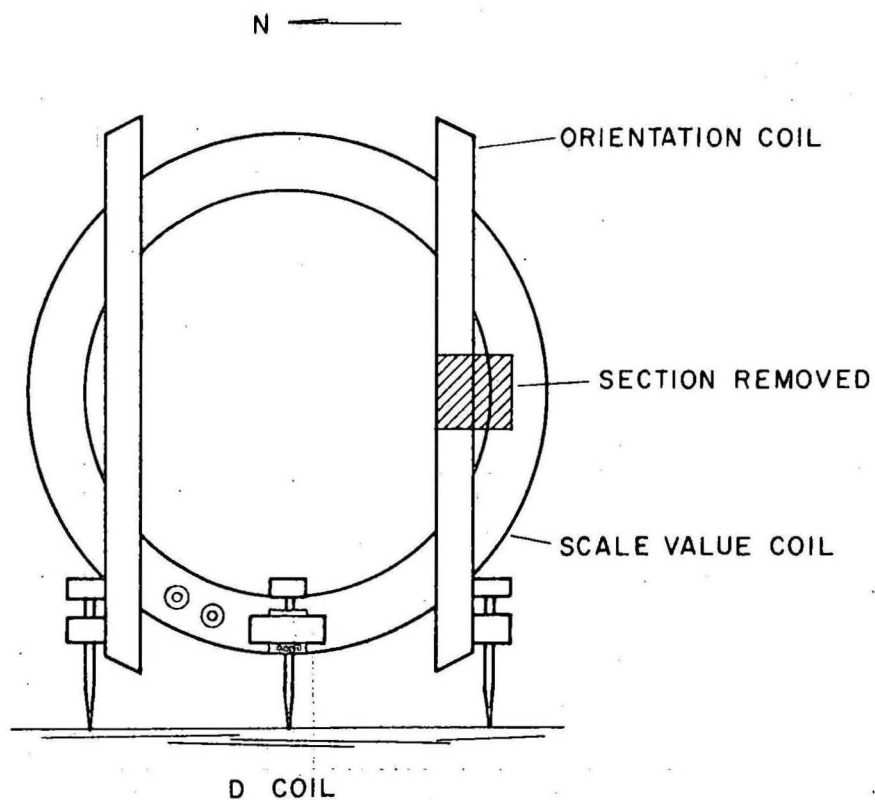
# SCALE-VALUE/ORIENTATION COIL MODIFICATIONS

3. New scale-value/orientation coils were installed, modified, and reinstalled on the H and D normal-run variometers. These replaced the original Helmholtz coils (see Plate 3). It was found that light rays to and from the H and Z variometers were obstructed by parts of the coil frames, and the variometers could not be repositioned to overcome this defect. Therefore the offending sections were carefully cut from the coil frames and then the parameters were thoroughly rechecked. Operation was then completely satisfactory.
