Record 1972/18

**GEOLOGY OF THE GOOGONG RESERVOIR,  
QUEANBEYAN RIVER, N.S.W.**

Geology of the  
GOOGONG RESERVOIR

Queanbeyan River, NSW

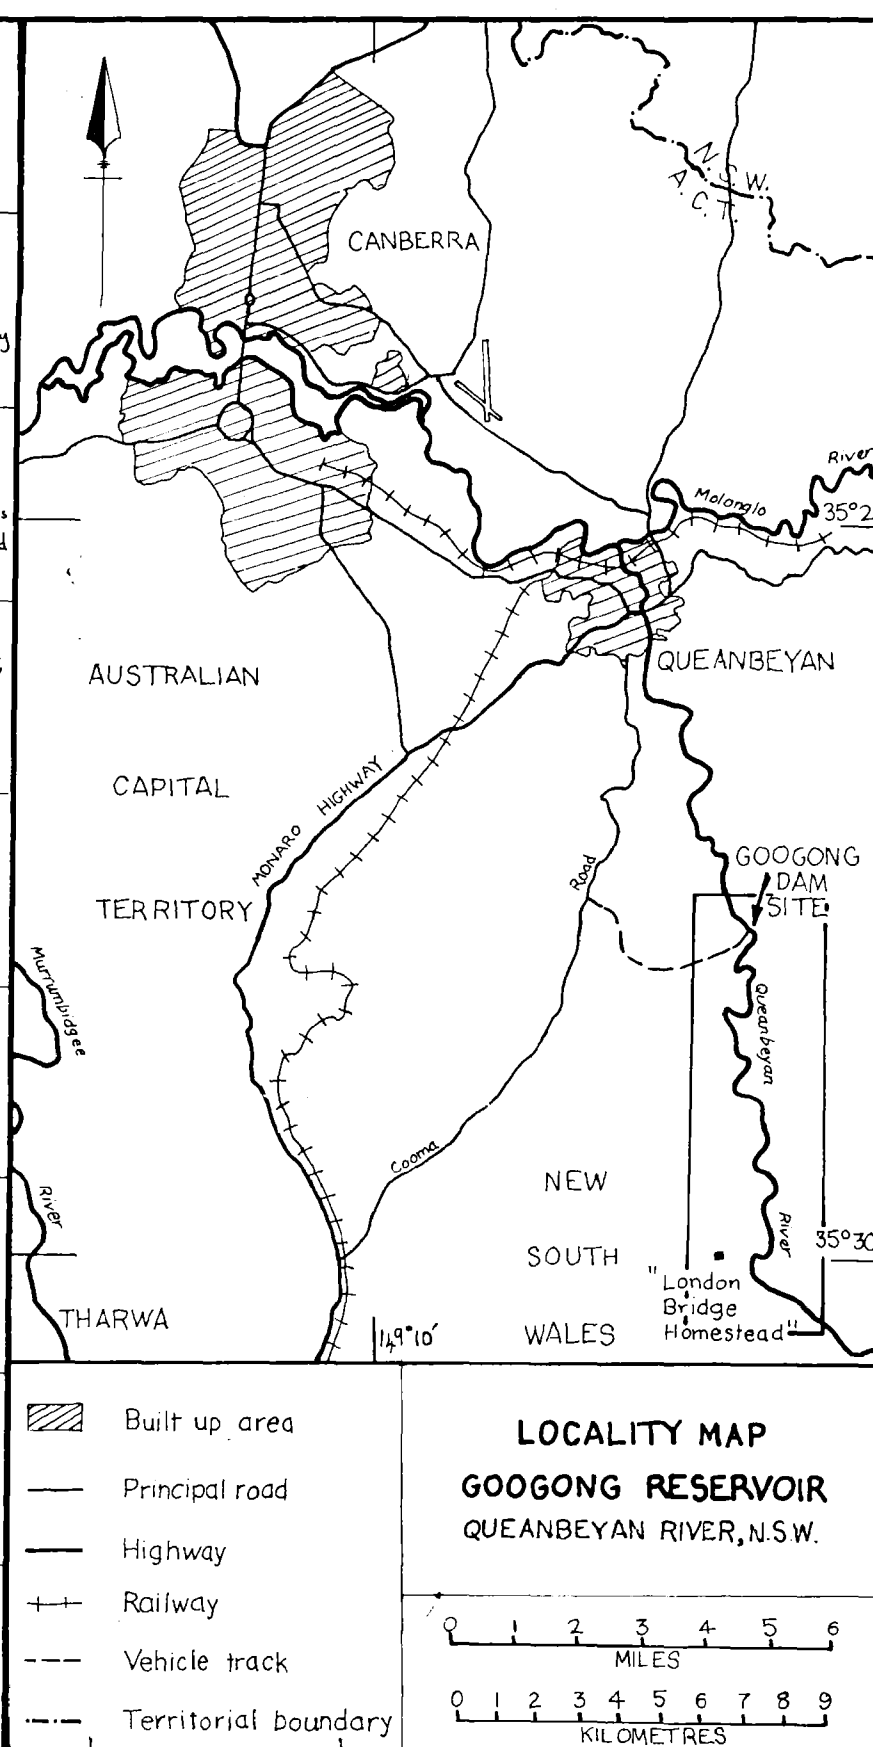
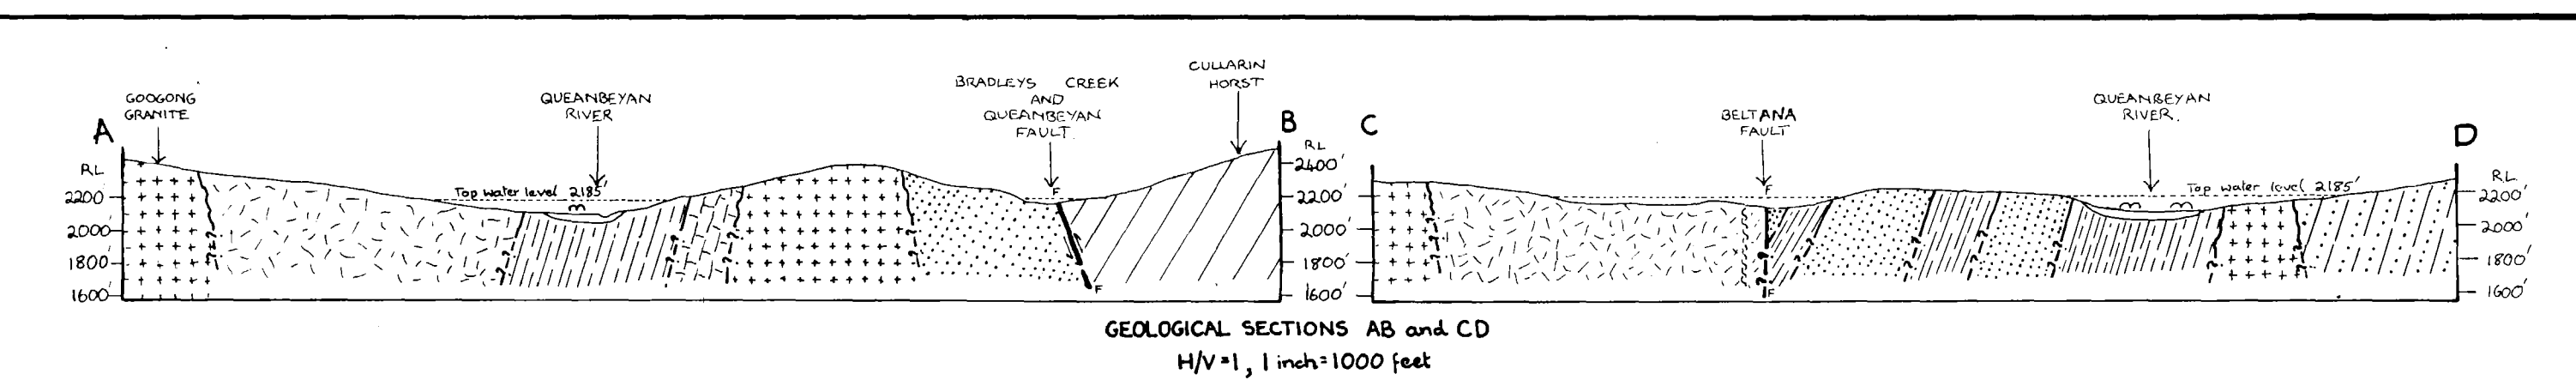
COLINTON VOLCANICS (Middle or Upper Silurian)	Dacite with lenses of slate, limestone and sandstone. Minor amounts of disseminated pyrite	Forms high ground with prominent outcrop ridges in areas of shearing. Good exposure on slate	Commonly sheared, parallel to the bedding strike direction (210°), particularly where outcrops are steeply folded. Less sheared where dacite forms thick, competent units	Weathering increases with increased shearing. Thin soil development. Deep weathering confined to major shear zones and fault. Rocks moderately to highly weathered in outcrops	Major permeability parallel to cleavage and decreasing with depth. Negligible intergranular permeability	Occurs in the north-west of the reservoir where slopes are gentle and only minor slumps of material may be expected
	Limestone and slate. Limestone is bedded with either fine or structural central limestone in the north of the reservoir, is silicified owing to grade, individual some hercynite mineralization		Forms rounded terrain, with slate gully depressions and limestone ridges. Good exposure on limestone, poor exposure on slate	Slate everywhere highly cleaved. The limestone is less cleaved and bedding is commonly preserved. Limestone is observed. General westerly bedding dip at high angles	Slate weathered from thicker soils than limestone, with 4-8 feet of soil cover, while limestone carries thin soil cover. Limestone moderately to slightly weathered in outcrops	Negligible permeabilities in the slate. Limestone is silicified and water movement is restricted to joint and cleavage openings. In the south some solution features are present, but the limestone crops out above top storage level	Gradients low with stable slopes

Sandstone with minor slate units (<20%). Sandstone silicified in places with some hercynite mineralization		Forms rounded, ridges with steep slopes on river bluffs in areas of dissection. Good exposure	Sandstone has acted more complexly than slate, and is less intensely sheared, but bedding can only be observed in good vertical exposures. Bedding dip is in general westerly at high angles, striking 020°	Slightly weathered, with development of thin soil	Low intergranular permeability due to silicification. Low permeability parallel to cleavage and joint planes, decreasing with depth. Low intergranular porosity due to poor sorting of sand grains	Steep slopes on river bluffs with thin soil cover. Minor movements of some material may occur but not involving large volumes of rock
	LONDON BRIDGE FORMATION (Middle or Upper Silurian)	Slate with minor sandstone (<20%) units	Forms low ground with poor exposure, and commonly covered by well-developed soils	Strongly cleaved. No bedding preserved, but cleavage probably parallel to the bedding strike direction (020°). Probable near vertical westerly dip	Pure, easily eroded, thin clayey rock types, with development of 4-8 feet of soil cover. Rocks moderately weathered in outcrops	Very low permeability	Occurs in low lying areas and problems of slope movement should not occur

Alternating slate and sandstone units (Less than 20%)		Forms higher ground, into which the river has eroded a gorge. Outcrop ridges are prominent with good exposure	Slate units highly sheared with sandstone less sheared. Cleavage direction parallel to bedding strike. Shearing near vertical with probable high angle dip to the west (striking 020°)	Generally resistant to weathering with development of thin soils. Sandstone moderately weathered and clay moderately to highly weathered in outcrops	Low permeability in slate. Permeability in sandstone controlled by sorting and joint systems, decreasing with depth. Low intergranular permeability	Forms steep slopes in the south of the area, where only thin soil cover is present. Minor movements of some material can be expected
	METASEDIMENTS (Upper Ordovician)	Greywacke and slate	Forming the Queanbeyan Fault scarp and higher ground to the east. Good exposure in stream sections	Dip steeply to the east with local (045°). Slates strongly more competent than greywacke, forming little or no cleavage	Shallow weathering with thin soil cover. Steep slopes do not allow accumulation of weathered material. Rocks moderately to highly weathered in outcrops	Low intergranular permeability, water movement being restricted to fractures and joints	Movement of some slope material on the fault scarp is expected, but should involve only small volumes of rock and soil
