Record 1972/59

GEOLOGICAL INVESTIGATIONS OF PROPOSED SITE FOR
RESERVOIRS 6A and 6B, BELCONNEN, A.C.T.

J.A. Saltet

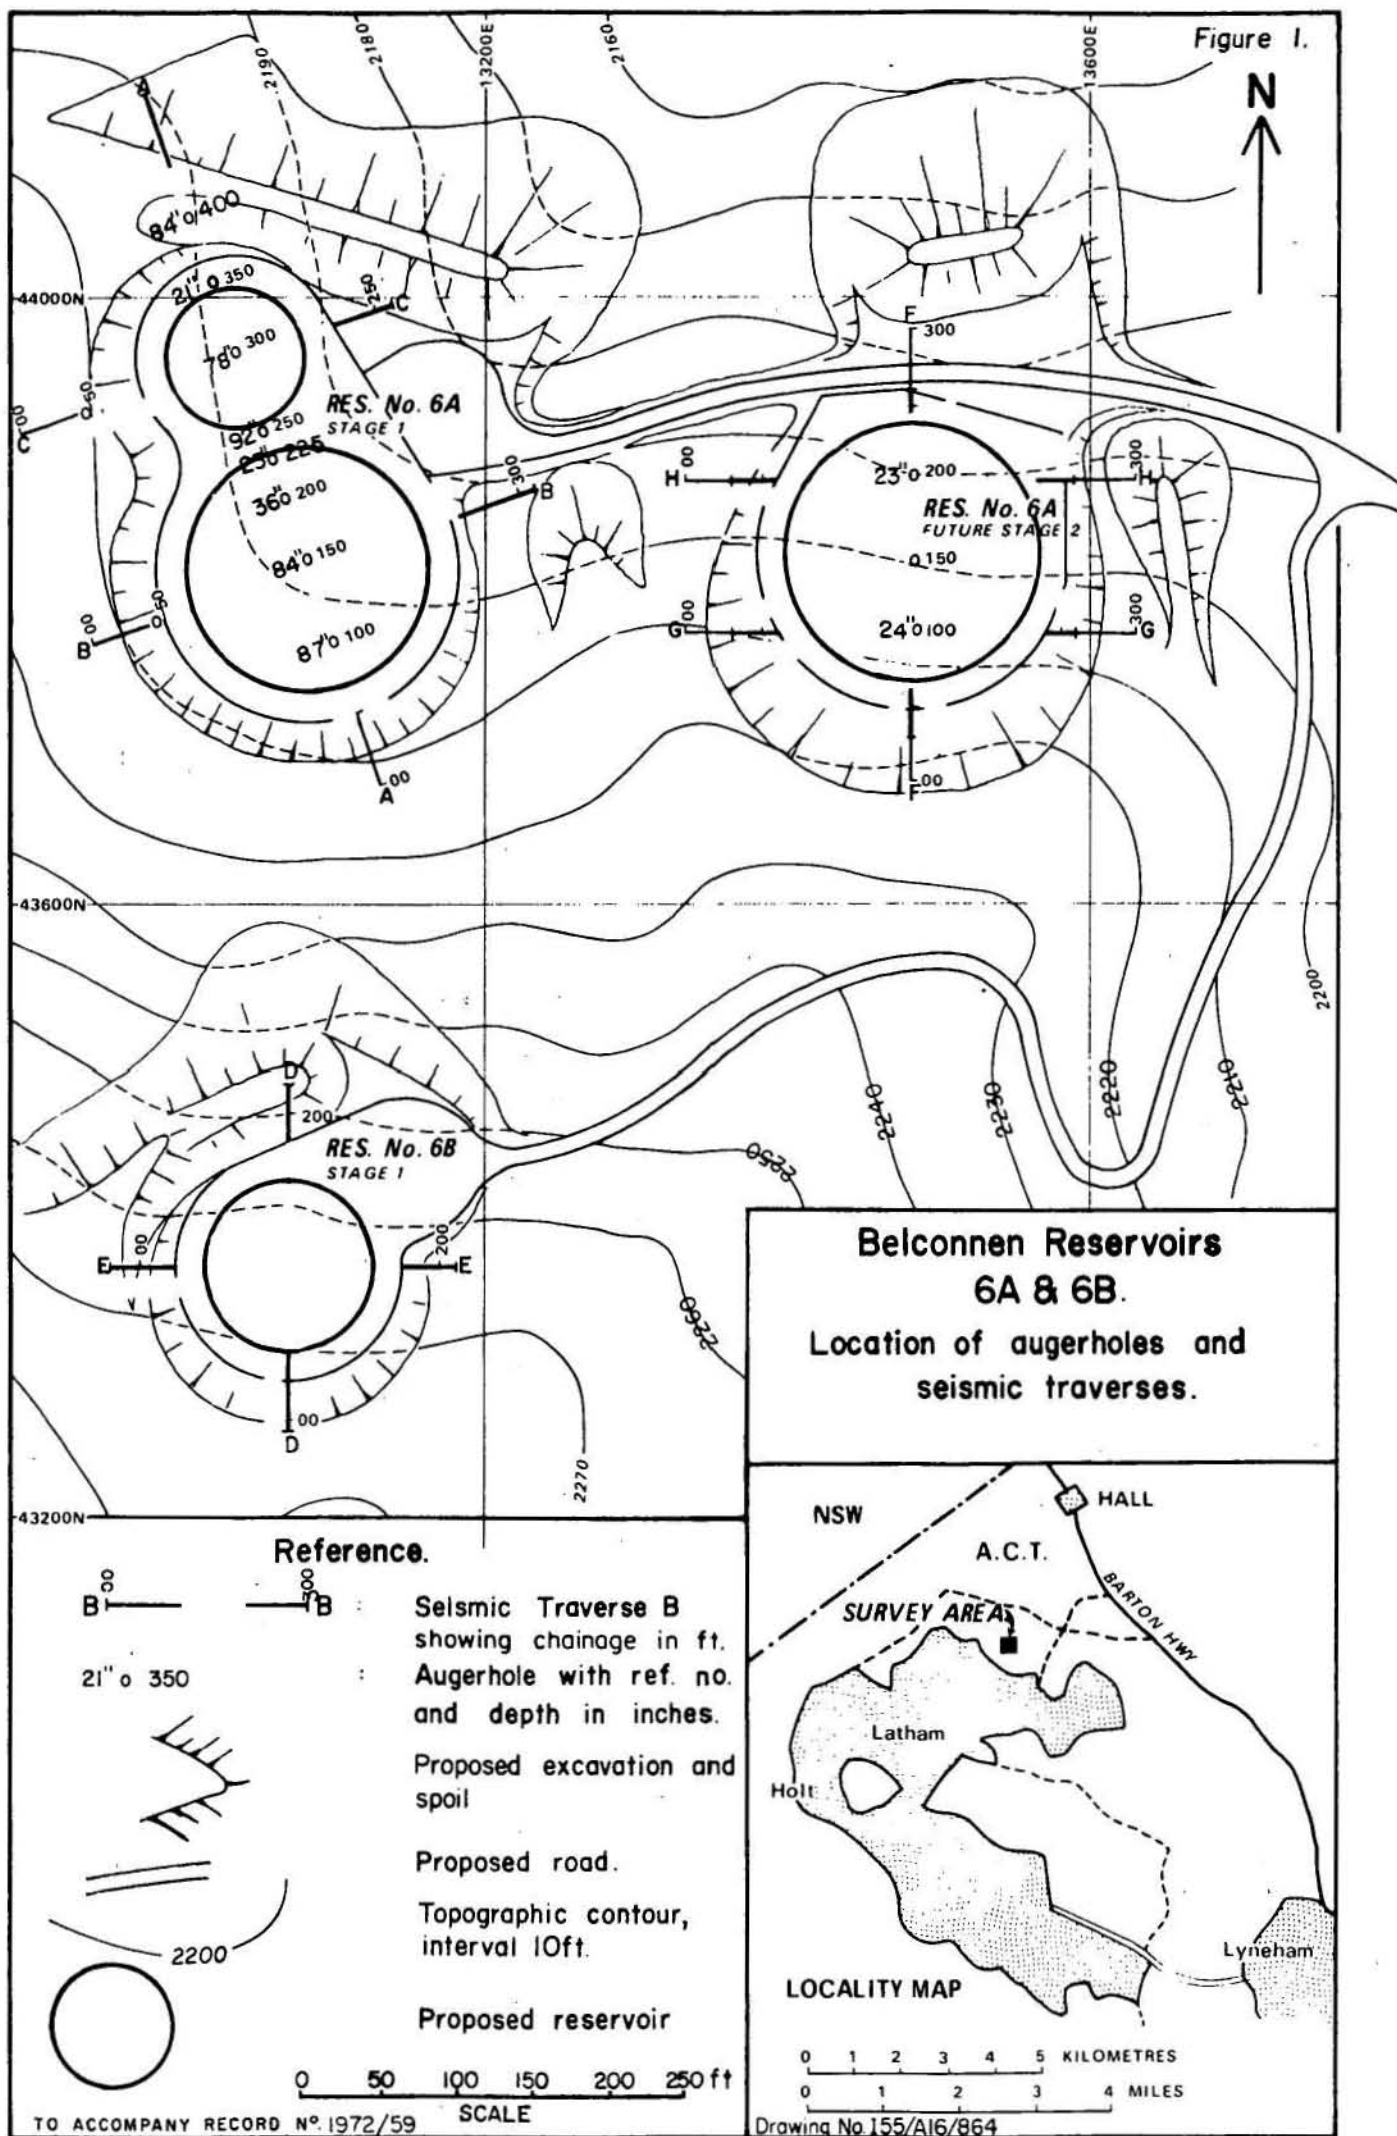
Figure 1.

To investigate the depth and nature of the overburden 12 augerholes were drilled with a Proline, Type J (manual drawdown) power auger (Figure 1). 6 holes were drilled with a split-tube undisturbed sampler until completely weathered bedrock was reached: below this level augering only was carried out. The 6 remaining holes were augered only. Drilling ceased when penetration was very slow or impossible; this took place in highly weathered rock.

The augerholes were drilled along the seismic traverses, and have a reference number indicating traverse and chainage, e.g. Augerhole A400 was drilled on Traverse AA at chainage 400.

Site 6A (stage 1) has the thickest soil cover; it is situated in a watercourse. Sites 6A (stage 2) and 6B have little soil cover and rhyodacite crops out over most of the area.

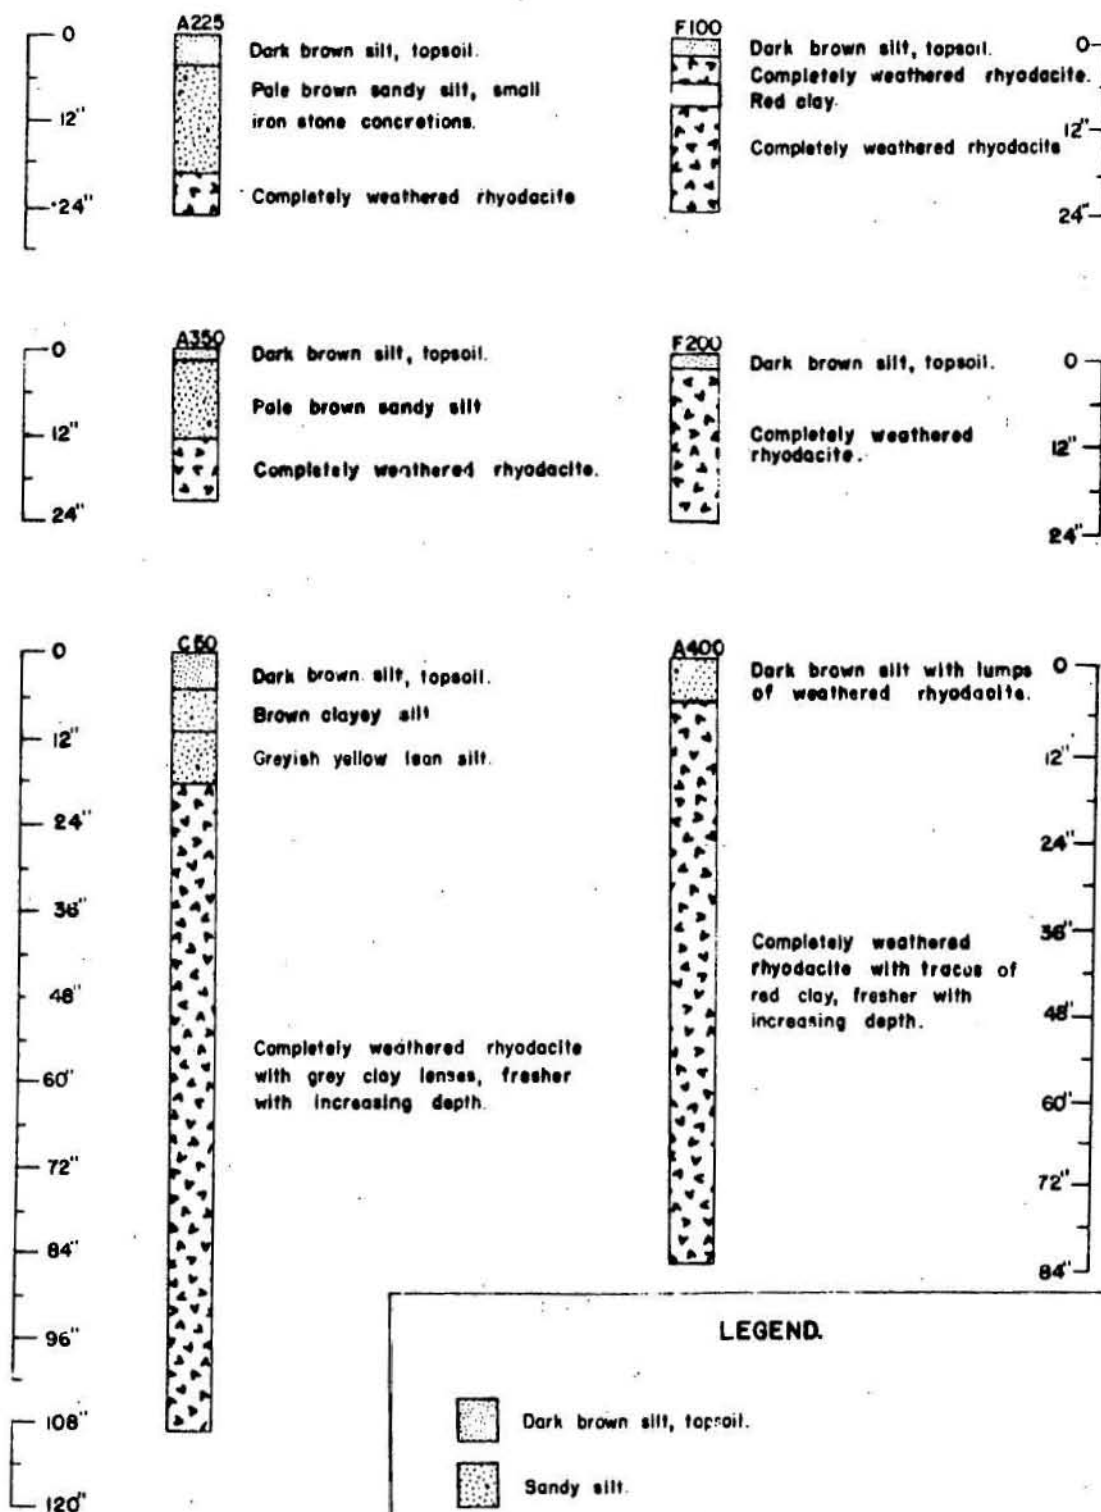
Figure 2.

Figure 2 gives the logs of the augerholes in which undisturbed sampling was carried out, and Figure 3 shows a generalized soil profile.

Reservoir 6A (stage 1) is in a watercourse, in the centre of which black organic soil (more than 1 foot thick) occurs, indicating swampy conditions. In Augerhole A150, in this watercourse, water was struck at a depth of 4 feet. This is thought to be a localized perched aquifer in the overburden. The discharge of this aquifer appears to be restricted, but the restriction will be removed during excavation of the overburden.

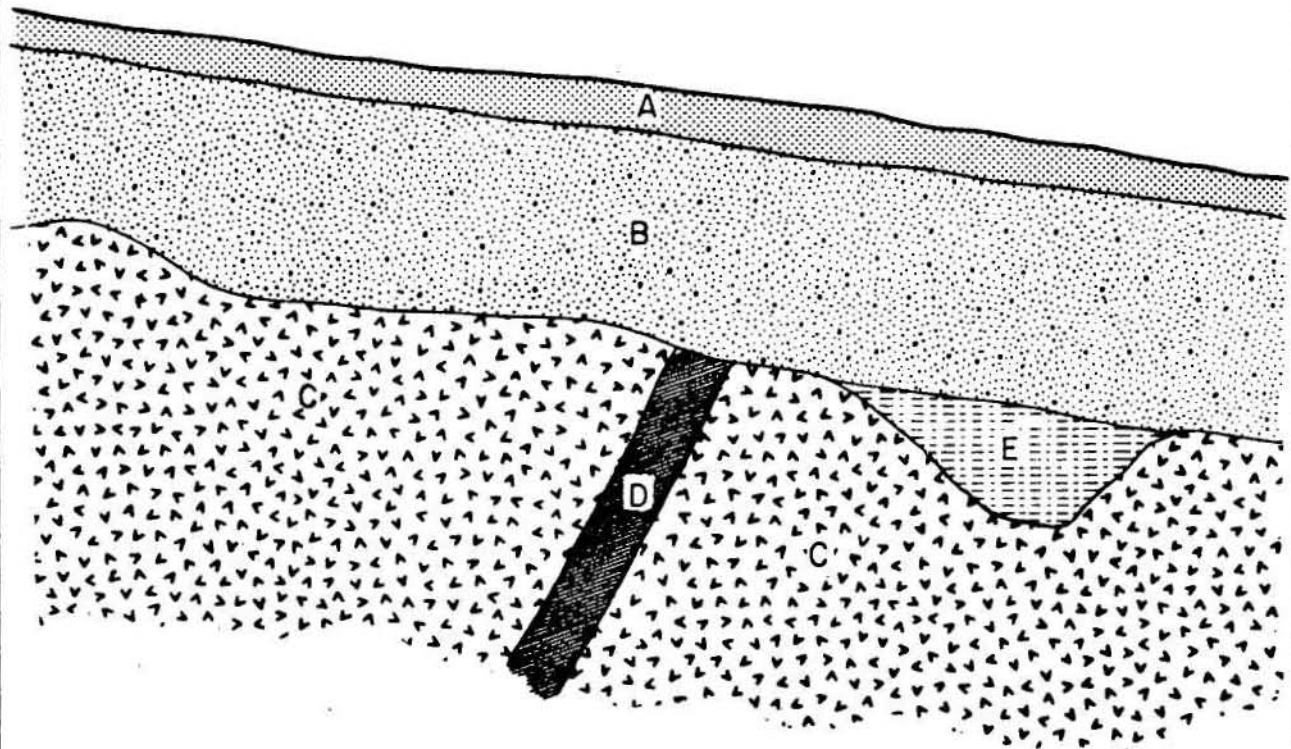
Belconnen Reservoir Sites 6A and 6B
GENERALISED SOIL PROFILE

The soil shows little lateral variation: dark brown silt, forming the topsoil, is generally less than 4 inches thick. Under it is a layer of pale brown sandy silt up to one foot thick. Completely weathered rhyodacite underlies the silt, and becomes less weathered with increasing depth. Heavy dark red clay is found within the weathered bedrock and may represent fracture zones, where the degree of weathering is greater than in the surrounding rock. Small traces of dark red lean clay are found in places immediately above the weathered bedrock. This could represent a buried soil horizon (B horizon).

A: Topsoil, dark brown silt, 0-6" thick.
-

B: Indurated sandy silt, pale brown. 0-2' thick.
-

C: Completely weathered rhyodacite getting fresher with increasing depth.

D: Fracture zone in rhyodacite, filled with heavy red clay.
-

E: Relics of old soil. B horizon, consists of dark red, lean clay.
-

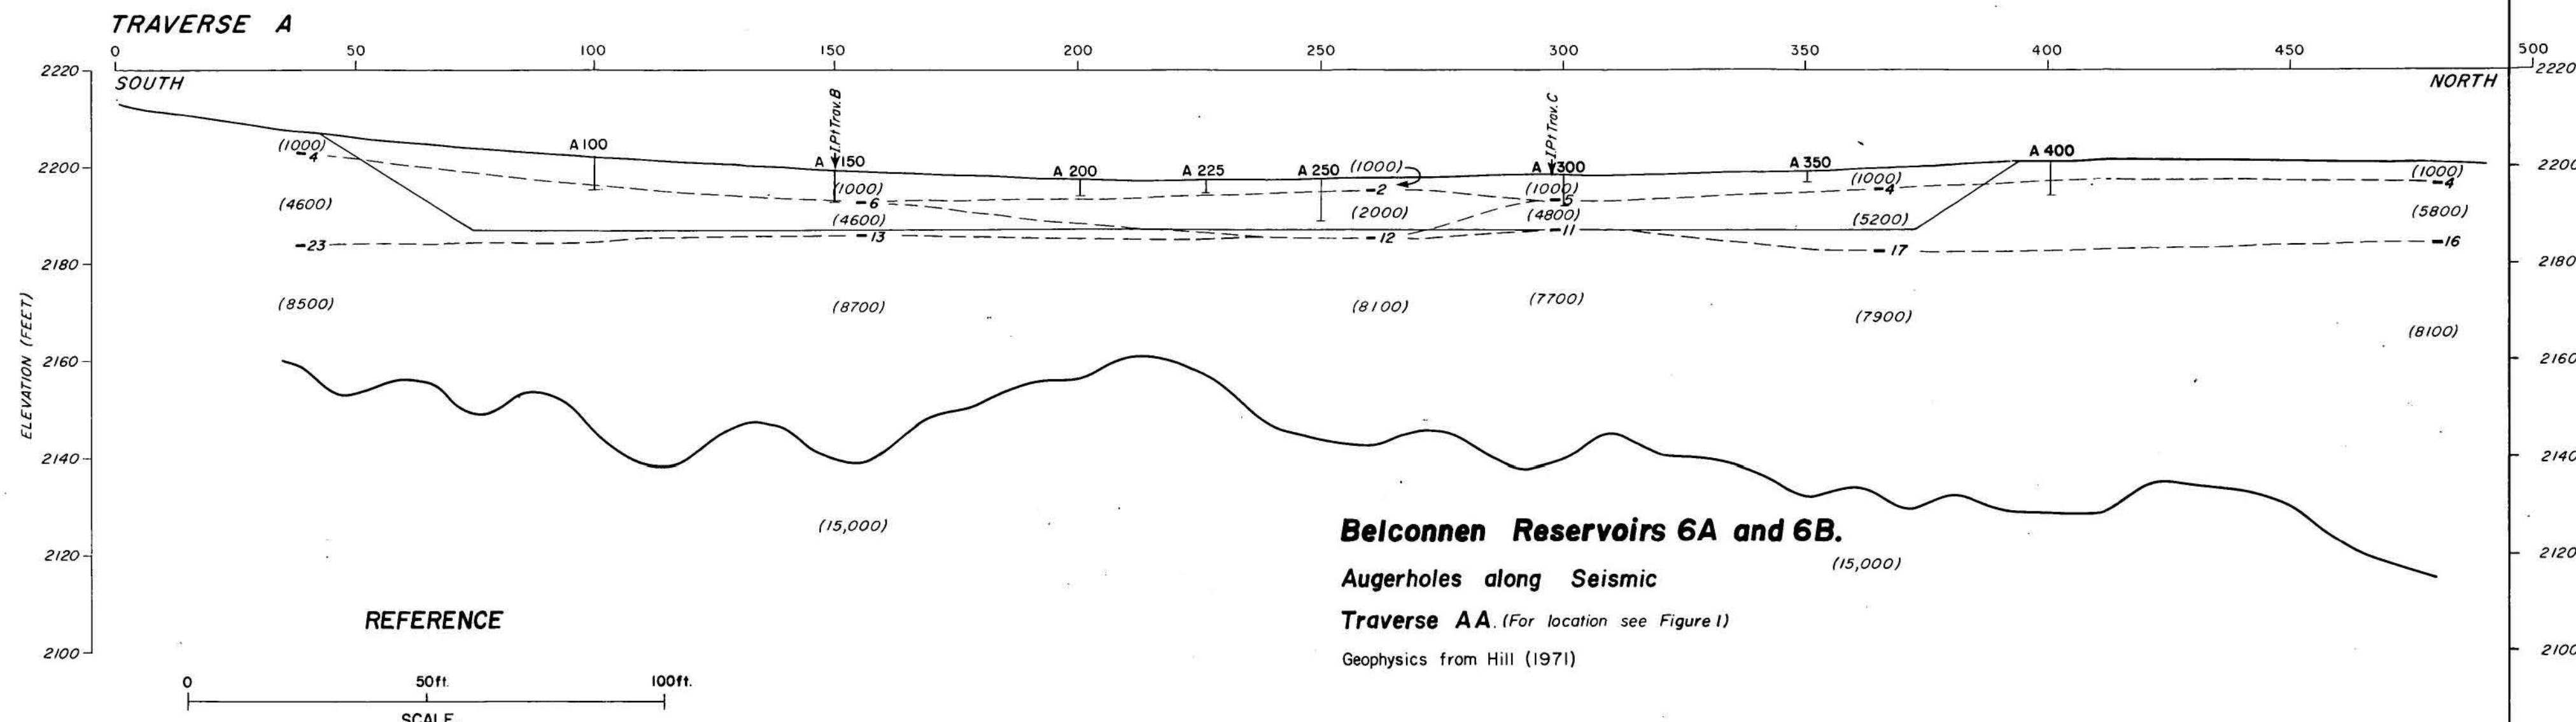
Augerholes along Seismic

Depth of penetration and the nature of the overburden, observed when augering, confirm the interpretation of the seismic survey given by Hill (1971) (Plate 1). His report also discusses suitable excavation methods and the nature of the reservoir floors.
