BUREAU OF MINERAL RESOURCES, GEOLOGY AND GEOPHYSICS

1975/144

MANUFACTURE AND TESTS OF RADAR REFLECTING
BUOYS FOR MARINE SURVEYS

BY
J.M. MULDER

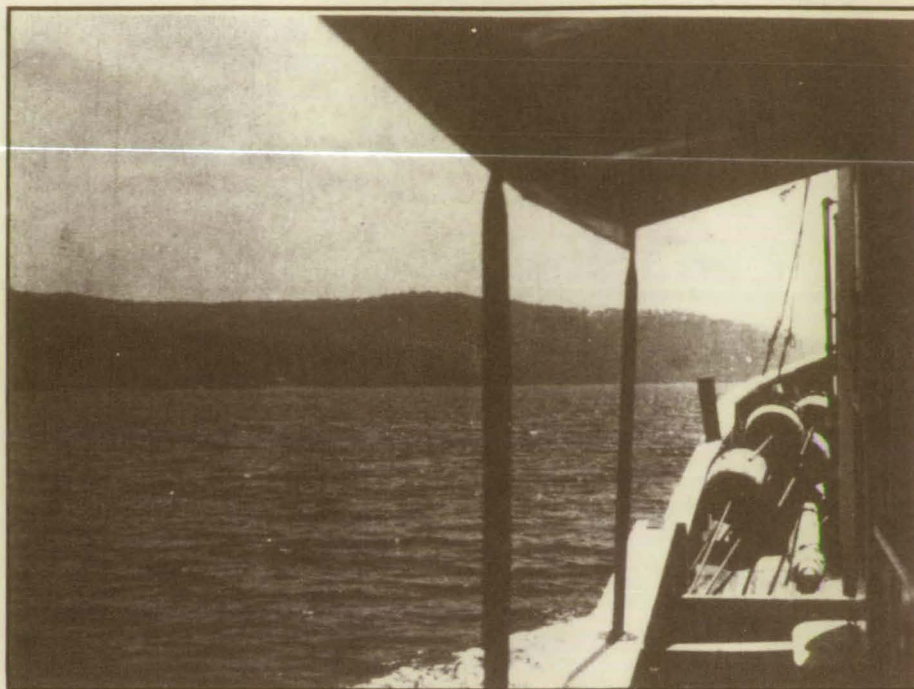
Fig.1 BUOYS ON DECK M.V.KRAIT

Six buoys were manufactured to designs tested in Lake Burley Griffin, transported from BMR in Canberra to Sydney, and put on board the Krait (Fig. 1). With the help of the crew under Commander Nobbs, a small party from BMR, consisting of the writer and Messrs Spence and Grace, positioned these buoys off Barranjoey Lighthouse in a moderate sea. To warn small-boat operators, who might be in the vicinity after dark, of hazards to their craft, each buoy was provided with a flashing navigation light, (see Fig. 2).

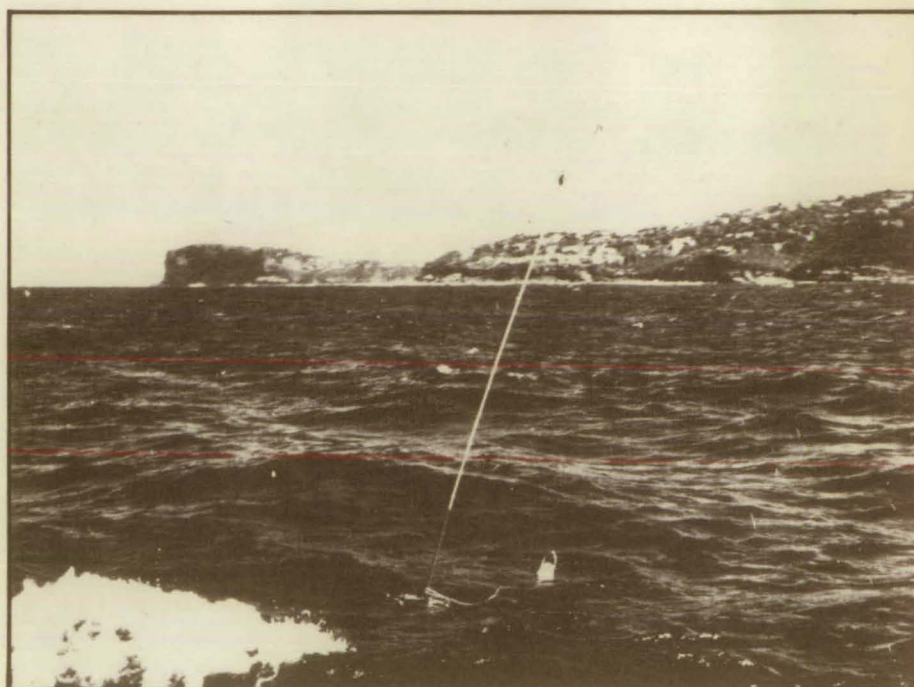
Fig.2 CLOSE-UP OF BUOYS AND NAVIGATION LIGHT

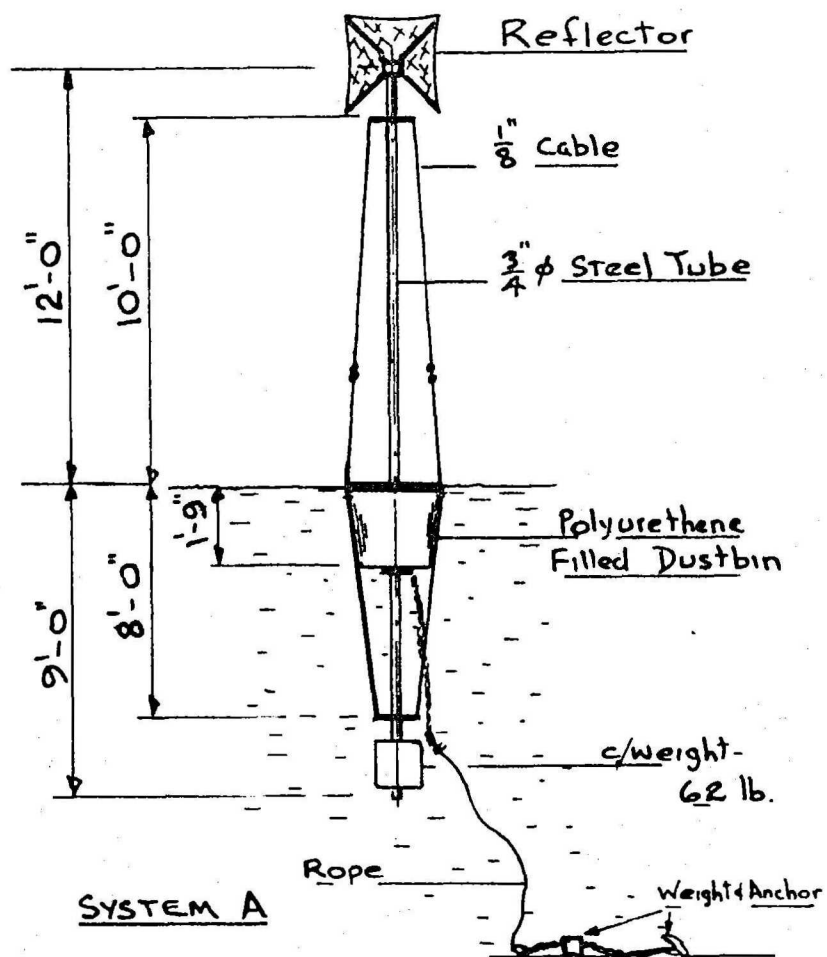
FIG. 3

On 26 May, Creighton relayed a message from the lighthouse keeper, who had a clear view of the buoys, which said that the buoy of Figure 6 had disappeared and that another buoy of Figure 3 type had been dismasted. The rip was dragging the buoy of Figure 5 type just under the surface of the sea, but the three remaining buoys, one as in Figure 3 and two as in Figure 4, were upright and appeared to be firmly anchored. After that message the weather deteriorated further, Creighton was unable to leave Narooma, and the lighthouse keeper could not be contacted because his phone was out of order. The PMG advised that communications with the island would not be restored until after a maintenance crew could be ferried across.

On 5 June Creighton reported that the extremely high current and winds had dragged the buoys about 1.5 km further out to sea, that the buoy of Figure 3 type had disappeared, but that the two buoys of Figure 4 type were still standing. When he inspected the mooring of one of these, he found that the anchor was badly damaged. This buoy was taken out of the water because sooner or later it would have drifted away. The last remaining buoy appeared solid enough to be left in place; its anchor held steady but to avoid damage to the anchor rope, a number of small spherical floats were attached to keep it clear from the rocky sea bottom. This buoy lasted just under 4 weeks in the water, after which it suddenly vanished. The buoy which was retrieved from the water was inspected for signs of wear and corrosion and although it was in a remarkably good condition, there was evidence of substantial corrosion in areas where dissimilar metals had been used e.g. along steel bolt heads,

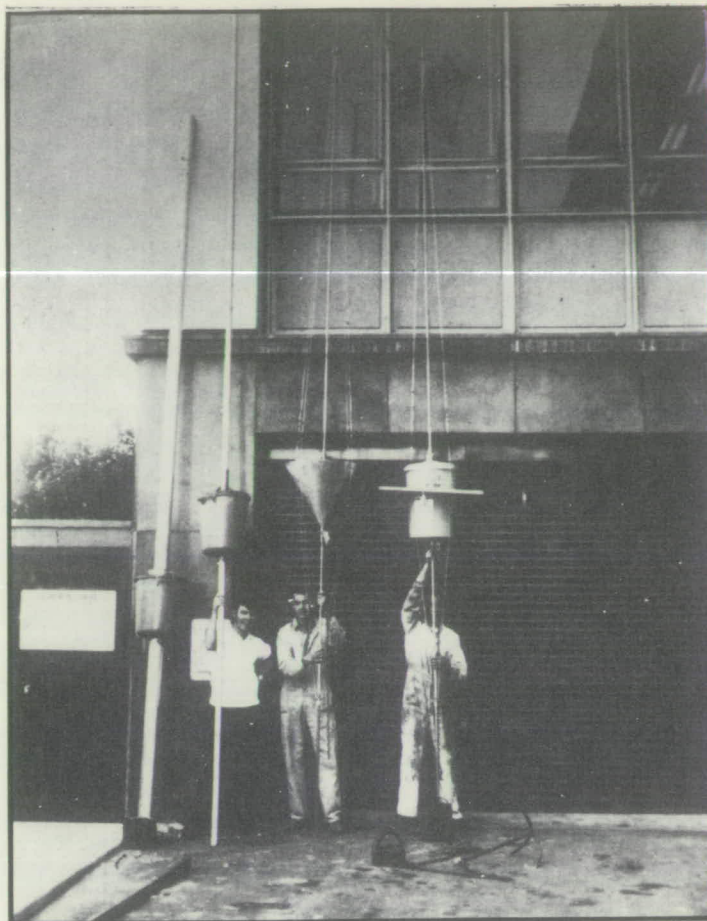
Fig.7 FOUR MANUFACTURED BUOYS
LEFT TO RIGHT C,B,D AND A

The four final assemblies (see Fig. 7) were tested in Lake Burley Griffin over a period of approximately 4 weeks. The lake tests were successfully concluded by mid-April 1970, when approval was obtained from the Department of Shipping and Transport for sea trials to be conducted near Montague Island over an eight-week period.
