Record 1976/19

TUGGERANONG SEWERAGE TUNNEL CONNECTION:  
GEOLOGICAL INVESTIGATION, 1975

R.C.M. Goldsmith

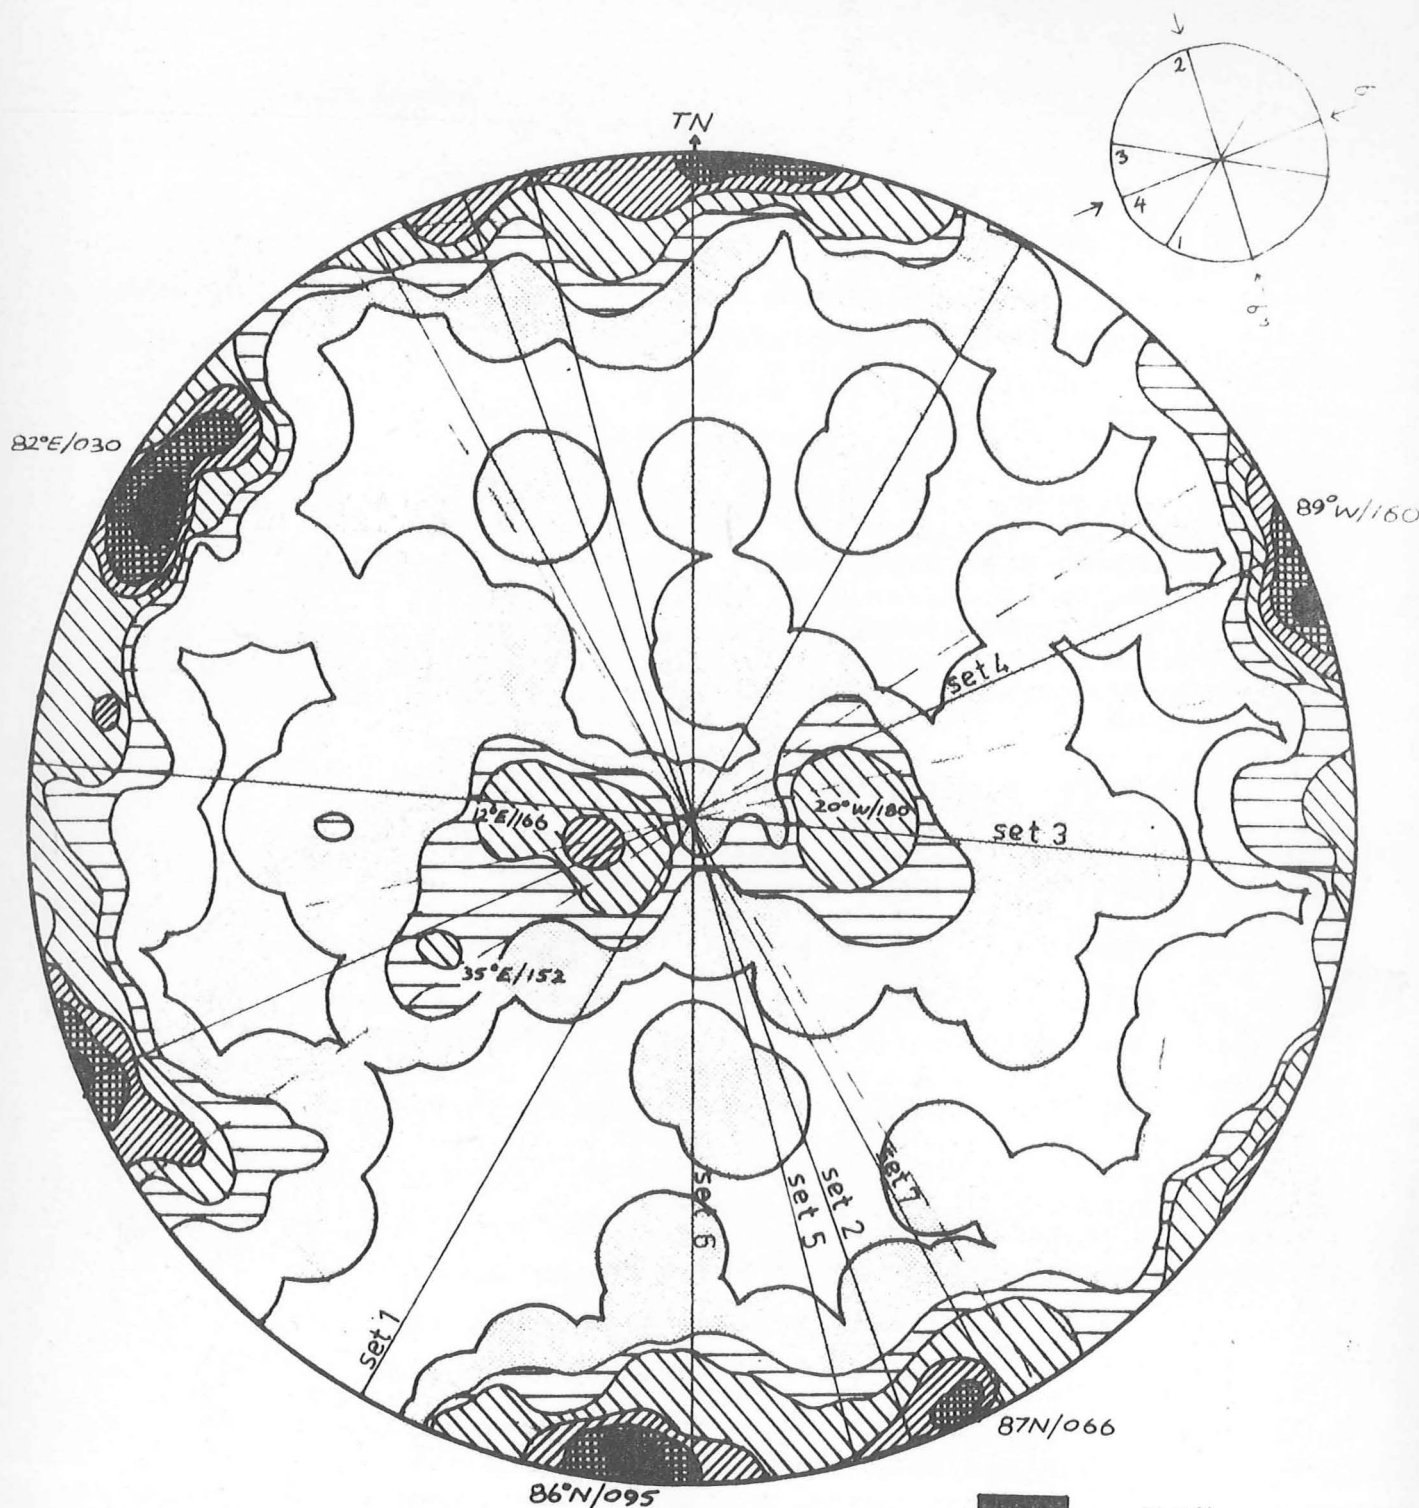
# TUGGERANONG CREEK-JOINT STEREOGRAM

Jointing is generally moderately spaced (See Appendix 1) and tight, and open-fractured zones and closely spaced joints are localized; there are marked changes in joint patterns over 20 m in some outcrops. A joint stereogram of the general area (Fig. 2) shows four steeply dipping joint sets that indicate a stress pattern with the maximum principal stress parallel to  $066^{\circ}$ ; joint set 4 is tensional, set 2 compressional, and sets 1 and 3 are conjugate 'shear' joints (Price, 1966). Also present are three shallow-dipping sets which are probably the result of

1. 82°E/030
2. 89°W/160
3. 86°N/095
4. 87°N/066
5. 12°E/166
6. 20°W/180
7. 35°E/152

From 10-15 m the rock is slightly weathered to fresh-stained and is generally tight. Joints are either shallow-dipping or near-vertical, as indicated by the joint stereogram (Fig. 2). Numerous veins of sericite and epidote parallel the joints.

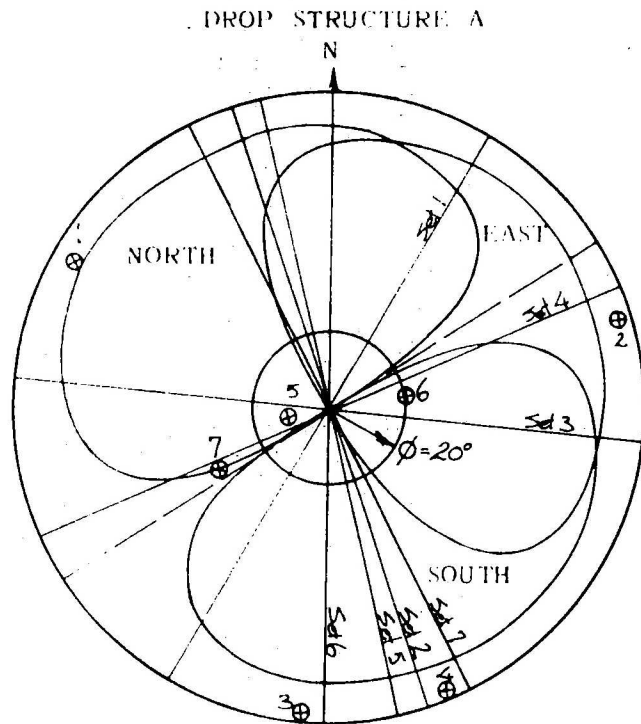
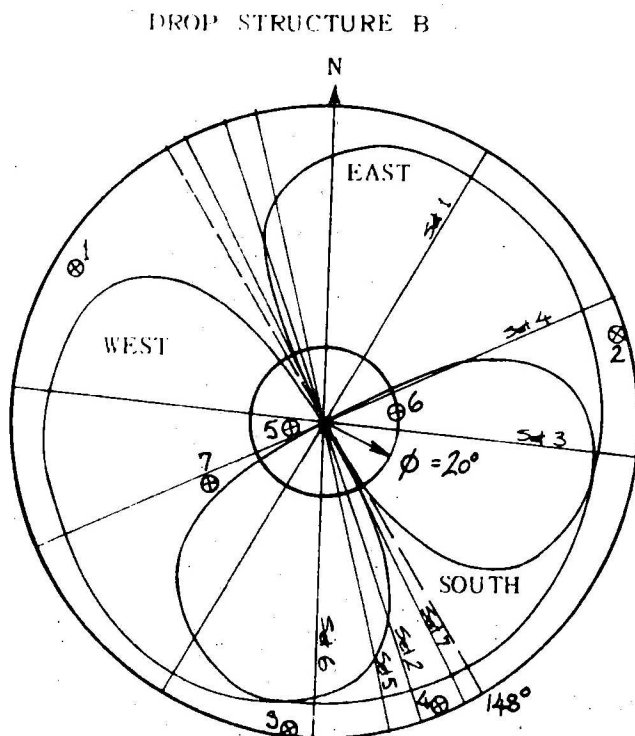
# STEREOGRAMS SHOWING STABILITY OF JOINTS IN EXCAVATIONS

Figure 3 lists the joint faces and joint intersections likely to fail in a slope at  $80^{\circ}$ . The angle of friction of the dacite has not been measured, but is likely to be steeper than

20°, so that only set 6 and three joint intersections would be kinematically and kinetically unstable.

Below 10 m the rock is slightly weathered to fresh. Joint set 6 is unfavourably oriented in the south and east faces, as is set 7 in the west face. Six unsafe joint intersections could lead to wedge failure (Fig. 3). Narrow clayey seams along joints also contribute to instability, and they may be found on joints that have not been located by this investigation. Drill hole B intersected four narrow shear and crush zones. Defects in the drill core mostly dip 0-30° with some up to 45°; but the stereogram (Fig. 2) shows no major joint sets dipping between 35° and 82°. The discrepancy indicates that irregular localized joints are superimposed on the regional pattern, and that reassessments of stability in excavations should be made from the geological mapping of rock defects during construction.

4. The regional joint pattern indicates two joint gaces and six joint intersections are kinematically and kinetically unsafe in the proposed cuts if the angle of joint friction is over  $20^{\circ}$  (see Fig. 3). The joint orientations may occur singly or in groups on any one face. Clay seams in the exposures will cause the greatest stability problems, but their location cannot be predicted.

Joints and joint intersections indicated are both kinematically and kinetically unstable in the indicated face. Joint sets will induce planar failure and joint intersections will induce wedge failure.

Unsafe joint sets:

South face Set 6 (20W/180)  
East face Set 6 (20W/180)

Unsafe joint intersections:

South face Set 1/Set 7 (35/036)  
North face Set 1/set 2 (81/160)  
Set 3/Set 7 (31/092)

South face Set 6 (20W/180)  
East face Set 6 (20W/180)  
West face Set 7 (35E/180)

South face Set 1/Set 7 (35/036)  
West face Set 1/Set 7 (35/036)  
Set 4/Set 7 (35/063)  
Set 3/Set 7 (31/092)  
Set 1/Set 3 (79/072)  
Set 1/Set 4 (72/052)

Any stability problems in this excavation will be remedied by correct application of shoring or rock bolts, or both.

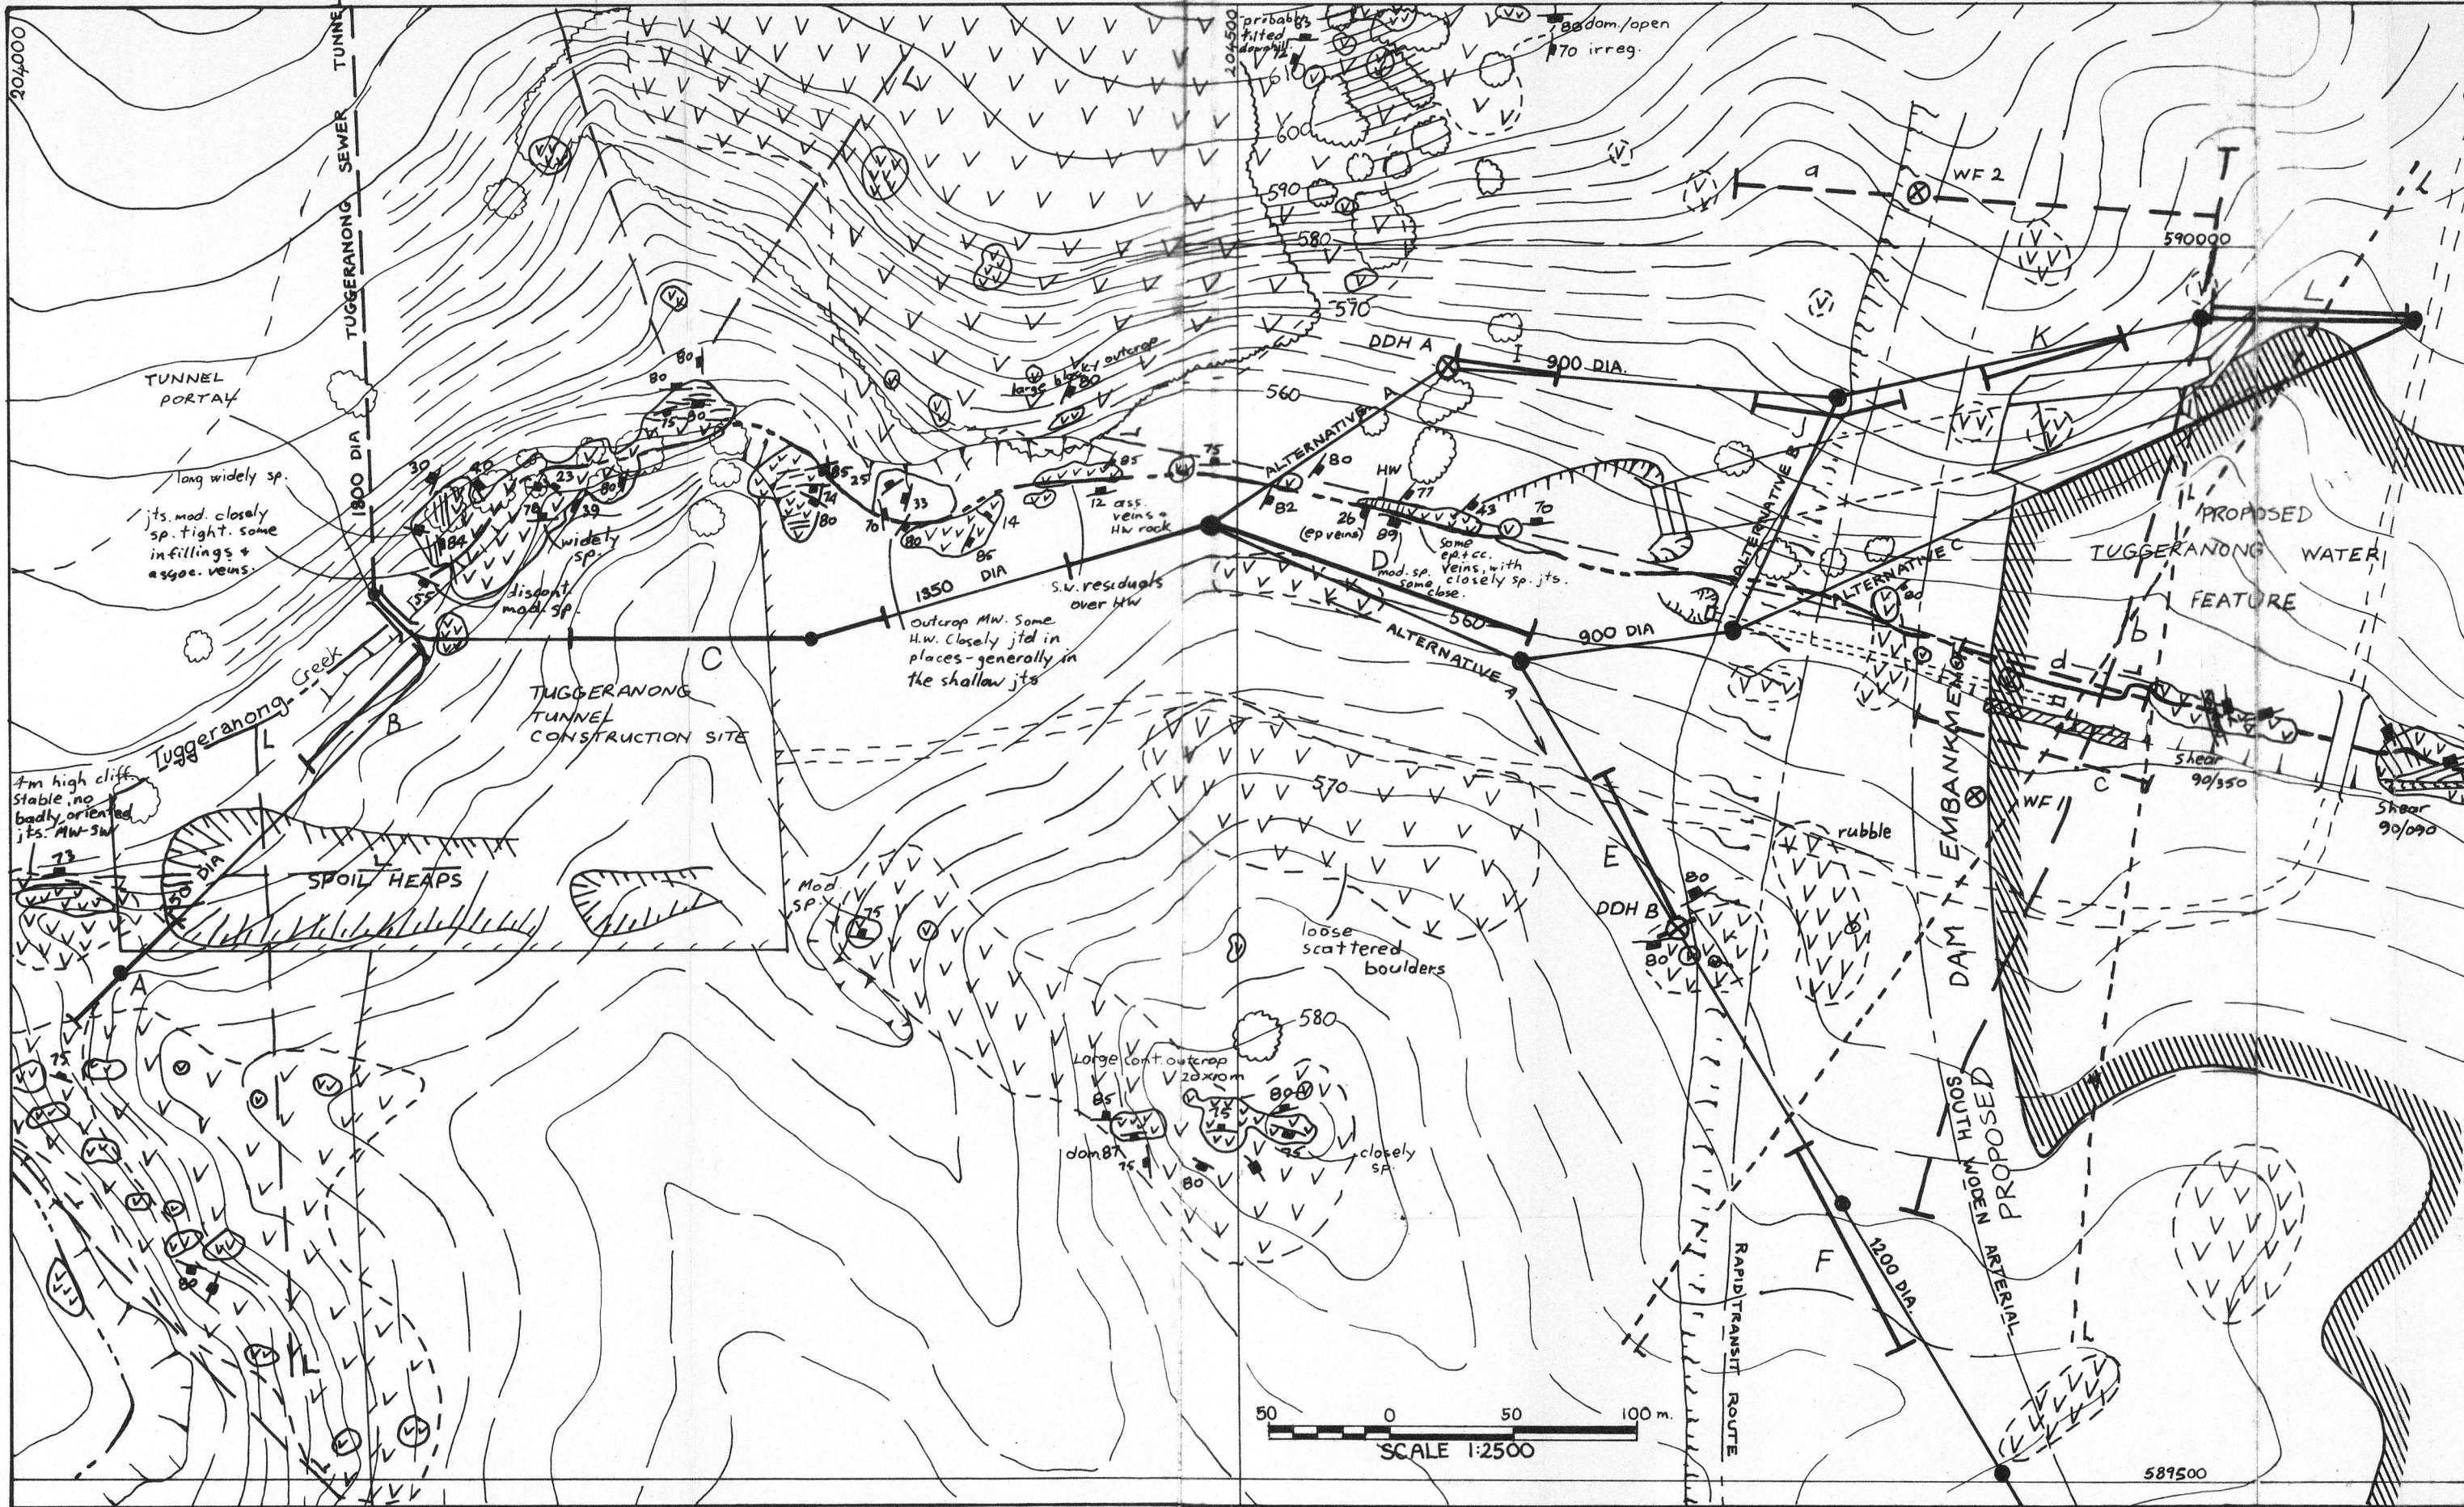
## Geology of Project Site, Tuggeranong Creek, A.C.T.

The area between Tuggeranong tunnel inlet portal and the proposed dam across Tuggeranong Creek has been geologically mapped at a scale of 1:2500 (Plate 1). The rock is a grey dacite with phenocrysts of quartz and plagioclase 2-8 mm in diameter. Rhyodacite is present in small localized zones, with orthoclase phenocrysts 1-3 mm in diameter.

Abundant outcrop of moderately weathered to fresh rock (Appendix 1) occurs on the steeper slopes north of the creek, and along the creek bed where much of the more highly weathered rock has been eroded from the gullies, but on some banks of the creek large areas of highly weathered rock are exposed.

No major faults are known to intersect the project area, but airphoto-lineaments along Tuggeranong tunnel were found to represent either a joint pattern, sheared zones, or concealed faults. Airphoto-lineaments are shown in Plate 1.

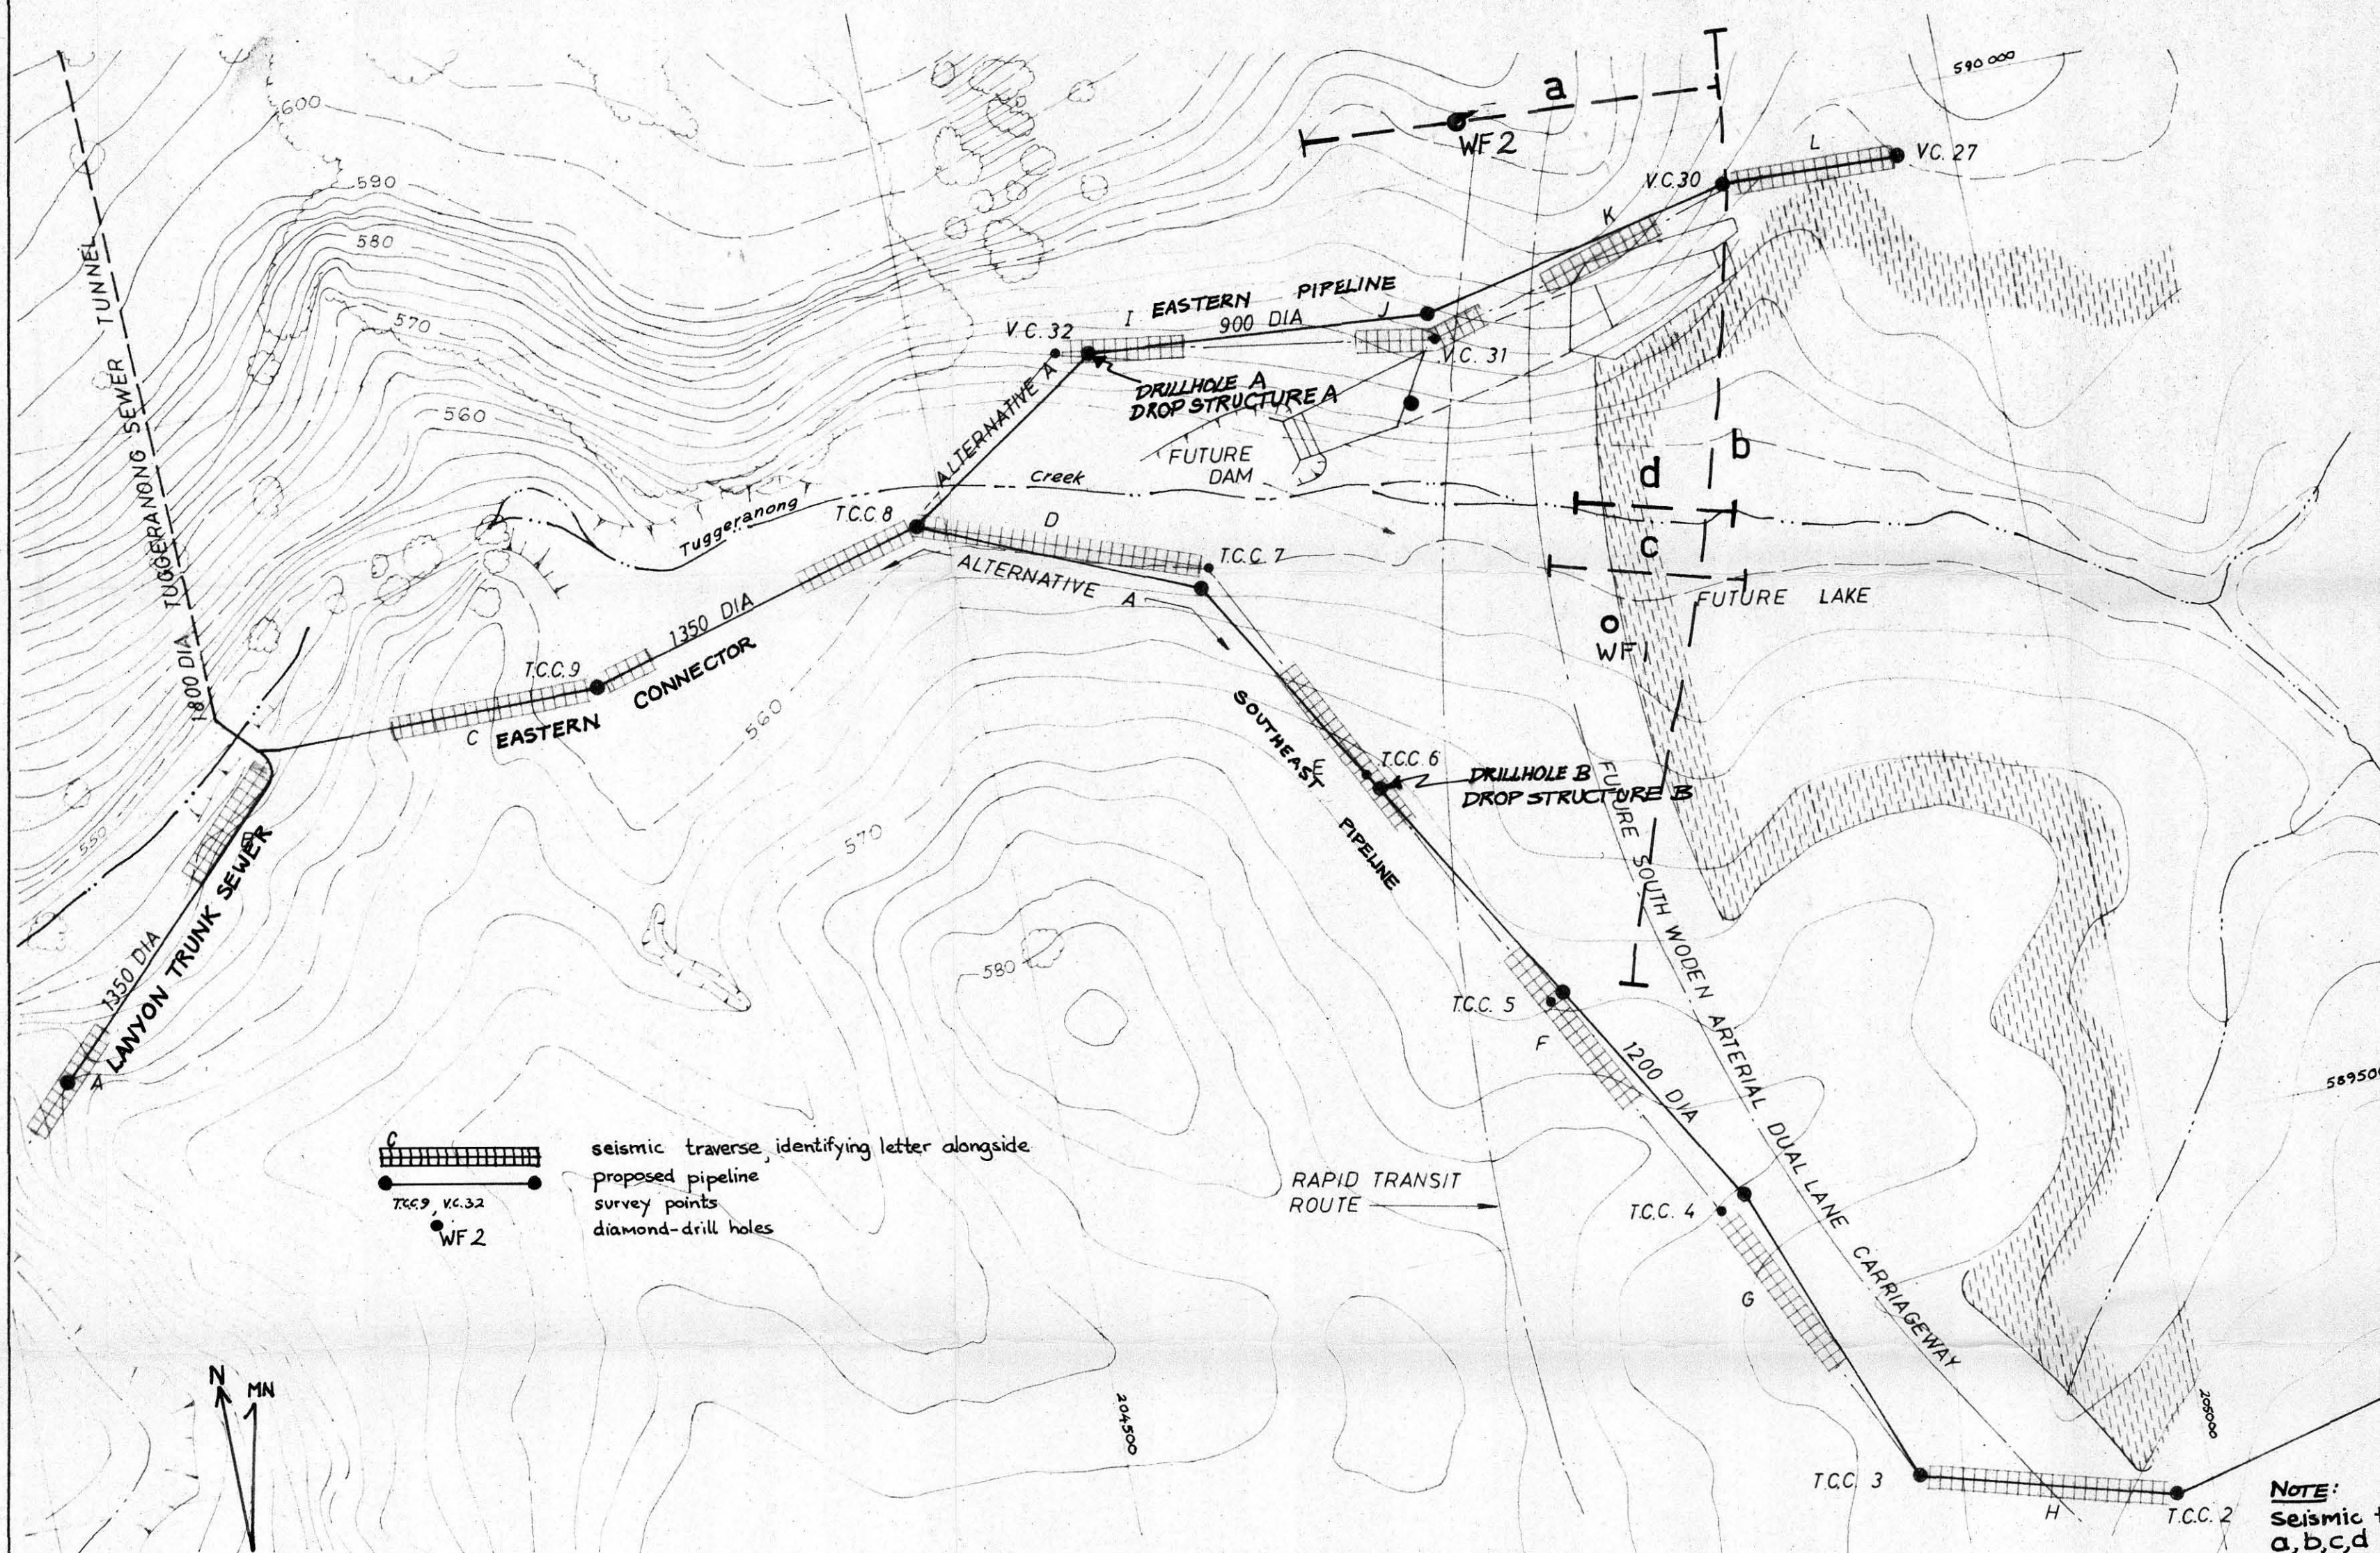
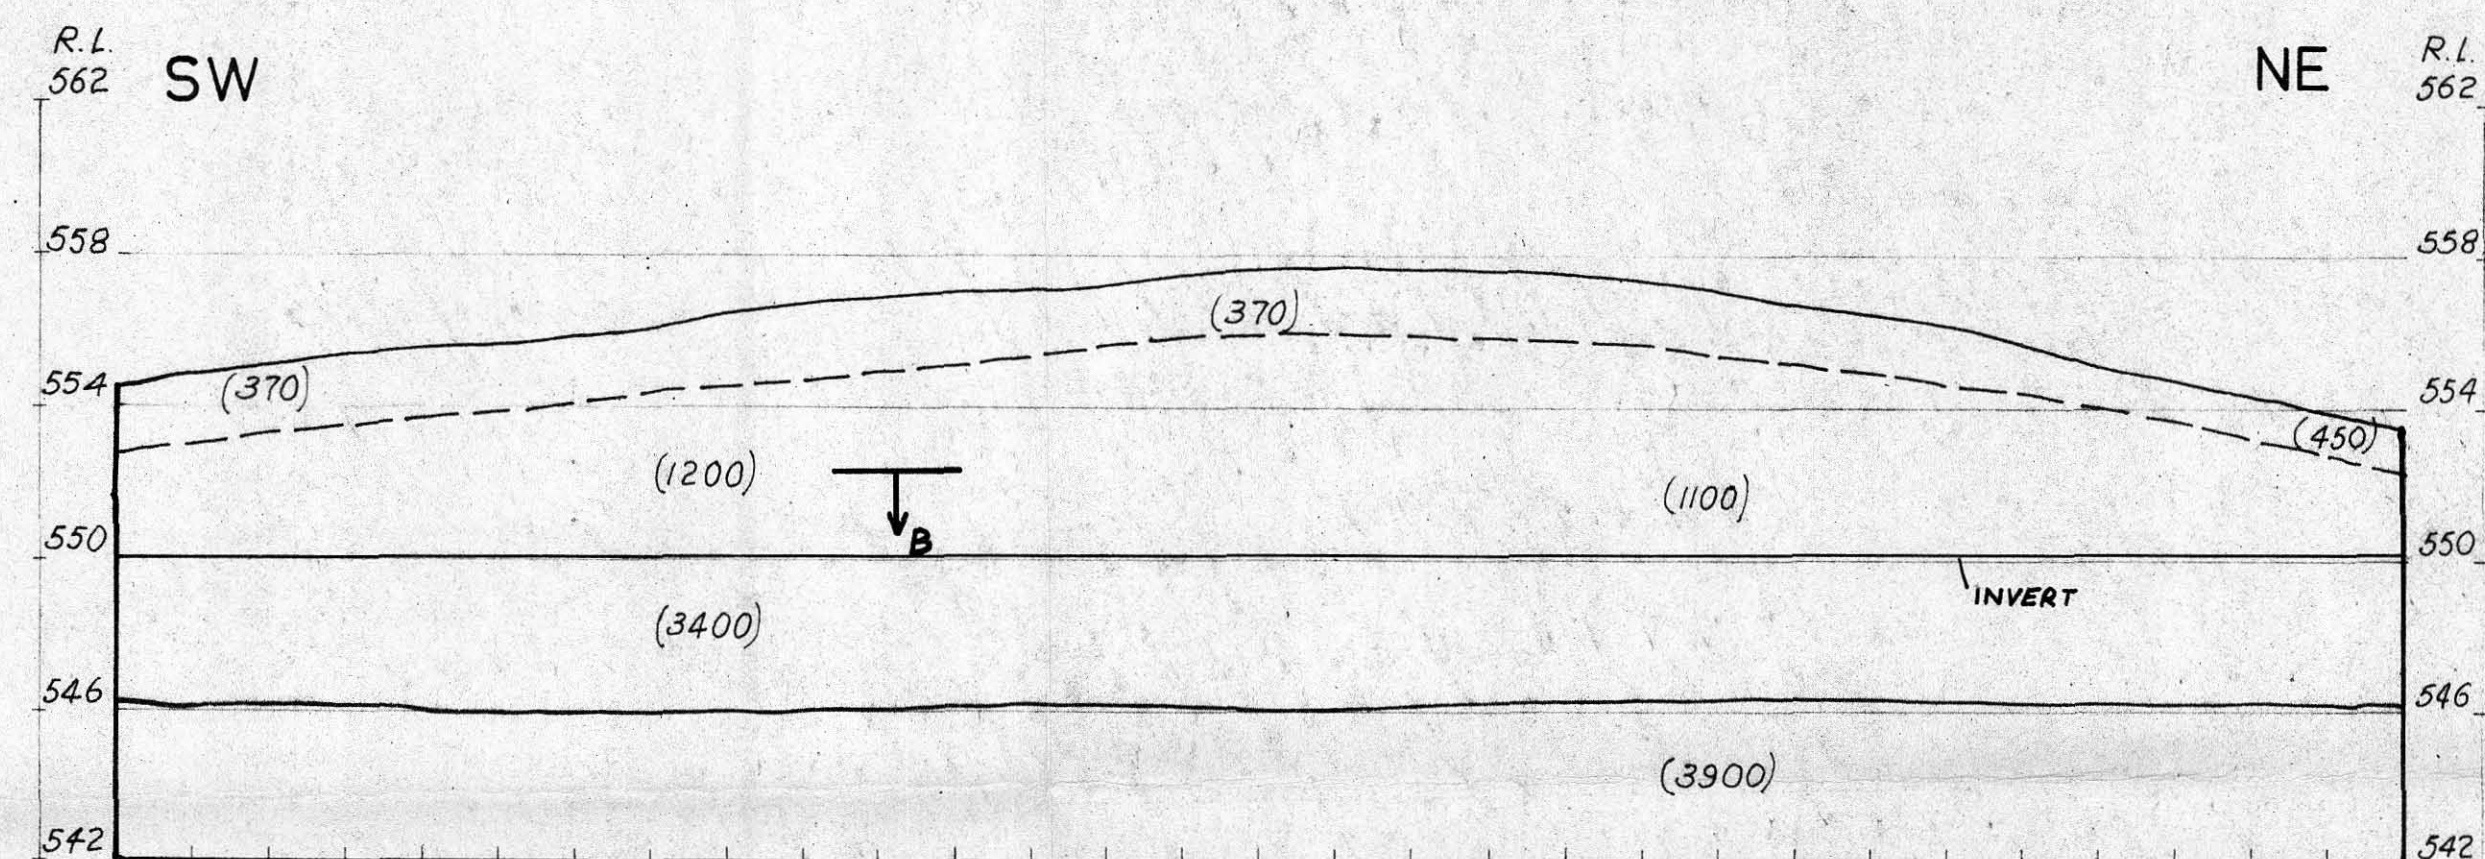
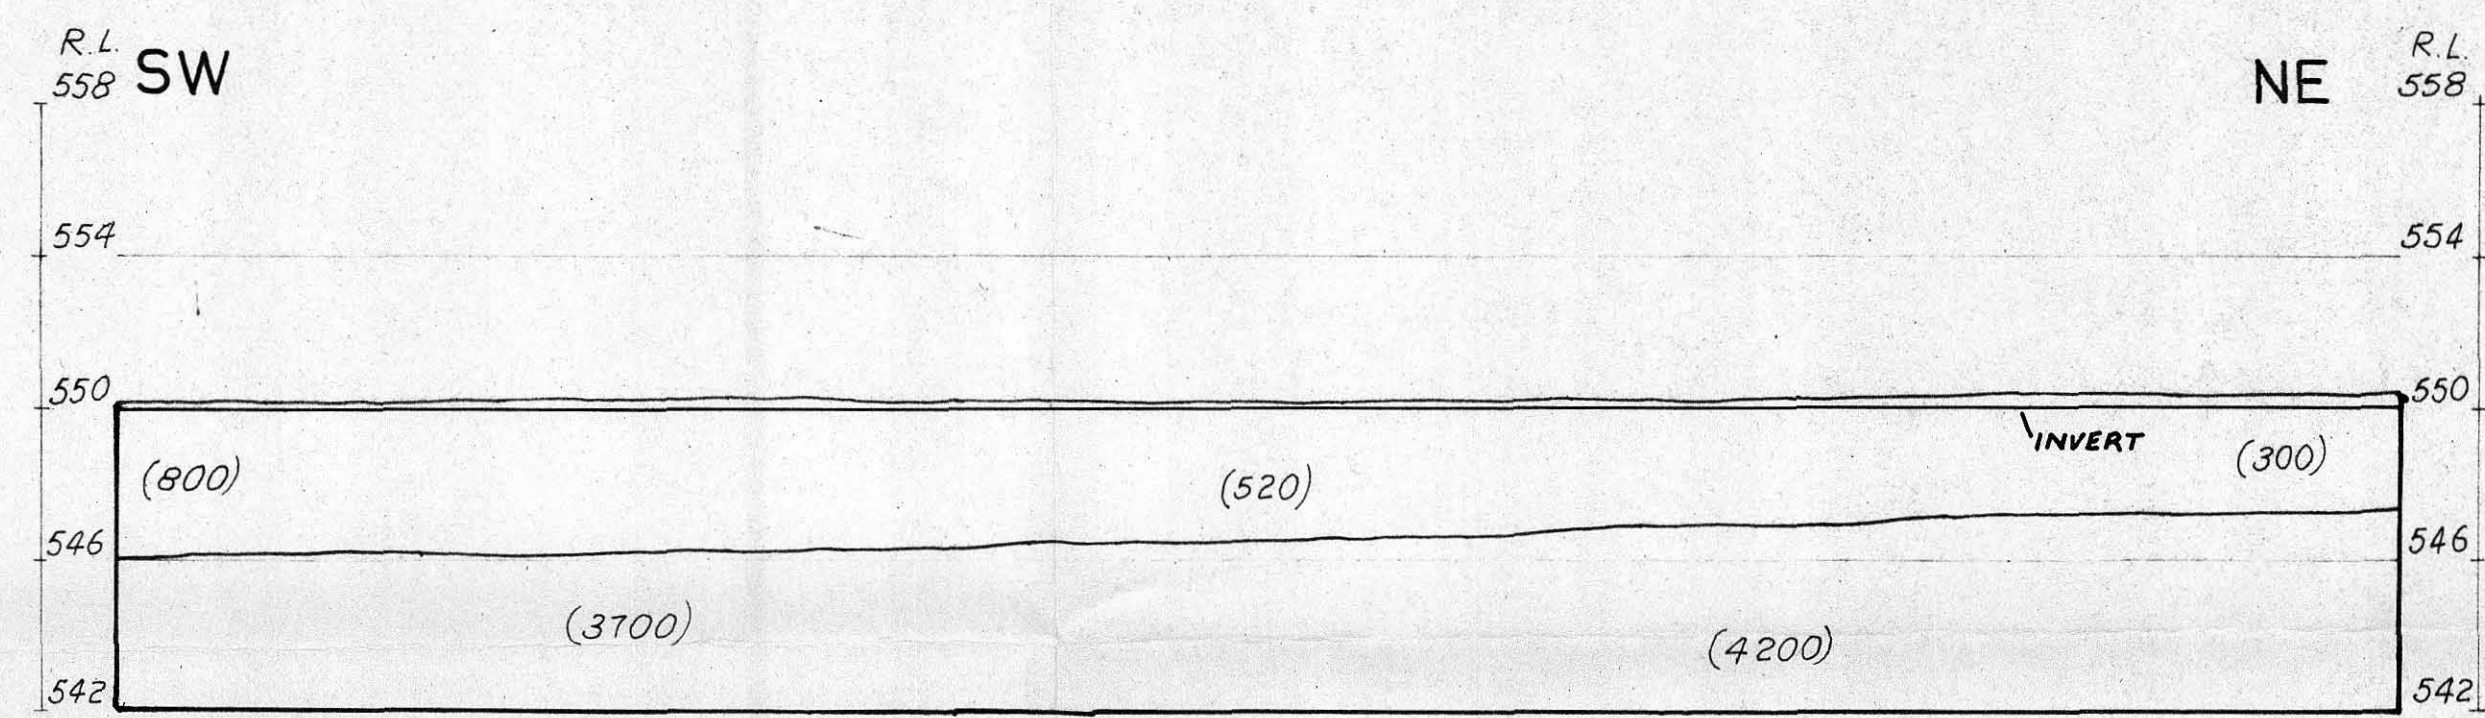
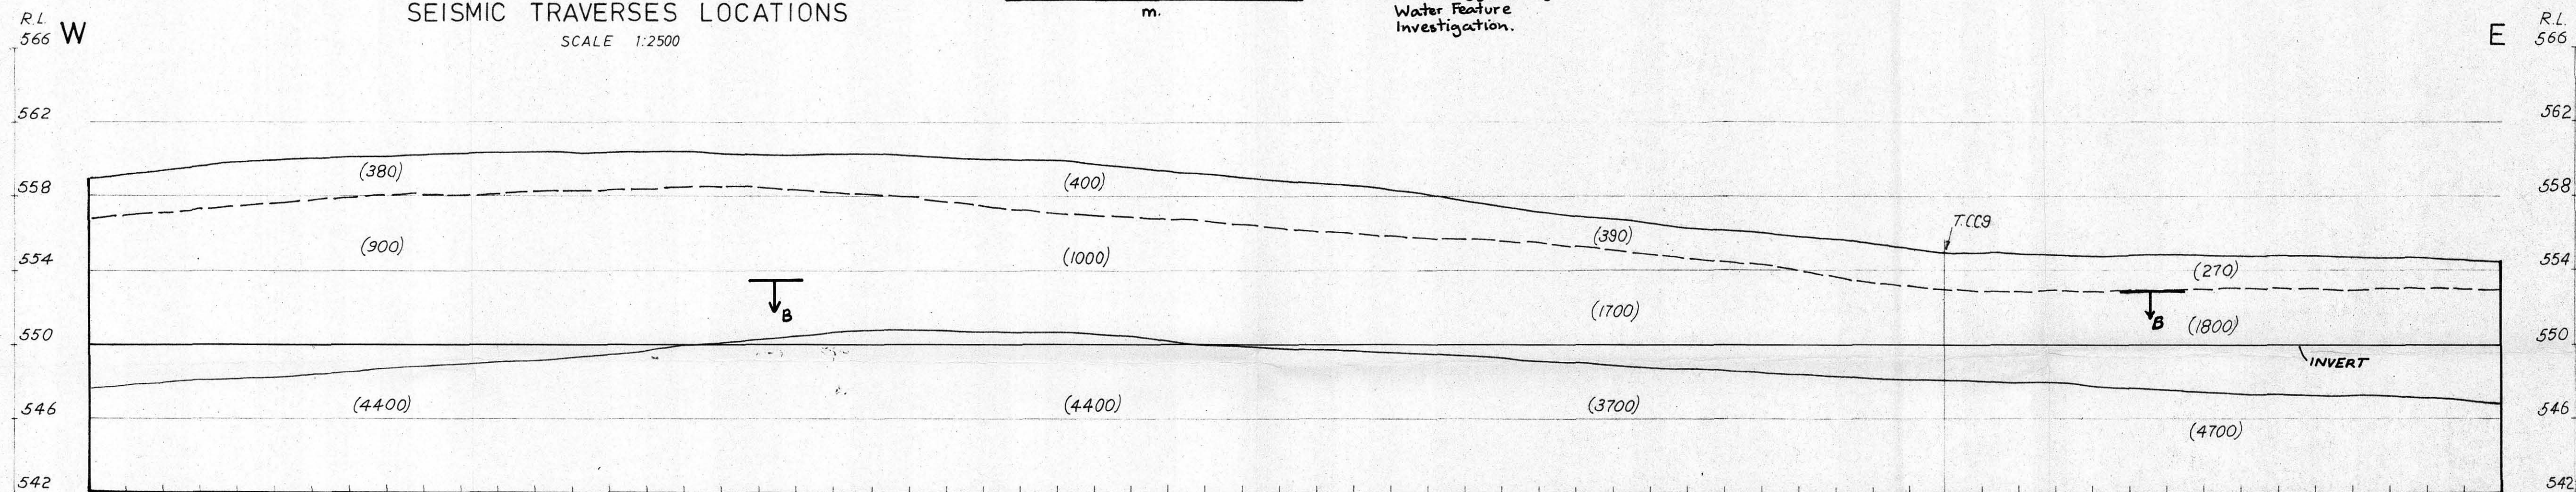
Canberra Sewerage  
TRUNK SEWERS - TUGGERANONG  
TUGGERANONG TUNNEL  
SEWER CONNECTION  
SEISMIC SURVEY - TRAVERSES A,B,C

Much of the lengths requiring blasting near invert are less than 2 m thick (based on DHC seismic results). The thickest section to be blasted will be 8 m near drop structure B (Plate 3).

Excavation conditions and stability. Excavation will be about 17 m deep, with blasting required below about 10 m. Drill hole B (Plate 3) intersected 8.5 m (9.2 m below ground) of extremely weathered dacite and soil, even though rubbly outcrop lies at the surface. It is therefore likely that residual boulders of moderately weathered to fresh dacite lie within this weathered mantle.
