Record 1976/71

DEFENCE FORCE ACADEMY SITE, DUNTROON A.C.T.:
INVESTIGATION OF THE SUBSURFACE, 1975

D.G. Bennett and G. Jacobson

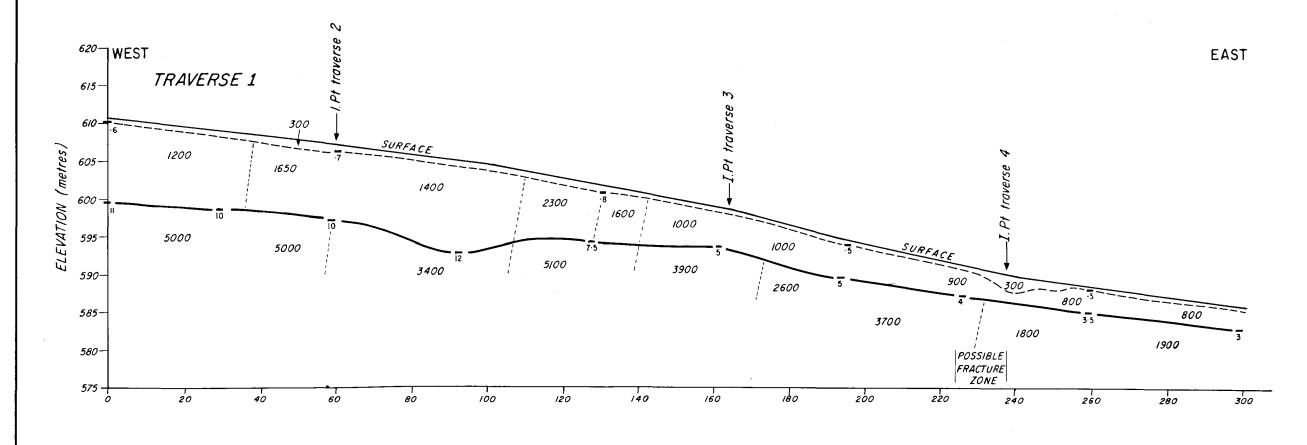
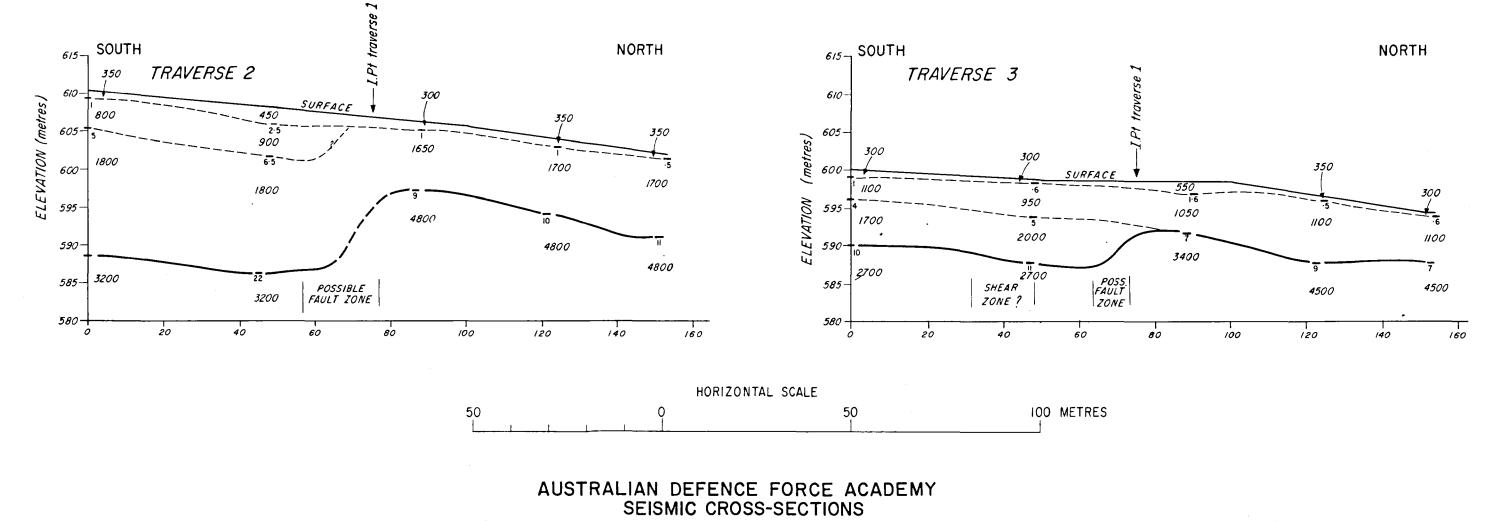
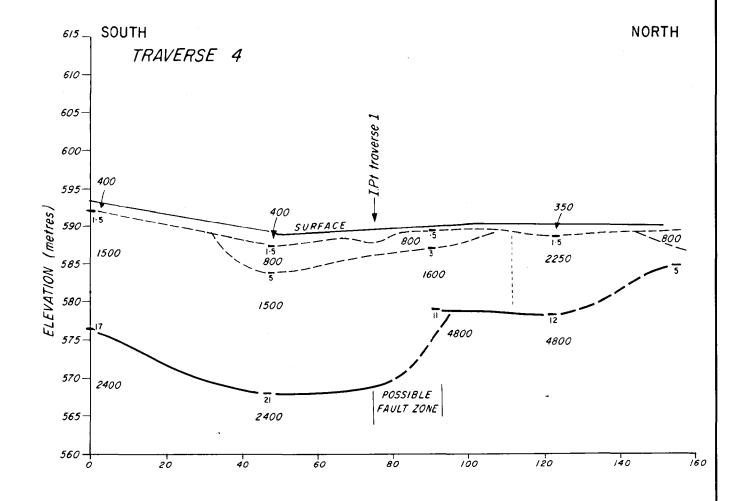
Traverse 1 (centreline): This traverse shows a thin surface layer, generally less than 1 m, of soil with a seismic velocity of 300 m/s. At the intersection point with traverse 4 this layer thickens in a pocket to a depth of 2.5 m.

The underlying layer varies considerably in depth and seismic velocity: under the western end of the traverse its seismic velocity is between 1200 and 1650 m/s, which may represent rippable material; between chainages 105 and 140, hard rock with a seismic velocity between 1600 and 2300 m/s will have to be blasted for excavations; east of this the second layer thins gradually, but its seismic velocity indicates that it should be rippable.

The bedrock velocity also varies. Up to chainage 230 the bedrock has two main velocities: one about 5000 m/s, the other between 3400 and 3700 m/s. At chainage 230, the seismic velocity changes abruptly from 3700 m/s on the west to 1800 m/s on the east. The velocity of 1800 m/s represents moderately weathered rock, possibly in a fault zone.

Traverse 2 (cross): The surface layer of soil (300-450 m/s) is generally a metre or less over most of the traverse, but thickens to 2.5 m at chainage 50, near where a fault has been indicated (Plate 2). On the southern side of this fault a second layer with velocity of 600-900 m/s (highly weathered rock) extends to a depth of 5-6 m. A layer with similar velocities was not detected on the northern side. Underlying this layer is moderately weathered rock with a velocity between 1650 and 1800 m/s. The bedrock on the northern side of the fault has a velocity of 4800 m/s, and was detected at a depth of 10 m. On the southern side, the bottom refractor has a velocity of 3200 m/s, and its average depth is 22 m.

Traverse 3 (cross): This traverse is similar to cross-traverse 2. A thin surface layer of soil thickens near the fault. The second layer of highly weathered rock appears to be continuous. It has a velocity of 950 m/s near the fault and increases to 1100 m/s farther away. This material should be rippable; its thickness varies from about 7 m at the northern end to about 4 m near the southern end. On the southern side of the fault a third zone of higher velocity, 1700-2000 m/s, overlies the bedrock. At the northern end of the traverse, bedrock velocity was 4500 m/s at an average depth of 7-8 m. Near the fault this velocity decreased to 3400 m/s, and at the southern end the velocity was 2700 m/s, indicating a zone of deep weathering.

Traverse 4 (cross): This cross-traverse follows a similar pattern to the other two, with a fault indicated near the intersection of the centreline traverse. A thin layer of soil thickens slightly at the intersection point with traverse 1. Below it, highly weathered rock or indurated colluvium up to 5 m deep has a seismic velocity of 800 m/s, and extends roughly from chainage 30 to 110; it should be easily ripped. Underlying these layers, the weathered rock has a velocity of 1500-1600 m/s south of chainage 112; north of chainage 112, a seismic velocity of 2250 m/s indicates an area of hard rock. At the southern end, hard fresh bedrock was not reached and the refracting layer has a velocity of 2400 m/s at a depth of 17 to 21 m below the surface. At the northern end, a bedrock velocity of 4800 m/s was detected at a depth of about 10-12 m; bedrock appears to shallow to 5 m at the far northern end.

- 2. The locations of two areas of hard rock close to the surface have been indicated by the seismic results: between chainages 105 and 140 in the centreline traverse 1, and at the northern end of traverse 4. In these areas, rock at a depth of about one metre will require blasting.
- 3. A fault zone about 10 m wide trends northeast-southwest, nearly parallel to the centreline traverse. The rock immediately southeast of the fault is deeply weathered with seismic velocities of 1500-2000 m/s to depths of up to 22 m.
- 4. Pits have indicated generally deeper soils in the northern and eastern parts of the Academy site; these areas have not been investigated by seismic survey, but depths of weathering are expected to be greater than those in the southwest part of the site.
