**GEOLOGICAL SURVEY OF UPPER COTTER DAM**

**SITES A AND B1, A.C.T.**

**W. J. PERRY**

Records No. 1953/108.

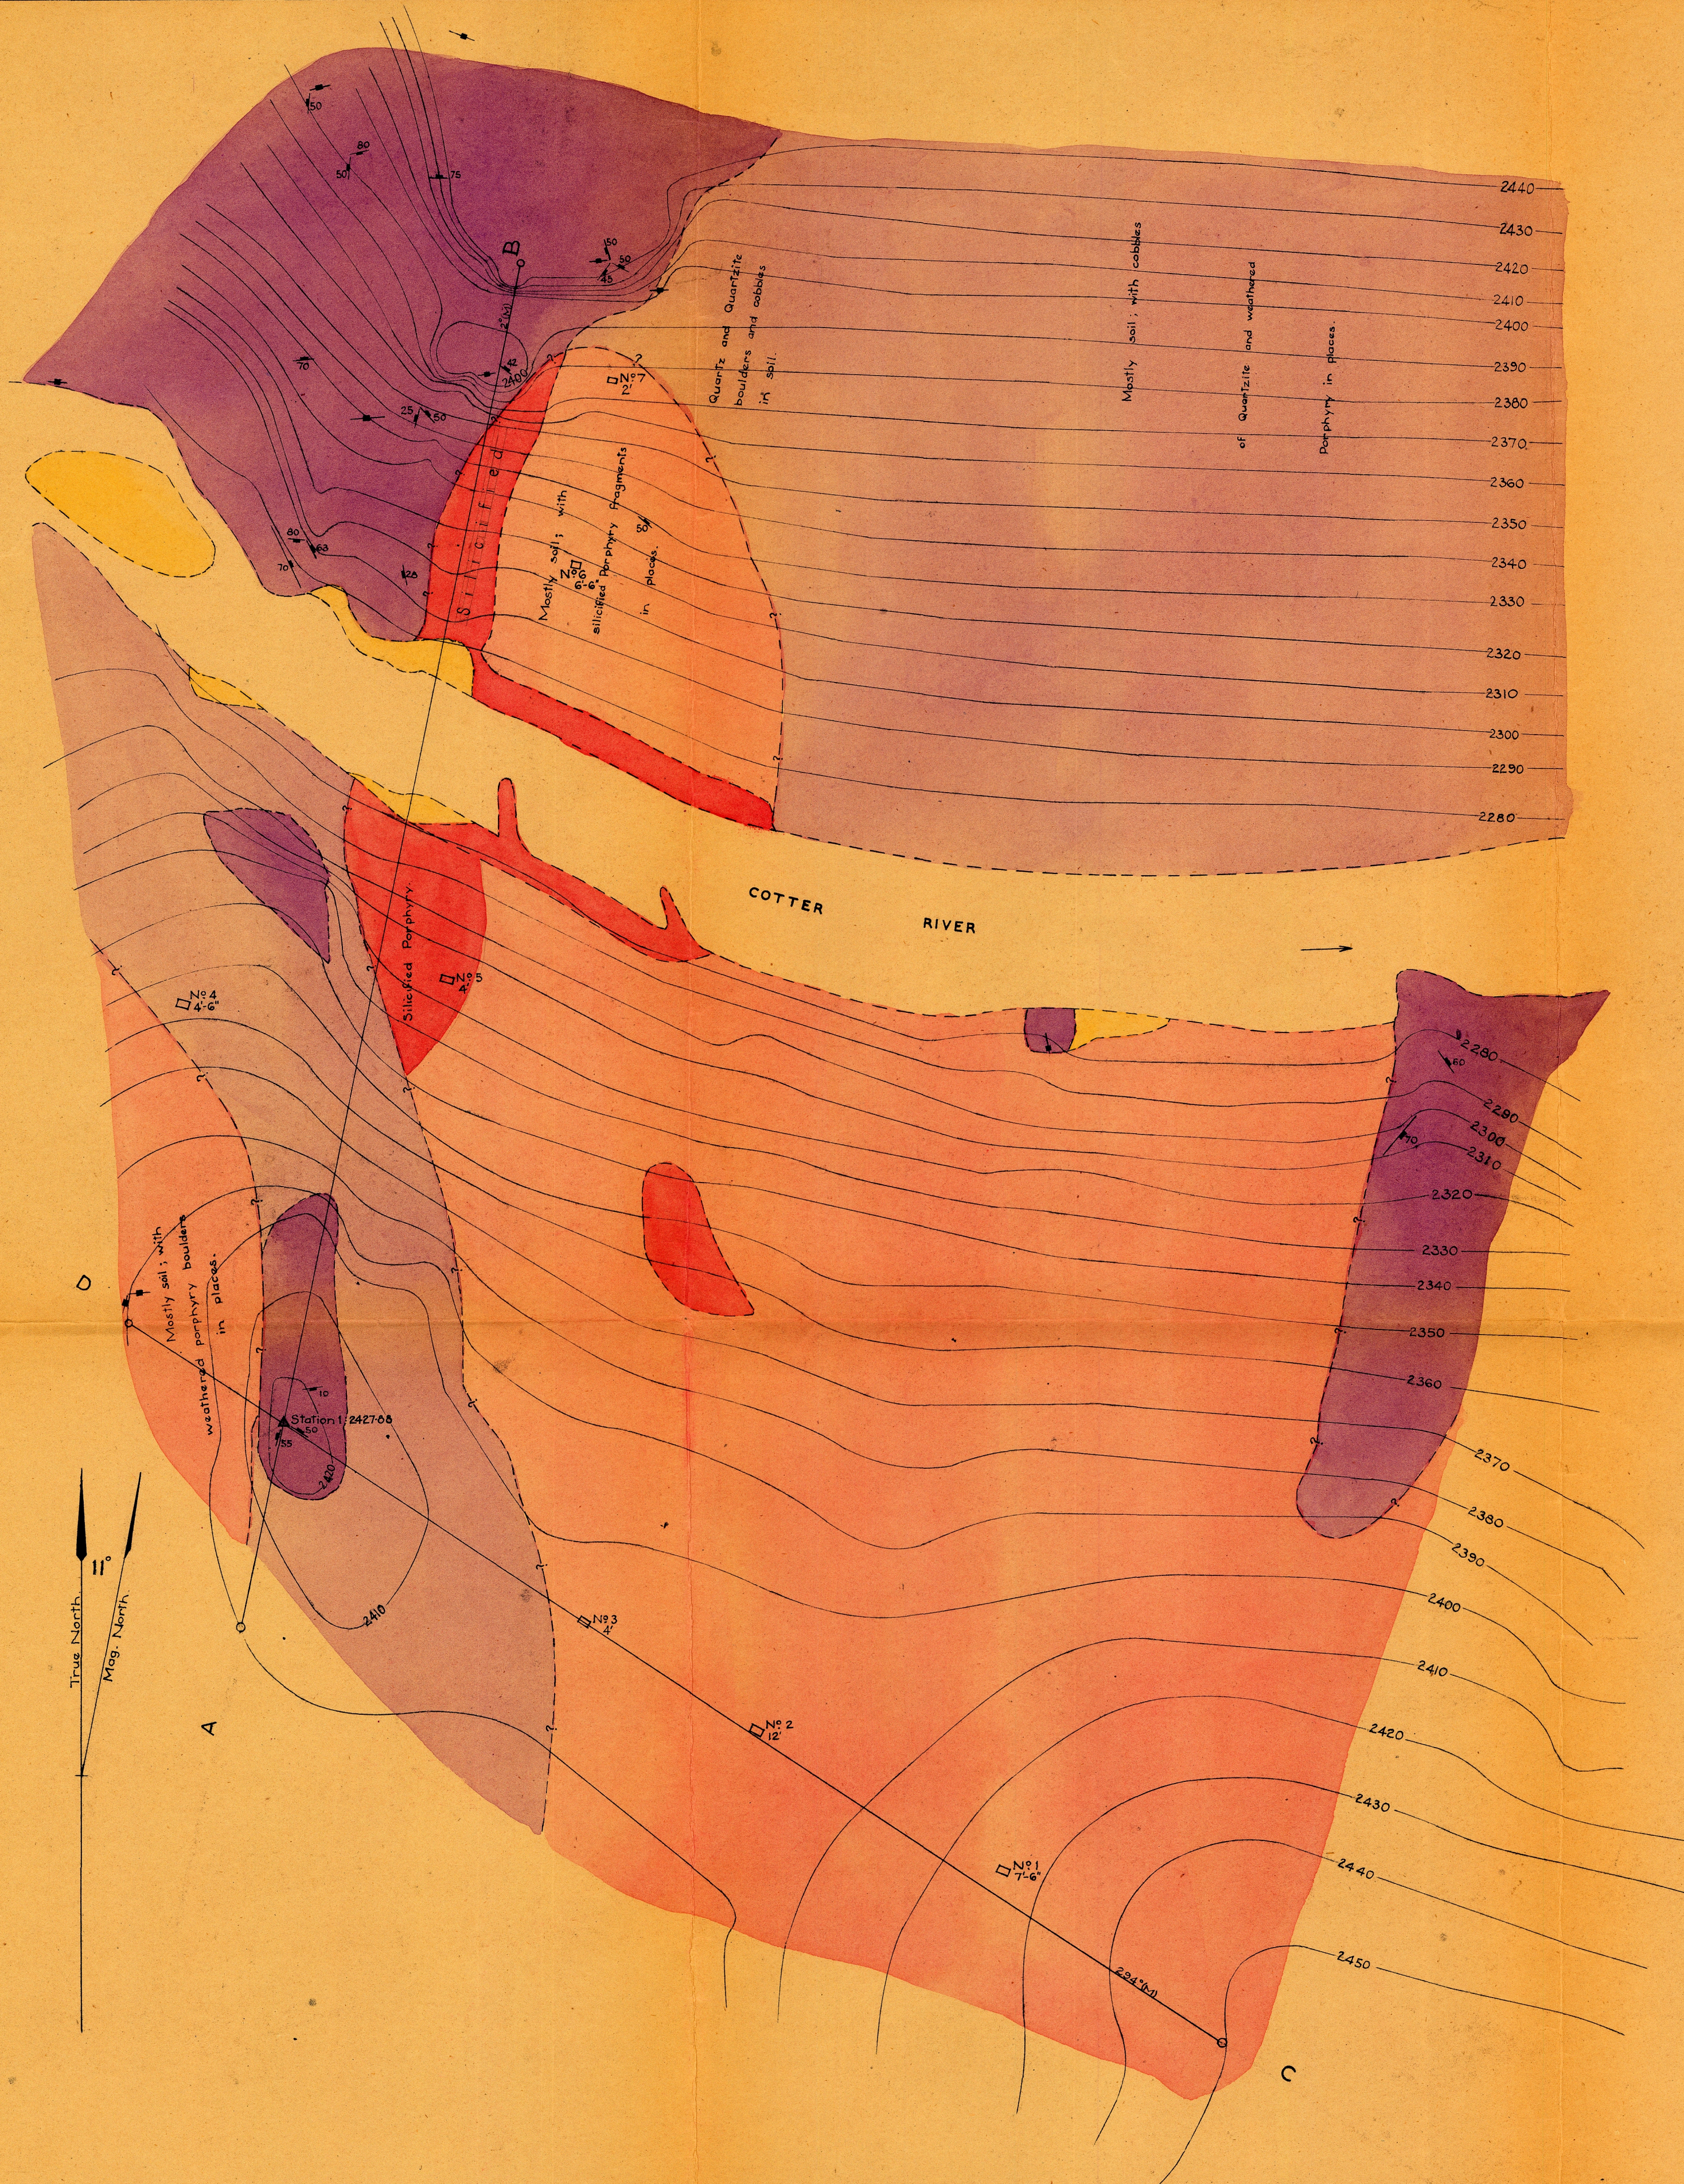
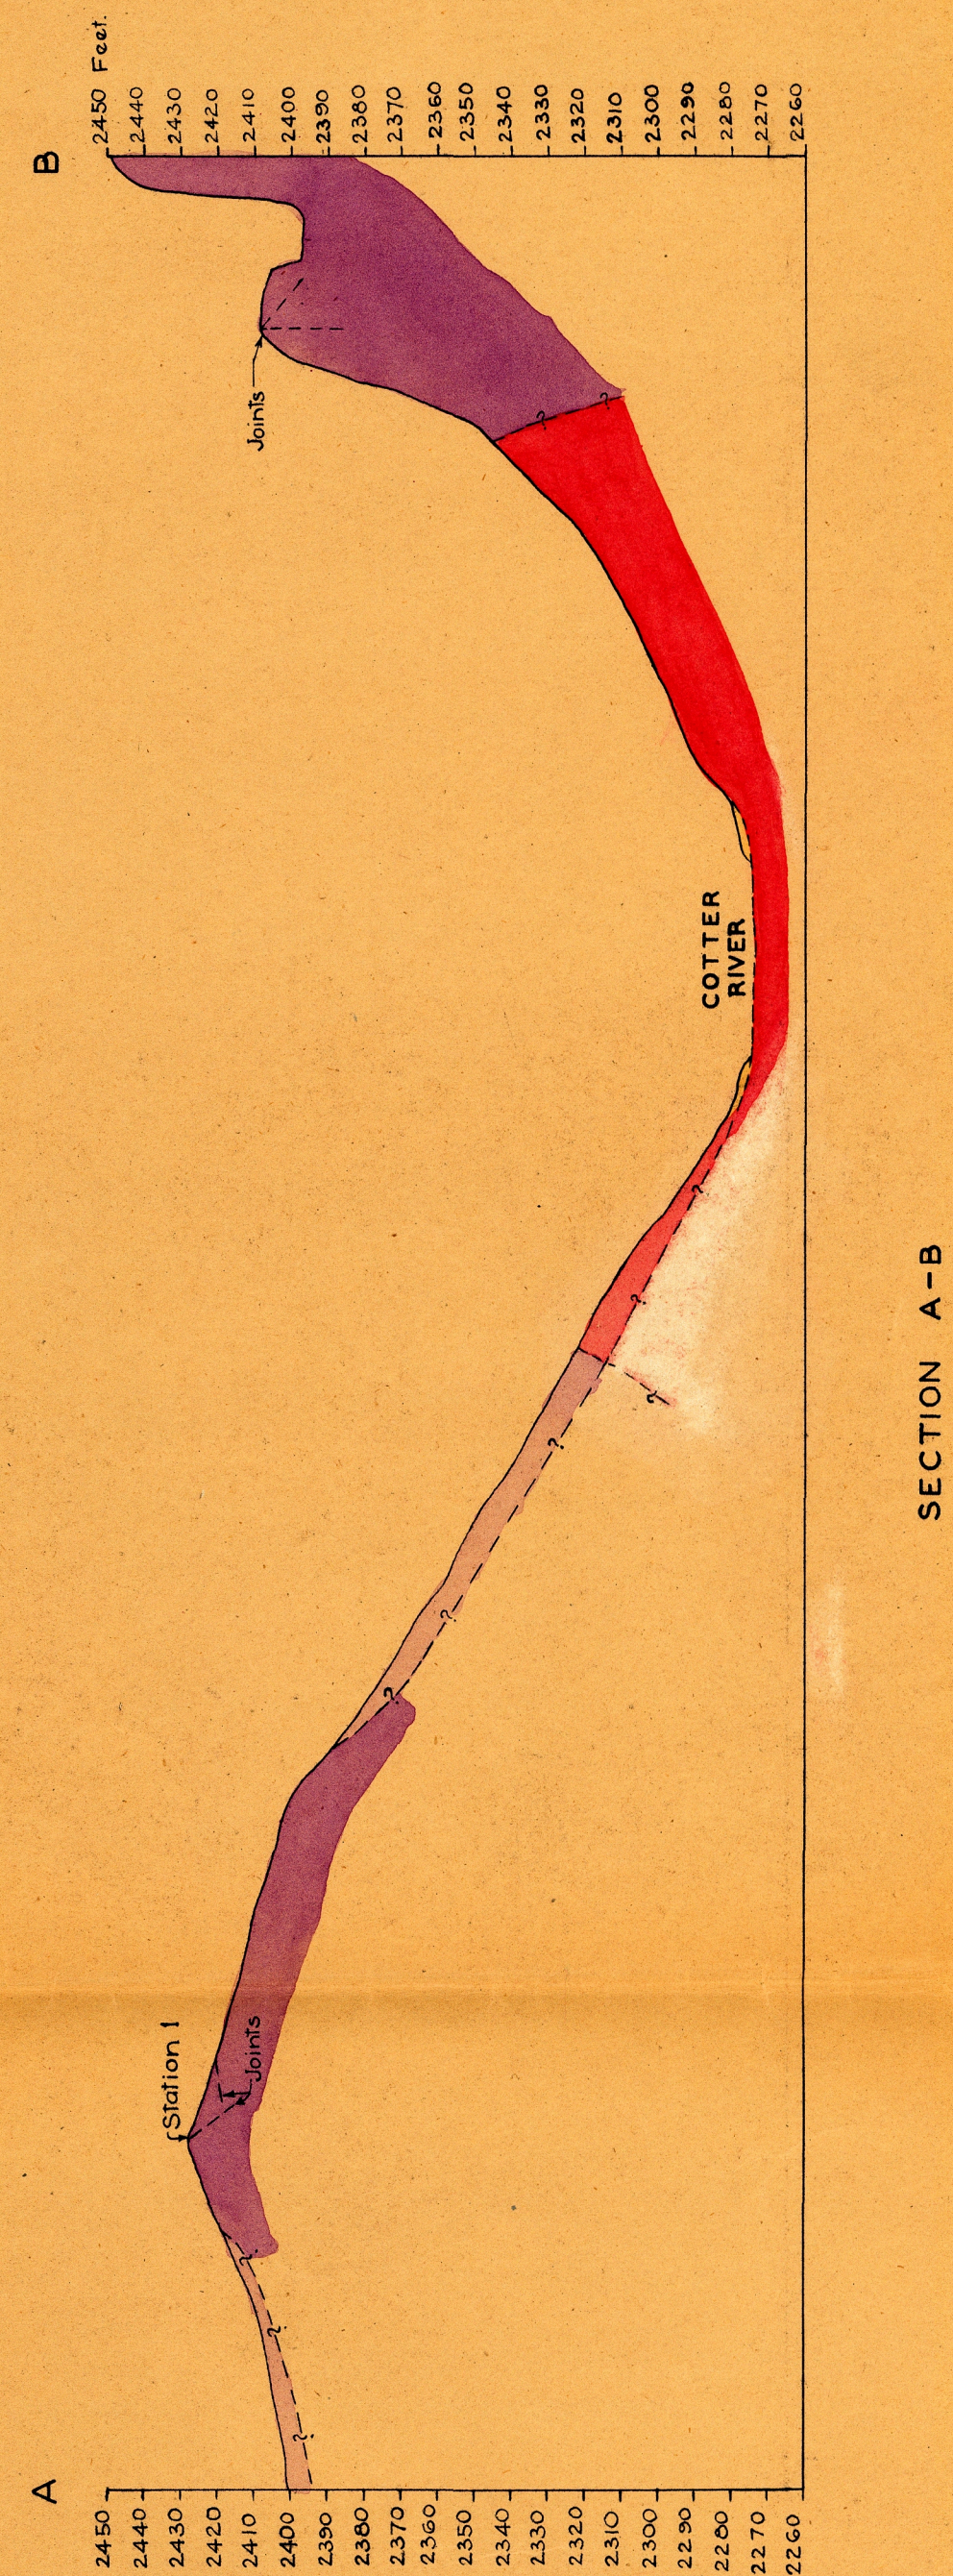
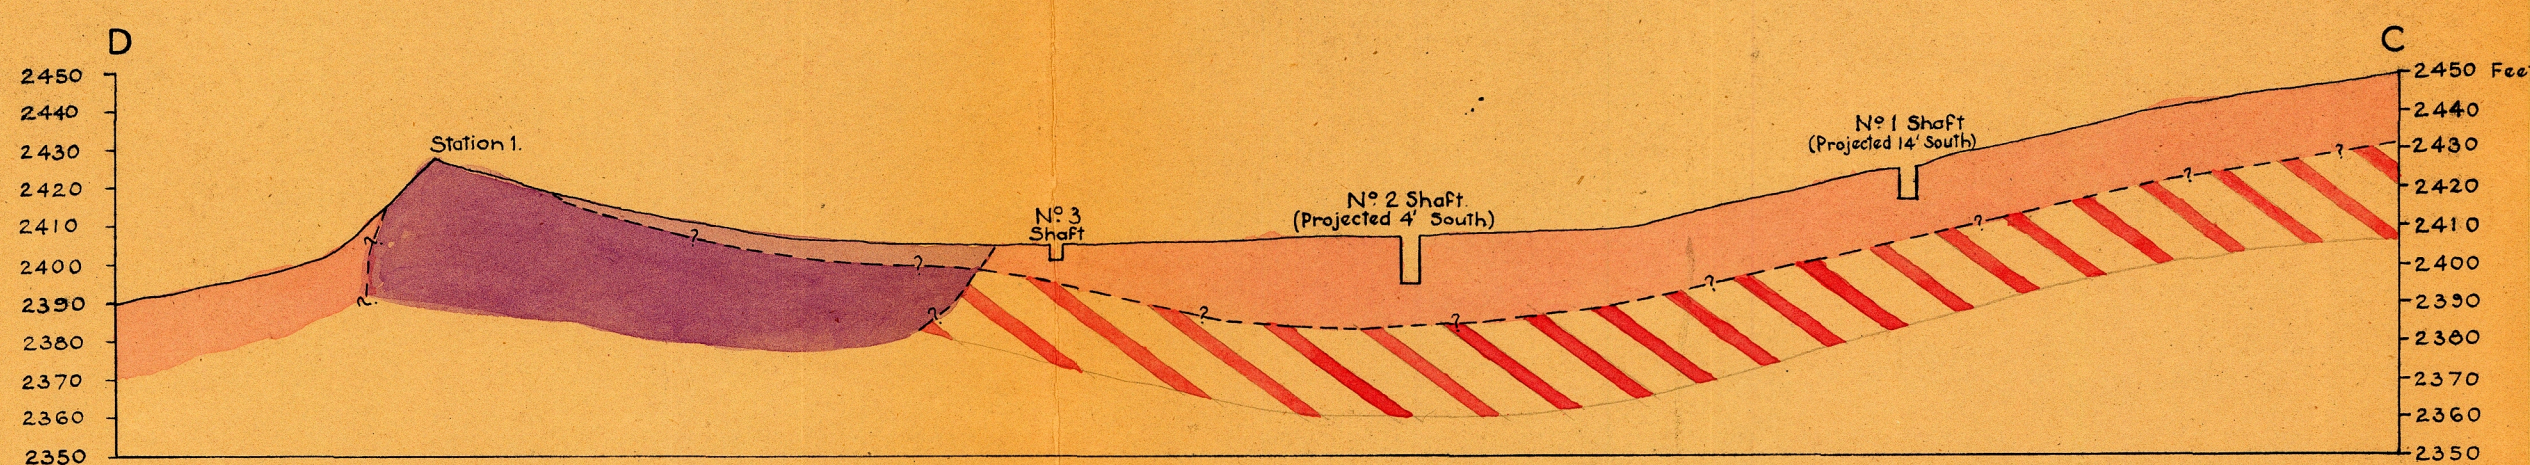
# DAM SITE A UPPER COTTER RIVER A.C.T.

The approximate distribution of rock types at the site is shown on the accompanying plan (ACT10/30). Field work and the examination of rock sections under the microscope has led to the conclusion that the probable sequence of events in the area was as follows, after the deposition of the Tidbinbilla Quartzite came the intrusion of the Cow Flat Granite, a porphyritic phase of which outcrops at site A. Four slides from the actual site indicate that the rock is a granodiorite porphyry, a granitic type in which plagioclase predominates over orthoclase.

The foundation rocks at the site are granodiorite porphyry, silicified porphyry, and quartzite. The granodiorite porphyry outcrops at river level about 50 feet downstream from section line AB; the unweathered rock is massive, shows large feldspar phenocrysts in places and is not much jointed; it has a rough uneven fracture and should bond well with concrete. In the area shown on the plan as silicified porphyry, the rock appears to have been fractured or brecciated to some extent and the fragments cemented together by silica. Under the microscope the original quartz phenocrysts show fracturing and shadow extinction, and fissures are filled with vein quartz. The rock surface has a smooth silicified appearance and the rock itself is very tough.

The quartzite in the vicinity of the dam site is resistant to weathering, particularly where it has been reinforced by the deposition of silica. No excavation should be necessary in areas of quartzite outcrops, but removal of loose blocks and some grouting of open joints may be necessary. On the line of the dam wall (Section AB), the north bank will require little excavation, but east of the zone of silicified porphyry some excavation will be necessary, though the depth to solid rock may be expected to be less than 10 feet in view of the information from test shaft No. 6. Here solid porphyry was struck at a depth of  $6\frac{1}{2}$  feet. The depth to solid rock in test shaft No. 2 was 2 feet.

On the lower slope of the south bank between contours 2280 and 2310 is a zone of silicified crushed porphyry, and here excavation may be expected to be of the order of 5 feet or less. Solid silicified porphyry was struck at a depth of 4 feet in test shaft No. 5. From 2320 to 2390 feet on the line of the dam is an area characterised by quartzite boulders and cobbles in the soil; here also the depth to solid rock is likely to be about 5 feet. Quartzite outcrops from 2390 to 2427 feet, the highest point on the south bank on the line of the dam wall.

In this area the quartzite is traversed by numerous open joints, and some removal of loose rock and probably grouting may be necessary. Should it be necessary to build a wall along the saddle on the south bank (Section CD), much excavation will be necessary before solid rock is reached. Test shafts No's. 1, 2, and 3 were sunk to depths of  $7\frac{1}{2}$ , 12, and 4 feet respectively, and each hole showed only very weathered

The distribution and attitude of joints is shown on the accompanying plan. There are three major joint systems. The strike of the first system ranges from 330 to 10 degrees, and the dip of the joint surfaces ranges from 23 degrees west to vertical. Joints of this system striking 355 and dipping 50 degrees west are prominent in the quartzite particularly on the north bank. The strike of the second system ranges from 65 to 85 degrees and the majority of the joints dip vertically though a few joints dip steeply north or south, and one dips 10 degrees to the south. The third system strikes from 285 to 310 degrees and the dip ranges from 42 to 52 degrees north with the exception of one joint which is vertical.

Though the site is close to the Cotter Fault and probably on a subsidiary fault, it is not considered that there are any serious drawbacks to the construction of a dam because of this situation. Any fracturing of rocks due to faulting has probably been sealed by the subsequent introduction of silica; in the event of these being open fractures or joints, these should be evident during excavation for the dam foundations, and can be sealed by grouting. L. C. Hoakes has indicated previously (loc. cit.) that none of the seismic activity experienced from time to time in the Canberra-Goulburn region can be referred to movement along the Cotter fault; as far as is known there is no record of such movement nor is it considered that movement is likely to occur in the future.

1. In view of the situation of the dam site in relation to the saddle CD, consideration should be given to the possibility of constructing a rock fill dam at AB, using the saddle CD as the spillway. Considerable excavation along C-D in part thereof would be necessary to provide a spillway but this construction in conjunction with a rock fill dam would probably be cheaper than a masonry wall at AB. Furthermore the height of a wall at AB is limited by the height of the saddle CD, and unless the saddle were protected by concrete, the spillway of a masonry wall at AB would need to be much lower than 2405 feet, the minimum height along the saddle, to avoid the possibility of a break-through during floods.

2. If it is decided to build a dam at site A, detailed geological examination of excavations should be made from time to time to map structures, with particular reference to faulting, shattering of rock, and degree of silicification. A detailed map of the completed excavations should be made.

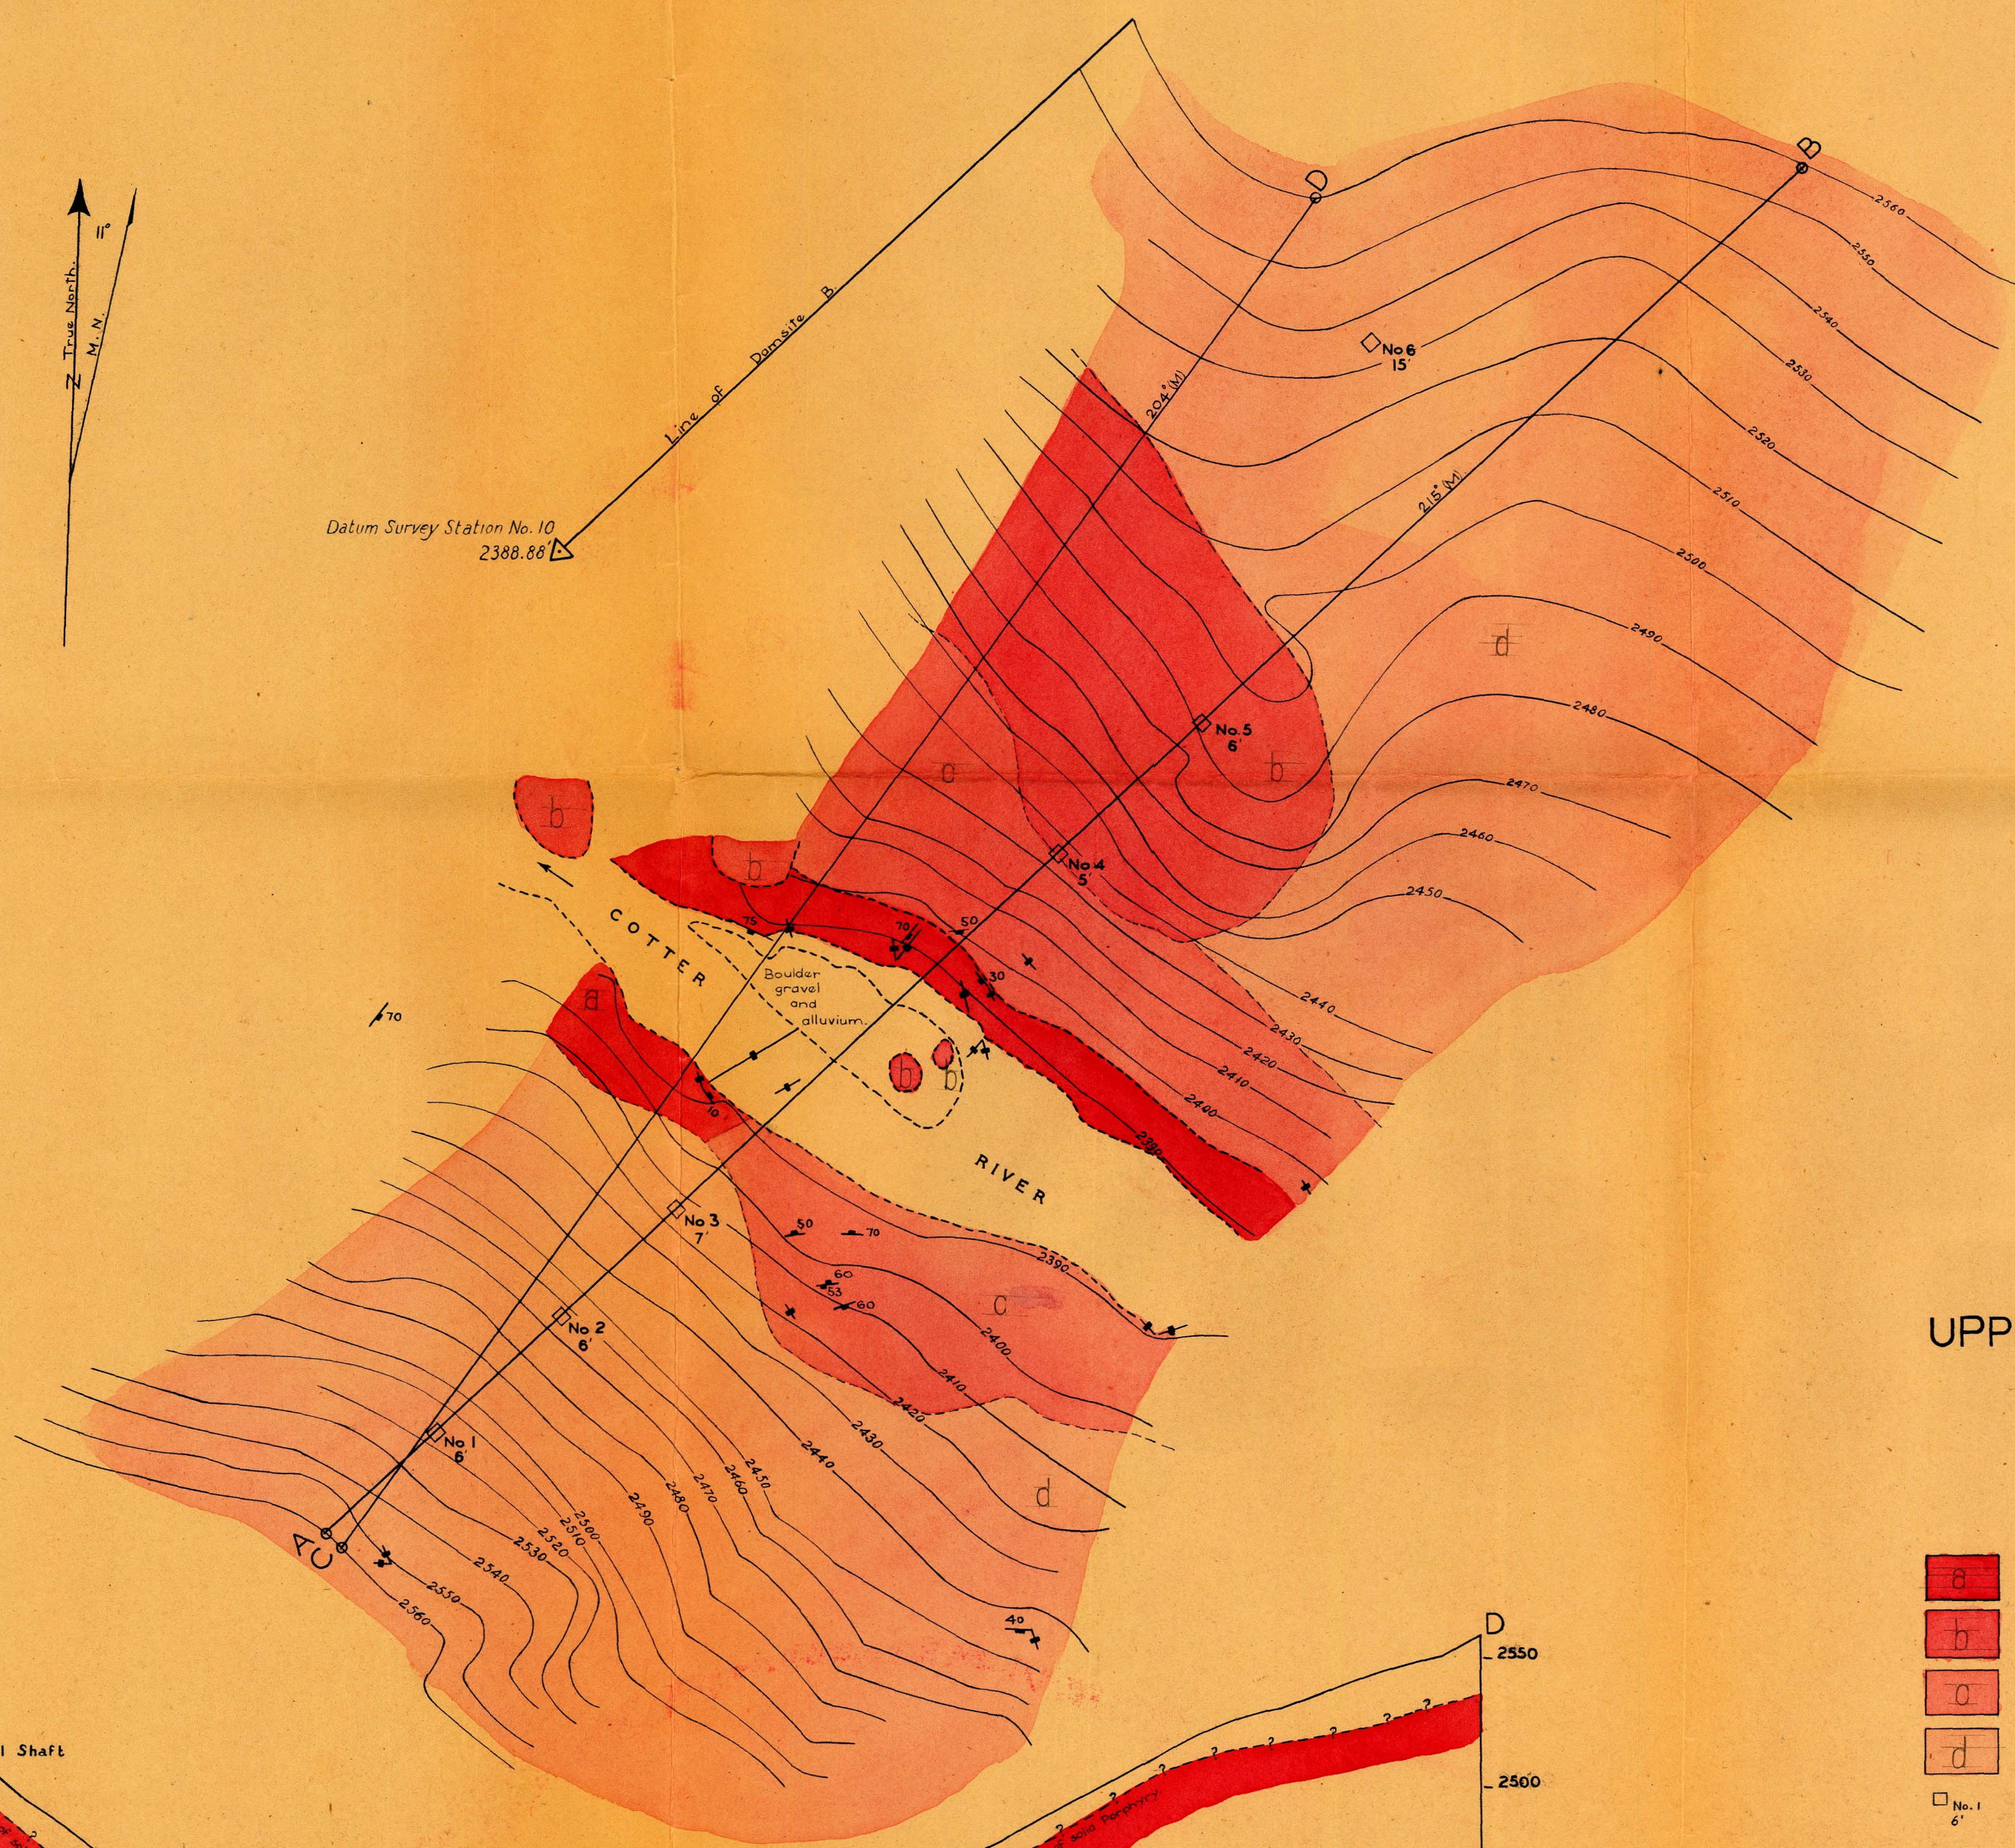
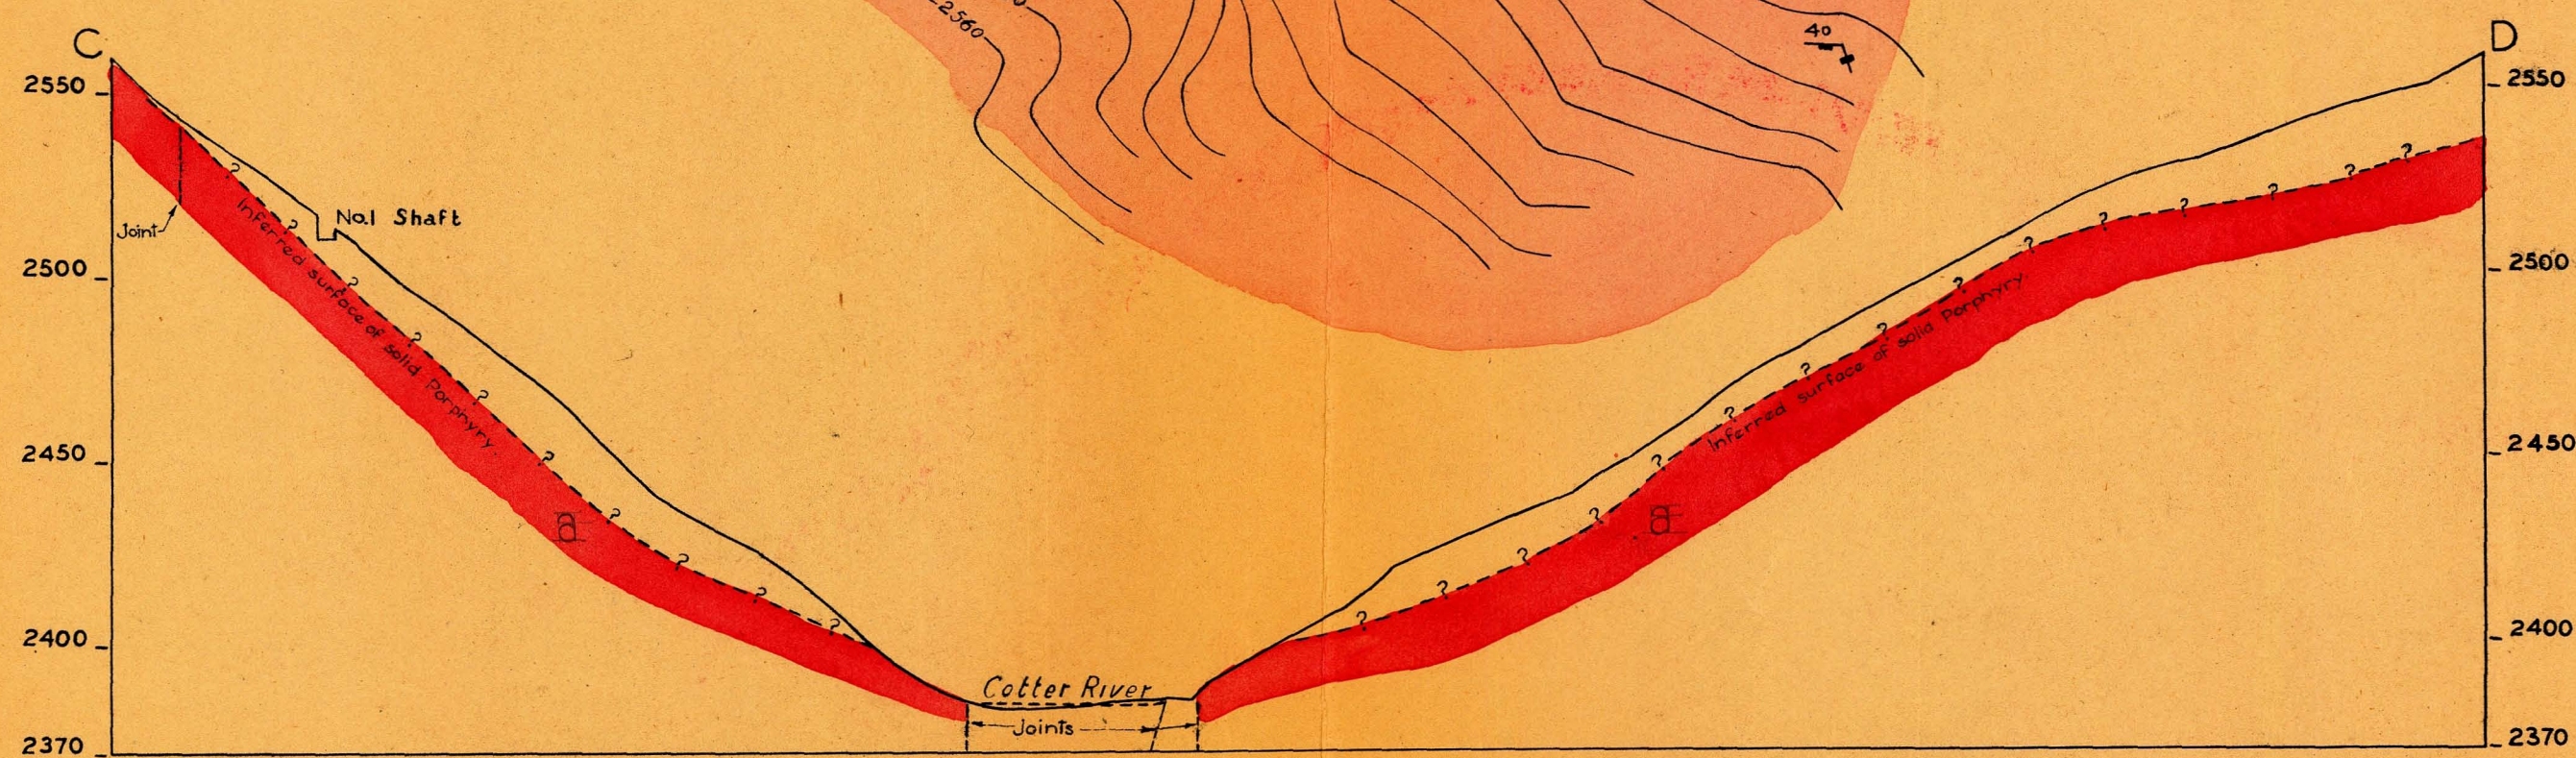
# DAM SITE B.I UPPER COTTER RIVER, A.C.T.

The survey work was begun with the assumption that the dam wall would be 220 feet upstream from site B and parallel to the line of B. On the contour plan ACT/10/31 site B1 is thus shown by the line AB. However, it is apparent from the plan and the sections AB and CD that the line CD will give a more economical wall section than AB.

Subsequent to the geological survey, six test pits were dug at the site in order to determine the depth of the zone of weathering. The approximate locations of the pits are shown on the plan (ACT10/31). Little excavation will be necessary in the stream bed at this site, for the porphyry presents a relatively smooth unweathered surface. Away from the stream bed up the valley walls, the depth of the zone of weathering may be expected to increase, as it is dependent on the depth of the water table. On the plan (ACT10/31) three types of weathering are shown:-

- (a) areas of large porphyry boulders; here solid rock is probably close to the surface but in places there may be pockets of deeper weathering between boulders;
- (b) areas of loose cobbles and small boulders; probably deeper weathering than (a);
- (c) area of deeply weathered porphyry and soil, with cobbles and small boulders in places; probably deep weathering of the order of 10 feet or more.

On the south-western bank of the river, that part of the slope on the line AB between contours 2400 and 2450, is in weathered porphyry soil and therefore the necessary excavation is likely to be deep. Test pits Nos. 2 and 3 in this area went to 6 feet and 7 feet respectively and encountered only very weathered fragmental porphyry. Above the 2430 contour the proportion of small boulders in the soil increases, and although this area does not come into category (b) it is probable that the depth to solid rock is less than that on the slope below. Test pit No. 1 in this area was abandoned at a depth of 6 feet in very weathered porphyry.

The disposition and dip of joints at the site is shown on the plan (ACT10/31). In direction the joints fall into two broad groups, one which ranges from 283 to 335 degrees and the other from 25 to 80 degrees. Most joints in the first group are vertical while in the second group the dip ranges from 70 degrees to the north-west to 70 degrees to the south-east. It is unlikely that these joints will prove troublesome from an engineering viewpoint, with the possible exception of two low dipping surfaces; one on the south-western bank which strikes 310 degrees and dips 10 degrees to the north-east, and the other on the north-eastern bank which strikes 305 degrees and dips 25 to 30 degrees to the south-west. Such joints may cause rock slips during excavation, as their dip is less than the slope of the valley walls.

Geologically, site Bl is quite satisfactory for the building of a dam. The porphyry provides a good foundation, though much excavation would be necessary to expose the unweathered rock, jointing is unlikely to cause difficulty, and the site is over  $\frac{1}{2}$  mile from the Cotter Fault. However, it is understood that re-calculation of the storage capacity of site Bl by Works Department engineers has shown that a dam in this position would store insufficient water for Canberra's future requirements. Hence this site is not likely to receive further consideration.

It is evident from the preliminary testing of the site that a considerable amount of excavation will be necessary before a firm foundation is reached and to enable an accurate estimate of the average depth of excavation to be made the test pits should be carried down to solid rock. Consideration should also be given to the possibility of using drilling methods to determine the configuration of solid rock along the line of the dam, as drilling may prove cheaper than the digging of test pits.
