### Department of Transport & Regional Services

### **Cocos (Keeling) Islands**

### Report On Seawall Upgrade Design Concept

January 2000

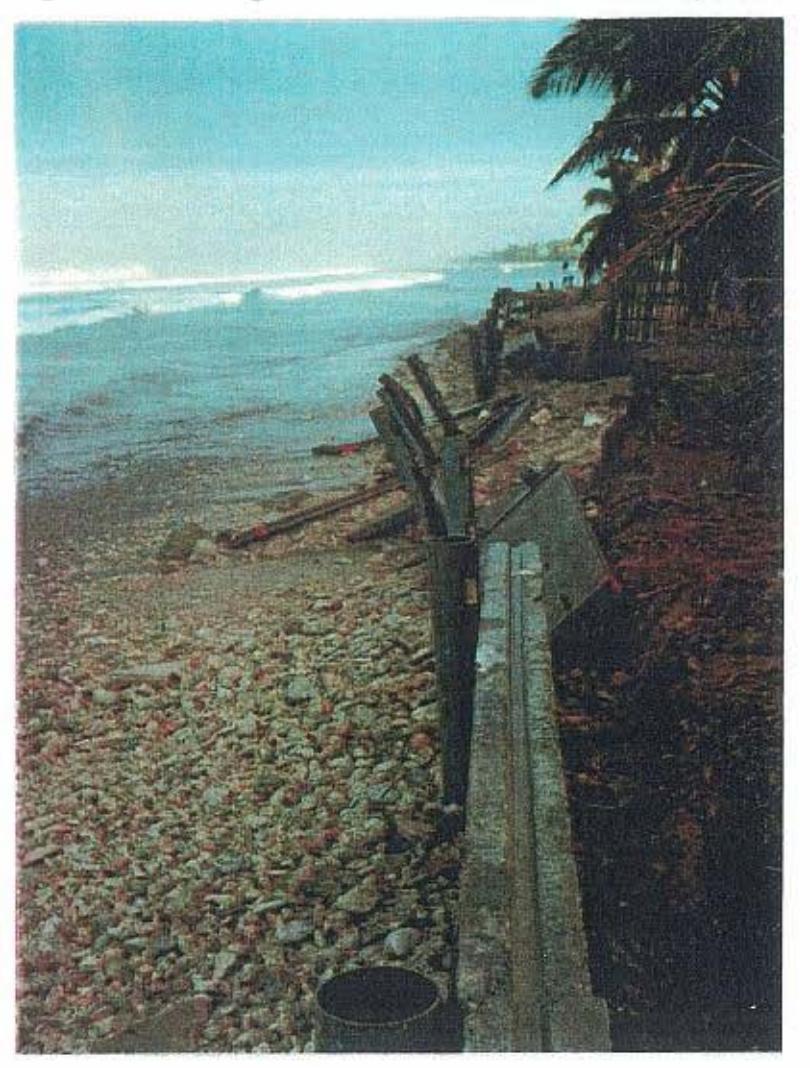
Significant amounts of wave overtopping occurred in August 1980 and eroded the soil behind the seawall, resulting in collapse of the northern 70m of the wall, as illustrated in Figure 2. This section was subsequently reinstated.

Figure 2. Damage to northern end of seawall, 1980
