## CHAPTER 3: A REGIONAL REVIEW OF COASTAL HAZARDS

### 3.1 INTRODUCTION

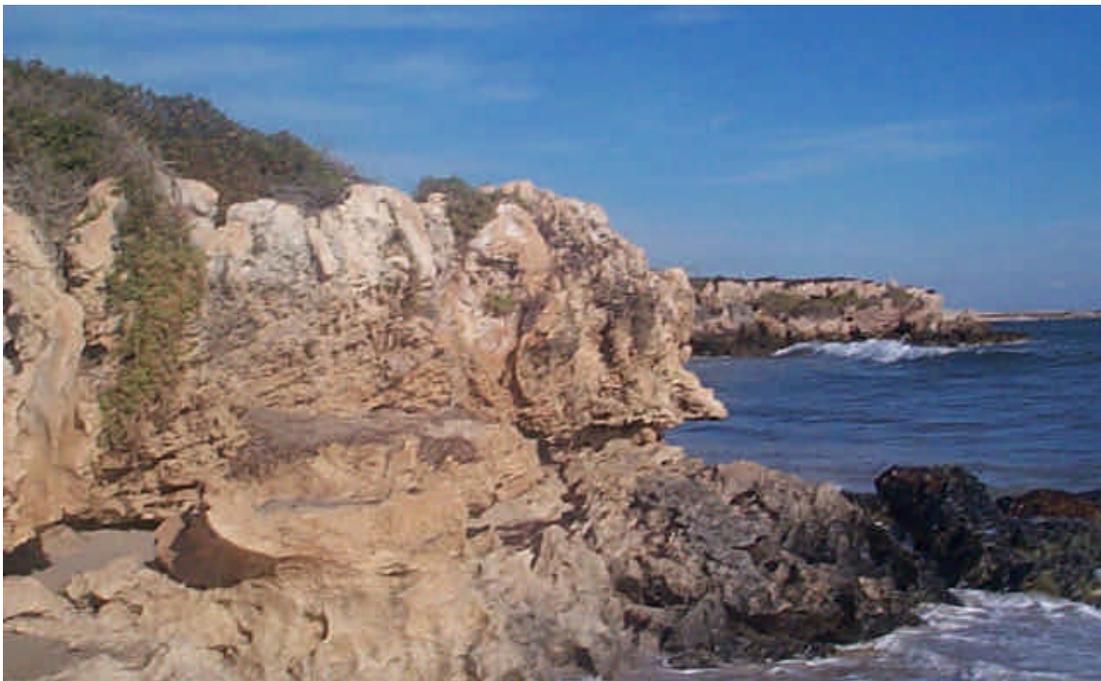
**Figure 3.2** Typical exposure of Tamala Limestone within study area no.1. The cliffs in this photo are 3-4 m tall and are located at site 4 (see Appendix A).

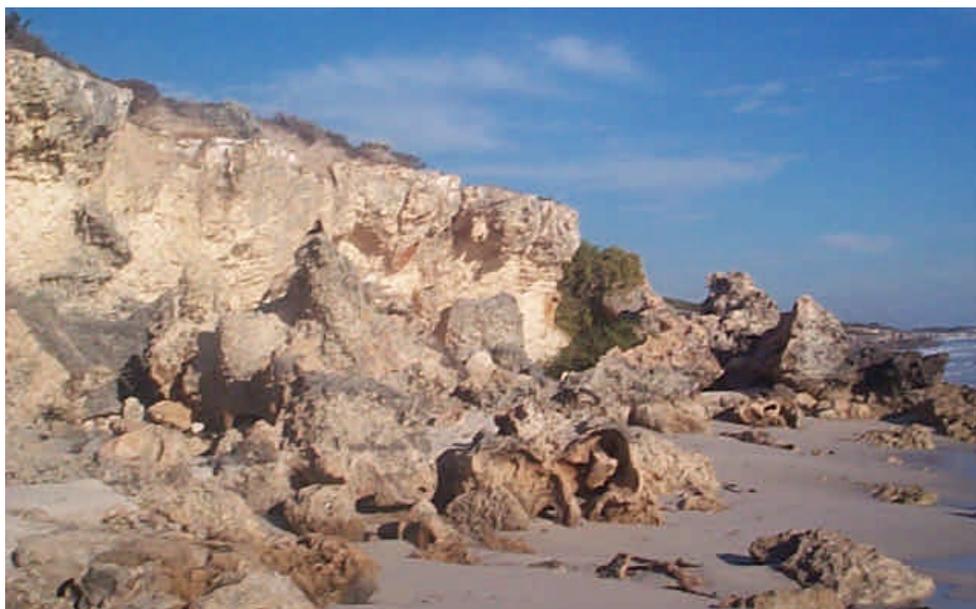
The most obvious feature pertaining to the cliff hazard, are the large limestone blocks that have separated from the parent body and fallen onto the beach (Figure 3.5). These limestone blocks can be up to 1m<sup>3</sup> in dimension. The timing of collapse is not known, however in certain instances, variations in the colour of the exposed rock formations indicate recent fracture.

**Figure 3.5** Large limestone blocks (<math><1\text{m}^3</math>) have separated from the cliff and fallen on to the beach (Site 5).

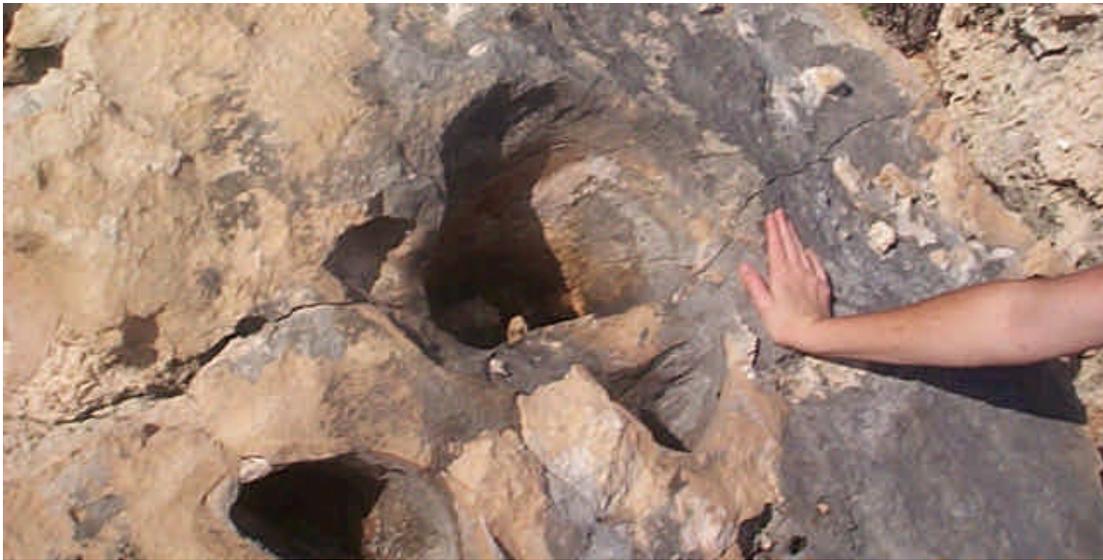
Other features seen within the limestone include cracks and fissures, along with solution piping. This piping was apparent at most sites, but was most noticeable at site 5 where the limestone was riddled with solution tubes up to 60 cm in diameter (Figure 3.6).

**Figure 3.6** Solution piping is a common feature within the Tamala limestone. At site 5, these solution tubes were up to 60cm in diameter.
