Survey of Kalgoorlie earthquake damage

Assessing the vulnerability of older buildings

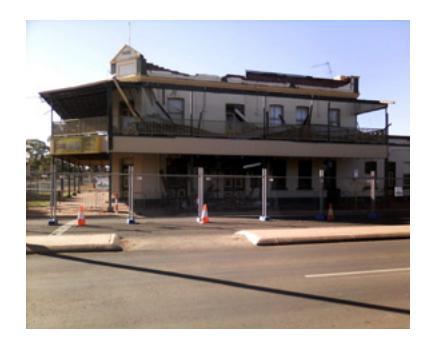
The field team found that the severity of shaking in the Boulder business district was approximately 6 on the Modified Mercalli scale. This level of shaking caused widespread damage to unreinforced masonry buildings built before World War One. The loss of chimneys, gables and parapets was widespread as well as extensive cracking of walls (figure 2). The timing of the event at 8:17am was fortunate as falling masonry would have landed on school children walking through the area if the earthquake had occurred just 15 minutes later. Only a few minor injuries resulted. More modern masonry residential buildings also experienced some damage. The severity of shaking beneath the Kalgoorlie business district was approximately 5 on the Modified Mercalli scale causing only slight damage to older masonry buildings. Preliminary findings from this work have shown that older masonry buildings are particularly vulnerable to the nature of the ground motion experienced in the Kalgoorlie event. Furthermore, more contemporary cavity brick construction was found to experience greater damage than equivalent wooden-framed construction, though damage was light.

Figure 2. Damage caused to a hotel in Boulder. The damage is typical for two storey unreinforced masonry buildings with toppling of parapets either outwards into the street or inwards through the roof. This building also sustained other types of damage such as cracking over doors and windows and substantial cracking to internal masonry walls.
