RECORDS.

1962/147

STABILITY OF THE WESTERN SIDE OF HEAVITREE GAP,
ALICE SPRINGS, N.T., MAY 1962.

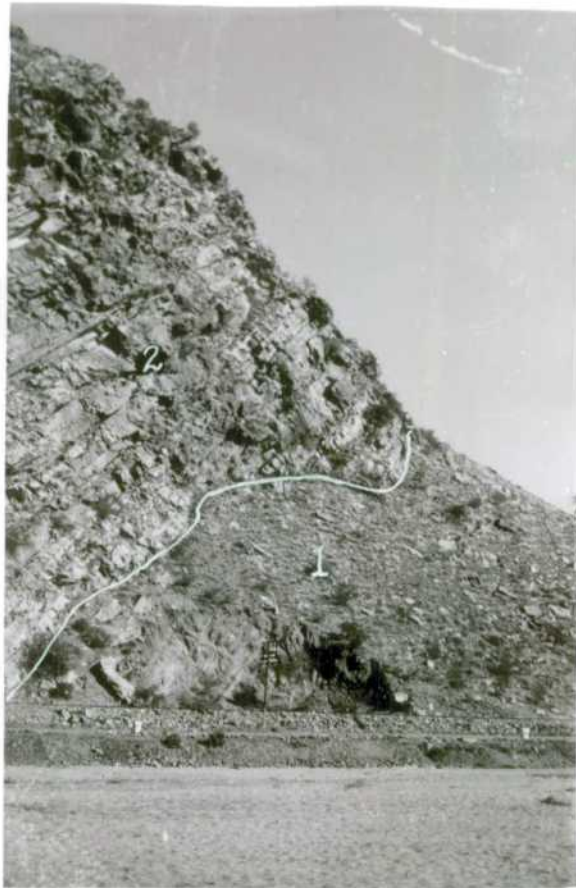
PLATE 4

The maximum gradient on this slope is 1 in 2, which is considered to be less than the angle of rest. It is covered by a vigorous growth of spinifex, which adds considerably to its stability. It is most unlikely that any material already on this slope will move. If the slope were cleaned, it would become a less efficient buffer to material falling from the scarp above it, and the angle of rest would be reduced, i.e. new material accumulating on the slope would be unstable.

There are many blocks in this area which are separated from solid rock by open joints. A count of these blocks in a representative area indicated a density of 3 cubic yards per 50 square yards. The total area of the escarpment is 15,000 square yards, and the total volume of loose material is estimated to be 900 cubic yards. Some of it could be removed with a crowbar, but a considerable amount could only be moved by the use of explosives.

There is a small overhang at the top of the eastern end of the escarpment. This could become unstable, although there do not appear to be sufficient open strike joints to cause immediate danger. The volume of this overhang is estimated at 1,500 cubic yards.

Most of the material within the zone of surface weathering on this escarpment appears to have already fallen, but a thin veneer remains in places. It is estimated that an average thickness of 3 feet of potentially dangerous material remains on this face, so that a total of about 15,000 cubic yards would need to be moved to clean the escarpment back to solid rock.

1. Northern scree
2. Northern escarpment

of			
<u>Stage 1.</u>	Removal/loose material from -		
	(a) Northern escarpment	...	900 cu. yards
	(b) Southern escarpment	...	250 " "
	(c) Pediment outcrop areas	...	160 " "
	Removal total volume of central strike ridge	...	4,000 " "
	Removal total volume of scree in southern part of pediment scree area (a)	...	1,700 " "
	Total :		<u>7,010 " "</u>
<u>Stage 2.</u>	Benching under the scree in the southern part of pediment scree area (a)		
		...	8,500 " "
	Total :		<u>8,500 " "</u>

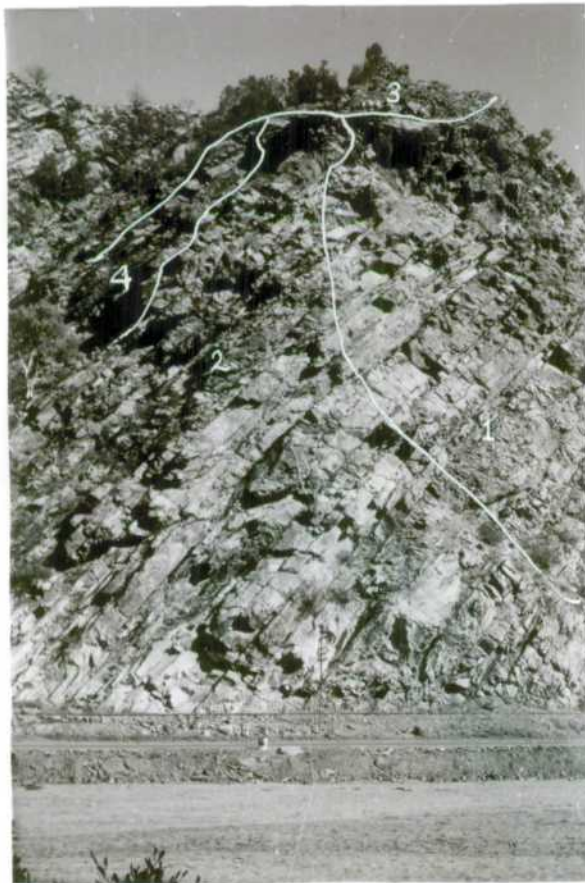
PLATE 5

This area is underlain by outcrops with numerous large loose blocks. The surfaces involved are small, and slope at less than the angle of rest. The area is stabilised by spinifex and scrubby vegetation. No serious rock falls from this area are likely.

This area is on the southern flank of the northern strike ridge. Bedding planes and the major set of joints appear to be open to a depth of 20 feet, but the minor sets of joint planes do not appear to have been opened. The likelihood of rock falls from this area is therefore low, but any blocks which did break loose would probably be very large and would probably fall to ground level. Approximately 17,000 cubic yards would have to be shifted to remove the zone of open joint and bedding planes.

(a) The exposed end of the northern strike ridge, on which the overall gradient varies from 2 in 1 to almost vertical. Loose material falling from the top would probably reach level ground, but may be caught in a projecting ledge on the irregular surface. A count of loose material in a sample area indicated a density of 2 cubic yards per 80 square yards. The total area involved is 2,600 square yards, so that the removal of 65 cubic yards would be required to clean this face of loose material.

Part of this area includes the cutting made when the railway was constructed; in this part fairly solid rock is present. In the remainder, open joint and bedding planes probably persist to a depth of 20 feet; 18,000 cubic yards would therefore have to be moved to clean the face back to solid rock.

1. Northern escarpment
2. Pediment outcrop (a)
3. Northern strike ridge
4. Northern dip slope

A limited programme of rock bolting could be useful in increasing the stability in some areas, particularly the northern dip slope and the central strike ridge.

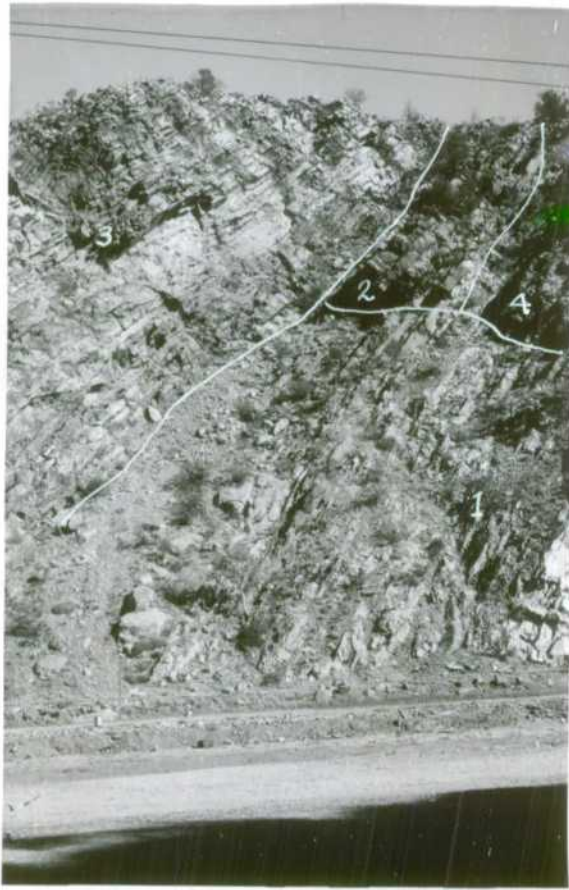
PLATE 6

This ridge occurs at the head of the valley between the two main strike ridges. The joint planes and bedding planes appear to have been opened throughout the ridge. Blocks with a volume of one cubic yard or more are likely to become dislodged from the ridge, and some of these would probably reach level ground. The volume of rock in the ridge is about 4,000 cubic yards, and the complete removal of this material is considered desirable.

The thickness of the zone of surface weathering on this escarpment appears to be about 20 feet. In one area the material within the zone has fallen, leaving apparently solid rock on the face of the escarpment. On the assumption that the density of existing loose blocks is similar to that on the northern escarpment, the volume of loose material on this escarpment would be about 250 cubic yards. To clean the escarpment back to solid rock would require the removal of about 25,000 cubic yards.

However, the southern part of this area is occupied by a scree slope, the gradient of which (1 in 1.3) appears to be close to the angle of rest, as a minor disturbance results in considerable movement of material. The angular blocks which form the scree range from a few inches to one foot long; around the margins, there are several much larger boulders (up to a cubic yard). There is no vegetation on the slope. Assuming an average depth of 3 feet, the total volume of the scree material is 1,700 cubic yards, and all of this should be removed. This could exaggerate the effect of falls from the eastern end of the southern escarpment. Additional safety could be provided by cutting a series of benches in the outcropping rock after removal of the scree. Six benches, each 30 feet wide, could be constructed, involving the removal of 8,500 cubic yards.

1. Pediment scree (a)
2. Central strike ridge
3. Southern escarpment
4. Northern dip slope

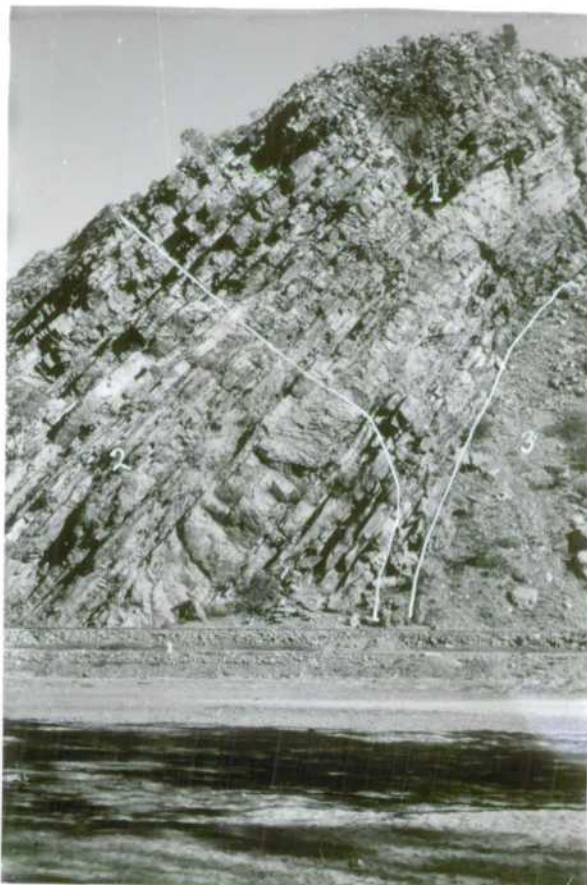
PLATE 7

(b) The exposed end of part of the southern strike ridge, is similar to (a). The total area is 1,260 square yards, and it contains an estimated 50 cubic yards of loose material.

1. Southern escarpment
2. Pediment outcrop (b)
3. Pediment scree (a)
