RECORD No. 1966/152

**DARWIN RIVER
WATER STORAGE SCHEME,
NORTHERN TERRITORY,
GEOLOGICAL INVESTIGATIONS
1963 - 1964**

D.F. MAGGS and J. BARCLAY

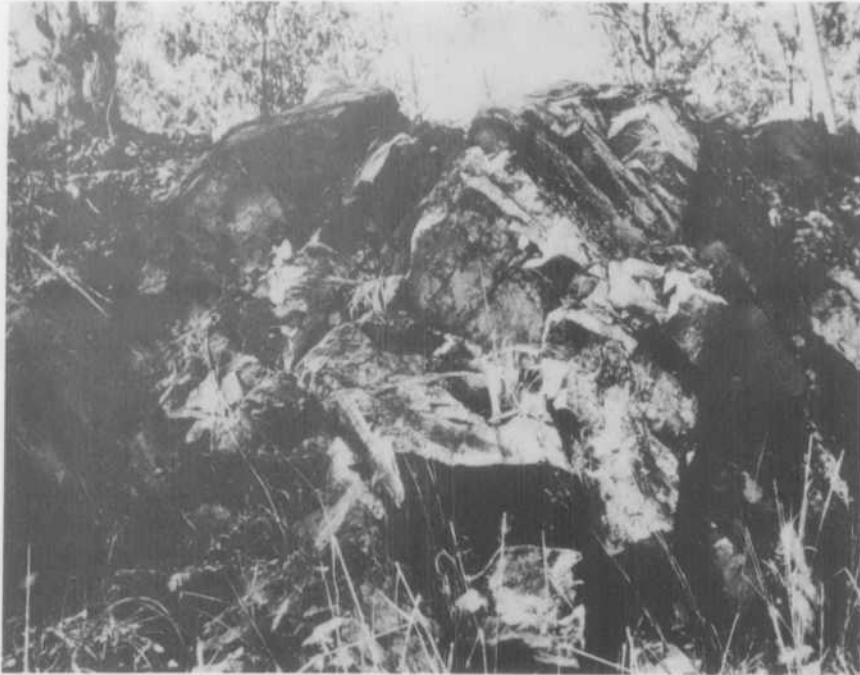
Fig. 1

Darwin River Dam Site - Railway cutting, northern face. Interbeds of schist and quartzite are contorted into a recumbent anticlinal fold, plunging to the south-west at 35 degrees.

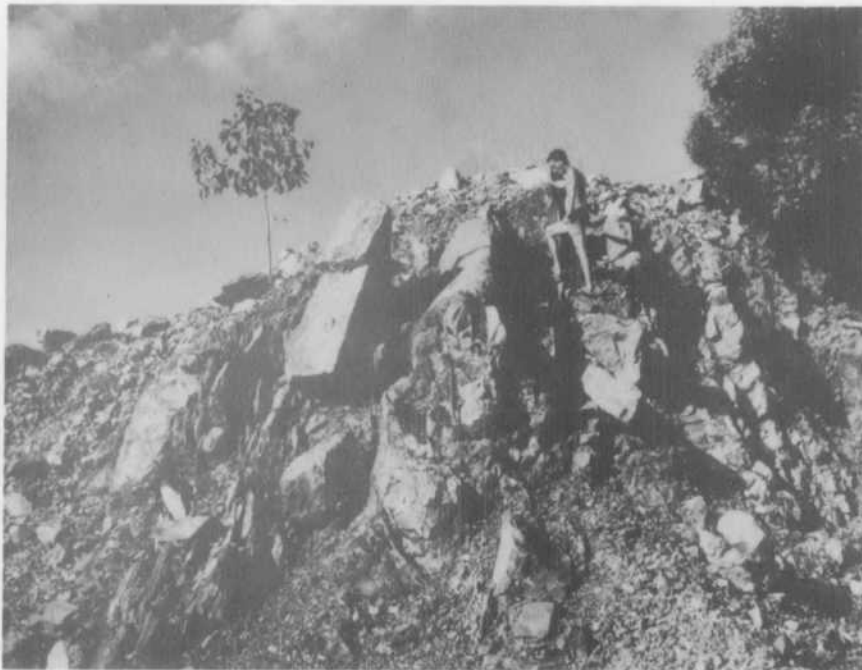
Fig. 2

Darwin River R.A.A.F. quarry. Interbeds of quartzite and schist have been folded into a tight anticlinal structure; the axis of the fold plunges 30°S.

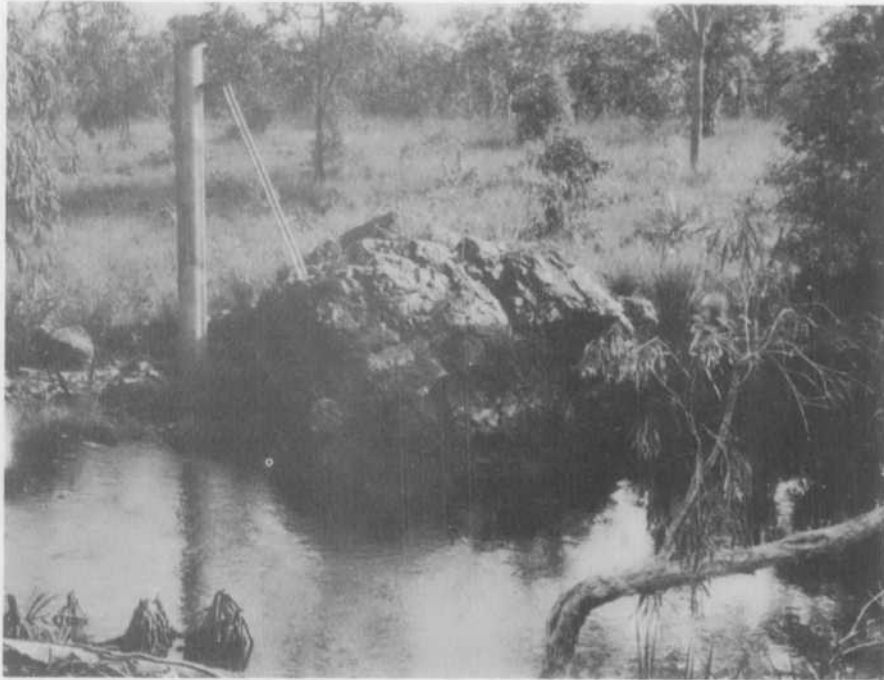
Fig. 1

Upper Pondage Site A - southern abutment. Sandstones of the Depot Creek Sandstone Member (?) have been silicified to a closely jointed pale pink orthoquartzite. Seismic evidence indicates deep weathering at the site.

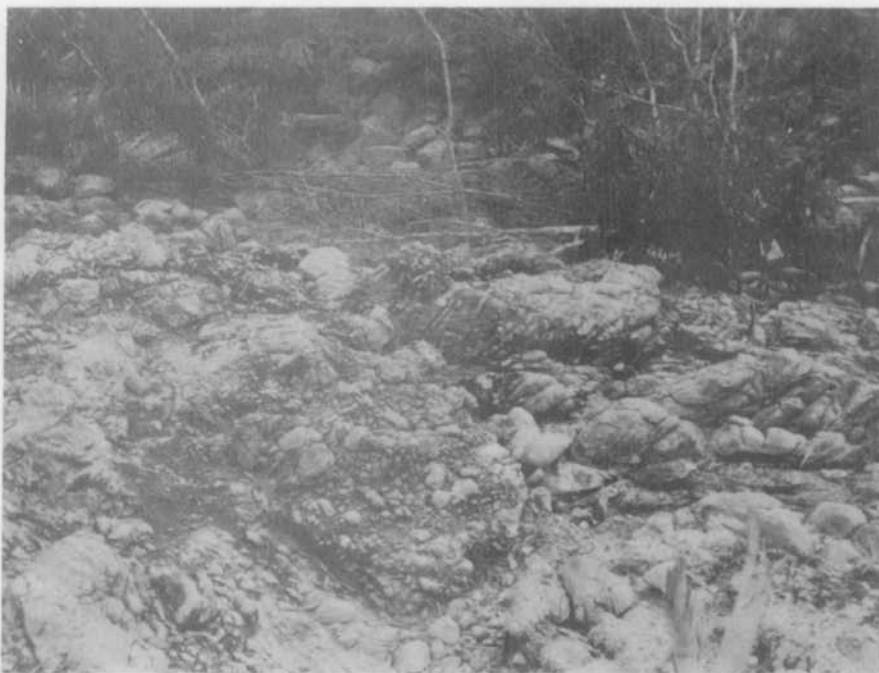
Fig. 2

Lower Pondage Site B - northern abutment. The Depot Creek Sandstone Member (?) strikes at 090° and dips at approximately 20° to the south. A lens of sandstone breccia can be seen in pale pink closely jointed sandstone.
