PRELIMINARY GEOLOGICAL INVESTIGATION OF STAPLETON CREEK
DAM SITE, NORTHERN TERRITORY, 1966.

Record 1967/133

In the course of an investigation into the development and control of the Adelaide River drainage system, Stapleton Creek has been suggested as a site for a 40-foot-high dam to control flooding and to impound water for irrigation. The site lies across the Stuart Highway, 67.2 miles south of Darwin; it extends from a low central knoll, east of the highway, across Stapleton Creek to the north-east, and across a low-lying flat to the west.

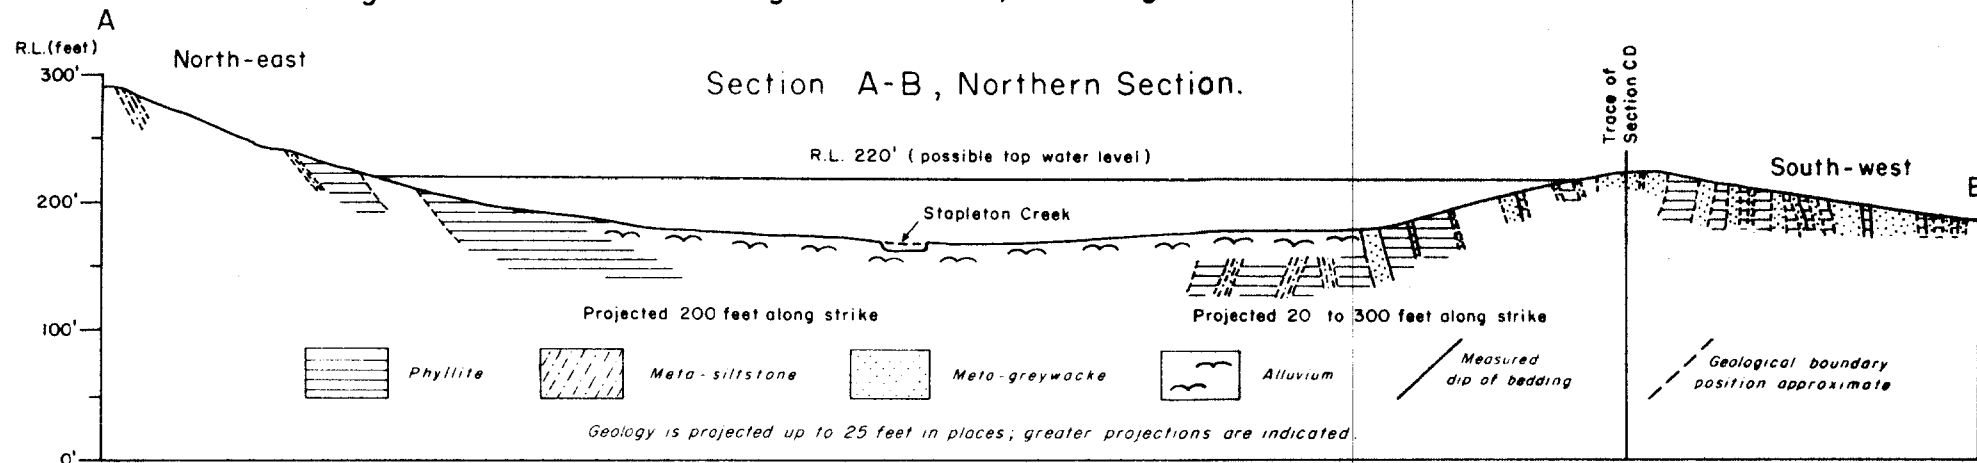
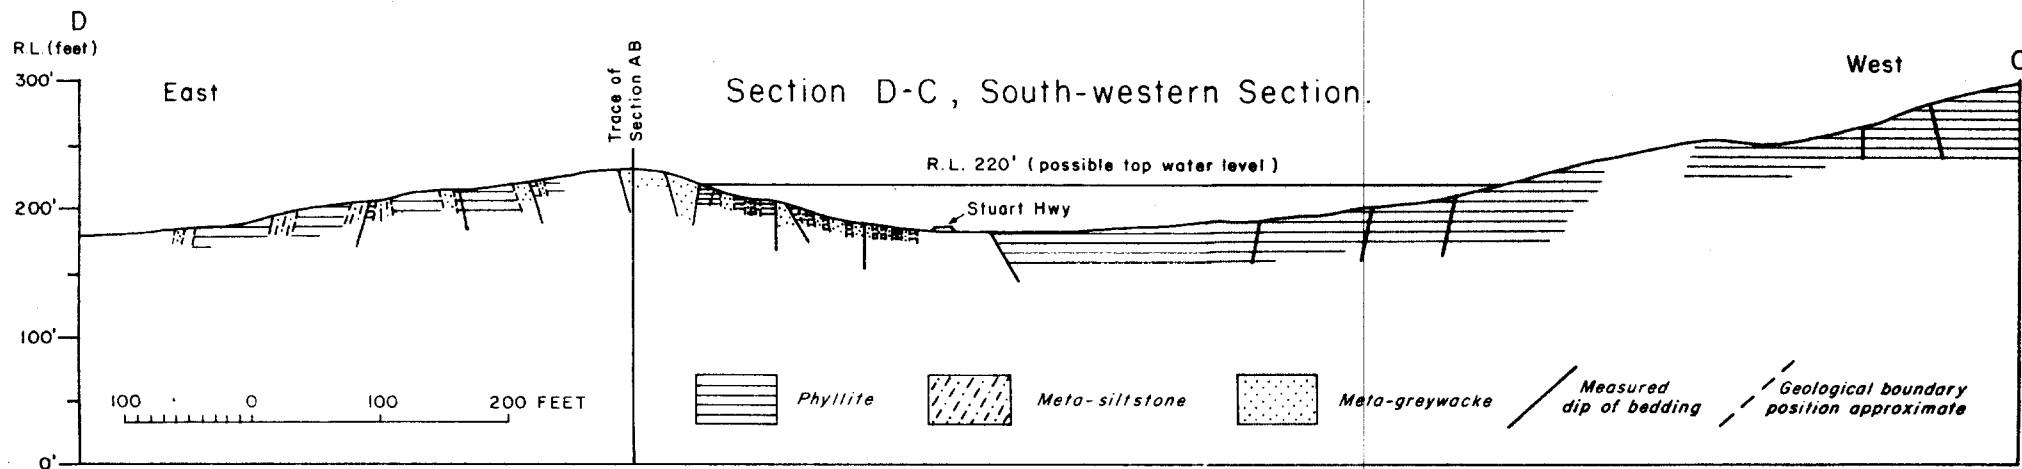
PLATE 5.

Geological Sections through Damsite, looking downstream (see Plate 4)
