Record No. 1969 / 24

The Kokopo (New Britain)
Earthquakes of the
14th August 1967

R.F. Heming

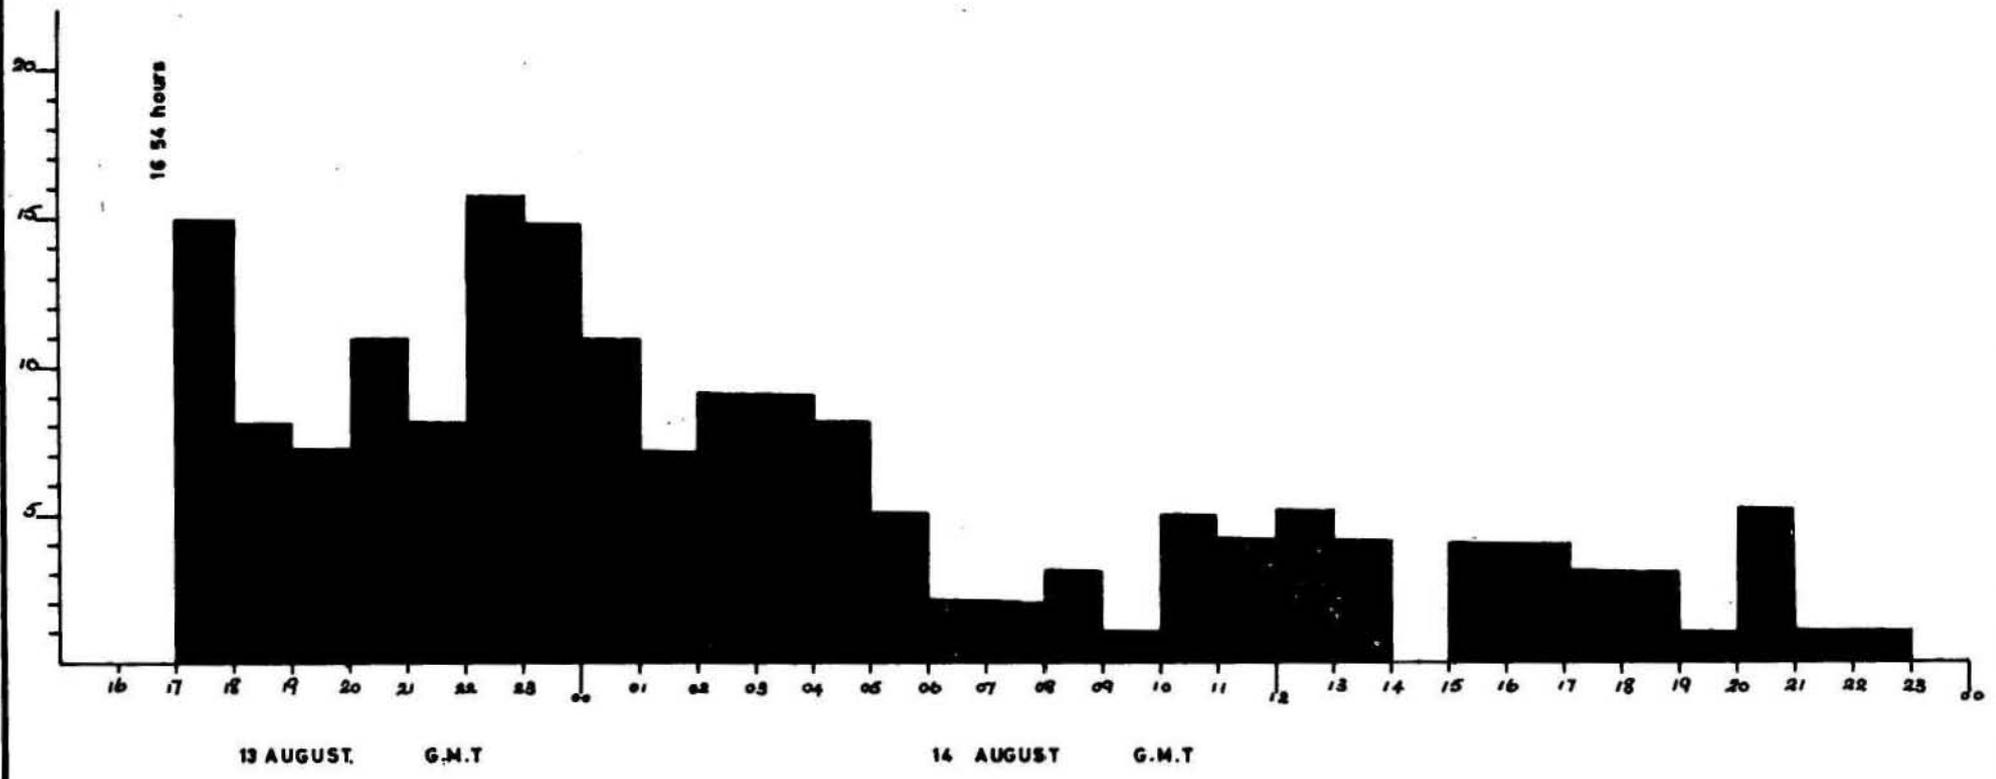
Fig 1.

NUMBER OF AFTERSHOCKS PER HOUR FOLLOWING THE EARTHQUAKE AT 1654 HOURS G.M.T. AUGUST 13, 1967.

No major earthquakes were felt after this, although numerous small ones were felt in the Kokopo district throughout the day. Aftershocks were recorded at Rabaul for over two weeks (see Figures 1 and 2).

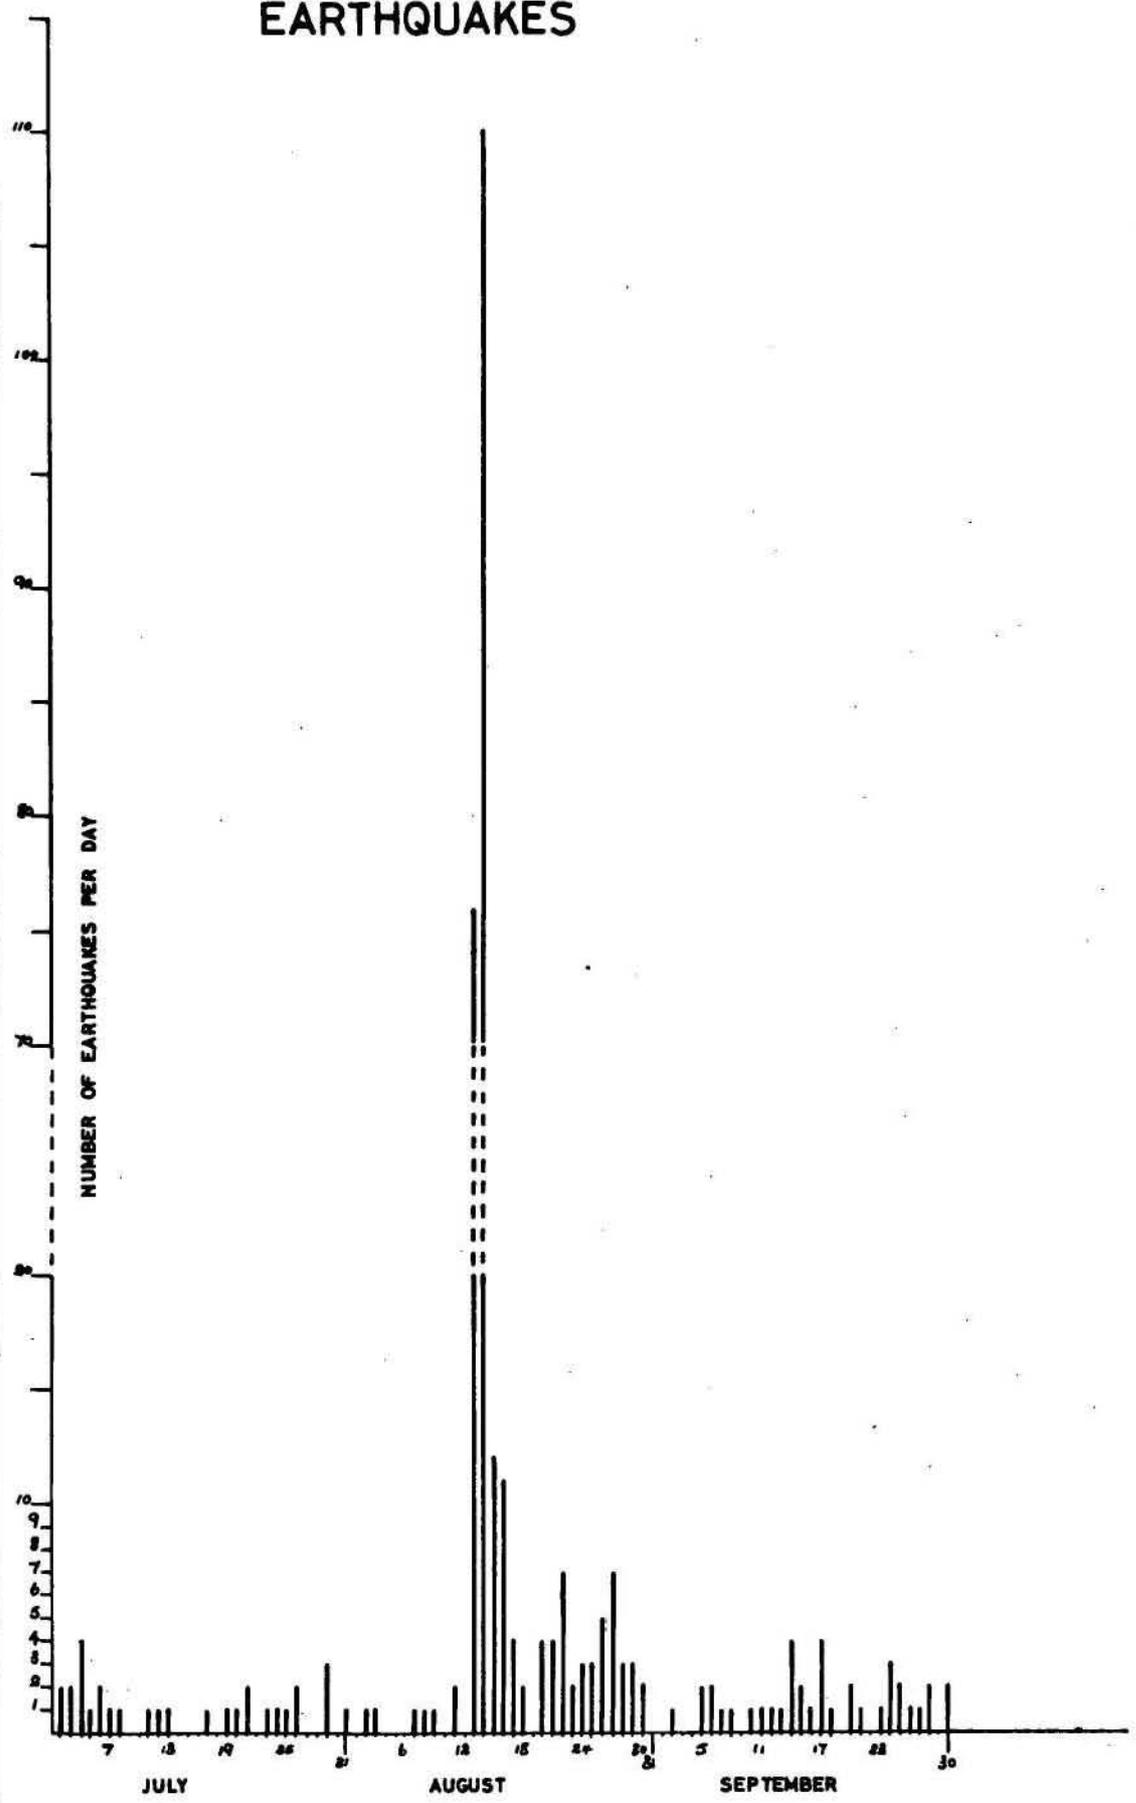
SEISMIC ACTIVITY WITHIN ONE DEGREE OF RABAUl BEFORE AND AFTER THE AUGUST EARTHQUAKES

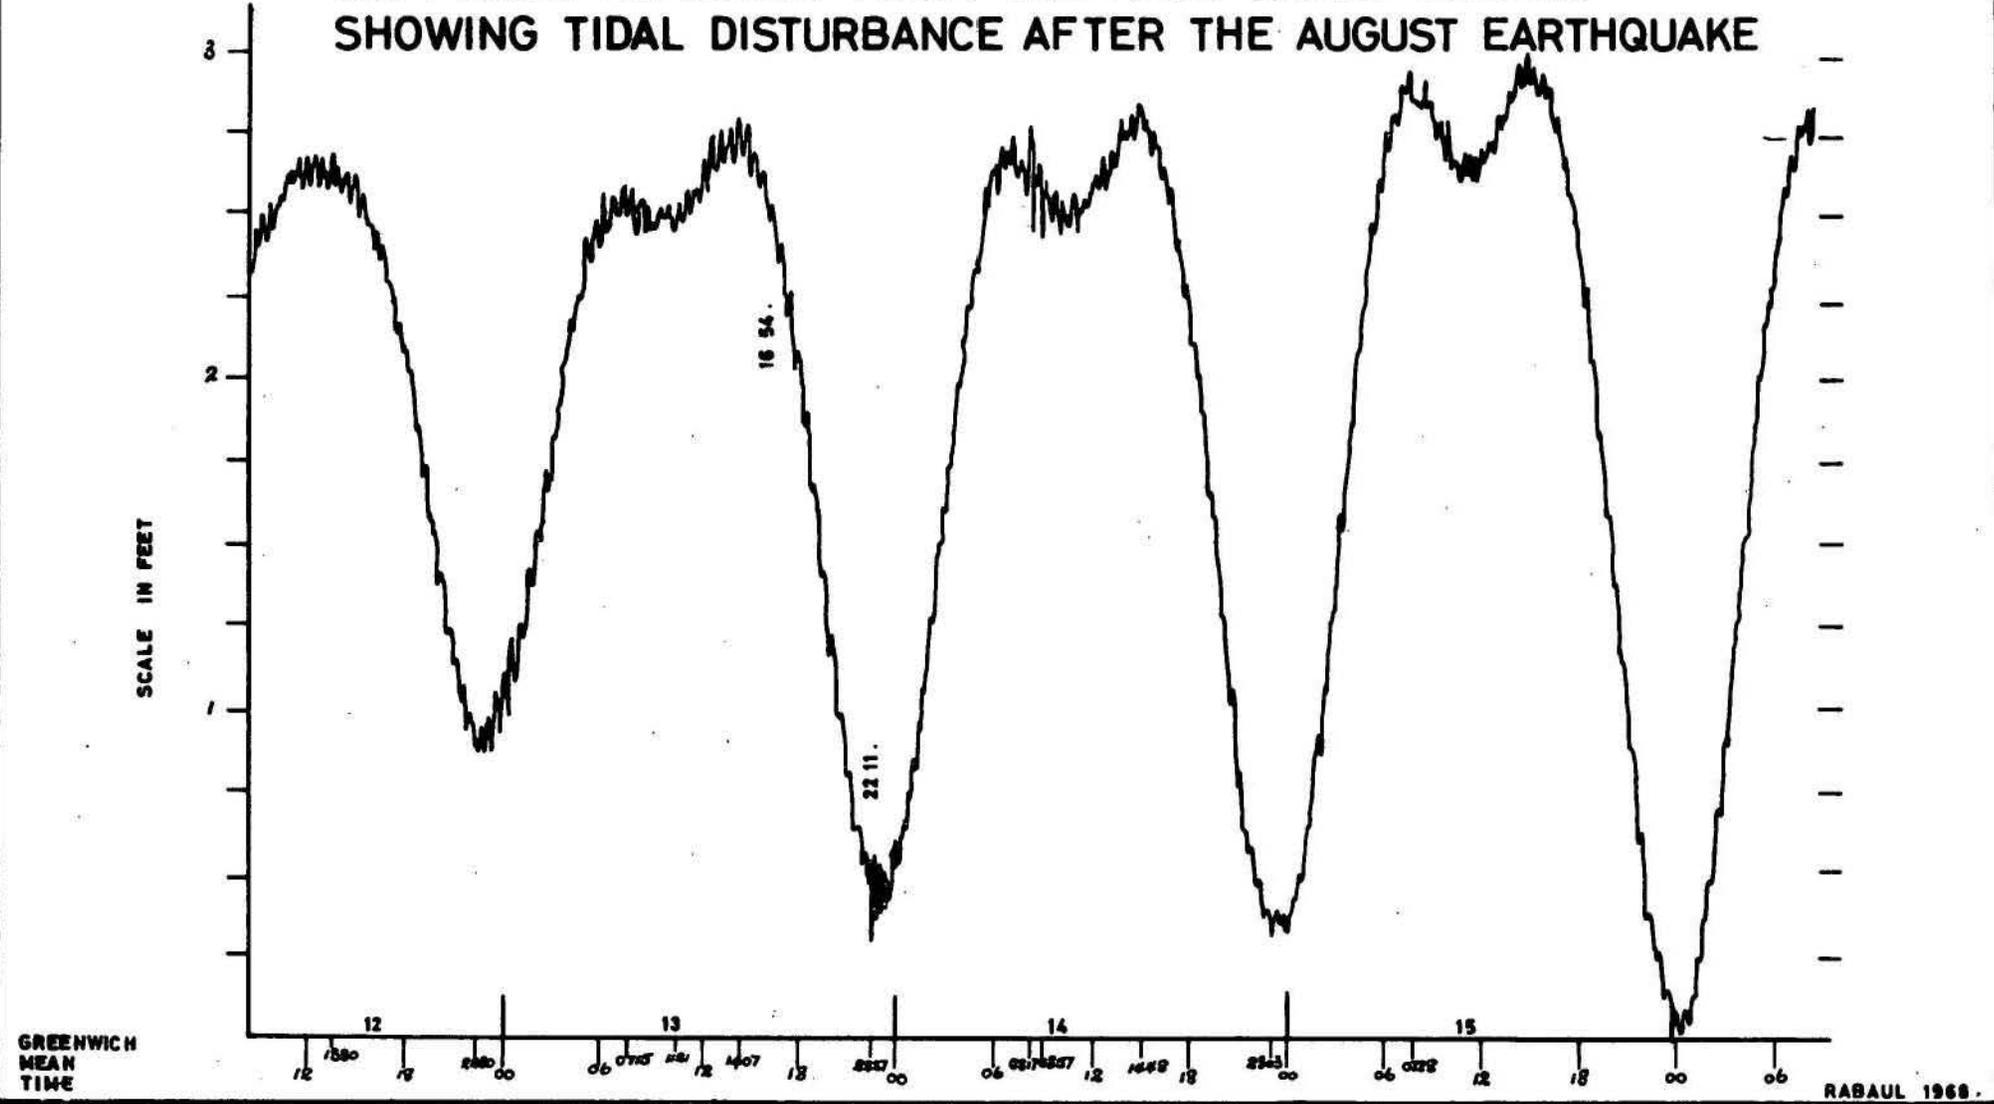
TIDE GAUGE RECORDS FROM THE MAIN WHARF RABUL SHOWING TIDAL DISTURBANCE AFTER THE AUGUST EARTHQUAKE

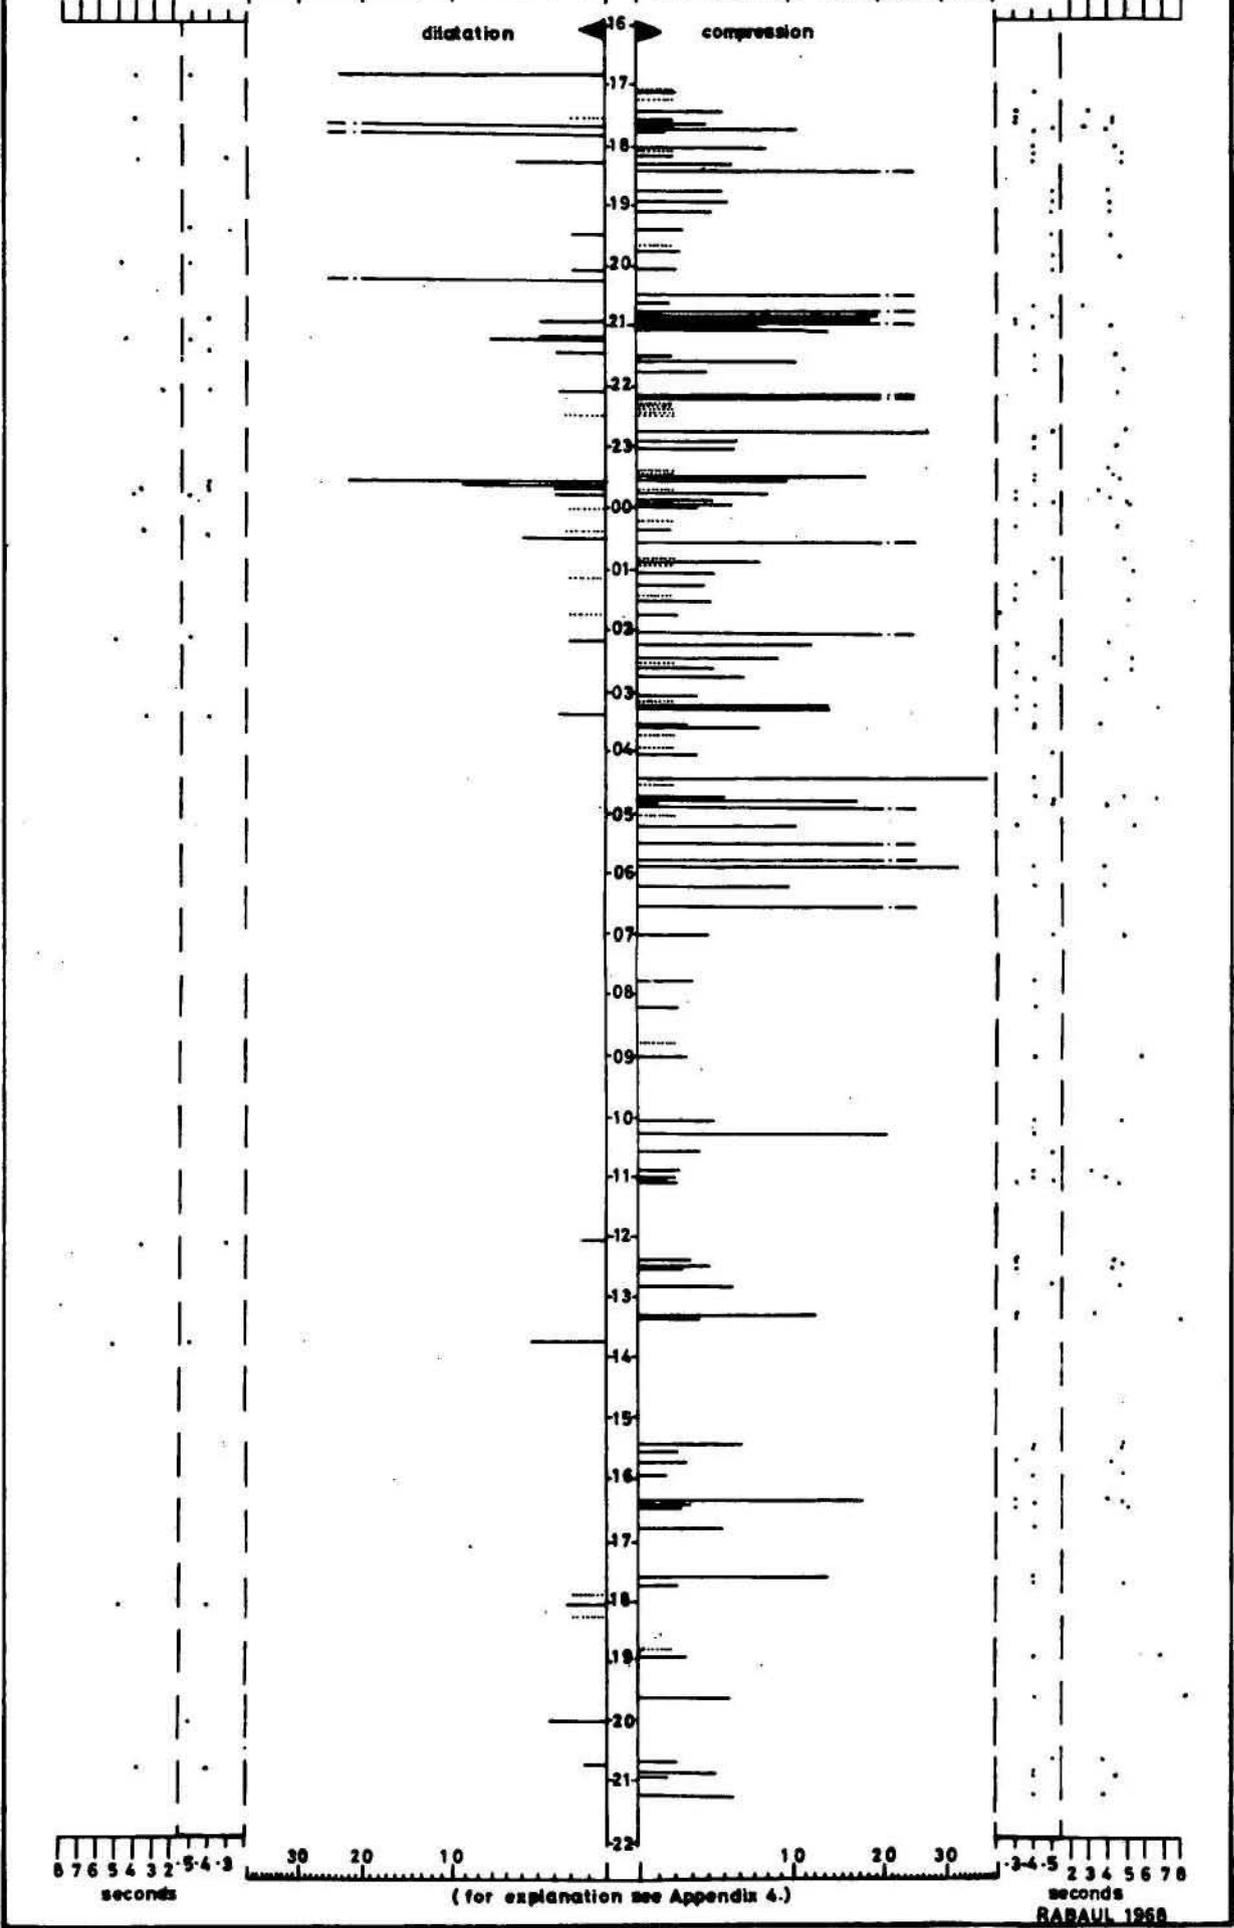
Fig. 4.

CHARACTERISTICS OF THE KOKOPO EARTHQUAKES

The first motion of each earthquake was found to be in the same sense at all of the Rabaul stations. Of the three major earthquakes only the 0254 hrs earthquake showed a dilatation: the other two showed compressions. Throughout the aftershock sequence, compressions outnumbered dilatations. Those earthquakes with dilatations rarely occurred singly, and were sometimes in groups of three. (Figure 4 and Appendix 4).

The S waves of the aftershocks were sharp events with amplitudes as much as ten times as great as the P waves and following them after an interval of from three to six seconds. Normally the period of the S waves was half a second. Typical aftershocks are shown in Plate 3, and a more detailed analysis of the characteristics of the Kokopo earthquakes is presented in Appendix 4 and Figure 4.

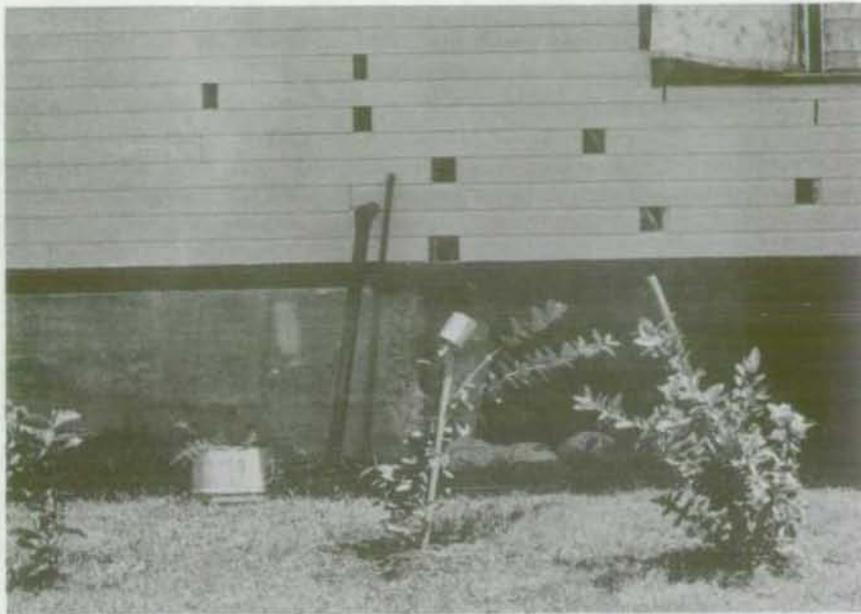
Plate 5: Damage to sister's house, Kabaleo

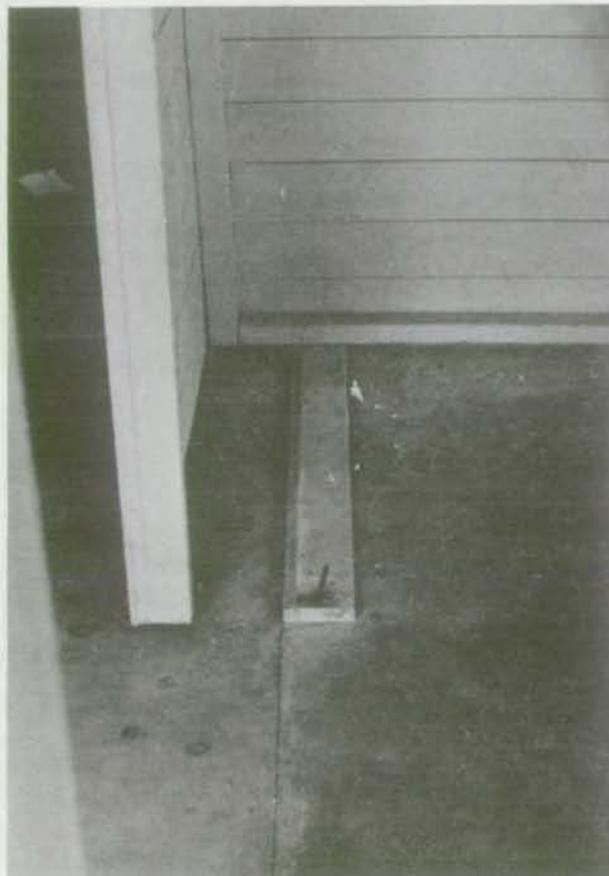
Plate 6: Detail showing how sister's house is held by concrete pier beneath rear wing.

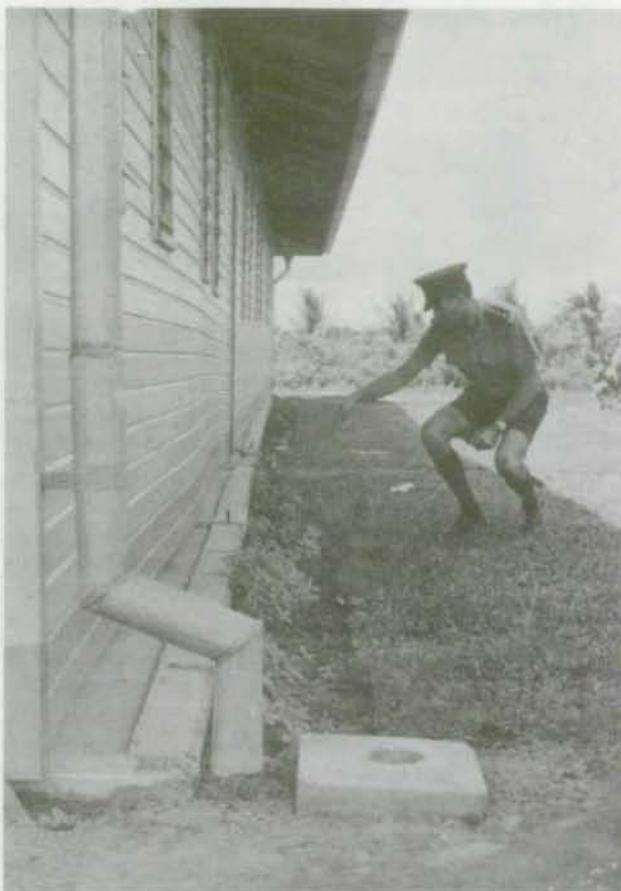
The Kabaleo Teacher Training College and Vunapau Seminary suffered considerable damage and reports indicated intensities in this area of M.M. VIII. The surrounding villages also suffered considerable damage. All the buildings at Kabaleo and Vunapau were of timber frame construction: some, such as the school classrooms, set on concrete slabs; the others built on concrete posts rising $2\frac{1}{2}$ feet above ground. The displacement of the majority of the buildings was northwards. A classroom at the northern end of the grounds, which was built up on concrete posts, showed evidence of $9\frac{1}{2}$ inches of movement with a residual displacement of $3\frac{1}{2}$ inches to the north. The Sisters' house (Plates 5 and 6) would have collapsed but for the anchoring effect of the large concrete base beneath the rear wing of the house. In all of the buildings with concrete slab foundations, the wooden stanchions jumped off their dowels and were moved as much as one foot from their original position (Plate 7) causing the buildings to be severely warped (Plate 8). Most of the dowels were only slightly bent unless they had been pulled out of the concrete, which would mean that the building was warped upwards as much as two or three inches before moving laterally.

Plate 7: Shifting of frame from foundations in dormitory block, Kabaleo. Note method of construction and fixing of frame to the foundation.

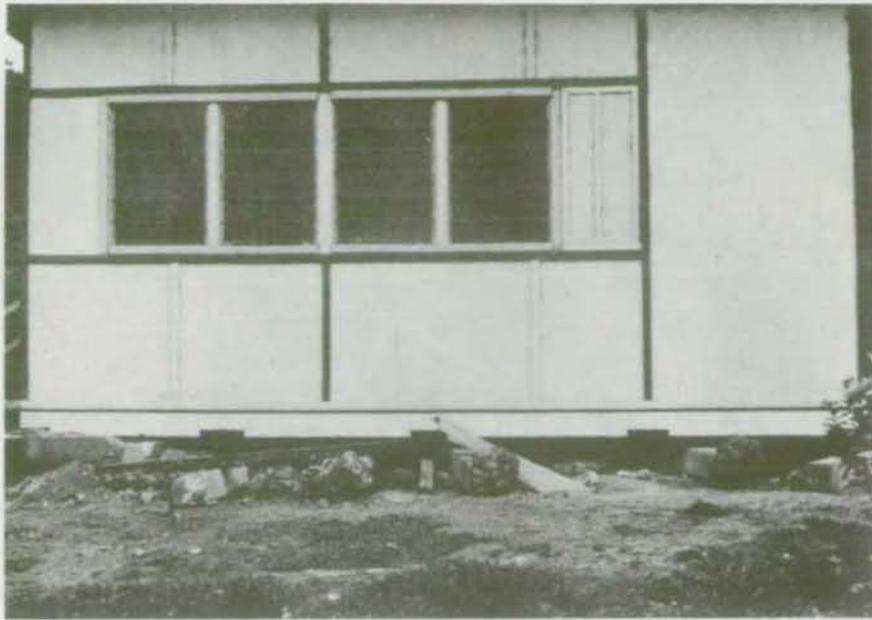
Plate 9: Collapse of village house, Livuan.

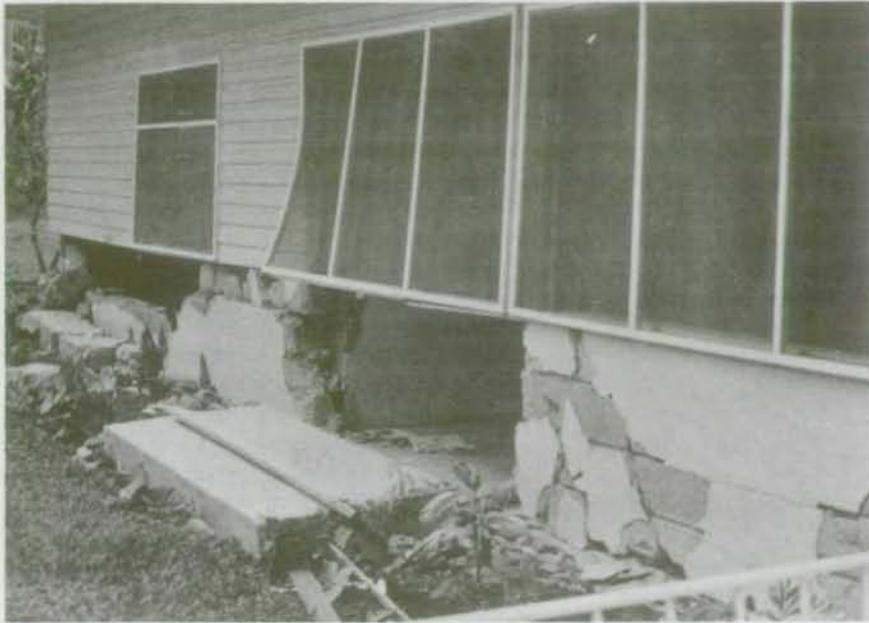
Much of the damage was to buildings of a unit type construction using stabilised earth or low quality concrete with insufficient reinforcement (Type 'D' masonry - see Plate 11).

Plate 11: Early stage in failure of concrete walls built
by unit method. Note the absence of reinforcing,
Makurapau.

The damaged buildings were inspected by a number of engineers who pointed out many weak points in their construction. Mr. R.I. Skinner, Engineer Seismologist from the New Zealand Department of Scientific and Industrial Research, made a number of suggestions regarding building design which would result in more earthquake resistant buildings (Skinner & Denham 1967). The most common causes of damage were inadequate bracing in the building and poor foundations with minimal reinforcement. A lot of concrete work was also of poor quality.

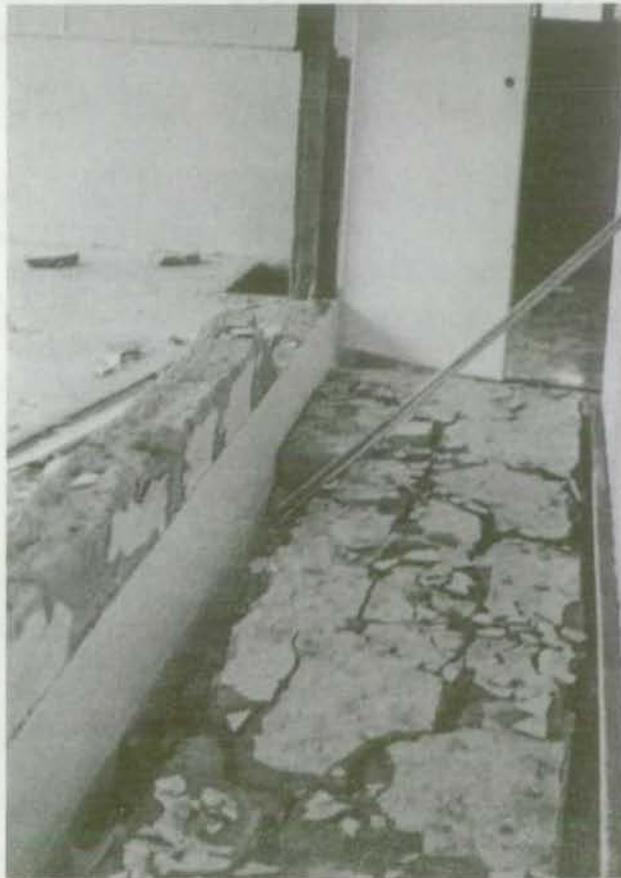
At Rainau Plantation, one house which was being constructed on concrete slabs collapsed like a house of cards because of the lack of reinforcement between the slabs. Another residence on the same plantation was severely damaged (Plates 12 and 13) and was eventually demolished. At Makurapau, where a similar type of construction was used, one labourer's quarters collapsed spectacularly (Plate 14). The walls failed completely allowing the very heavy roof to collapse, demolishing what remained of the walls almost to their foundations. An engine house nearby shows an early stage in the failure of this type of construction. (Plate 11). The plantation house at Makurapau was supported on piers made of shell cases filled with cement and set in the ground within a concrete base. Most of the bases remained firm, but some had moved east or west of their original positions and others which were resting on a concrete pavement were rotated clockwise through 30°.

Plate 12: Collapse of concrete walls in half
timbered building, Rainau.
