DEPARTMENT OF  
MINERALS AND ENERGY

# BUREAU OF MINERAL RESOURCES, GEOLOGY AND GEOPHYSICS

Record 1973/35

GEOLOGY OF THE CAPITAL HILL AREA,  
CANBERRA, A.C.T.

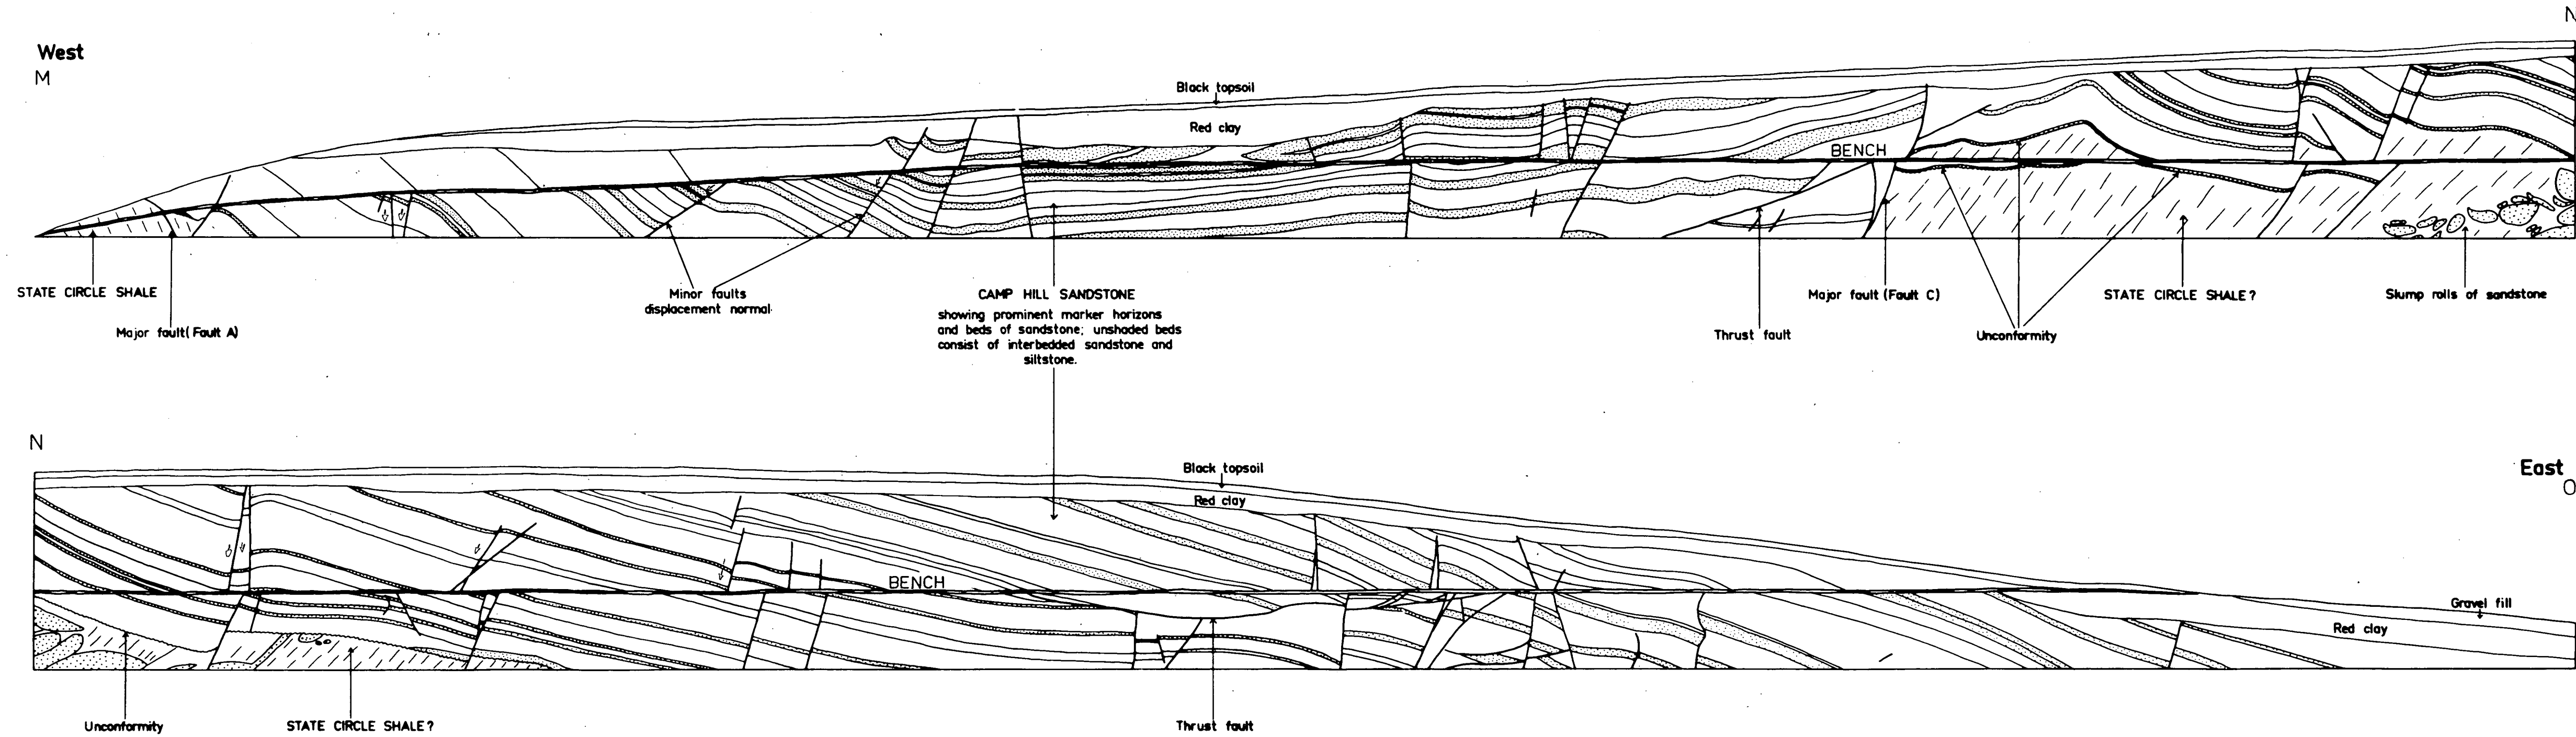
# GEOLOGY OF CUTTING IN STATE CIRCLE

← CAMP HILL SANDSTONE | BLACK MOUNTAIN SANDSTONE and STATE CIRCLE SHALE →

The deepening of the cutting in State Circle increased the exposure of the Camp Hill Sandstone and created a new exposure of the unconformity (Plate 3). Beneath the unconformity is a shale and mudstone formation containing slumped sandstone, which is probably part of the State Circle Shale. This further suggests that the State Circle Shale does not overlie the Camp Hill Sandstone as was concluded by Opik.

Fault C was seen in the sewer tunnel beneath Queen Victoria Terrace and is also visible in the main cutting in State Circle (Plate 3). It is a normal fault dipping at about  $75^{\circ}$  to the northwest; the downthrow is on the north-western side. The displacement is estimated to be about 30 m.

A number of minor faults of small displacement were exposed in Capital Circle and State Circle (Plates 2 and 3), and those not hidden behind the concrete facing are still visible. The commonest direction of strike is north to northeast. Where displacements can be seen they are generally less than 1 m; however, some show displacements of as much as 5 m and possibly more. Most of the faults dip at angles steeper than  $50^{\circ}$  and are normal, but there are a few reverse faults. There are two low-angle thrust faults in the State Circle cutting, one near fault C and the other towards the eastern end of the cutting. Similar faults were observed in the Black Mountain Sandstone and State Circle Shale in the Capital Circle cutting; they dip to the west or northwest. Most of the minor faults contain little crushed rock, although some show slight drag of the adjacent beds. A large quartz reef in the southeast part of the Capital Circle cutting may represent a fault; no displacement is evident. *thrusts?*
