Record 1973/184

DARWIN SECOND STEAM POWER STATION  
STAGE 1 - SITE INVESTIGATION  
REPORT OF FIELD VISIT 5-10 AUGUST 1973

# DARWIN SECOND POWER STATION QUARANTINE ISLAND SITE

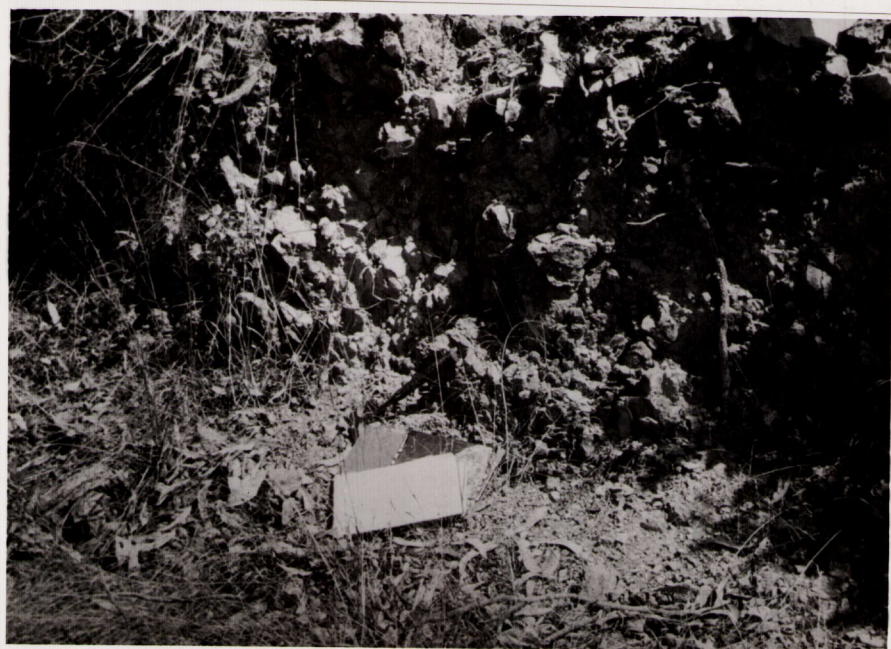
The quartz sandstone is slightly weathered in outcrop, but where covered by topsoil it is moderately to highly weathered. Near the proposed drill hole 20 (Plate 1) a shallow cut had been made into the side of the hill exposing up to 1.2 m of red-brown quartz sandstone beneath approximately 0.3 m of skeletal topsoil (site h). Here the sandstone is fine to medium-grained,

highly weathered, and strongly and irregularly fractured. The irregularity of the fractures is mainly attributable to tree roots (see photograph 2).

Photograph 2 (D52/4/108)  
Costean near proposed drill hole 20F, showing  
highly weathered sandstone of Mullaman Beds

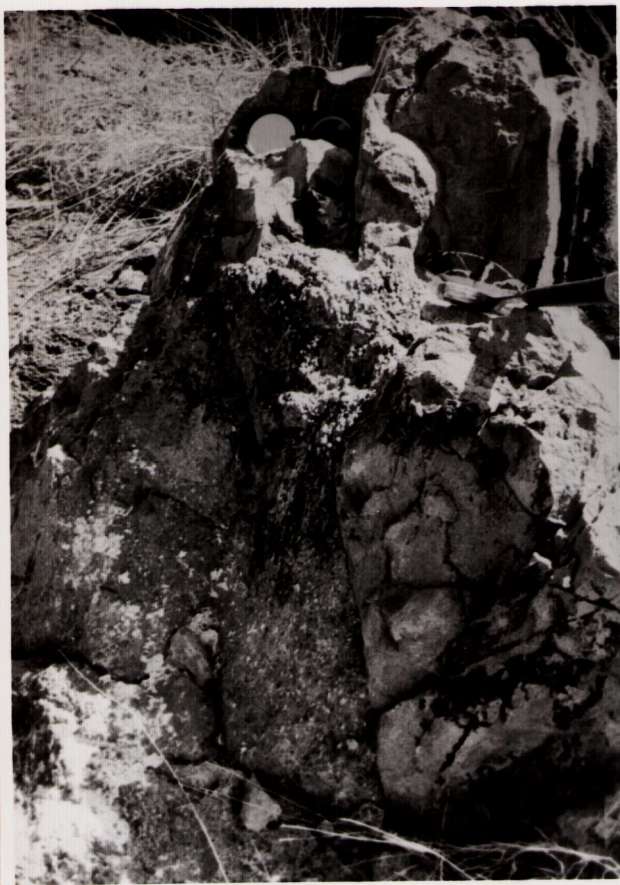
The underlying conglomeratic sandstone was only visible at locality d (see photograph 3) giving the appearance of a faulted contact between the conglomerate and the overlying sandstone; however there was no indication of the amount of movement. In the core of Hole 24F the contact between the two sandstones was sharp, but showed no evidence of an unconformity (Photograph 6).

No surface evidence of major faulting was discovered either from aerial photograph interpretation or from surface mapping. A minor fault was noted at outcrop d (see Photograph 3) but the amount of movement was not determinable.

Photograph 3 (D52/4/109)  
Outcrop at locality d (see  
text) - shows faulted contact  
between medium-grained  
sandstone and conglomeratic  
sandstone

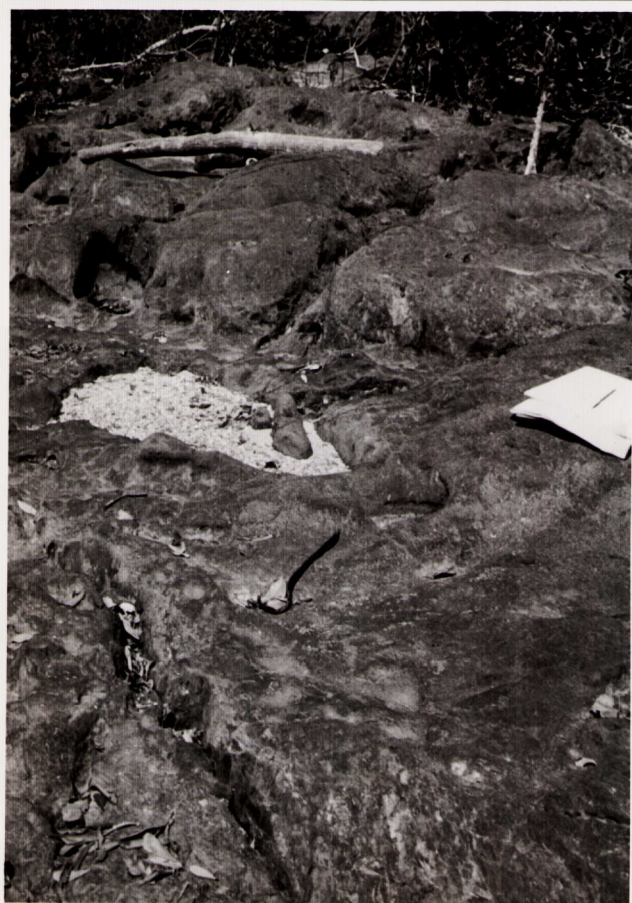
The two outcrops of siltstone show evidence of metamorphism to phyllite; at outcrop f (see Pl. 1) the phyllite had been worn into a wave-cut platform (see Photograph 4); it was highly weathered and very soft, and bedding was not discernible. At outcrop I (see Pl. 1) the phyllite outcrop was above the main highwater mark but was strongly contorted; once more bedding was not discernible. At both outcrops the phyllite was highly weathered and soft and no structural data on S planes were measurable; some bands had been completely weathered to clay, and some bands of fine-grained sandstone were generally moderately weathered.

Photograph 4 (D52/4/110)  
Outcrop at locality f (see  
text) - showing wavecut  
platform in completely  
weathered phyllite of the  
Noltenius Formation

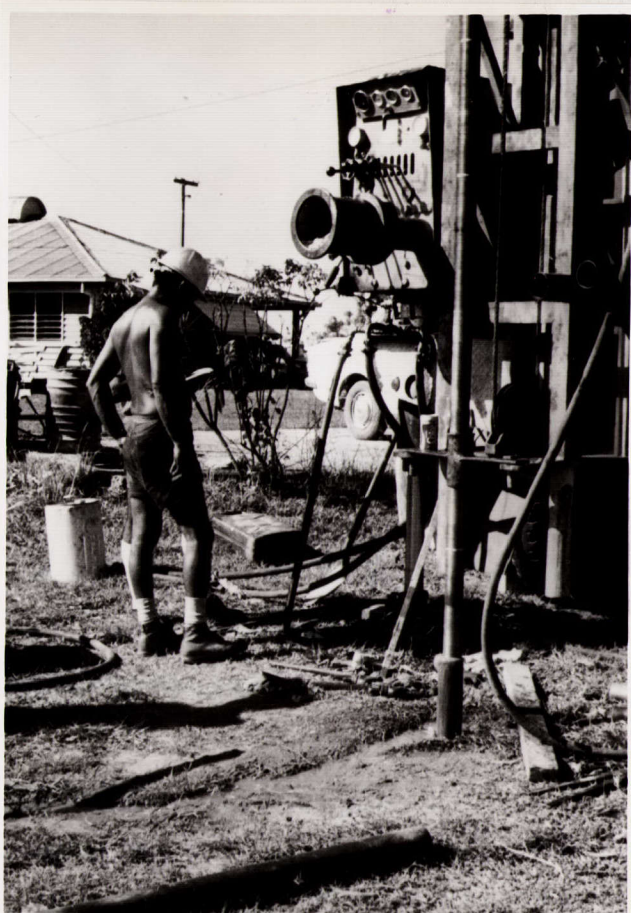
Photograph 5 (D52/4/111)  
Drilling in progress at  
Hole 24F,  
Drilling rig is a Fox Mobile

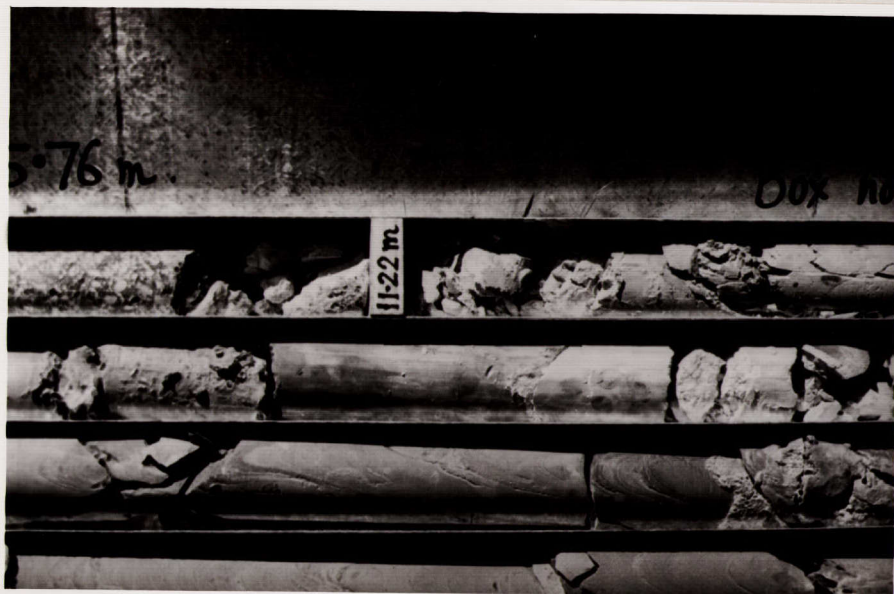
Photograph 9 (D52/4/115)  
Close-up of contact between conglomeratic sandstone and micaceous siltstone. Note complete weathering to a white clay, and other joints completely weathered to clay

2. The method of logging drill cores showed some weaknesses in methodology. There was no reference to strength (estimated) nor was there any fracture log, and the method of describing the varying degrees of weathering was inadequate. Core losses were not being shown in the core trays by the insertion of wooden blocks and a false impression of core recovery was being obtained (see photographs 6 to 12).

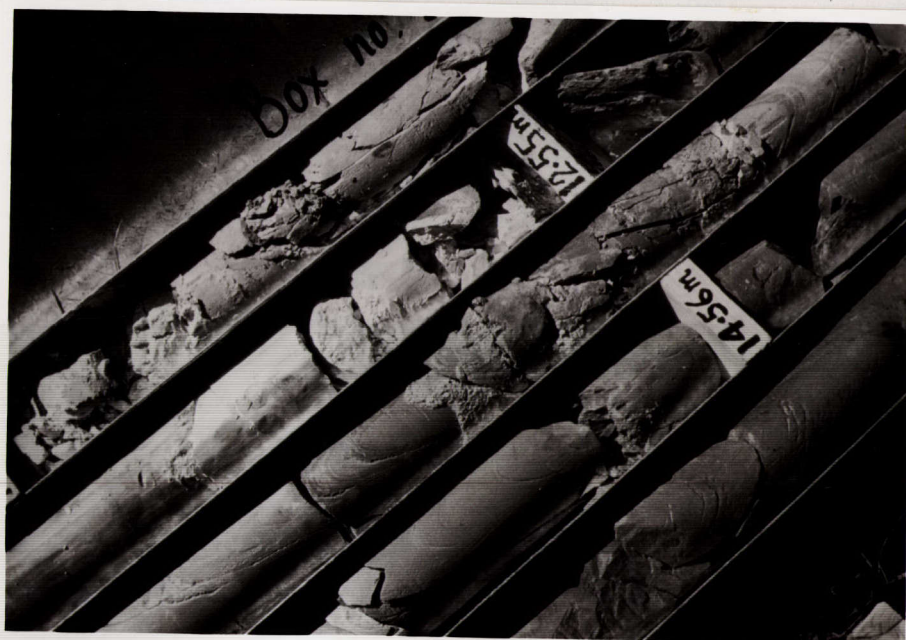
Photograph 10 (D52/4/116)  
Close-up of micaceous siltstone  
Note steep bedding and highly to completely weathered state of the siltstone

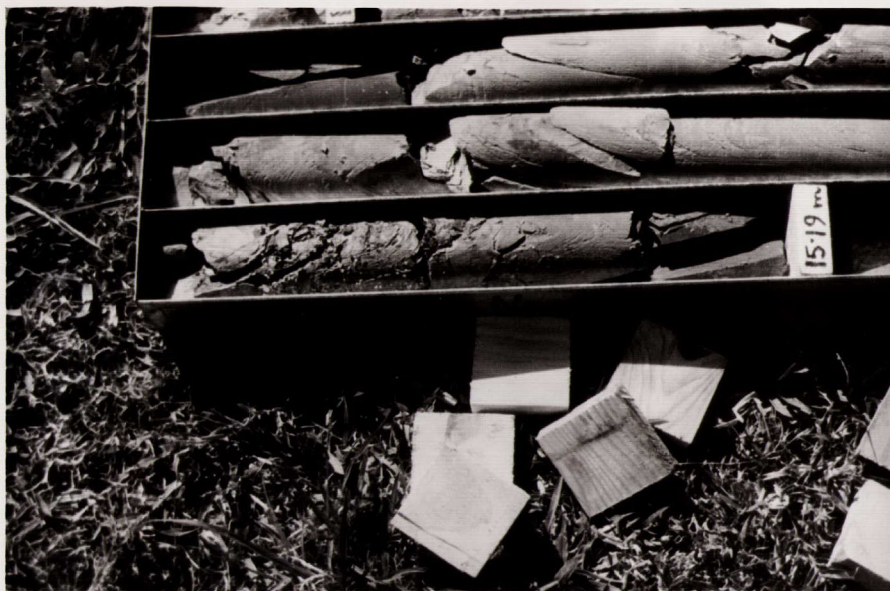
Photograph 11 (D52/4/117)  
Close-up of shear zone in highly weathered micaceous  
siltstone

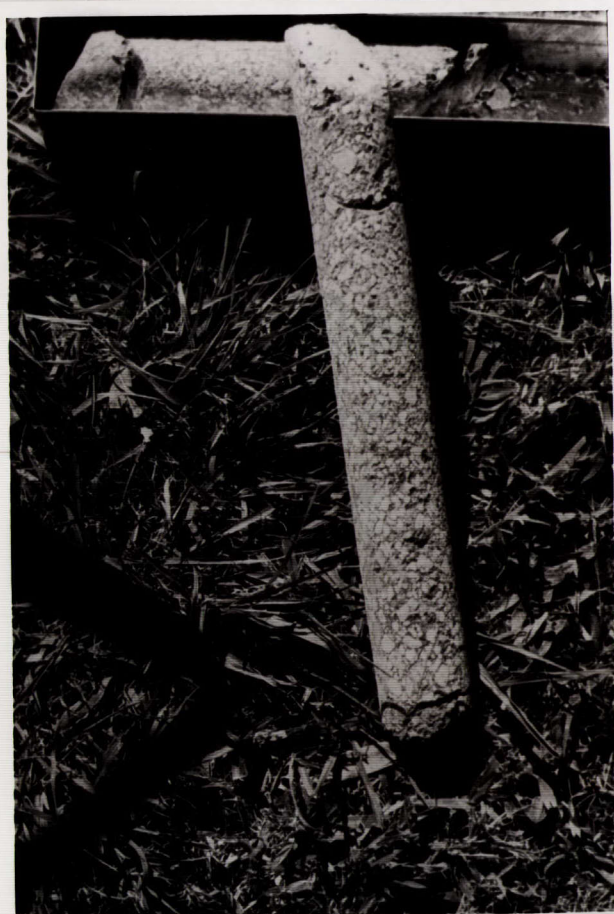
Photograph 12 (D52/4/118)  
Close-up of sample of  
core of coarse-grained  
conglomeratic sandstone

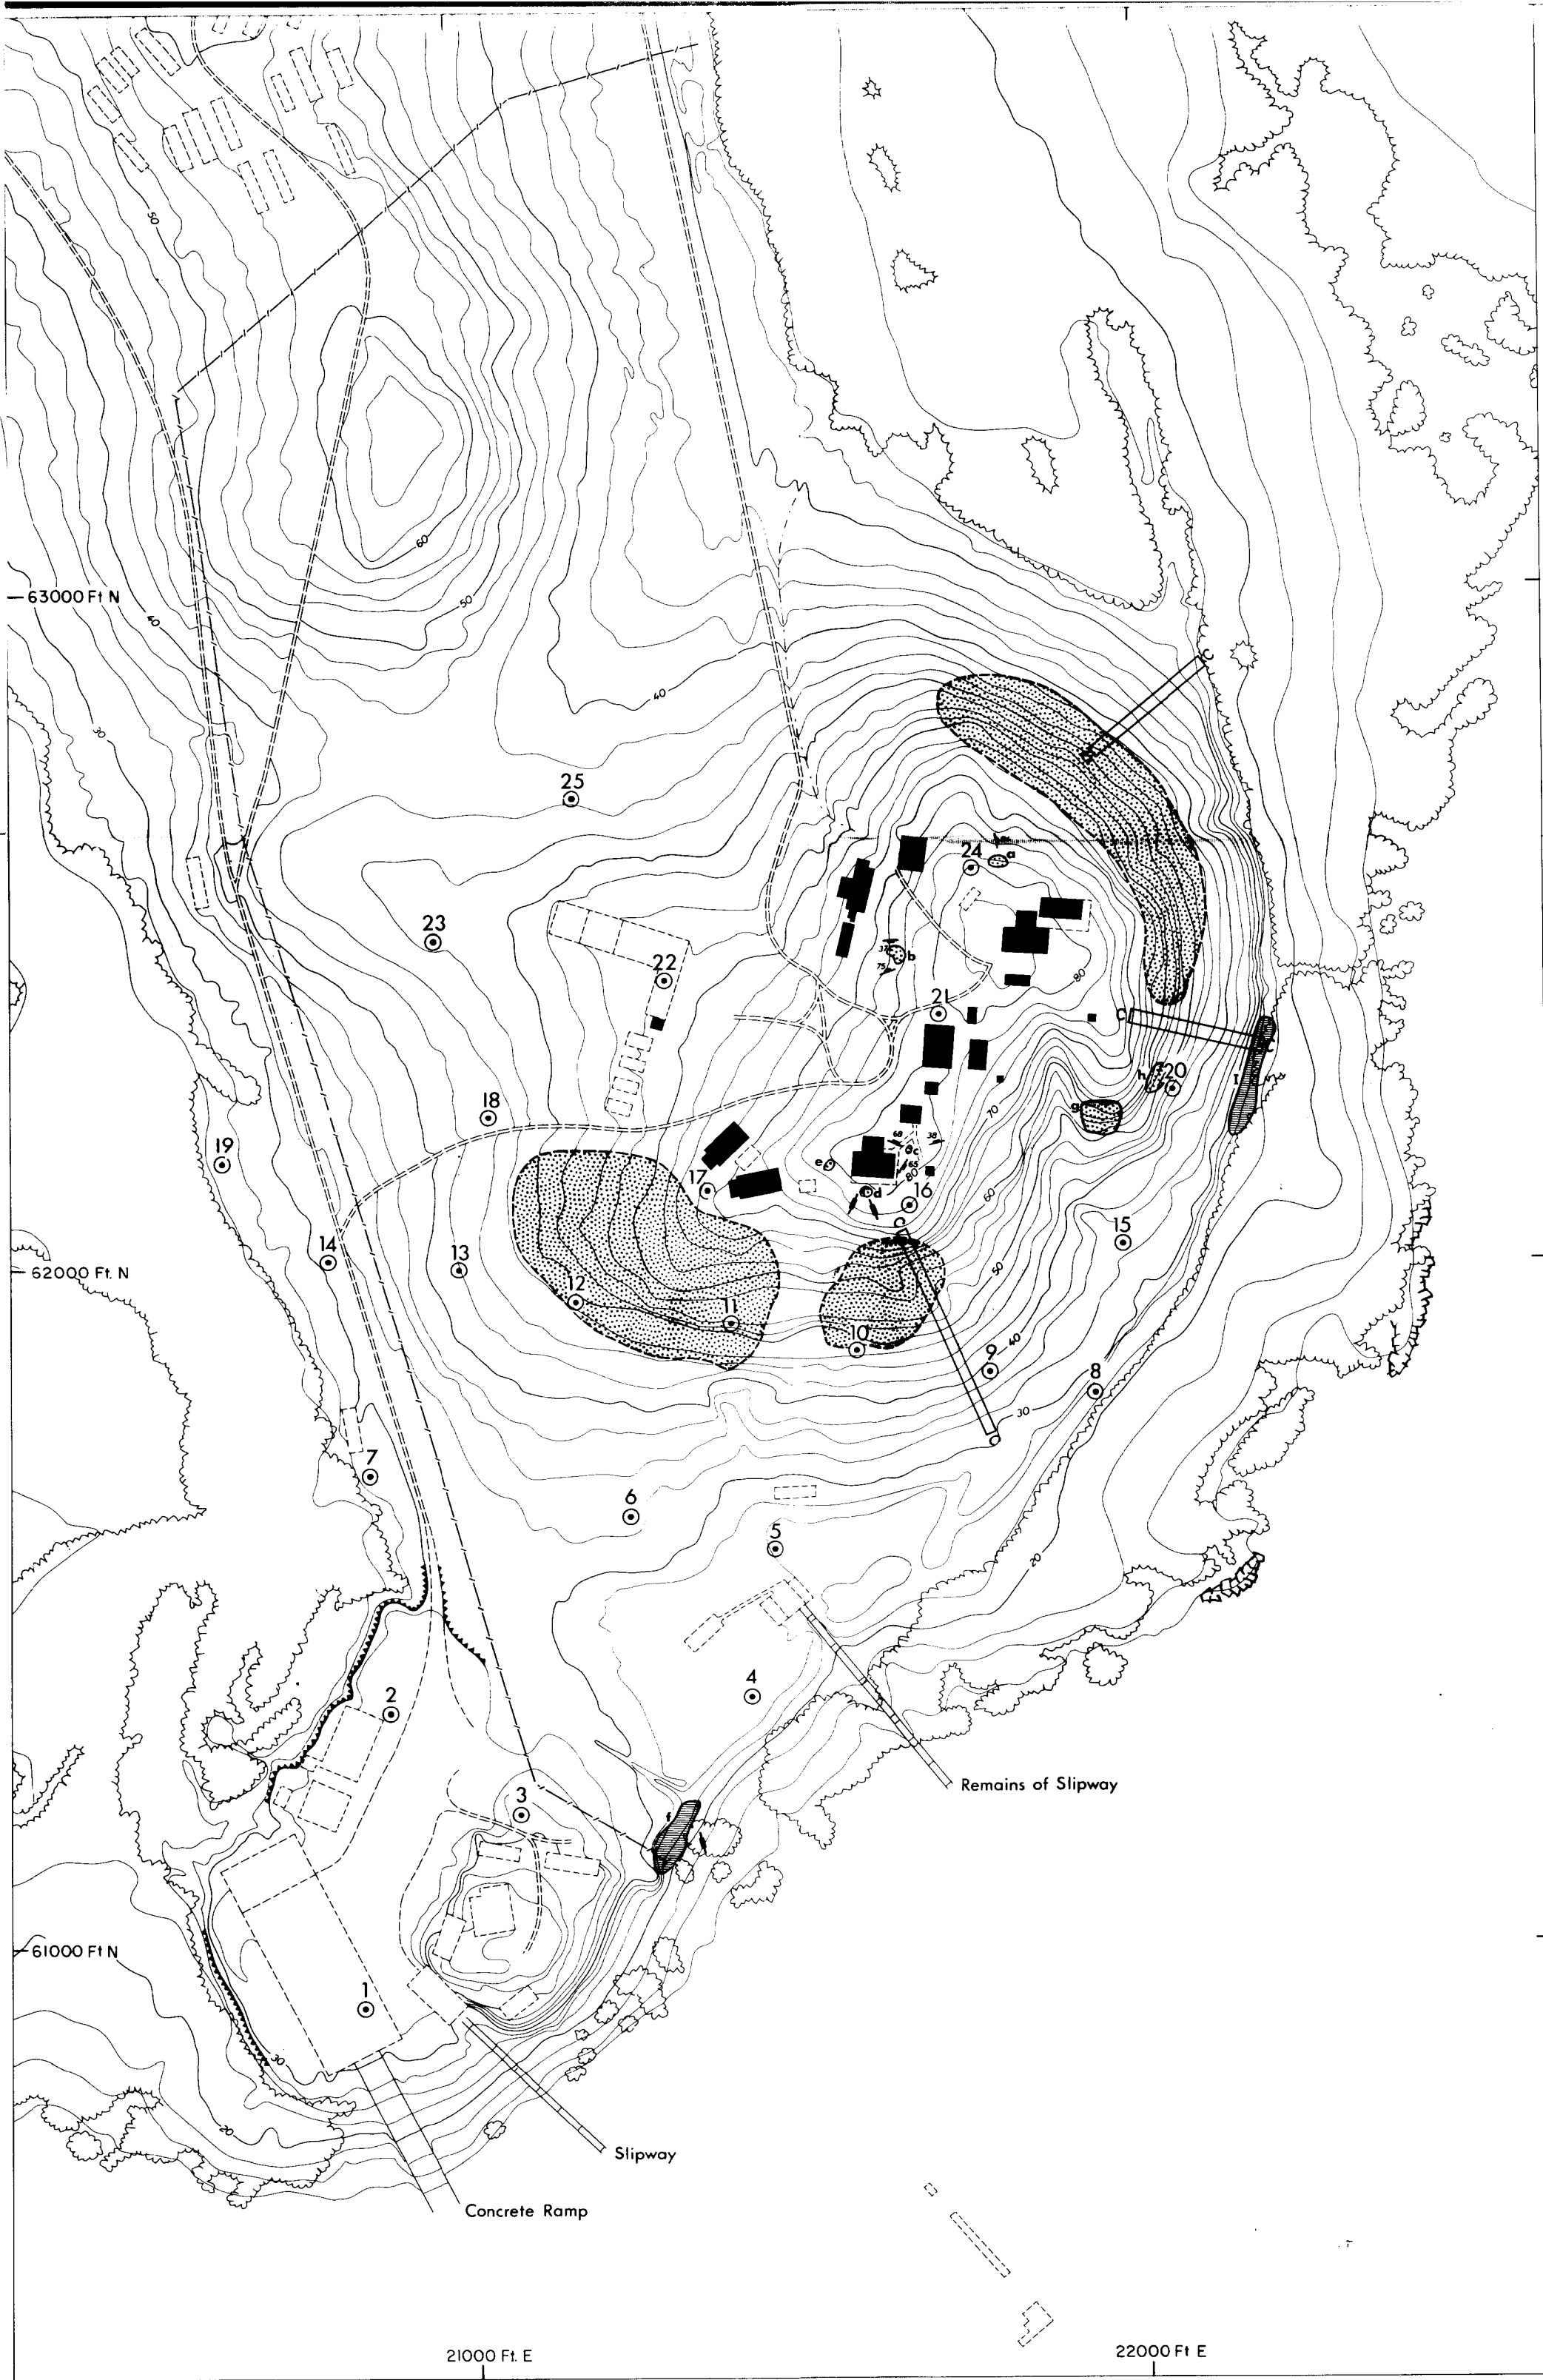
TITLE **QUARANTINE ISLAND — GEOLOGY AND  
DRILL HOLE LOCATION**

The few outcrops in the immediate site area are shown on Plate 1. The first drill hole was in progress at the time of the site investigation.

Three major rock units were mapped at the site; these are a sub-horizontal fine to medium grained quartz sandstone conformably overlying a conglomeratic sandstone, which in turn unconformably overlies a micaceous siltstone. The latter formation grades to a phyllite with depth.

3. Two and possibly three costeans should be excavated in order to obtain more detailed information on the succession in the area. The locations of these costeans are shown on Plate 1. There is no particular order of preference.
