RECORD 1975/57

QUARRY SITE INVESTIGATION AT CAPTAINS FLAT

NEW SOUTH WALES 1974

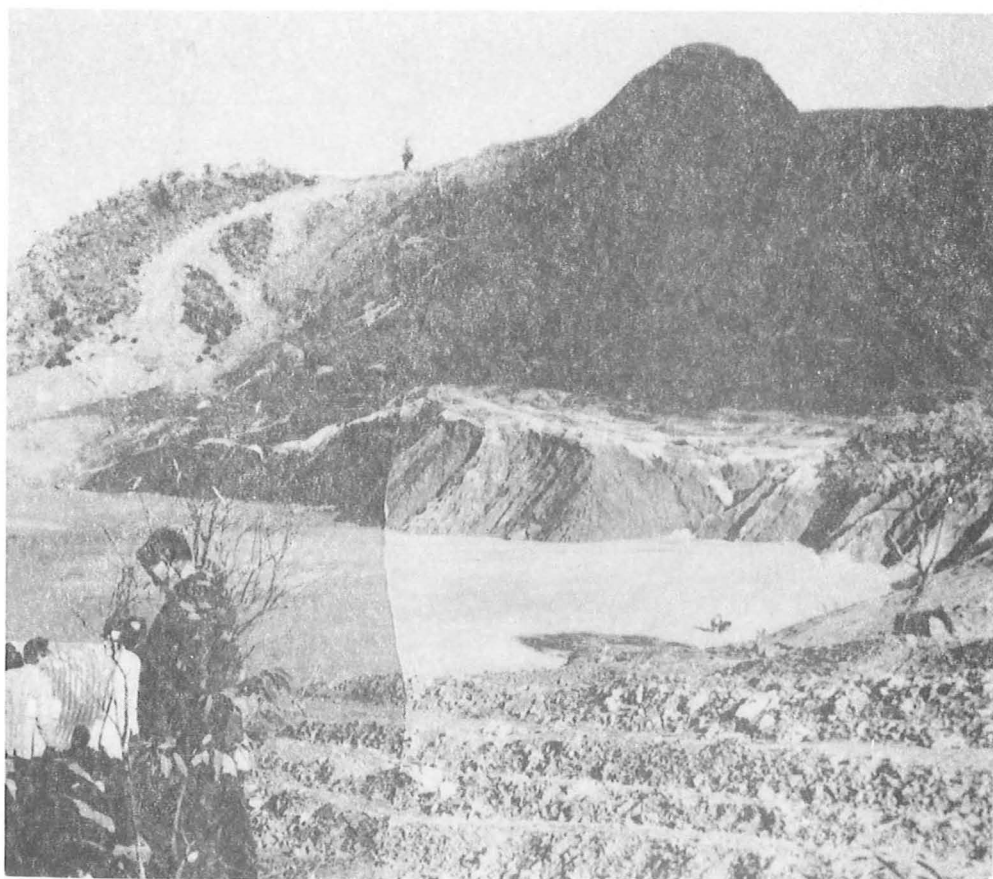
FIGURE 1

TAILINGS DUMP AT CAPTAINS FLAT

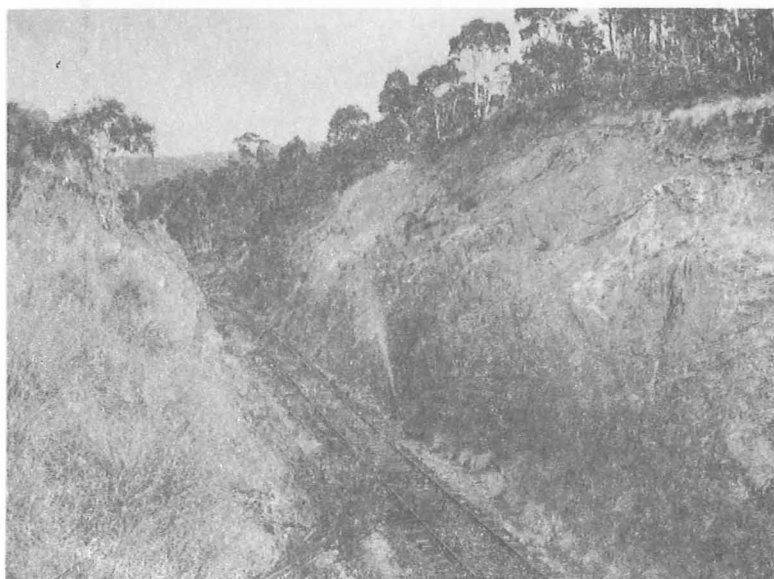
FIGURE 2

METAVOLCANIC ROCKS EXPOSED IN RAILWAY-CUTTING

(Quarry Site 2)

Sufficient reserves are probably available in both sites 2 (Fig.2) and 6, which would have to be opened as quarries for the reclamation project; this, however, would destroy grazing land and create an additional scar on the landscape. Both sites are believed to be on freehold land. The haulage to the works area would be longer from site 2 than from site 6. However, site 6 has the disadvantage that it is adjacent to the main road, and quarrying operations would affect the road traffic.

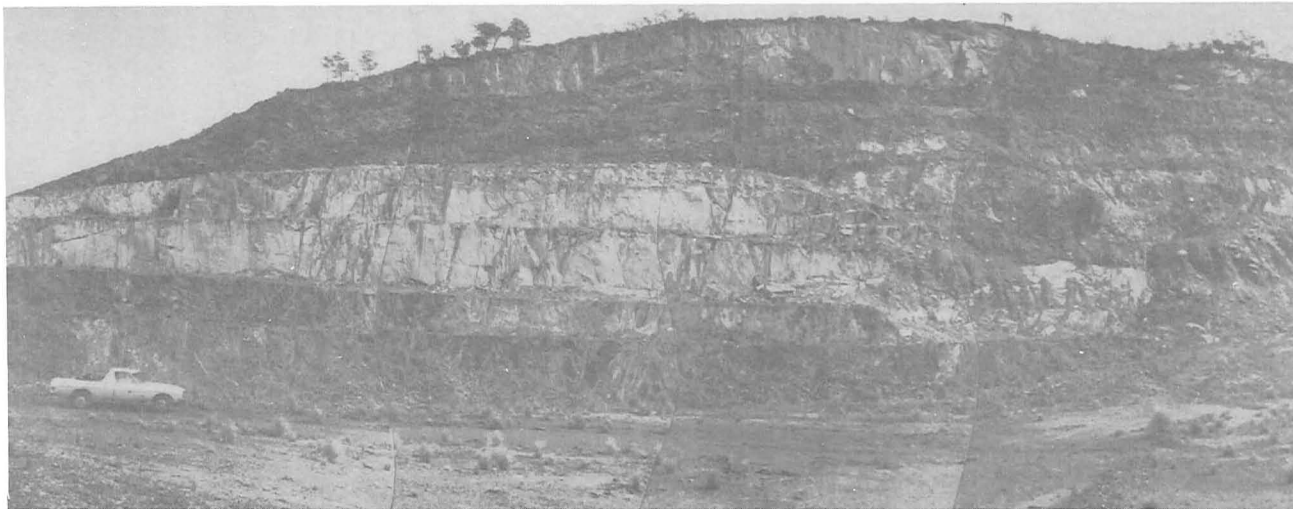
FIGURE 4

NORTH QUARRY, CAPTAINS FLAT (Quarry site 1)

Site 1 is the North Quarry, which was originally worked for material to backfill mine workings. The quarry has sufficient reserves but is of mixed lithology with varying degrees of weathering; an appreciable proportion of fines is to be expected. The quarry (Fig.4) is conveniently sited in the project area and re-opening it would be more desirable environmentally than opening a new quarry elsewhere. Quarry operations would be close to the Captains Flat hotel and other buildings.
