Record 1975/93

URBAN GEOLOGY OF
TUGGERANONG, A.C.T.

G. Jacobson, J.R. Kellett, A.T. Laws, J.A. Saltet

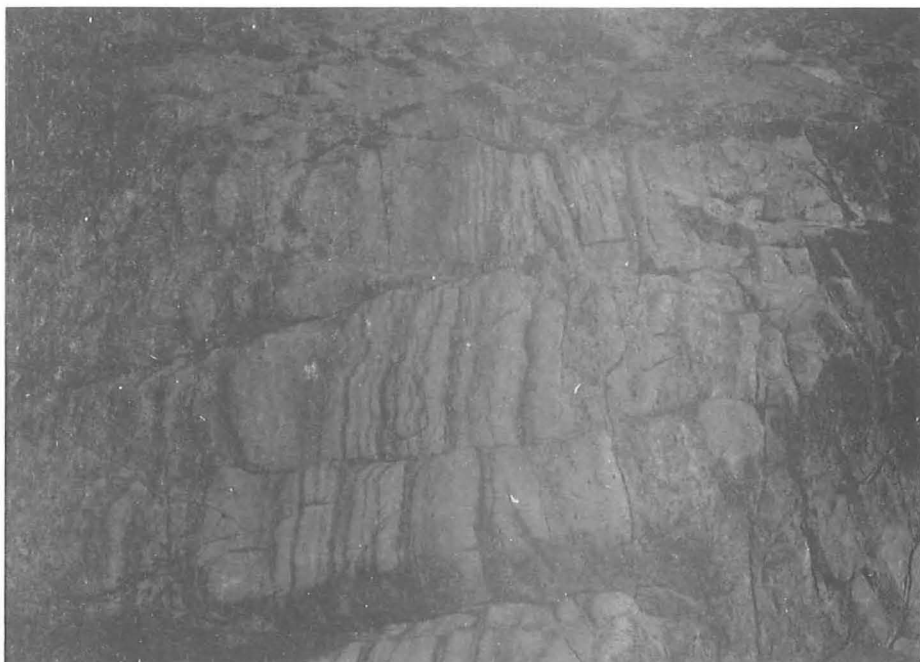
Fig. 3. Steeply dipping shale, left bank of
Murrumbidgee River, Point Hut Crossing.

The rocks of the Tuggeranong area east of the Murrumbidgee Fault comprise Silurian sedimentary rocks (Figs 3 and 4) which are unconformably overlain by Siluro-Devonian volcanic rocks (Figs 5, 6, 7 and 8). Intrusive granite crops out west of the Murrumbidgee Fault, a major fault defining the western margin of the Canberra graben.

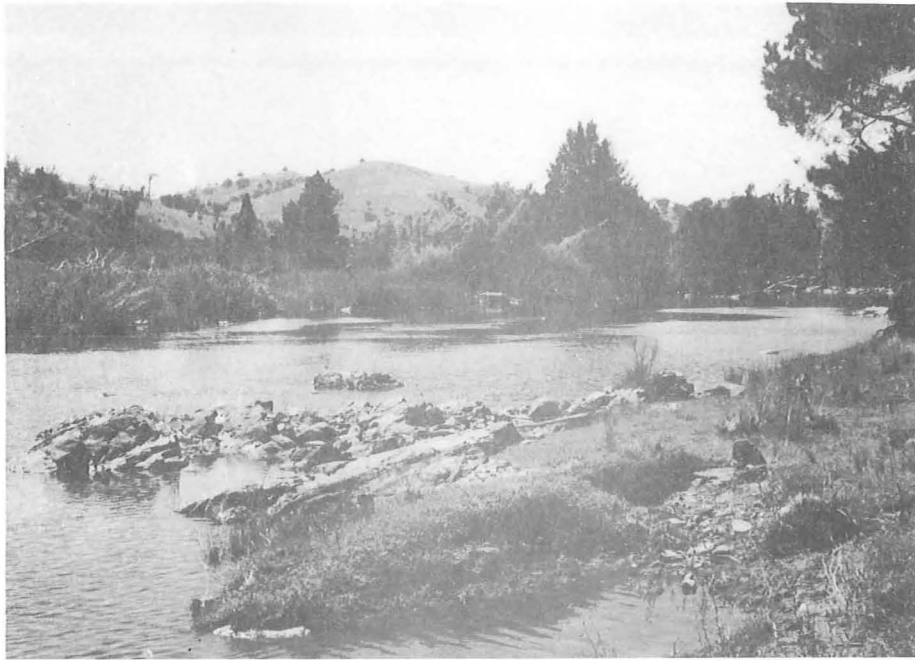
Fig. 5. Outcrops of rhyodacite, right bank of Murrumbidgee River near Pine Island looking downstream towards Urambi Hills.

All the rock units mapped consists of rocks which are hard and strong where fresh, as in river-bed outcrops (Figs 5 and 6). Elsewhere the rocks are weathered to varying degrees and depths. Dacite, rhyodacite, and rhyolite welded tuff underlie 70 percent of the mapped area, and in these rocks weathering may extend to depths of 15 m or more in places.

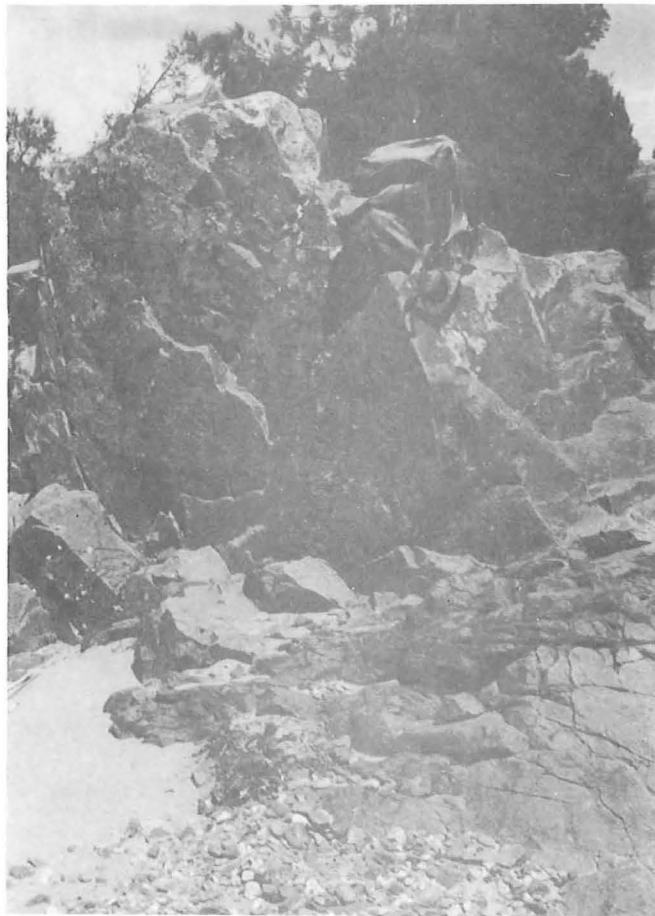
Fig. 6. Rhyodacitic welded tuff, right bank of Murrumbidgee River near Pine Island.

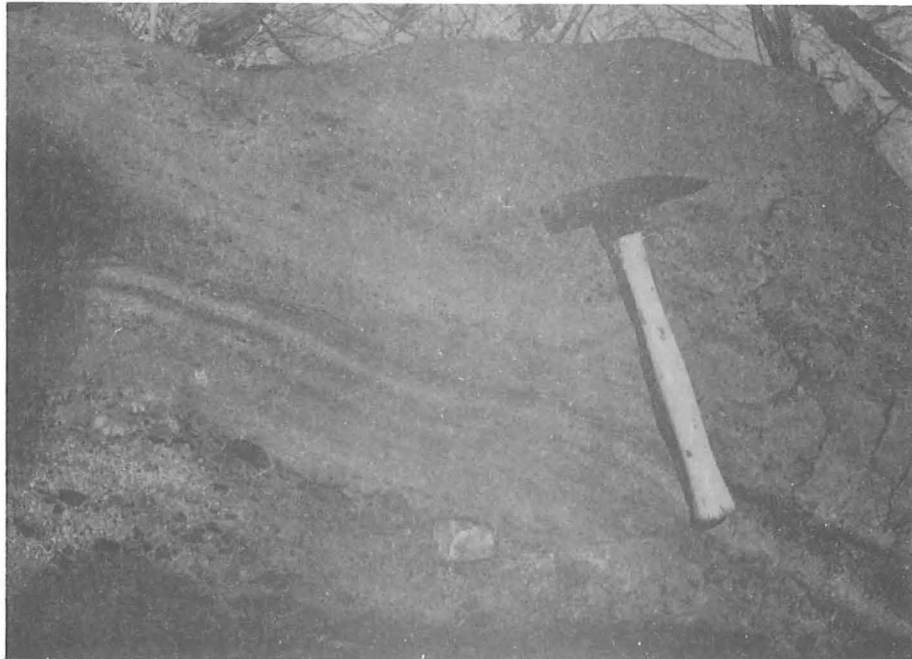
Fig. 7. Bedded rhyodacitic tuff, right bank of Murrumbidgee River, Pine Island.

These outcrops include a volcanic complex exposed in the river banks downstream from Pine Island (Figs 7 and 8), and a sequence of well exposed agglomerate breccia downstream from Point Hut Crossing.

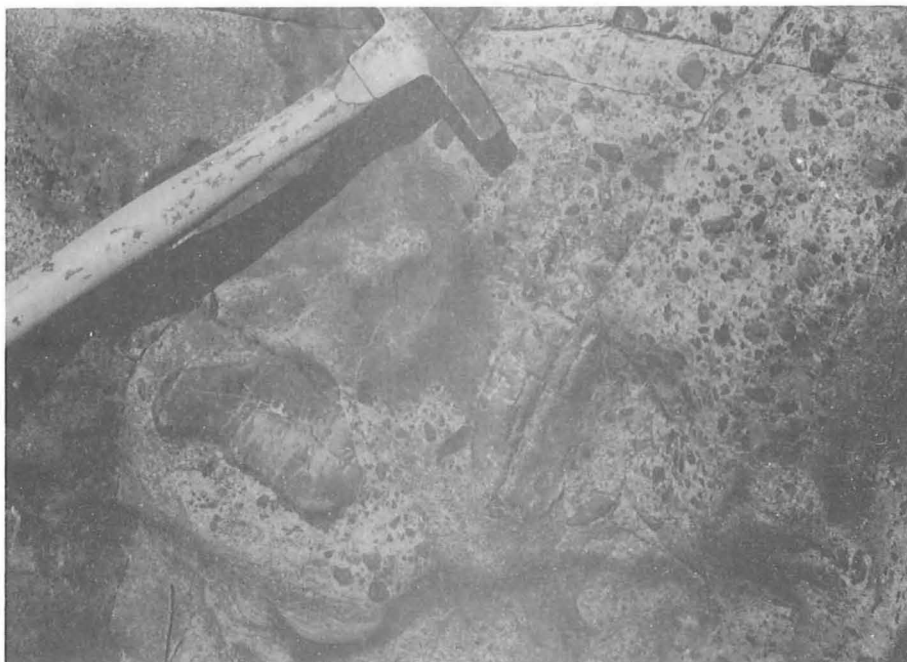
Fig. 8. Agglomerate, right bank of Murrumbidgee River, Pine Island.

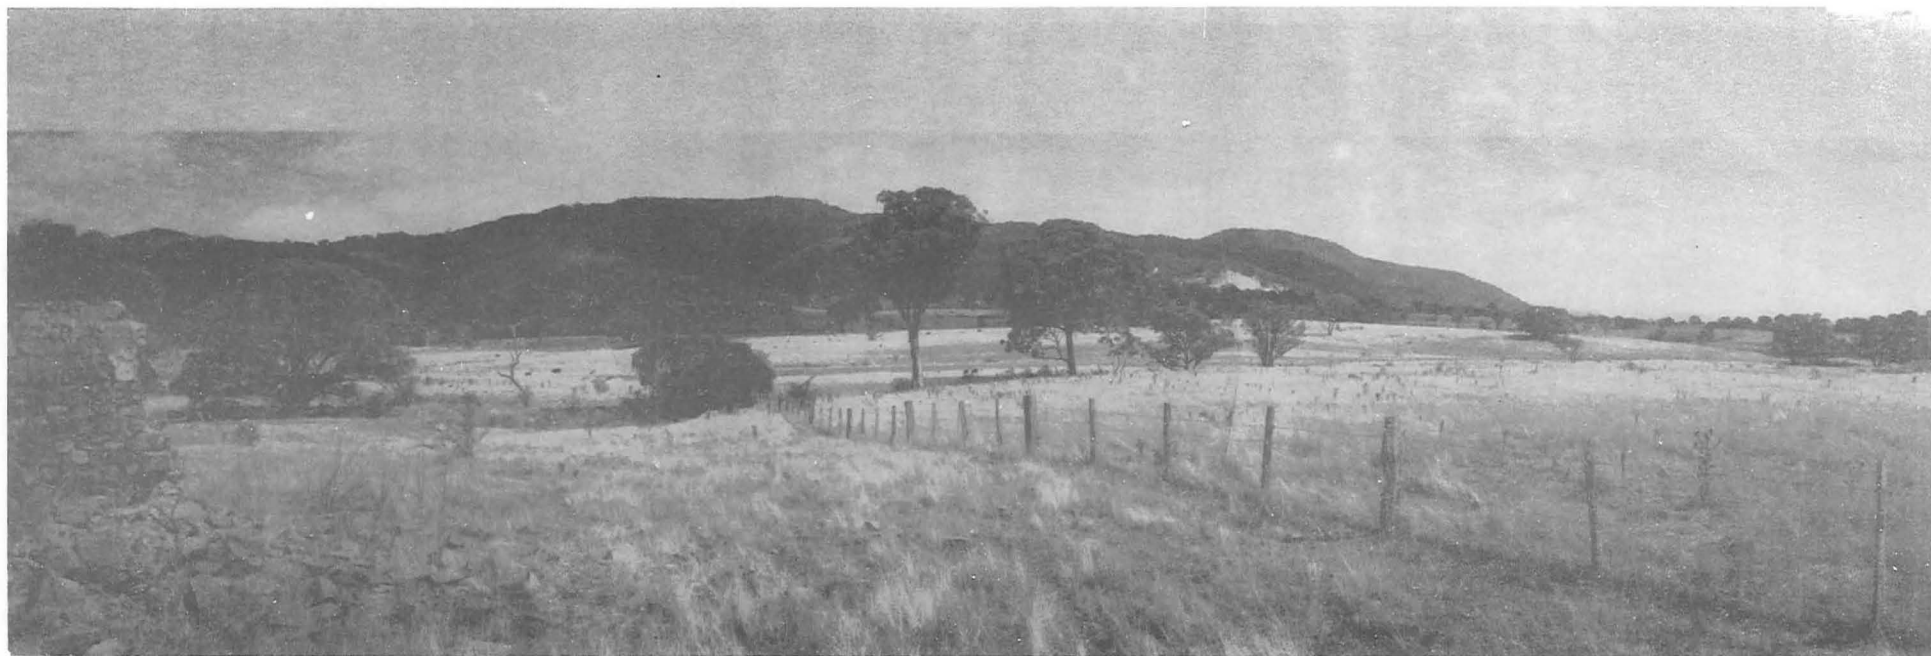
Fig. 10. The Murrumbidgee Fault Scarp at Freshford. The fault zone is about 400 m wide and underlies the gently sloping ground in the middle distance.

Tuggeranong is in the Murrumbidgee valley which is bounded on the west by the Murrumbidgee Fault scarp (Figs 9 and 10) and on the east by a range of hills, the most prominent of which are Rob Roy (1099 m) and Tuggeranong Hill (805 m). Rejuvenation of the Murrumbidgee River has left a series of pediplain basins in the valley at heights of 30 to 50 m above river level.

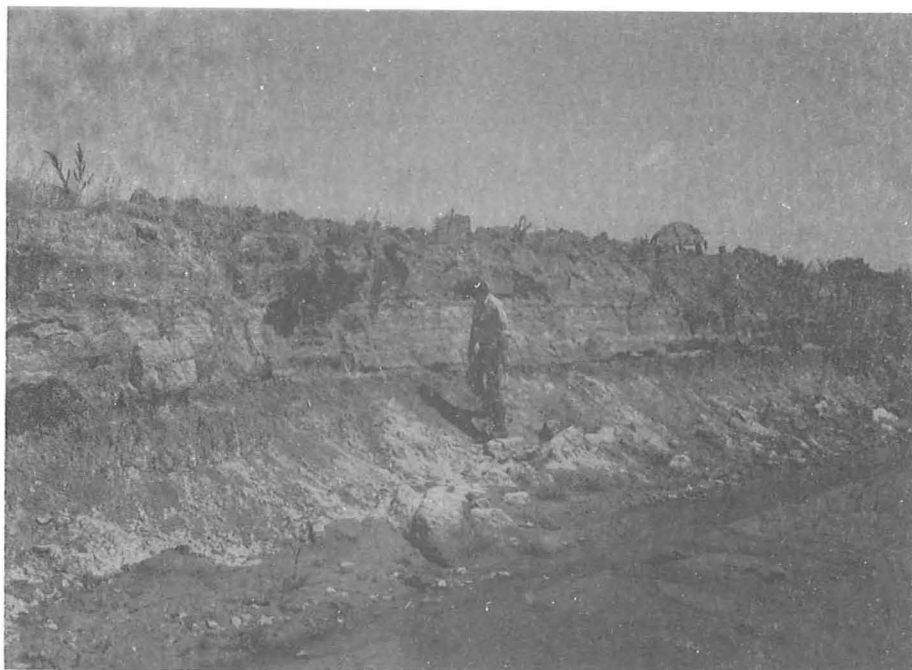
Fig. 11. Stratified alluvium, Isabella Plains; soil profile in the temporary drainage channel.

The soils of Tuggeranong are related to four main geomorphological settings (Fig. 2). Skeletal soils are present on the higher hill slopes and on those undergoing sheet erosion; residual podzolic soils have developed on the lower pediments and interfluvies; cemented hillwash has formed mostly on the pediments; and thick alluvium has been deposited on the pediplains (Fig. 11).
