**BUREAU OF MINERAL RESOURCES,
GEOLOGY AND GEOPHYSICS**

Record 1979/27

MOLONGLO VALLEY INTERCEPTOR SEWER, ACT:

ENGINEERING GEOLOGY COMPLETION REPORT, 1978

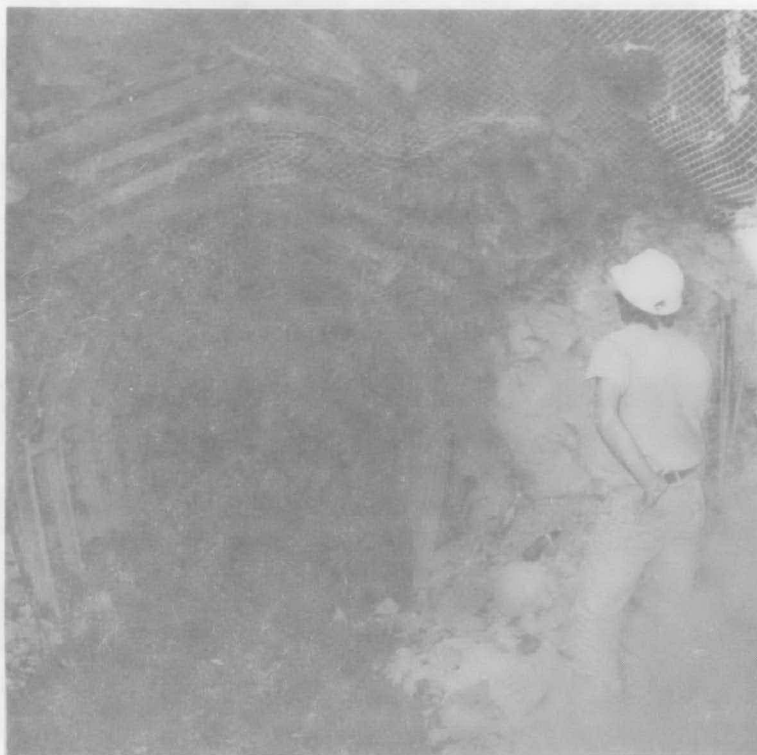
Fig 13 : Ryan Tunnel inlet portal - large overbreak with support and logging; mesh and rock bolts around the portal.

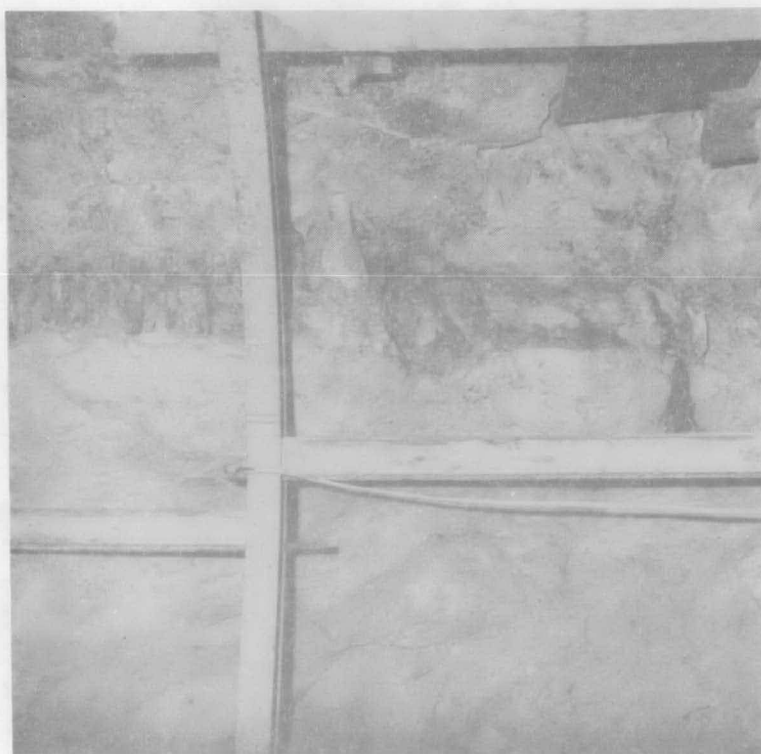
Fig 14 : Ryan Tunnel, stn 47 + 20 west wall, showing dark green olivine dolerite sill in rhyolite agglomerate. (RCN 4-5).

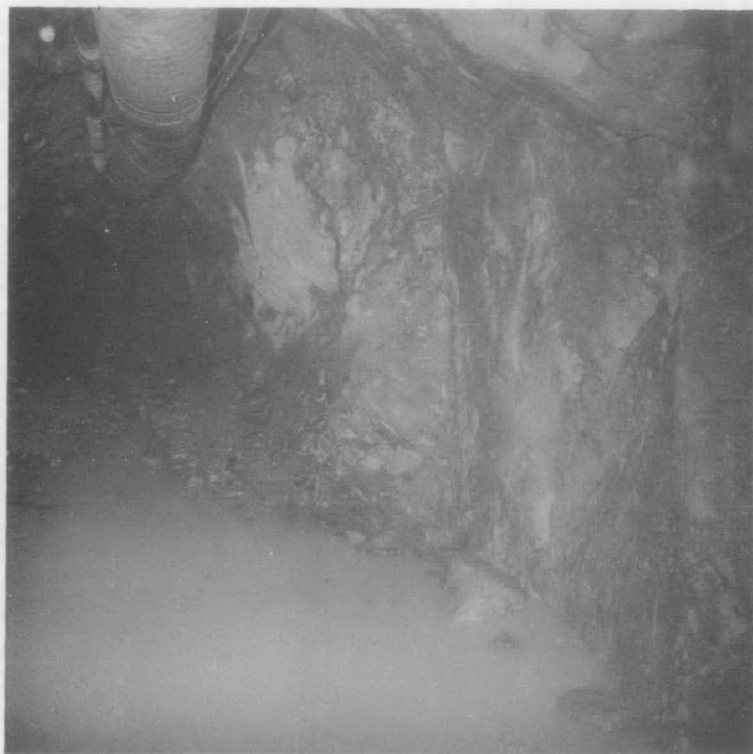
Tunnelling conditions were generally good in the grey dacite agglomerate (Fig. 5). Most joints were tight and not continuous, but in places were partly open, resulting in blocky conditions. Most of the overbreak appeared to be due to poor mining techniques. Shearing and the presence of a dolerite sill near crown level, resulted in poor tunnelling conditions between stations 48 + 00 and 49 + 00.

Fig 15 : Ryan Tunnel, stn 46 + 20. Overbreak in wall as a result of planar slickensided joints in grey dacitic agglomerate. (RCN 3-4).

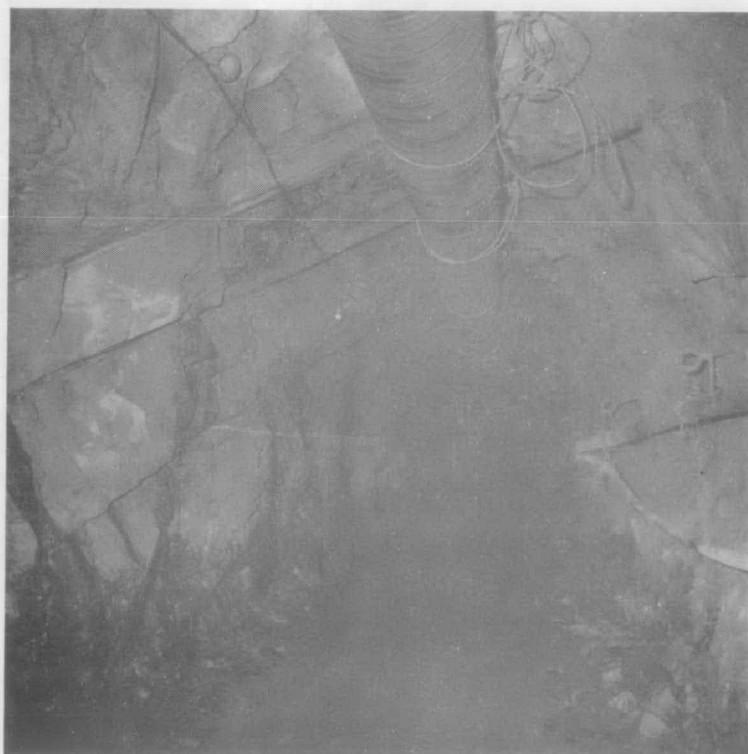
Green-grey and red stained dacite. Those rocks are generally hard, tight, and competent, and provided the best tunnelling conditions of all the rock types. Several sheared and fractured zones up to about 2 m wide occur; other sections are blocky, producing a ragged tunnel profile. Tunnelling conditions were very good (Fig. 16).

Fig 16 : Pine Ridge Tunnel, stn 62 + 70. Joints (? bedding) in blue grey dacite. (RCN 3-4).

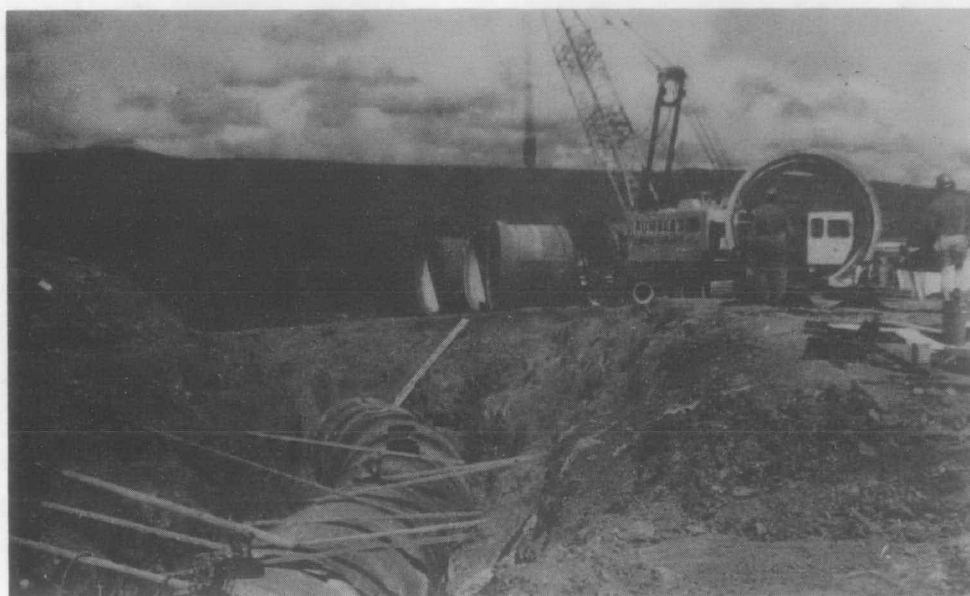
Excavation in the Mount Painter Porphyry was mainly in highly weathered and completely weathered rock, soil, and colluvium (Fig. 17). Although moderately weathered and slightly weathered rock does dominate some sections of the trench (e.g., stn 0 + 00 to 9 + 00) it is mainly confined to isolated elongated and dome-shaped occurrences. Fresh and fresh stained rock is relatively rare in the trench in the Mount Painter Porphyry. As the pipeline approaches the Ryan Tunnel (stn 0 + 00 to 9 + 00) it is located deeper within the Molonglo River Gorge where the rock is less weathered. An increasing amount of moderately weathered, and slightly weathered porphyry was excavated from the trench, and heavy blasting was required.

Fig 17 : Pipe-laying in Mount Painter Porphyry near Coppins Crossing Road. (M2256/4)
