RECORD 1981/5

GINNINDERRA SEWER TUNNEL, A.C.T.

ENGINEERING GEOLOGY COMPLETION REPORT, 1979

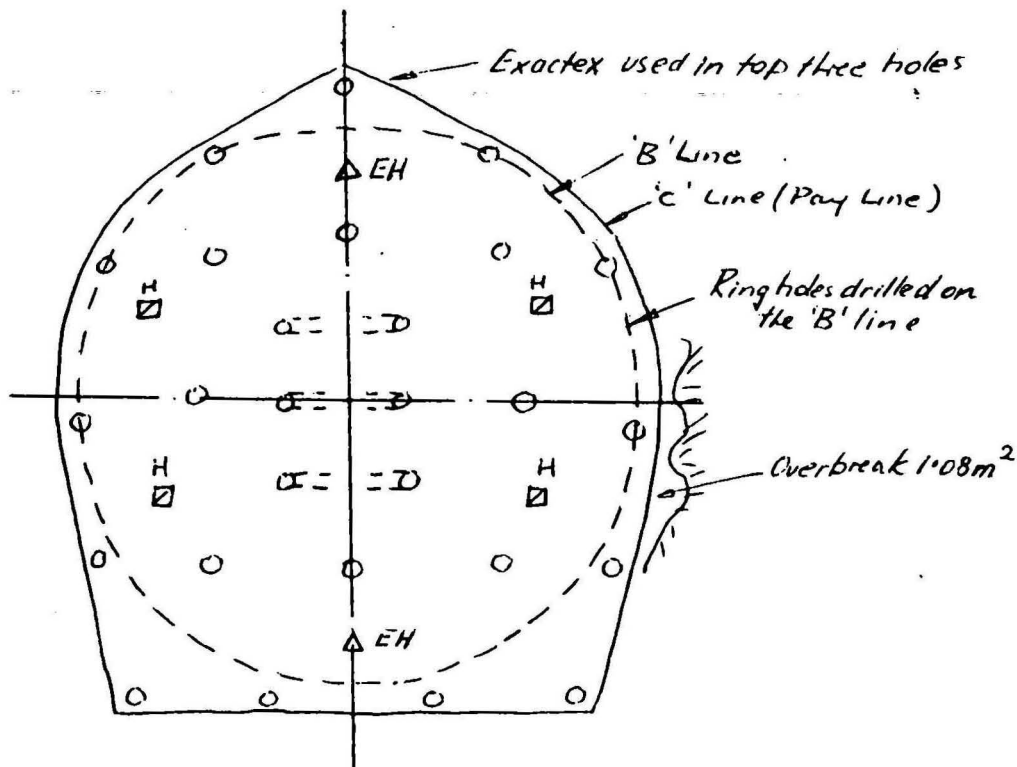
Example No. 2 Drill/load pattern

Chainage 3061; Date 31.10.77

Rock Type Granite Porphyry; Drill 1803 mm; Pull 1.57 m av.

Explosive 28 mm AN60 plus Exactex; Detonators safety fuse type.

1. Pattern - normal rock conditions

Hole	No.	Loading/hole	Primer	Sticks
Cut holes (wedge)	8	1 Primer + 4 sticks	8	32
Inner holes	6	1 Primer + 6 sticks	6	36
Ring holes	6	1 Primer + 6 sticks	6	36
Crown/shoulder	3	1 Primer + 1 stick + 3' exactex	3	9 (equiv)
Lifter holes	4	1 Primer + 8 sticks	4	32
<u>Total holes</u>	<u>27</u> No.		<u>27</u>	<u>145</u>
		<u>Total Explosive</u>		<u>172 sticks</u>

Explosive : 172 sticks x 0.385 lb/stick = 66 lb = 30 kg

Face area : Pay 'C' line 6.6025m² O/B 1.08m², total 7.68m²

Explosive consumption 30 kg = 2.48 kg/m³ solid excavated
7.68 x 1.57 m

2. Hard rock conditions: drill 4 extra holes to "1" marked 'H'.

3. Very hard rock conditions; drill 2 holes extra to "1" & "2" marked 'EH'.

The typical loading patterns shown in Appendix 2 for the granite porphyry and Walker Member dacite gave an explosive consumption in the order of 2.5 kg per m³ of solid rock excavated.

Exactex was used in the three crown holes in an endeavour to reduce crown fragmentation and overbreak.

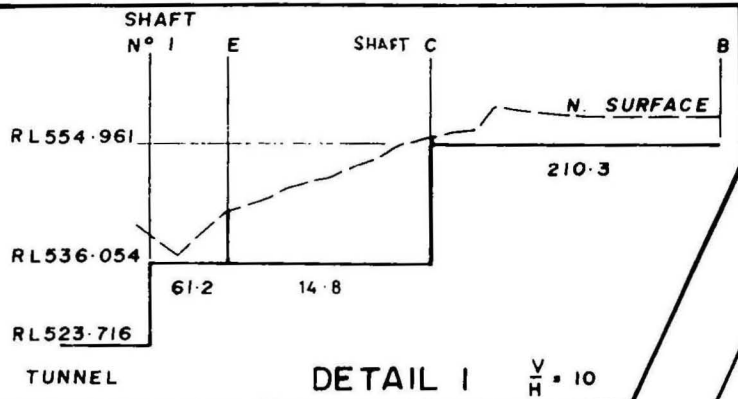
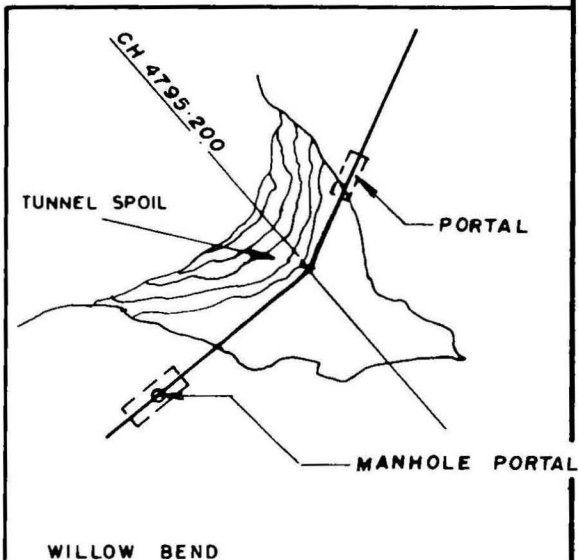
FIGURE 2

GINNINDERRA SEWER TUNNEL DESIGN DETAILS

SHAFT N° 1

SHAFT N° 2

SHAFT N° 3

WILLOW BEND - (SEE DETAIL 2).

OUTLET PORTAL

The general layout of the tunnel is shown in Figure 2. Access to the upstream and downstream sections of the tunnel was gained from Willow Bend where the site works were established, and the tunnel spoil was dumped in the gully to form a enlarged working area.

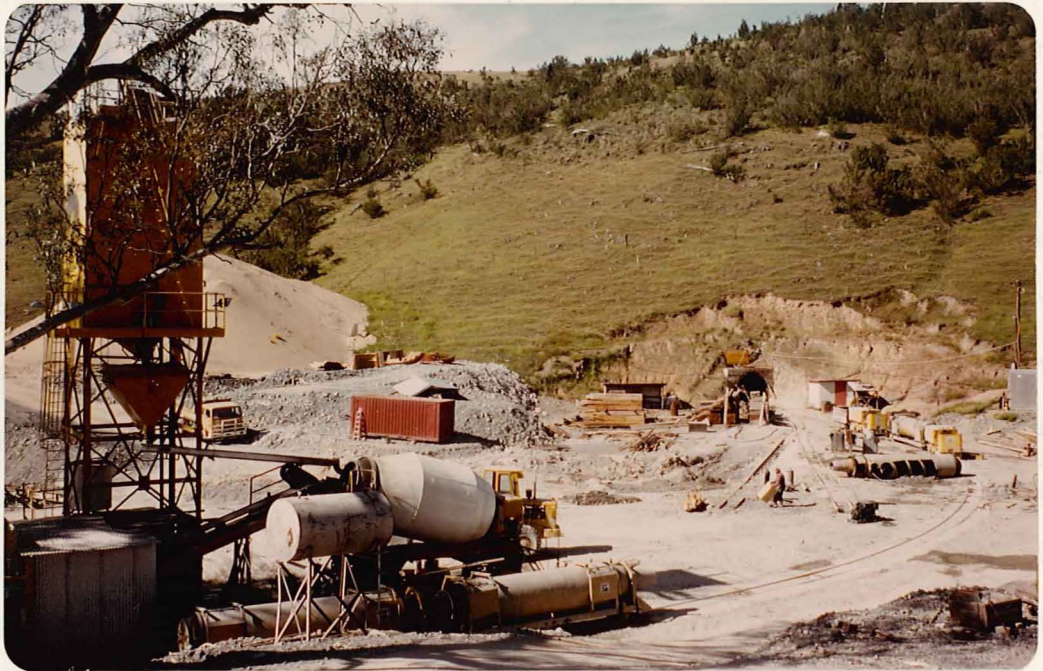
Fig. 3: General view of work area and upstream portal, Willow Bend. Slumping of the slope above the portal took place after benching of the work area at the portal.

A pre-construction geological report was prepared by the Bureau of Mineral Resources, Geology & Geophysics (BMR) (Lang & Purcell, 1976), and selected parts were subsequently incorporated into an "Information for Tenderers" document. On request from DHC, a BMR geologist was assigned to the DHC engineering team to provide a complete geological service during construction. A general view of the work area and upstream portal is shown in Figure 3.

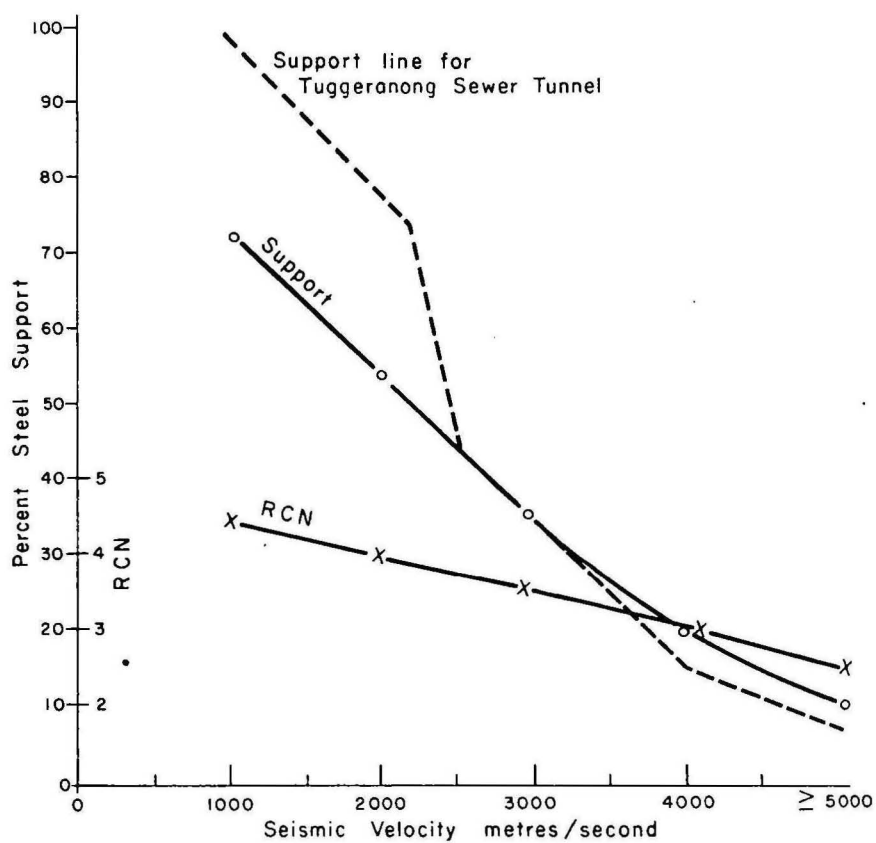
Fig.5 Relationship between Rock support, Rock condition and Seismic Velocity

A comparison of seismic velocities versus support may not be very meaningful owing to the depth of the tunnel below ground surface. However, a correlation of seismic velocity, rock condition number (RCN), and steel support is given in Table 4. The correlations are similar in the higher velocities to those obtained in the Tuggeranong, Ryan, and Pine Ridge Tunnels (Purcell, 1977 and 1979); however, there is some divergence from the

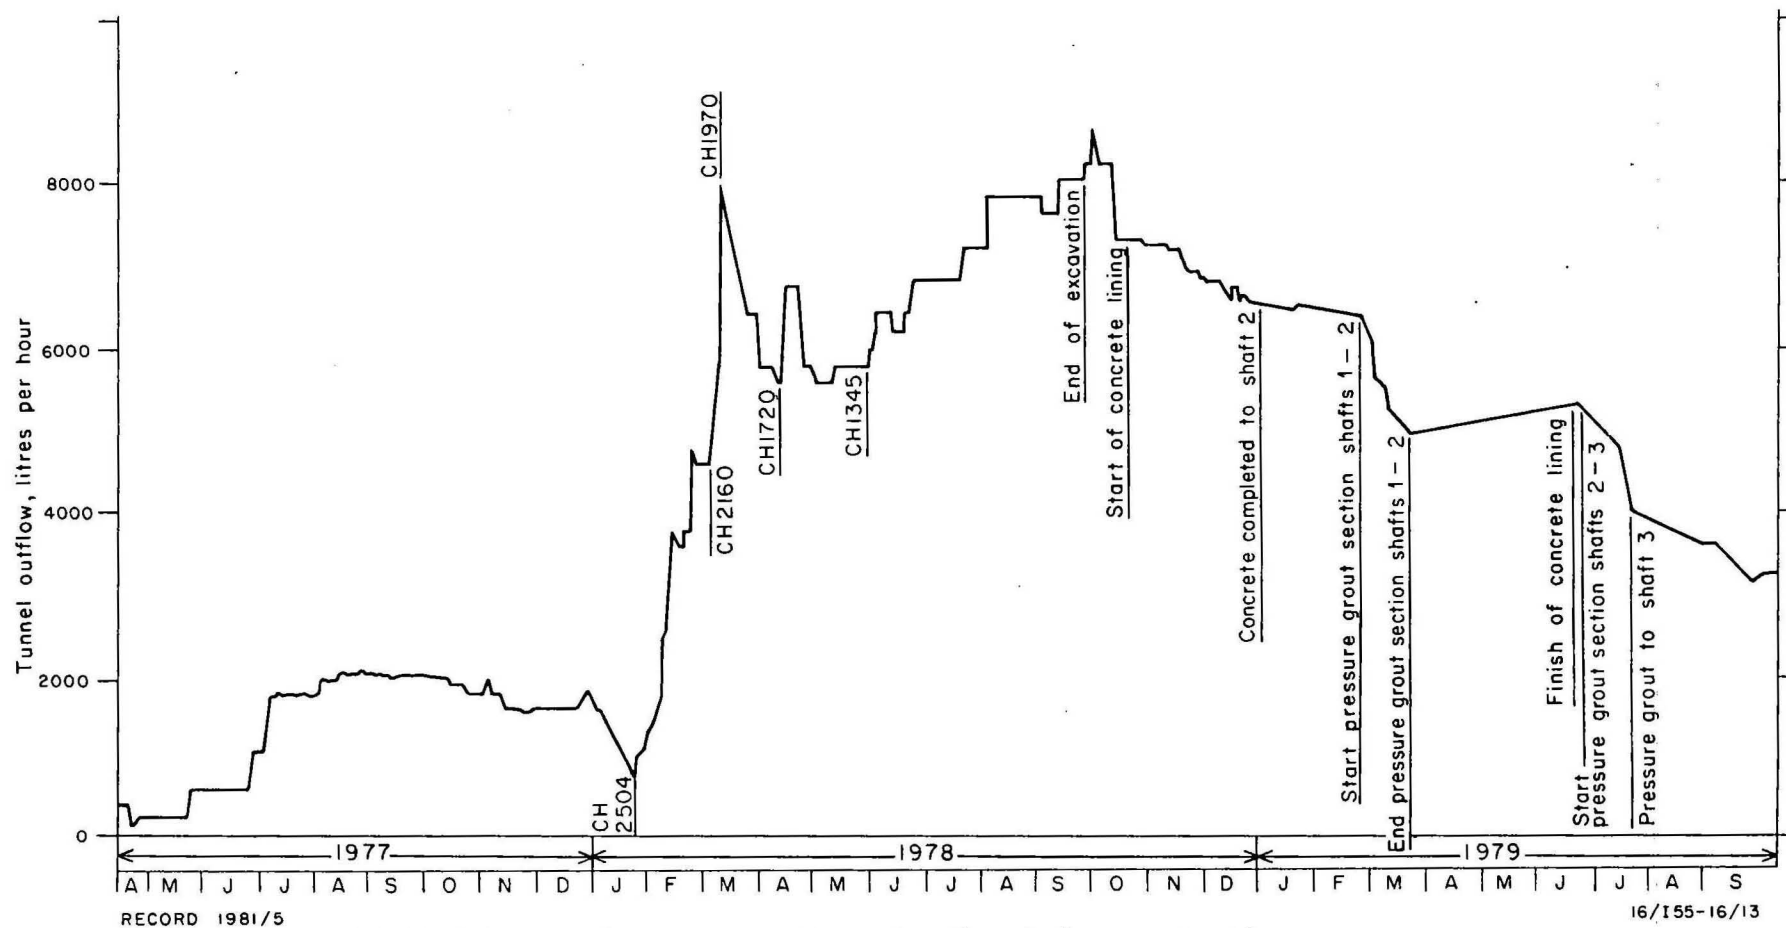
Fig.6 Water outflows from upstream heading during construction

Water infiltration into the tunnel on the upstream heading (Ch 0458-4756) increased progressively during excavation to a maximum constant flow of 37 000 litres per hour. Infiltration water flowed from the tunnel along an invert side drain and discharged through a V-notch weir. Measurements of water outflow were made daily, and a summary graph of these data is shown in Figure 6.

It is not possible to record separately the effect that concrete lining, backfill grouting, and pressure grouting had on reducing the water infiltration as these three operations were carried out concurrently most of the time. Pressure grouting of the tunnel section between shafts 1 and 2 reduced the short-term inflow through the concrete lining from 12 200 litres per hour to 3900 litres per hour.

At the completion of all concrete works the infiltration rate had been reduced to 13 200 litres per hour. It is expected that the long-term infiltration rate could be of the order of 22 000 litres per hour after the water-table stabilises.

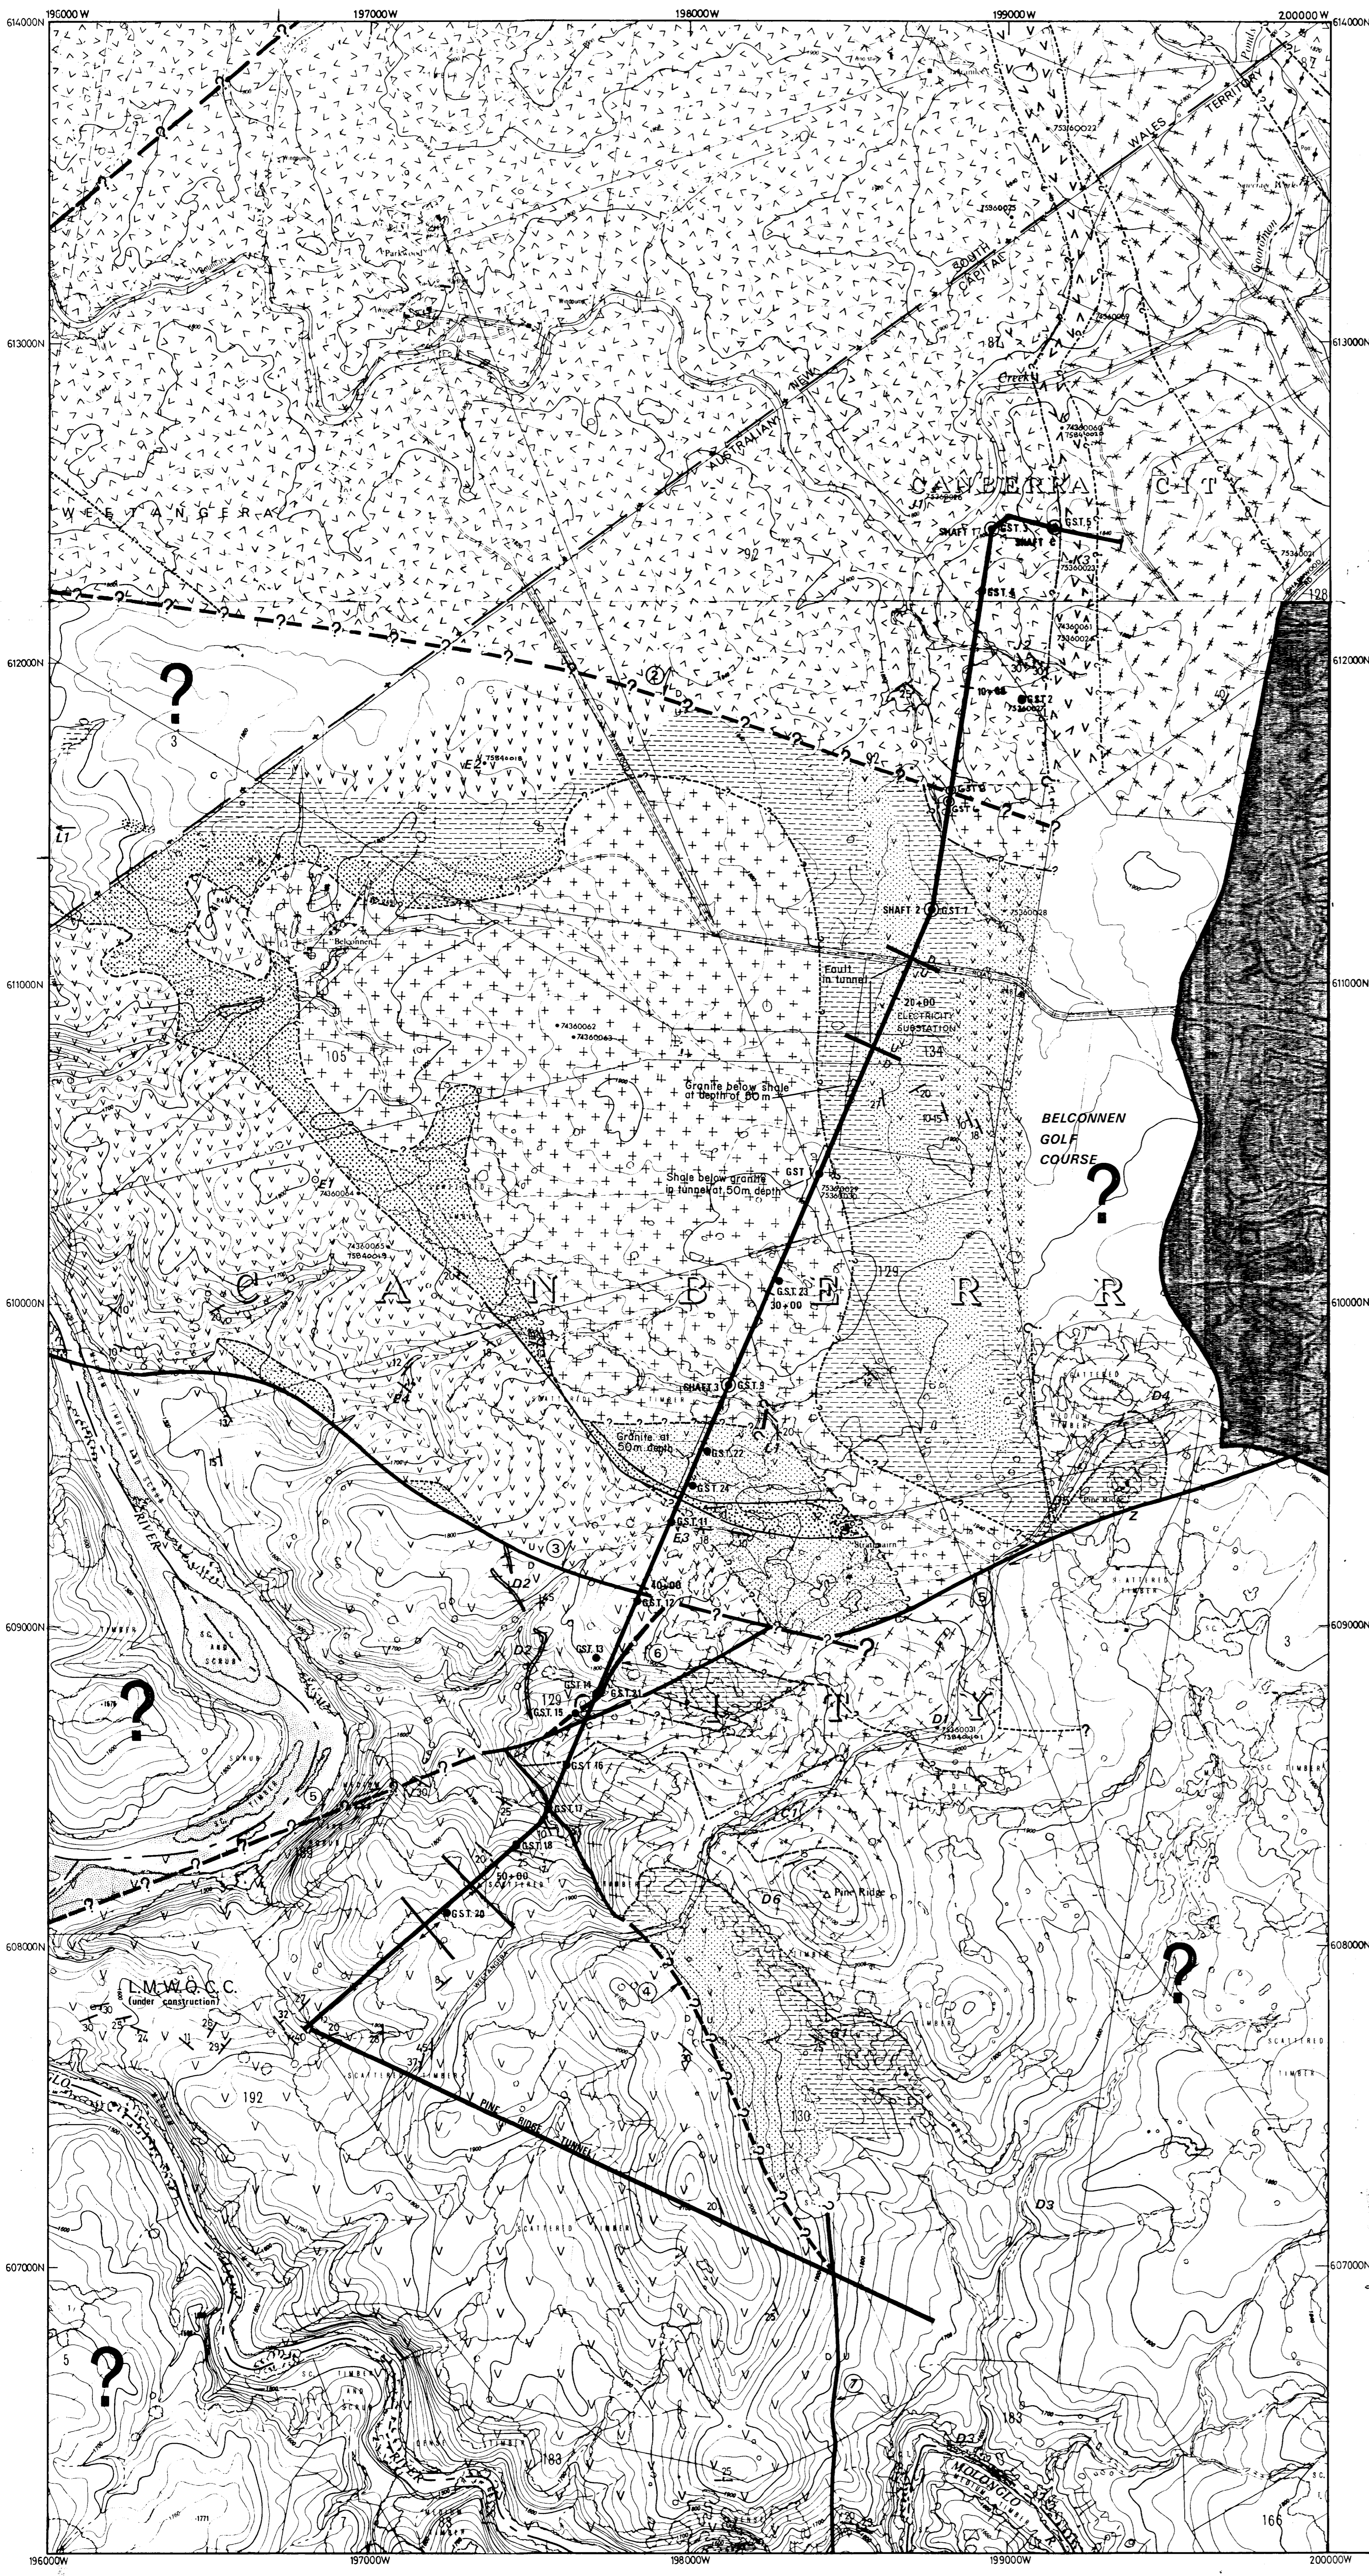
GINNINDERRA SEWER TUNNEL Interpretive Solid Geology

An interpretative solid geology of the area is shown in Plate 1. The tunnel was driven through a sequence of acid volcanics and tuffaceous sediments, intruded by granite; all rocks are regarded as Upper Silurian in age.
