# **BUREAU OF MINERAL RESOURCES, GEOLOGY AND GEOPHYSICS**

Record 1982/13

**GEOLOGICAL NOTES ON THE EXCAVATIONS  
FOR THE NEW PARLIAMENT HOUSE,  
CAPITAL HILL, CANBERRA, A.C.T.**

**G.A.M. Henderson**

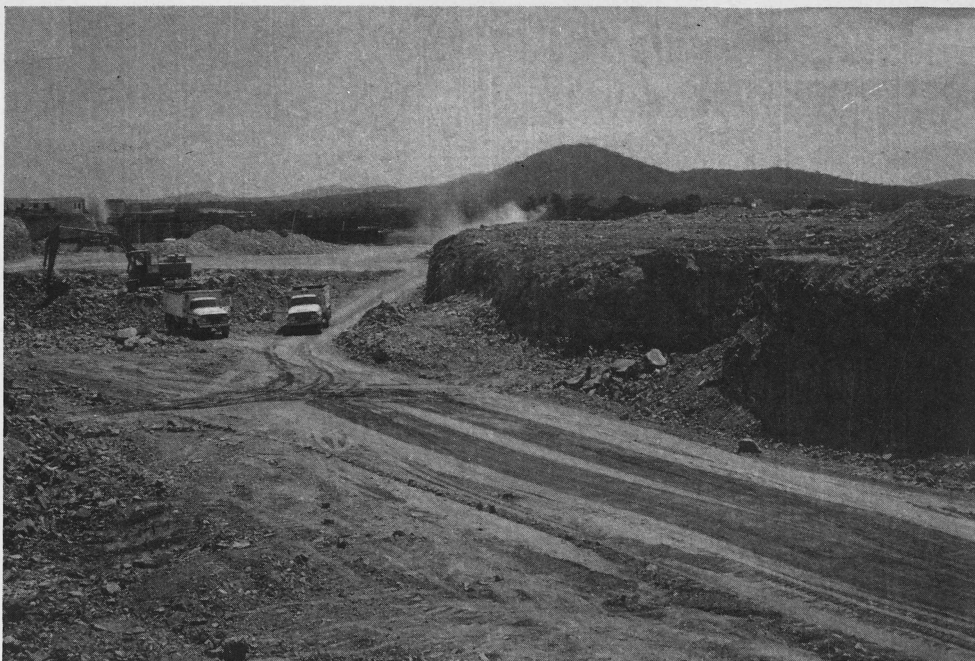
(Neg. No. GB2916)

Fig. 2. General view of central part of excavation in advanced state of completion. Looking north, Mount Ainslie on skyline. Exposure of unconformity shown in Fig. 5 is in rock face at right.

Numerous faults, of various types and differing amounts of displacement, cross the site. The main faults have been designated with letter symbols, as shown in Figure 2 and Plate 1, to facilitate discussion. The faults generally contain fracture fillings of either quartz or iron oxides along at least some of their length, but in places they are clean cut. One of the faults (Fault A) is illustrated in Figures 7 and 8.

The fault with presumably the largest displacement is Fault E. This fault is shown as a thrust fault in Figure 2, because of drag folding observed immediately to the south of it is a test trench. However if its inferred stratigraphic position is correct the net movement must be downwards on the southern side.

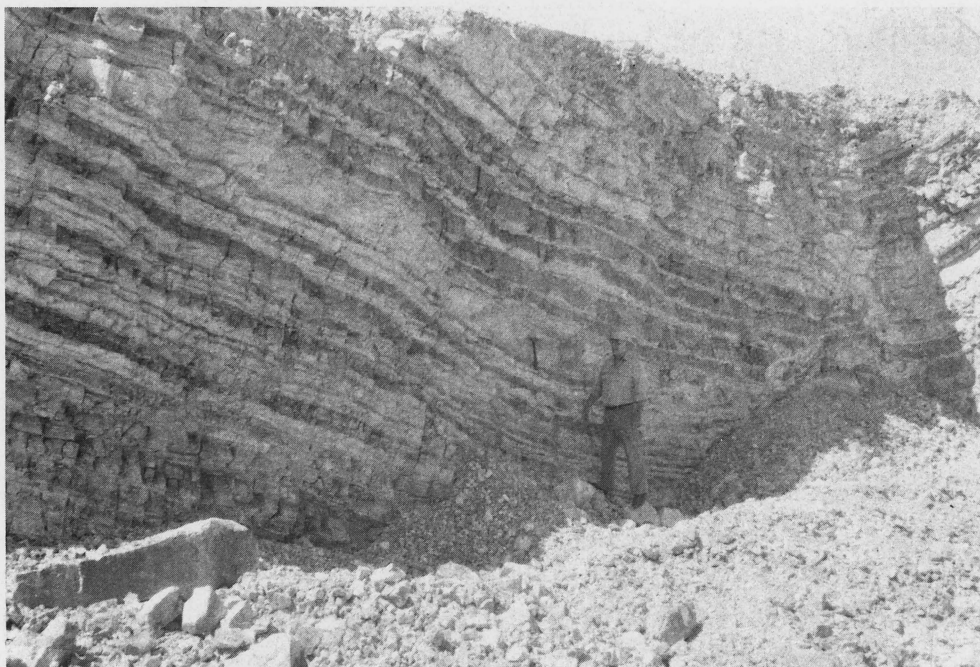
(Neg. No. M2502, frame 16)

Fig. 3. Well-bedded Camp Hill Sandstone Member showing dark sandy beds contrasting with pale, leached silty beds.

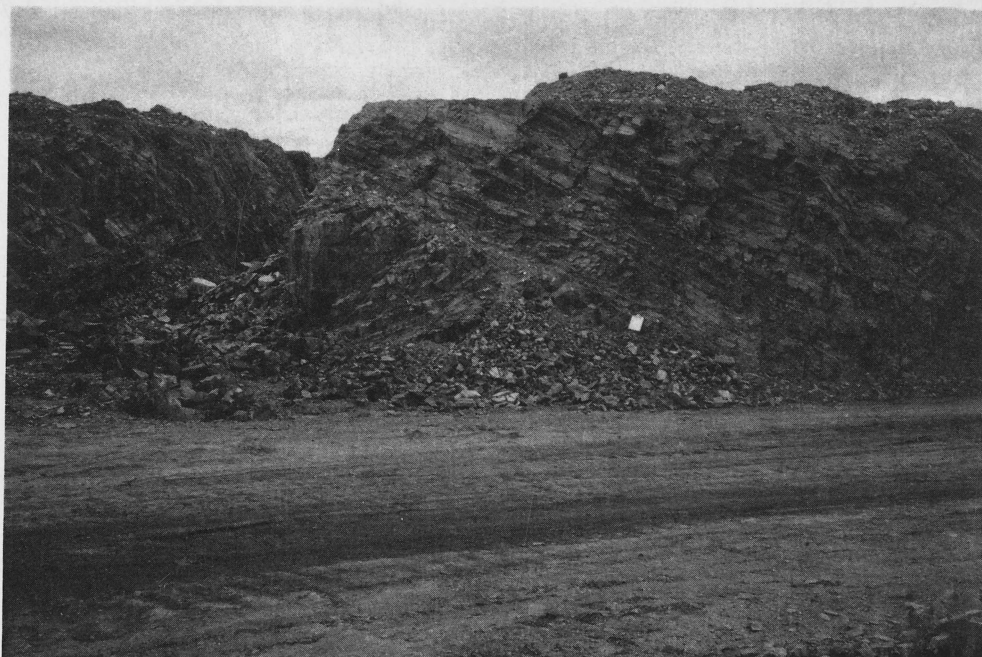
(Neg. No. GB2911)

Fig. 4. Exposure of unconformity at site co-ords 545X, 425Y (Plate 1). Camp Hill Sandstone Member dips to right and unconformably overlies Black Mountain Sandstone which dips to the left. Rock face is about 5 m high.

(February, 1982) in several vertical rock faces, one of which is sketched in Plate 3. Photos of the unconformity are shown in Figures 4 and 5. The Camp Hill Sandstone Member consists of interbedded sandstone and siltstone in beds ranging from 2 to 25 cm thick with sandstone giving way to siltstone towards the top of the unit. Typical Camp Hill Sandstone Member is shown in Figure 3. The beds are coloured red-brown, yellow-brown, purple and pale grey. In the site area the unit is about 17 m thick. The sandstone in the unit ranges from very coarse quartz sandstone to fine silty sandstone, the coarsest beds being near the base. Some of the coarse sandstone contains rock fragments. For example on the section illustrated in Plate 3 two coarse sandstone beds within one metre of the base contain small pieces of cherty mudstone ranging to 4 mm diameter. Generally the sandstone and siltstone are moderately to highly weathered and soft, but some of the coarse sandstone beds have been hardened by silicification.

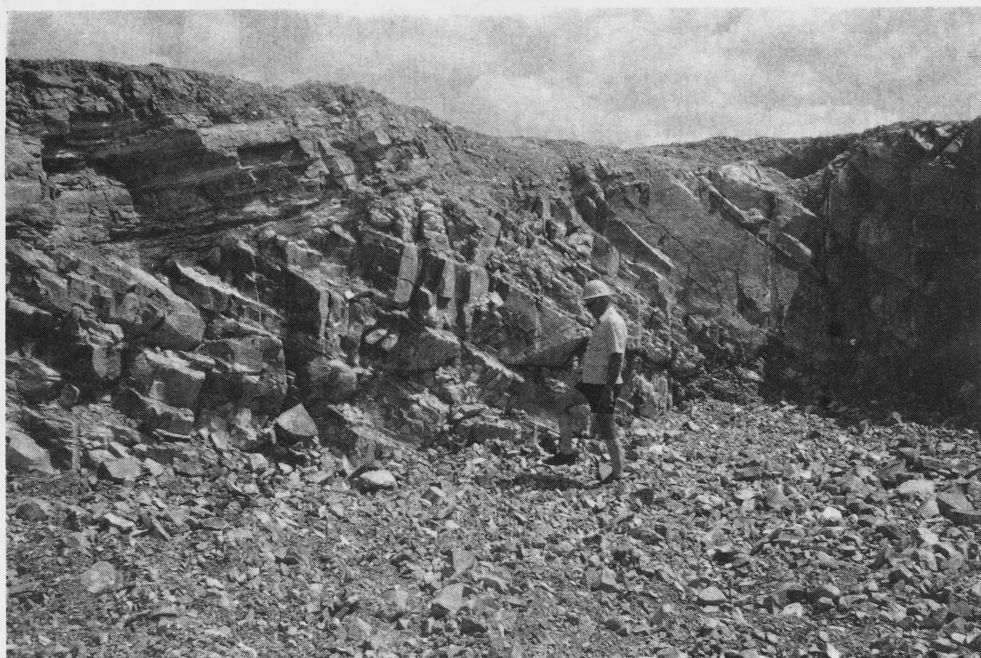
(Neg. No. GB2915)

Fig. 5. Exposure of unconformity at site co-ords 540X, 380Y. Camp Hill Sandstone Member dips to left, Black Mountain Sandstone, with siltstone interbed, to right.

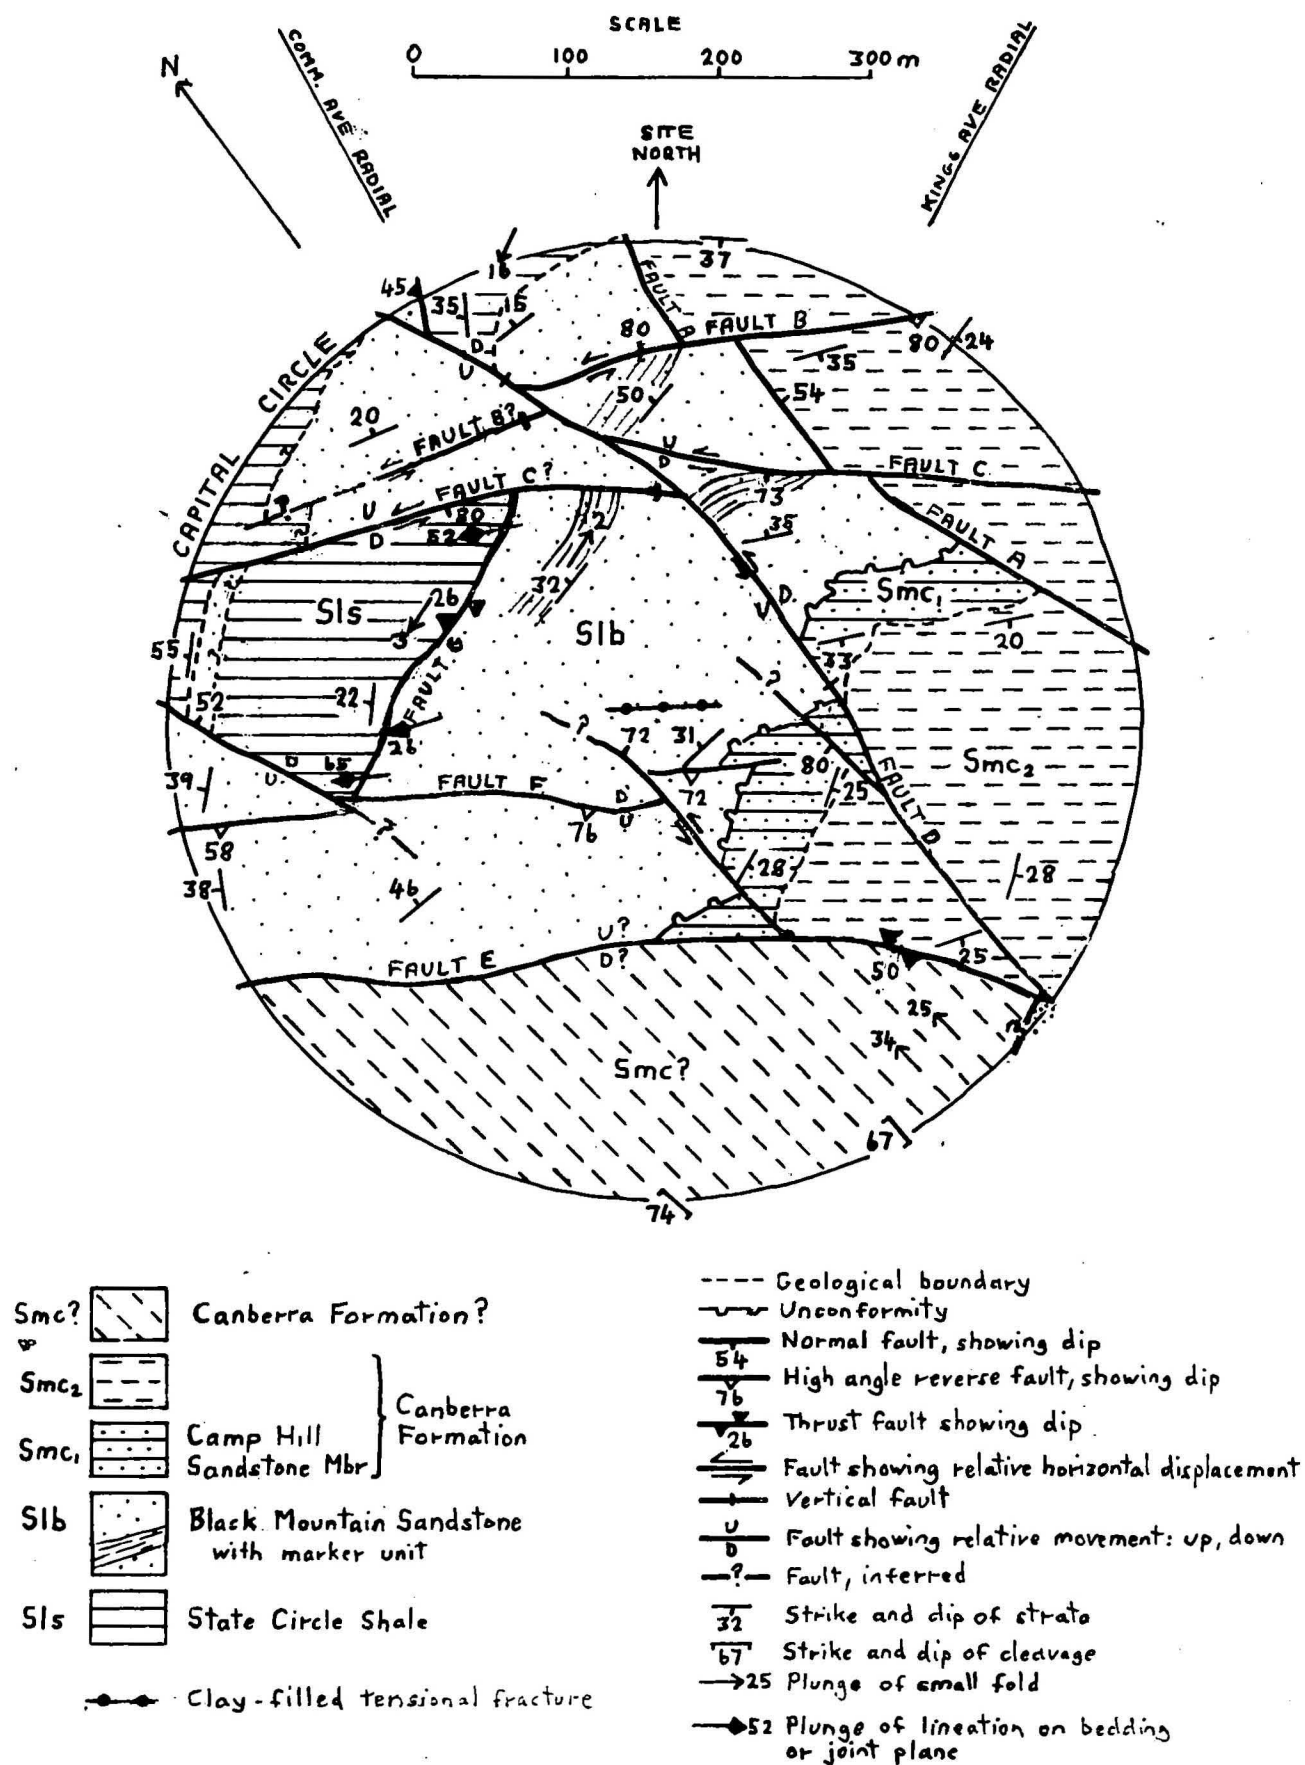
Fig. 6

## STRUCTURAL SKETCH MAP OF CAPITAL HILL

The structural relations between the various formations and fault blocks are shown in Figure 6. Two structural zones are clearly defined. One zone consists of the Black Mountain Sandstone and State Circle Shale where prevailing dip is to the north and northwest, and the other consists of the Camp Hill Sandstone and overlying siltstone ( $S_{mc_2}$ ) of the Canberra Formation where dips are to the south and southeast. A third zone consisting of the mudstone ( $S_{mc?}$ ) lacks bedding measurements in much of its outcrop area and the prevailing dip is not clear; however dips measured in the eastern part suggest folds plunging north, parallel to the strike of cleavage.

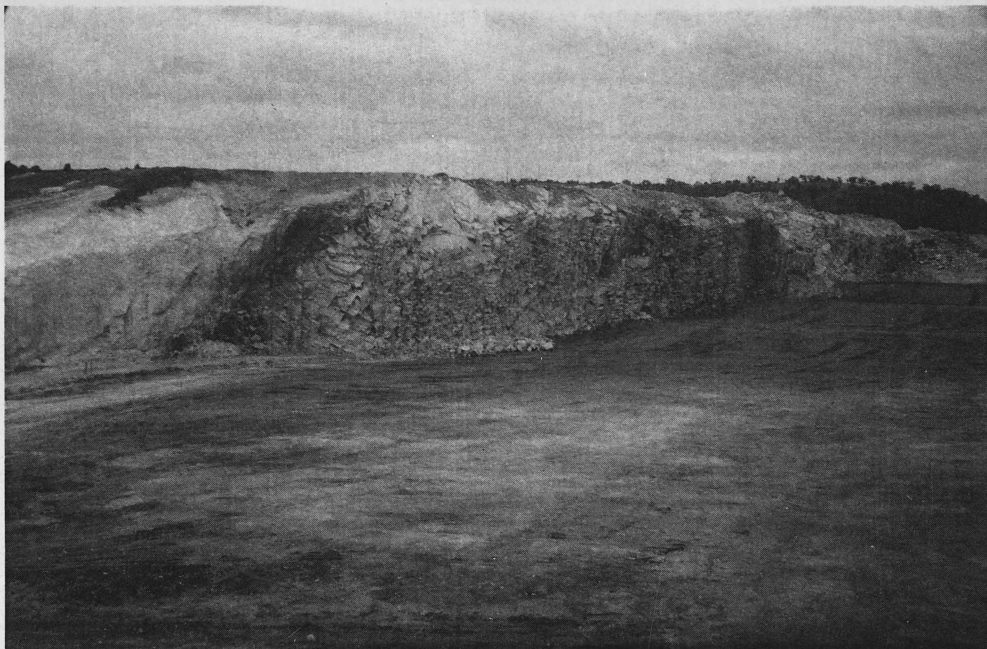
(Neg. No. GB2914)

Fig. 7. View of completed rock face on eastern side of central excavation at northern end. Dark patch on face at left centre is ferruginous fault zone (Fault A) separating white, leached siltstone of Canberra Formation at extreme left from Black Mountain Sandstone.

A large part of the building is being constructed on Black Mountain Sandstone which appears to be of more than ample strength for foundations. Potentially the worst foundations are in leached clayey siltstone of the Canberra Formation where it is crushed and decomposed adjacent to faults. Where the faults are at the contact with Black Mountain Sandstone there could be differential settlement between footings in the strong sandstone and footings in the adjacent weak decomposed siltstone. The contrasting hard sandstone and soft siltstone are well exposed in vertical section where Fault A crosses the northern end of the excavation (Figs 7 and 8).

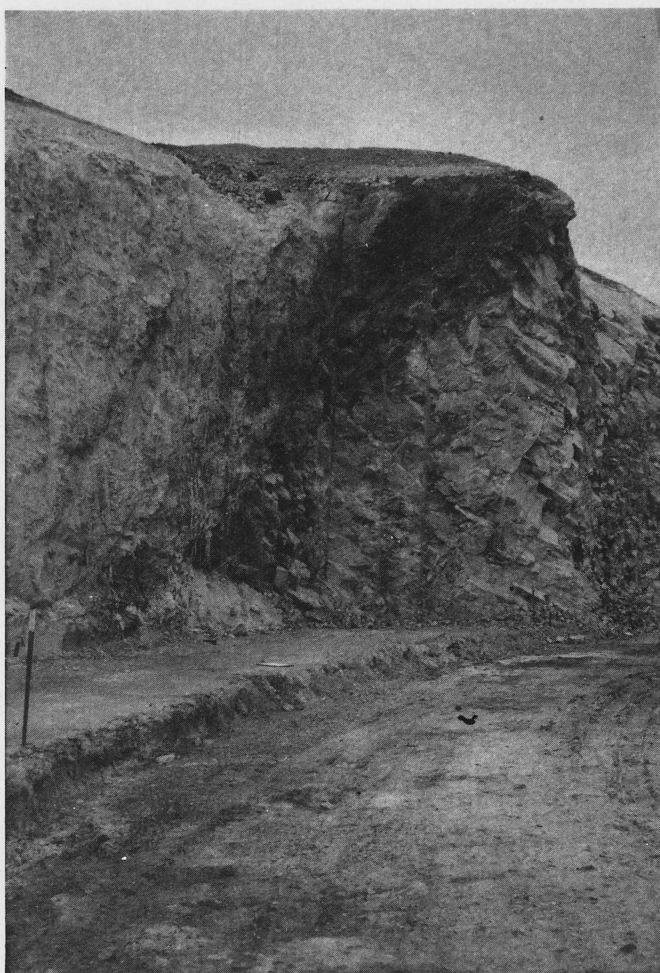
(Neg. No. GB2917)

Fig. 8. Closer view of fault zone shown in Fig. 7. Bedding in Black Mountain Sandstone at right dips towards rock face which is about 10 m high.

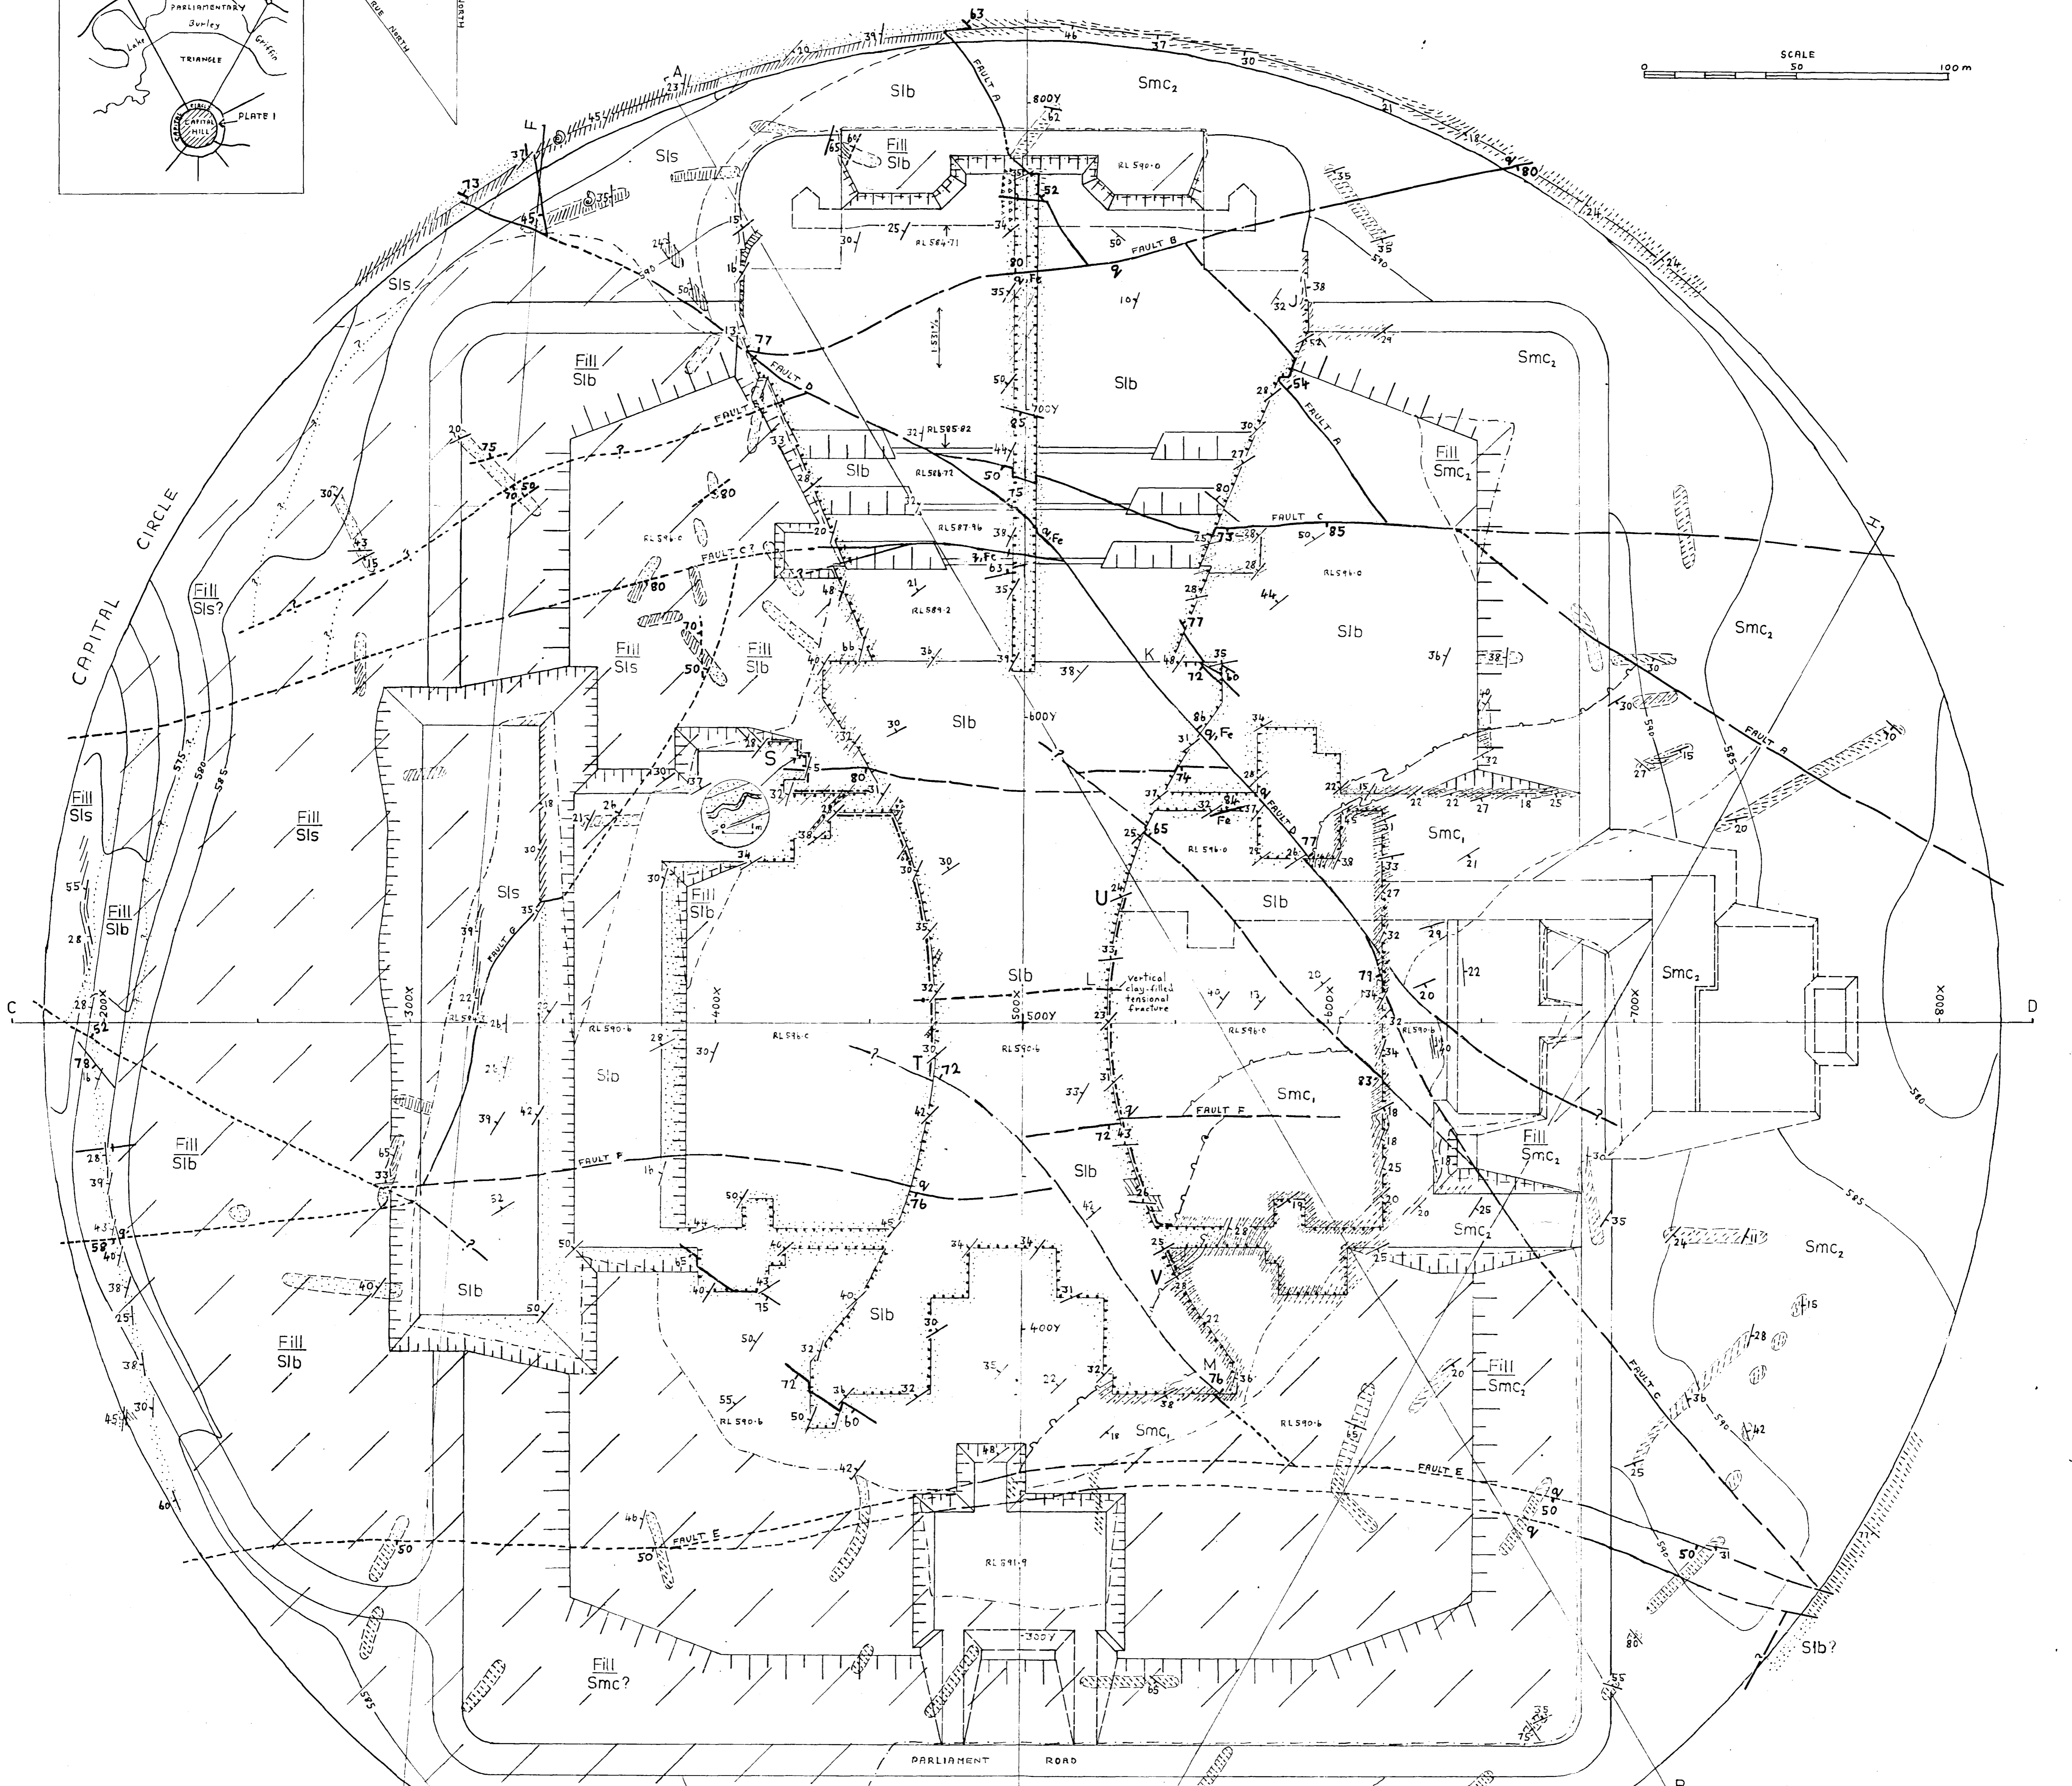
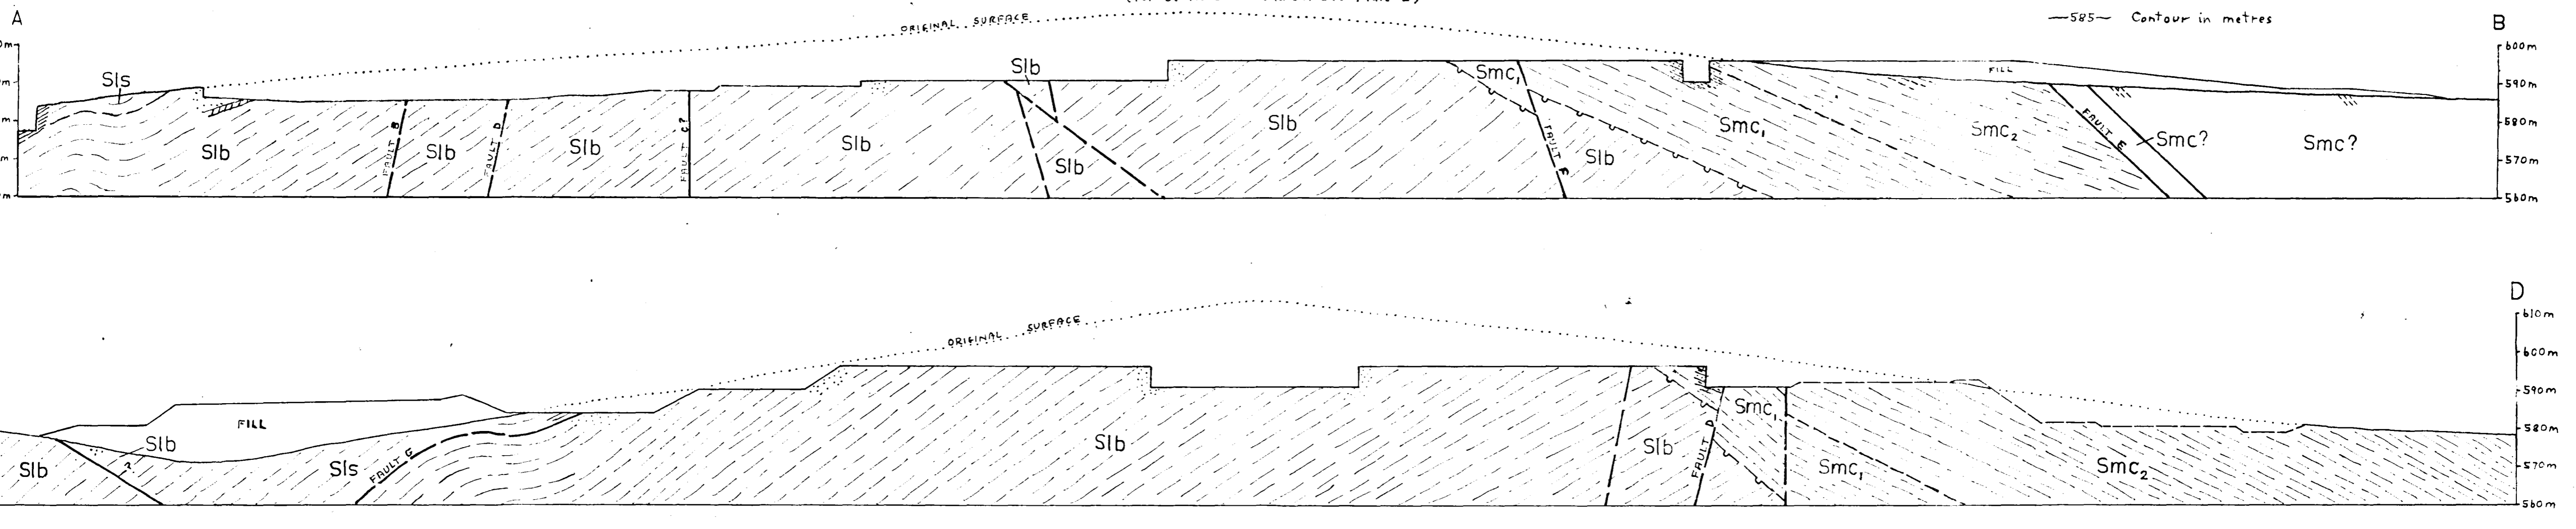
# GEOLOGY OF NEW PARLIAMENT HOUSE SITE CAPITAL HILL

- MIDDLE SILURIAN**
- CANBERRA FORMATION?
    - S<sub>mc</sub> Massive and cleaved mudstone
    - S<sub>mc</sub> Siltstone with minor sandstone interbeds
    - CAMP HILL SANDSTONE MBR S<sub>mc</sub> Interbedded sandstone and siltstone
- EARLY SILURIAN**
- BLACK MOUNTAIN SANDSTONE
    - S<sub>ib</sub> Thick-bedded sandstone with a few minor siltstone interbeds up to 1m thick Breccia lens
    - S<sub>ib</sub> Siltstone or shale interbed 1m or more thick
    - S<sub>ib</sub> Interbedded sandstone and siltstone
  - STATE CIRCLE SHALE
    - S<sub>ls</sub> Laminated siltstone and shale

- Geological boundary
- Unconformity
- Fault showing dip
- Vertical fault
- Fault containing: q-quartz, Fe-iron oxide
- Where location of boundaries and faults is approximate, line is broken; where inferred, queried; where concealed boundaries are dotted, faults are shown by short dashes
- Strike and dip of strata
- Strike and dip of cleavage
- Fossil locality
- Composite section of Black Mountain Sandstone (see Figure 1)

The general form of the site after excavation and placement of fill is shown in Plate 1. The levels and batters indicated are those shown on plans dated September 1981 modified in a few places to conform with amended excavation design. Some areas, mostly on the eastern side of the site, shown on these plans for excavation have not yet been excavated because of design changes; where this is so the excavation outline is dashed.

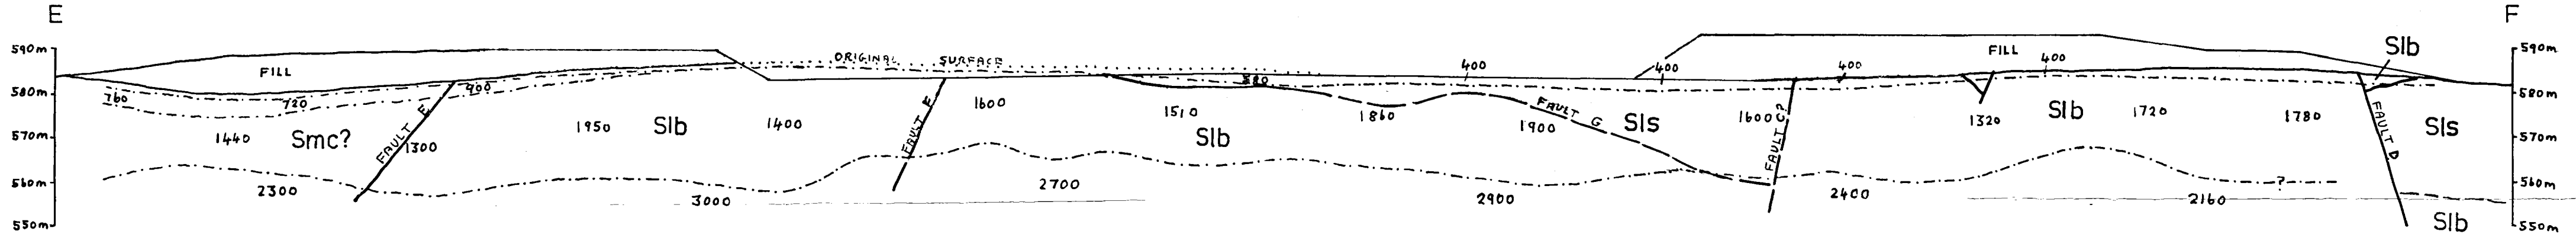
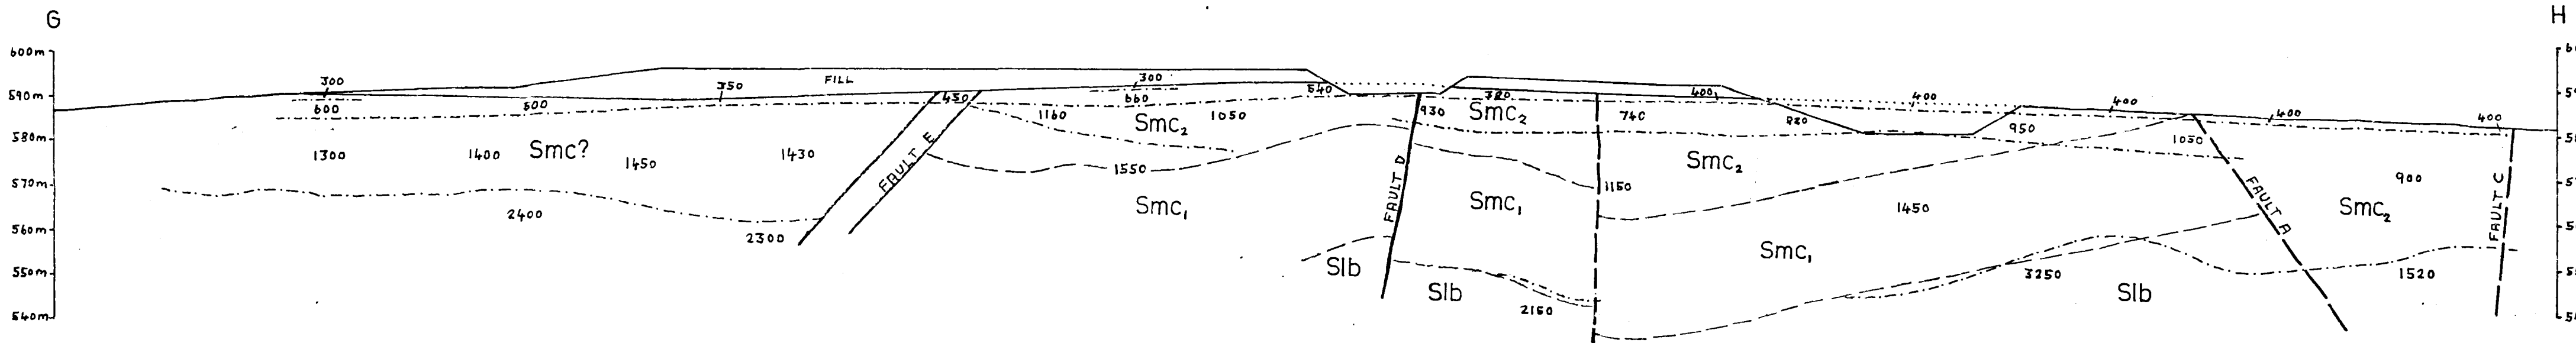
# CAPITAL HILL - COMBINED GEOLOGICAL AND SEISMIC CROSS SECTIONS

For locations of sections and reference to rock unit symbols see Plate 1

1400 Seismic velocity of rock layer  
 --- Boundary of seismic velocity layer

As part of more recent site investigations after the site was chosen definitely for the new Parliament House two seismic refraction traverses, one across the northwest and the other across the southeast of the hill, were done (Hill and Ramsay, 1979). The results of these two traverses are reproduced in Plate 2 with geological interpretation from the latest mapping added.
