AGSO  
RECORD  
1999/36

Cities Project

## **Quantitative Landslide Risk Assessment of Cairns**

MARION MICHAEL-LEIBA<sup>1</sup>, FRED BAYNES<sup>2</sup> & GREG SCOTT<sup>1</sup>

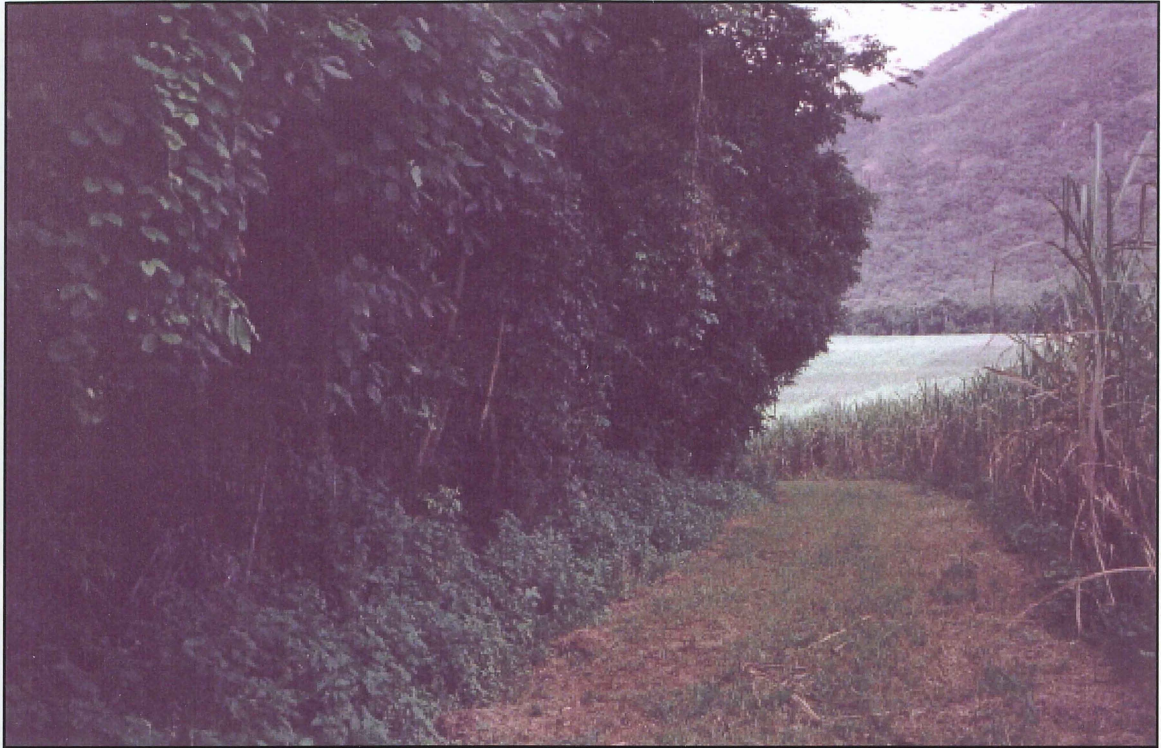
Plate 1. These trees are growing on the upper part of the remaining (northern) wall of Dead Man's Cutting at Riverstone (now part of Gordonvale), where five men were killed in a cave-in in 1900. The cutting was partly bulldozed in the 1980s. Walshs Pyramid is in the background. The photo was taken in 1999.

Landslides in the walls of trenches and cuttings in the plains have also not been considered in this study, but it must be remembered that this sort of failure can, and does, cause fatalities. On 31 May 1900, the landslide with the fourth largest recorded number of Australian landslide fatalities happened in Cairns. Five men were killed and one buried alive for ninety minutes when an 8 m-deep tramway cutting they were constructing at Riverstone for the mill at Gordonvale caved in. The location was at "Dead Man's Gully" or "Dead Man's Cutting" (A. Broughton, Cairns Historical Society, written communication, 1999), in a river terrace in Gordonvale, 3 km WNW of Walsh's Pyramid (Figure 1). The cutting was partly bulldozed in the 1980s, but the upper portion of the northern wall is still visible (Plate 1).

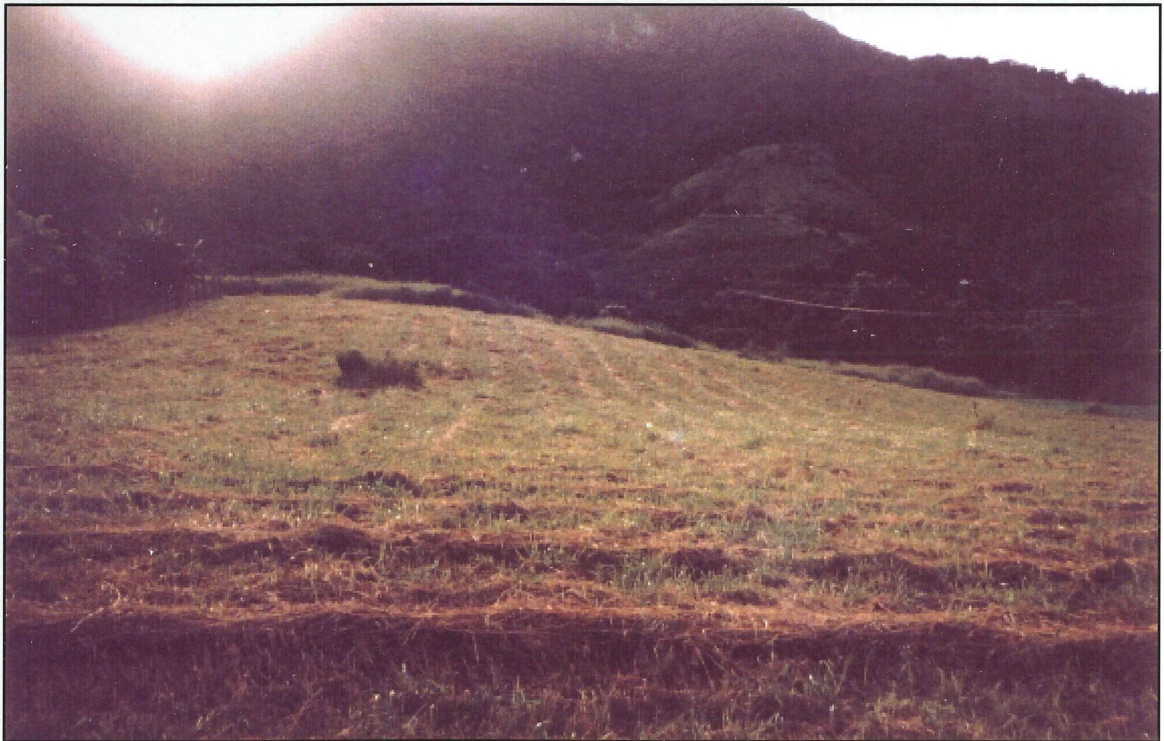
Plate 2. The gently sloping land in front of the escarpment is part of the proximal portion of the South Redlynch fan complex in Freshwater Valley.

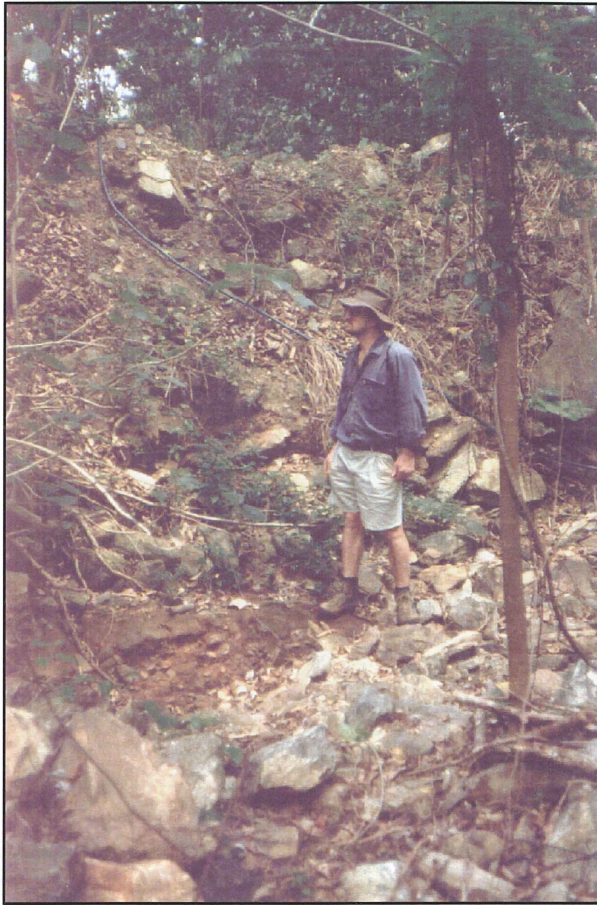
Plate 3. Proximal debris flow deposits in bank of creek in South Redlynch fan, just east of Harvey Road.

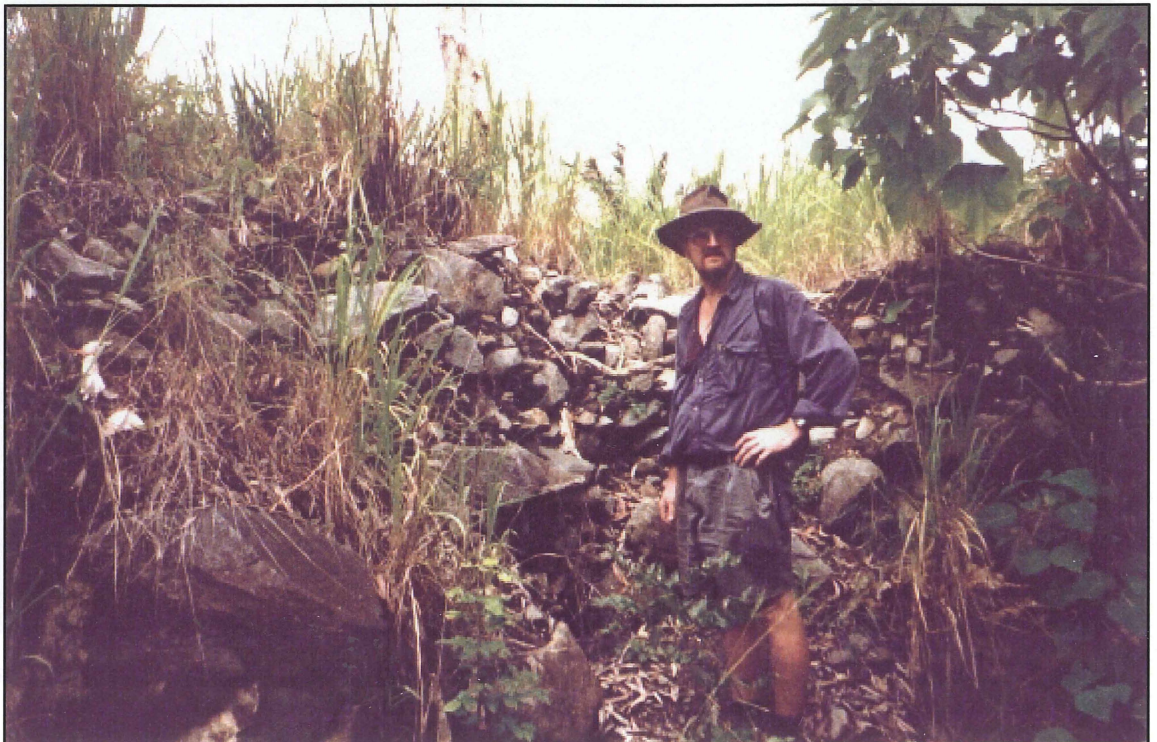
Plate 5. Debris, on the landward side of the Captain Cook Highway behind Ellis Beach, from one of the 1951 debris flows. The photo was taken in 1997.

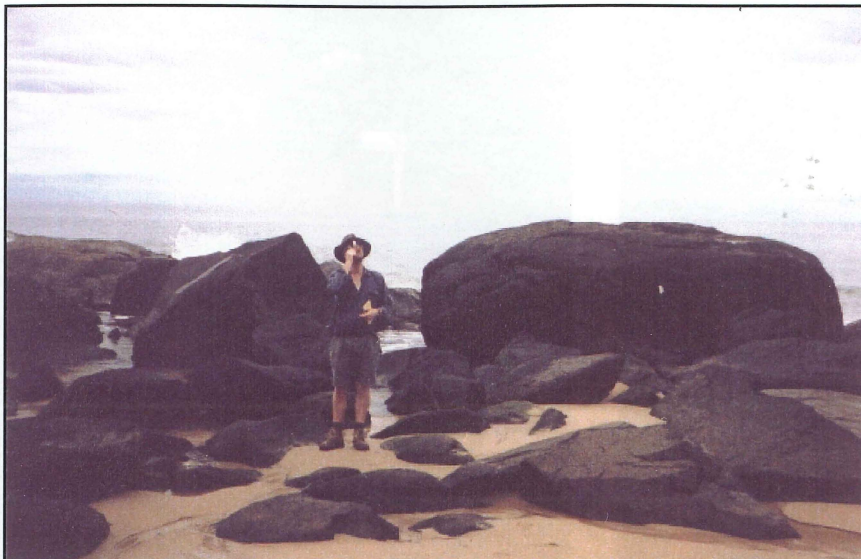
Plate 6. Boulders deposited on Ellis Beach by the 1951 debris flows. The photo was taken in 1997.

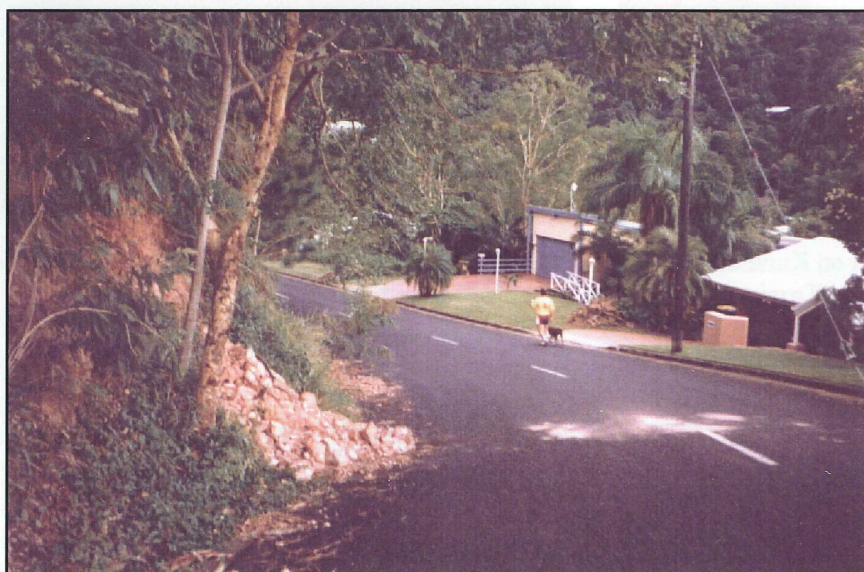
Plate 7. Landslide in Bayview Heights triggered by rain from Tropical Cyclone 'Justin' in March 1997.

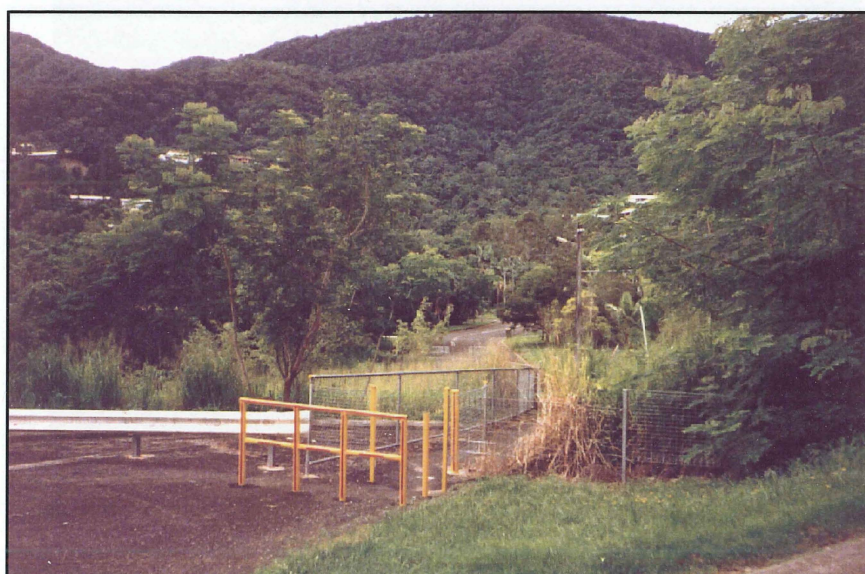
Plate 8. During Tropical Cyclone 'Joy' in December 1990 a landslide to the left of the steel fence in the centre foreground severed the traffic connection between Granadilla Drive in the foreground and Comet Street, Bayview Heights, near the centre of the photo. The two roads are now connected by only a footpath.

In 1990, during Tropical Cyclone *Joy*, presumed erosion of a creek bank below a road caused a landslide which severed the traffic connection between Granadilla Drive and Comet Steet, Bayview Heights. These two roads are now connected only by a footpath (Plate 8).

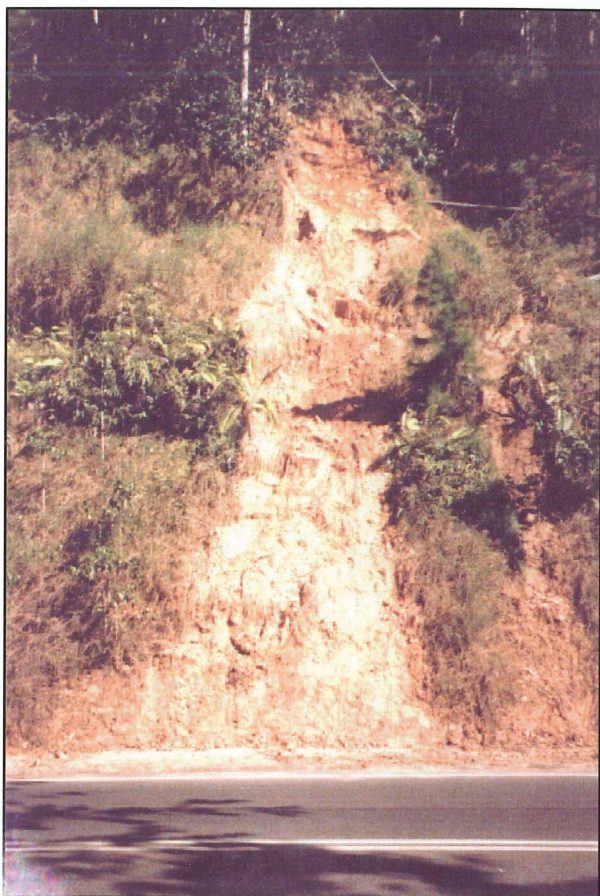
Plate 9. One of 46 batter failures on Kuranda Range Road, triggered by rain brought by Tropical Cyclone 'Justin' in March 1997.

Forty-six new batter failures (Plate 9) and one new fill failure were logged along Kuranda Range Road after *Justin*, and batter failures were noted along other roads in Cairns (Appendix C).

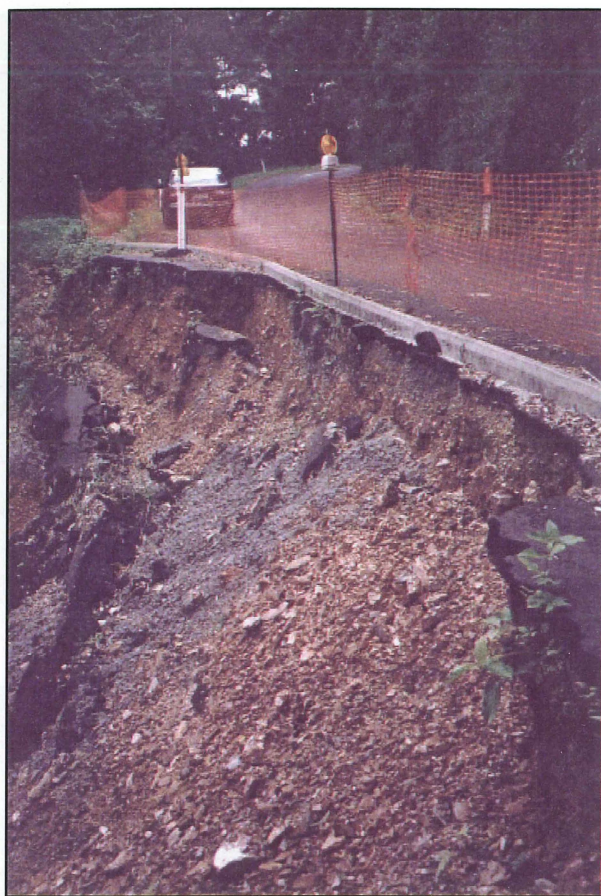
Plate 10. Fill failure on Lake Morris Road, triggered by the heavy rain in March 1999.

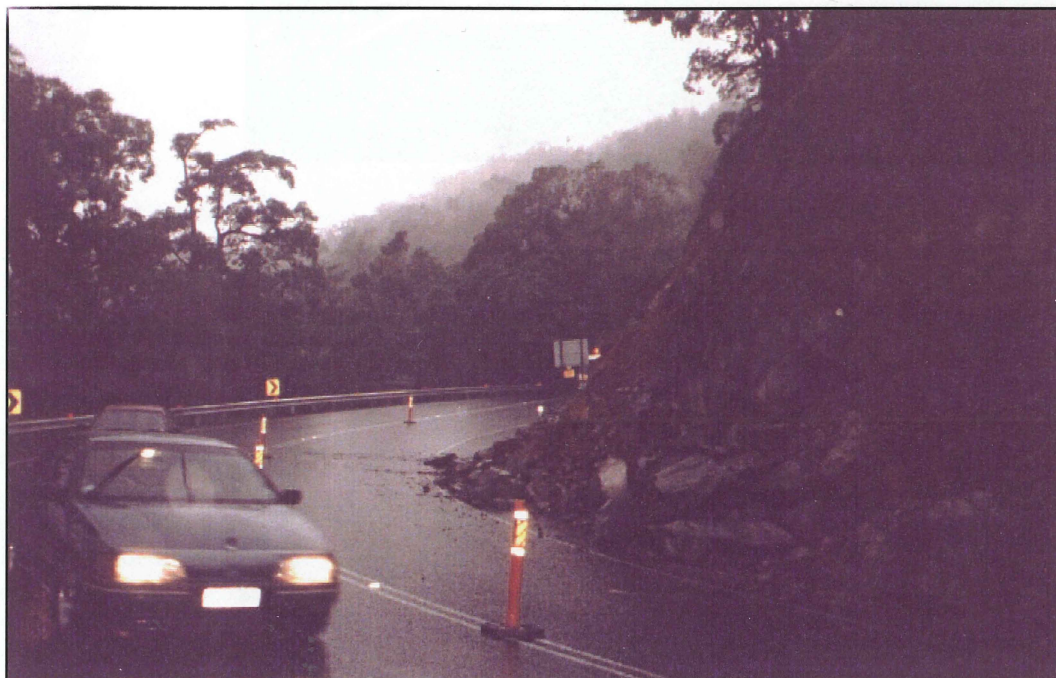
Plate 11. Rain on 26 February 1999 triggered this 500 cubic metre rock topple/fall near the Smithfield end of the Kuranda Range Road. The landslide was still active the next morning, when this photo was taken.
