# Nutrient Release from Sediments of the Torbay Drainage System, South-Western Australia

**Record**

**2005/14**

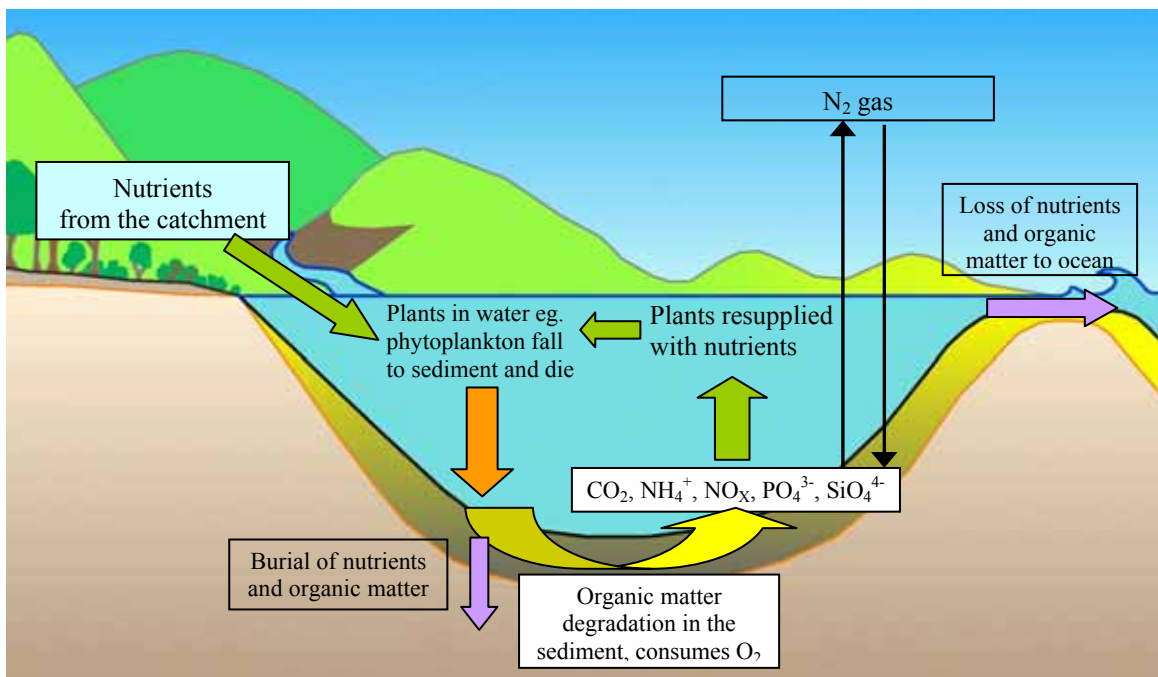
Figure 1-1. Schematic diagram of nutrient cycling in wave-dominated type estuaries. Green arrows indicate supply of nutrients to plants, the orange arrow indicates organic matter supply to the sediment, the yellow arrow represents organic matter breakdown, the black arrows show loss of N through denitrification, and N supply through N fixation, and the purple arrows show loss of nutrients and organic matter to the ocean and burial in the sediments (this is often limited in wave-dominated estuaries such as Torbay Inlet).

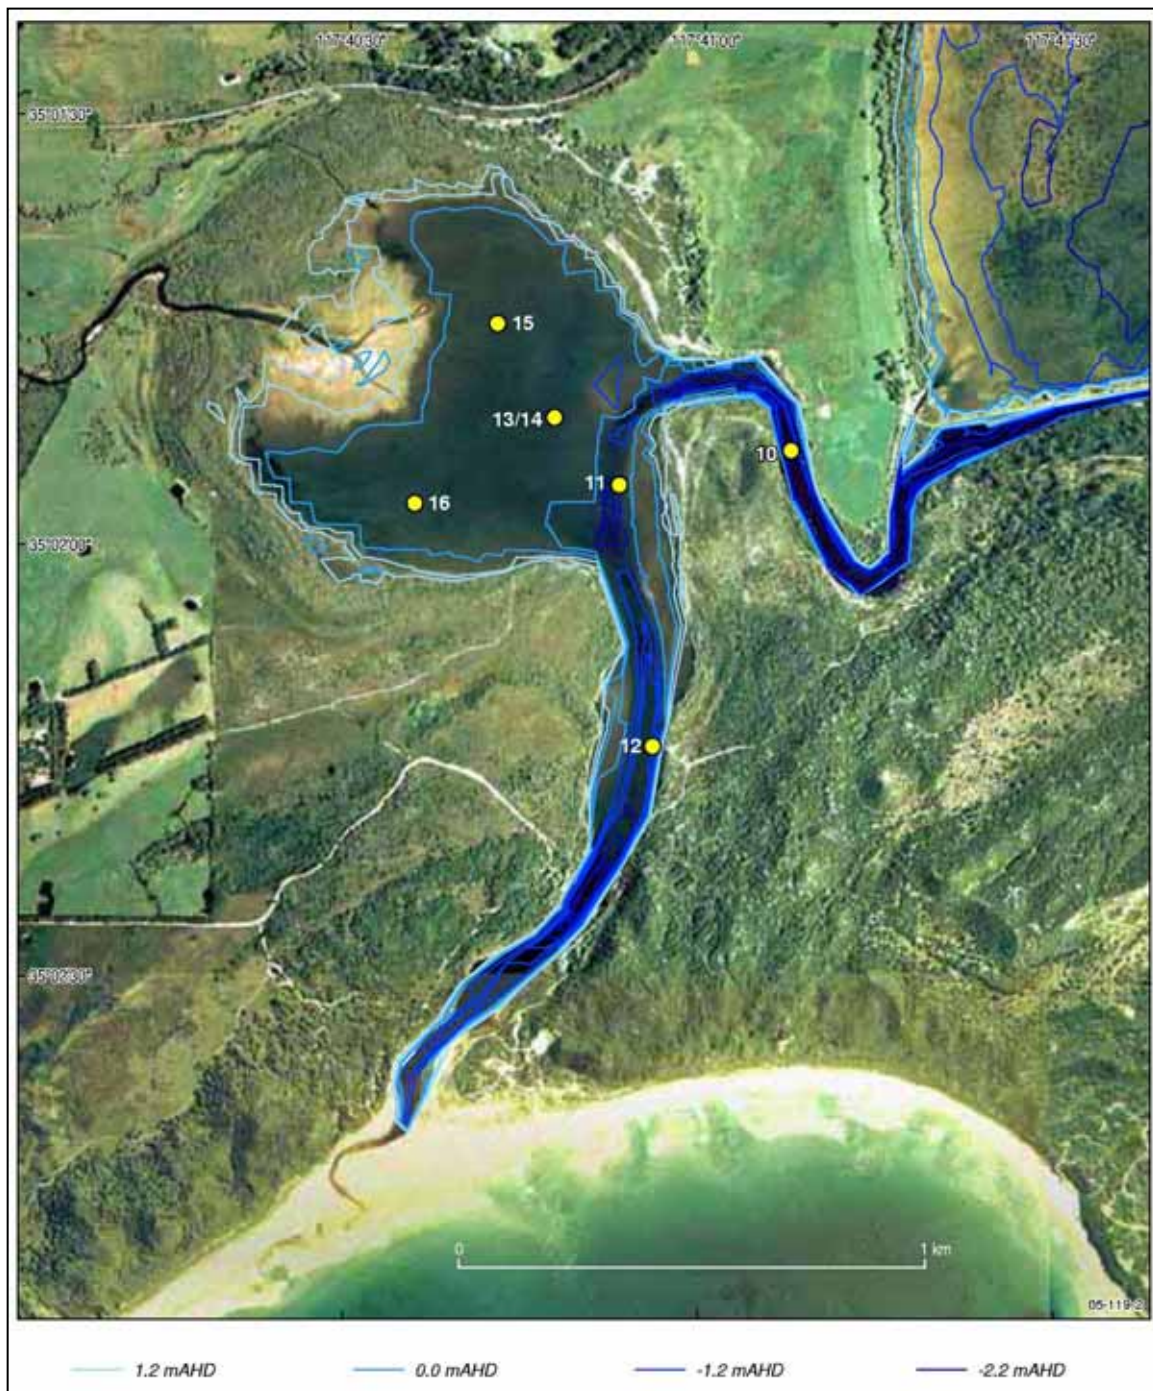
Figure 2-2. Torbay Inlet bathymetry and sampling site locations. mAH = metres above Australian Height Datum. Aerial photo base image source: Department of Land Information, WA Government.

Two chamber sites were chosen to represent conditions in the deep, muddy channel (TI\_11 and TI\_12; Figure 2-2; Table 2-1). A further two chamber sites were located in the shallow, sandy basin area (TI\_13 and TI\_14) and another site upstream of the Inlet in Marbelup High Level Drain (TI\_10). Sites TI\_13 and TI\_14, in the sandy shallow basin were less than 5 m apart. A light chamber was deployed at site TI\_14, whereas a dark chamber was deployed at site TI\_13 and all other chamber sites (Table 2-1). Section 2B2 explains the difference between ‘light’ and ‘dark’ chambers.

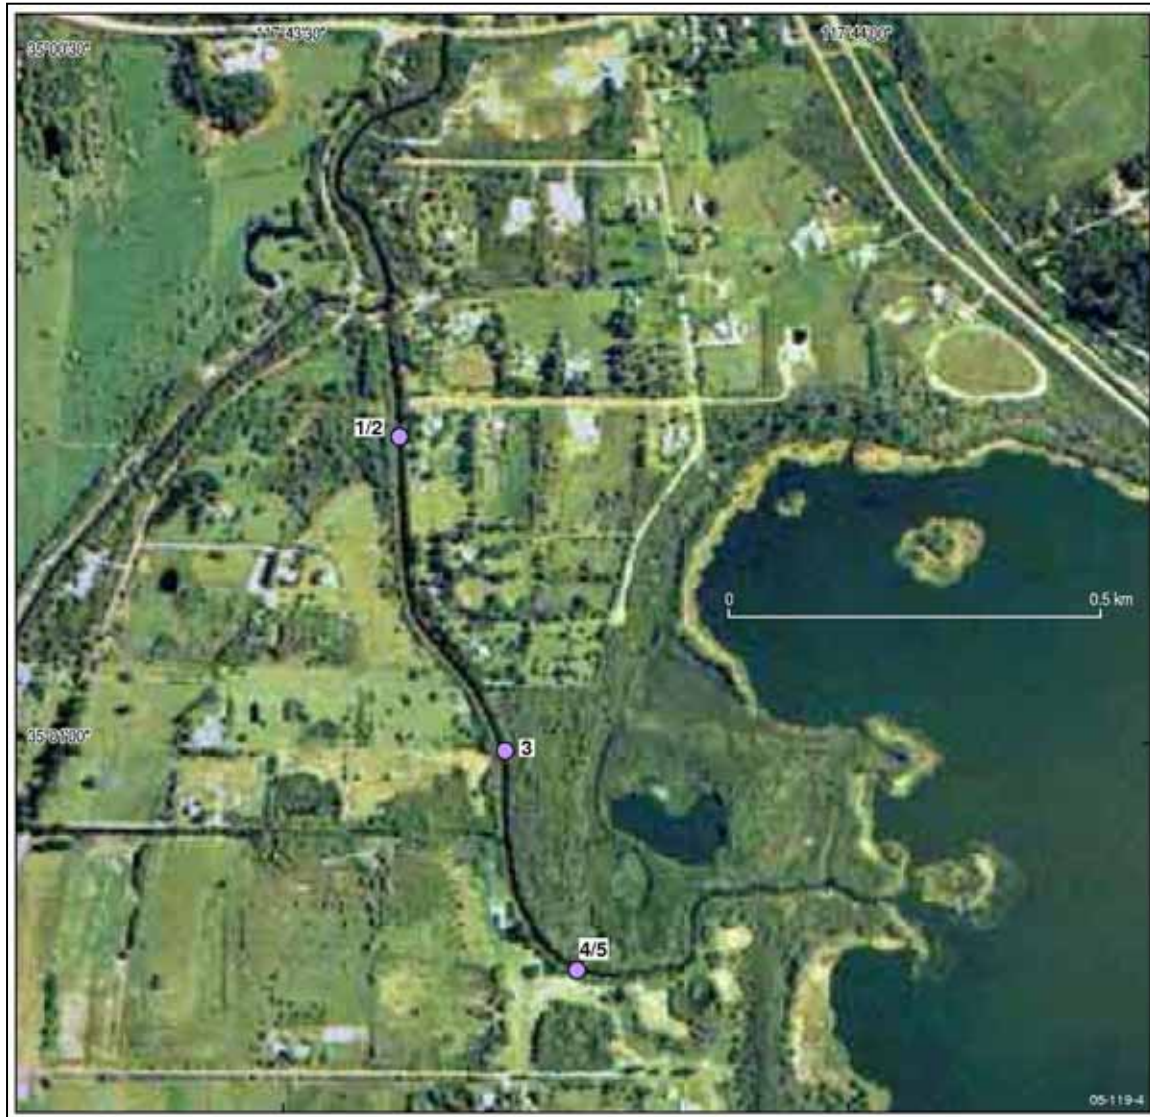
*Figure 2-4. Marbelup Brook sampling site locations. mAHD = metres above Australian Height Datum. Aerial photo base image source: Department of Land Information, WA Government.*

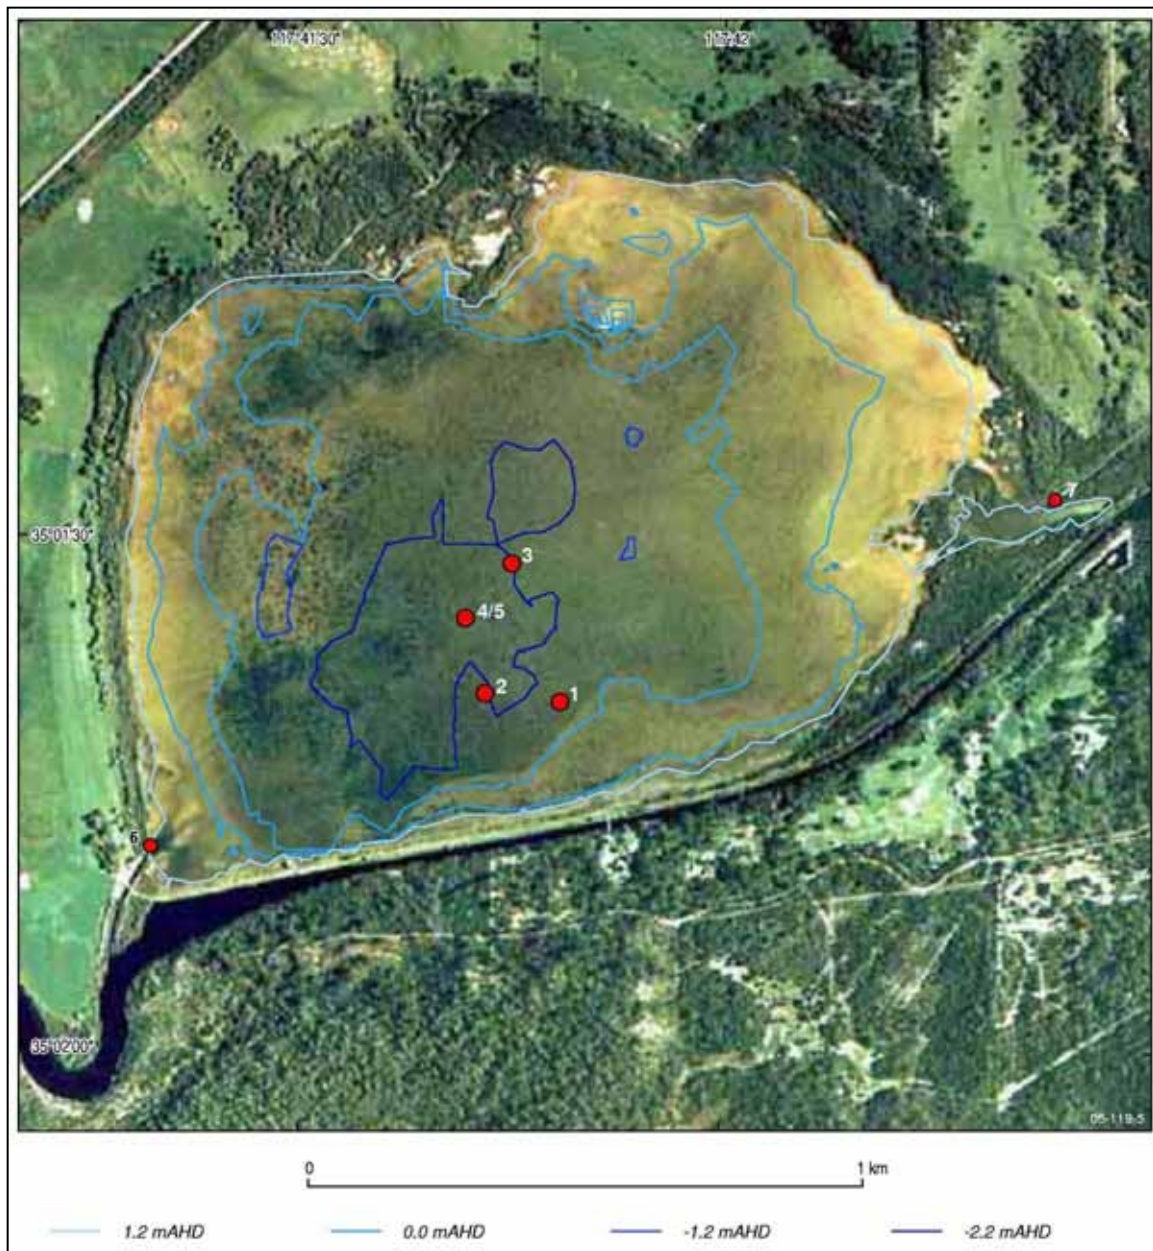
Figure 2-5. Lake Manarup bathymetry sampling site locations. mAH = metres above Australian Height Datum. Aerial photo base image source: Department of Land Information, WA Government.

The water column of Lake Manarup (Figure 2-5) was the clearest of all the waterways sampled. Water column properties were similar at all sites within the central part of the basin (MNL\_1 to MNL\_4/5), indicating this part of the waterway was well mixed. Temperatures ranged from 15.4 to 16.0 °C, salinity from 8.9 to 9.3, and DO was slightly depleted, ranging from 78 to 84 %. Water column conditions downstream near the floodgates (MNL\_6) and in the upstream drain (MNL\_7), differed significantly to the main body of the lake. At MNL\_6, the temperature was higher (18.6 °C), and DO was significantly depleted (53 %). Salinity was also much higher (24.9), possibly due to marine water leaking through the floodgates from Torbay Inlet. At MNL\_7, salinity was 2.4, indicating freshwater was entering the lake from the catchment (North Creek Drain; Figure 1-2). DO at this site was high (138 %), corresponding to extremely high Chl-a (116.5 µg/L).

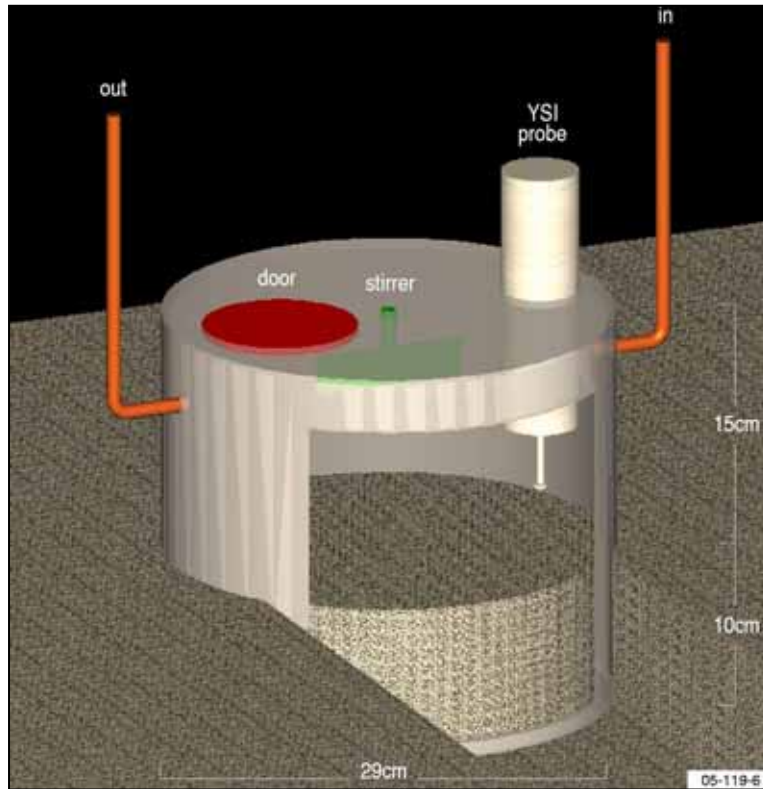
Figure 2-6. Schematic diagram of a benthic chamber experimental set-up.

Timing of sample draws from each chamber involved: an initial water sample representing ambient conditions (bottom water) taken immediately before lid closure; a sample draw taken 30 minutes after lid closure; then, a sample drawn every 0.5 to 1.5 hours, with the last sample taken up to 8 hours after lid closure. [Appendix 1](#) describes chamber specifications in more detail, as well as sample draw, sample handling, and sub-sampling procedures. Sample draws from each chamber

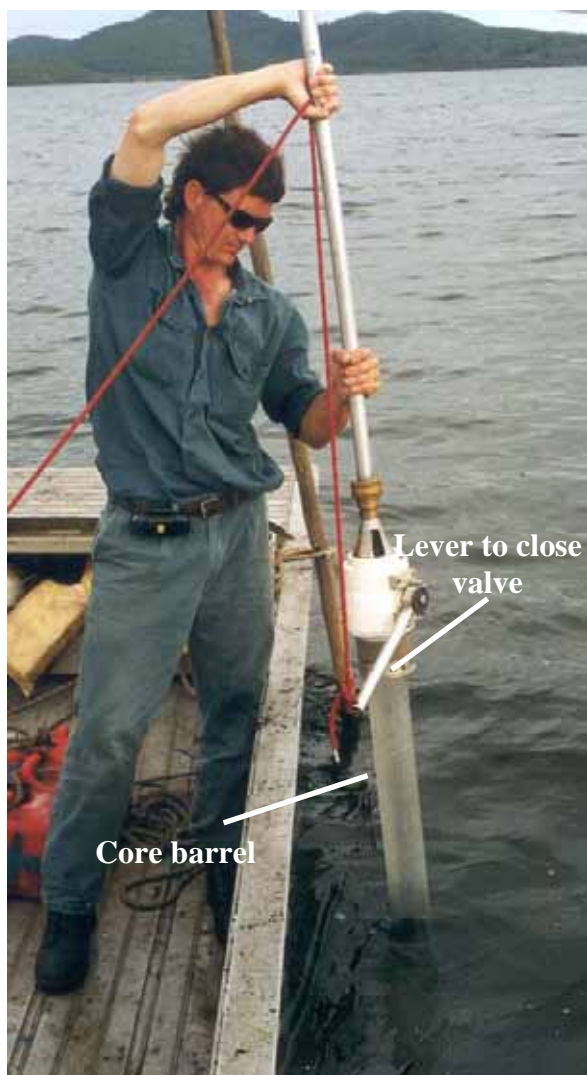
*Figure 2-7. Collecting a sediment core using a pole corer.*

Three sediment cores were collected within each waterway for porewater and sediment analysis ([Table 2-1](#)). These were all located at benthic chamber sites. We collected these cores using a manually operated corer ([Figure 2-7](#)), which we pushed into the soft sediment using a long pole (pole corer; see [Appendix 2](#) for more detail). The depth of sediment collected varied between 20 and 50 cm depending on how far the core barrel could be pushed into the sediment. Cores were sliced into depth intervals and centrifuged to separate porewaters from the solid phase. Porewaters were analysed for  $\text{PO}_4^{3-}$ ,  $\text{NO}_x^-$ ,  $\text{NH}_4^+$ ,  $\text{SiO}_4^{4-}$ , and  $\text{TCO}_2$  using the methods outlined in [Appendix 3](#). Note that  $\text{TCO}_2$  was measured by means of conductivity rather than the alkalinity titration method used for the lower concentration benthic chamber samples. We also measured the sediment porosity of each depth interval (see [Appendix 2](#)).

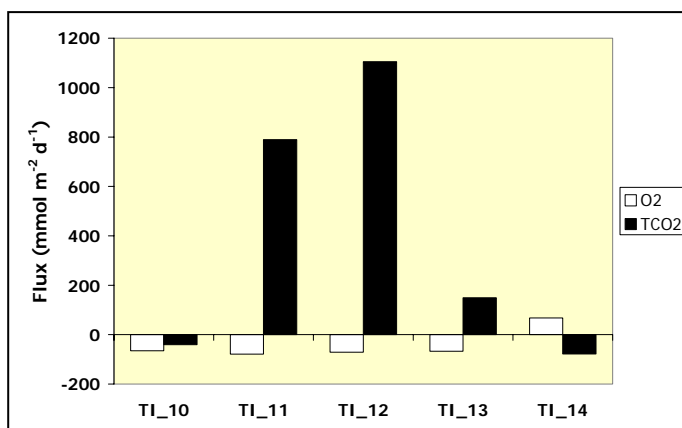
Figure 3-1.  $\text{O}_2$  and  $\text{TCO}_2$  fluxes from Torbay Inlet

Apart from site TI\_10, oxygen consumption rates in Torbay Inlet were all less than  $\text{TCO}_2$  production rates. The light chamber at site TI\_14 showed signs of photosynthetic production with oxygen produced ( $67.9 \text{ mmol m}^{-2} \text{ day}^{-1}$ ) and  $\text{TCO}_2$  consumed ( $-77.6 \text{ mmol m}^{-2} \text{ day}^{-1}$ ). The lower channel sites (sites TI\_11 and TI\_12) have extremely high  $\text{TCO}_2$  fluxes ( $789.5$  and  $1104.3 \text{ mmol m}^{-2} \text{ day}^{-1}$  respectively).

All fluxes were derived from dark benthic chambers except for Site TI\_14, which was a light chamber and located at the same site as TI\_13. The fluxes measured in the lower channel sites (TI\_11 and TI\_12) were consistently higher for all metabolites except  $\text{NO}_x$  compared to the upper channel (TI\_10) and the shallow sandy sites (TI\_13 and TI\_14; Figure 3-1 to Figure 3-3).

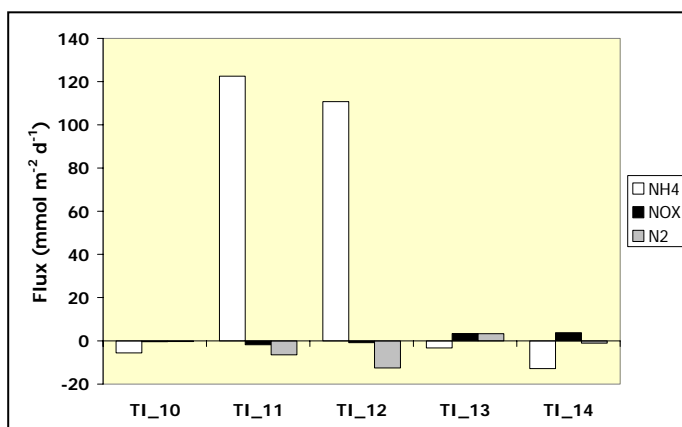
Figure 3-2.  $\text{NH}_4^+$ ,  $\text{NO}_x$ , and  $\text{N}_2$  fluxes from Torbay Inlet

The lower channel sites had very high  $\text{NH}_4^+$  fluxes ( $122.5$  and  $110.7 \text{ mmol m}^{-2} \text{ day}^{-1}$  respectively), whereas the remaining sites all had  $\text{NH}_4^+$  uptake (ranging from  $-3.3$  to  $-12.8 \text{ mmol m}^{-2} \text{ day}^{-1}$ ). The shallow sandy sites (sites TI\_13 and TI\_14) are the only sites with  $\text{NO}_x$  release ( $3.4$  and  $3.8 \text{ mmol m}^{-2} \text{ day}^{-1}$  respectively). There were significant  $\text{N}_2$  uptake rates in the lower channel sites ( $-6.4$  and  $-12.5 \text{ mmol m}^{-2} \text{ day}^{-1}$ ).

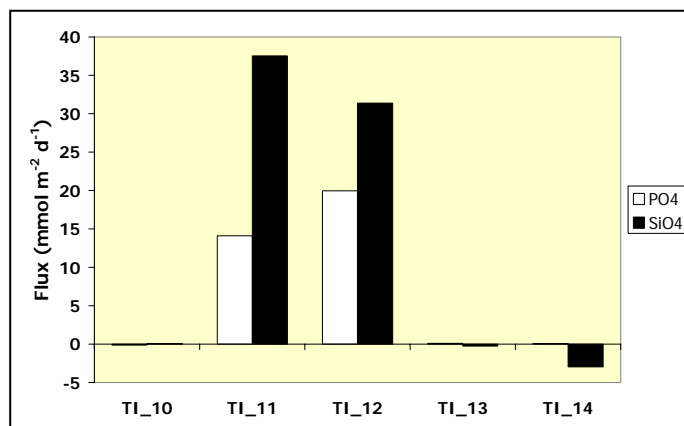
Figure 3-3.  $PO_4^{3-}$  and  $SiO_4^{4-}$  fluxes from Torbay Inlet

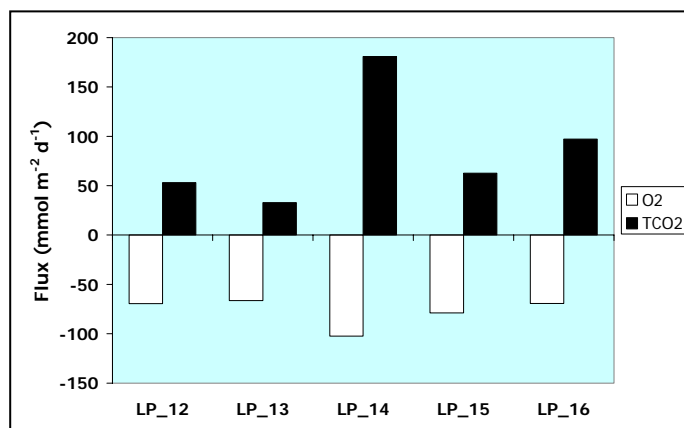
Figure 3-4.  $O_2$  and  $TCO_2$  fluxes from Lake Powell

All sites had similar  $O_2$  consumption and  $TCO_2$  release rates, except the site with black organic mud (site LP\_14), which had significantly higher  $TCO_2$  than  $O_2$  fluxes (180.8 and -102.3 mmol m<sup>-2</sup> day<sup>-1</sup> respectively).

Figures 3-4 to 3-6 show the benthic nutrient fluxes for Lake Powell. All fluxes were derived from dark benthic chambers except for Site LP\_16, which was a light chamber and located at the same site as LP\_15.

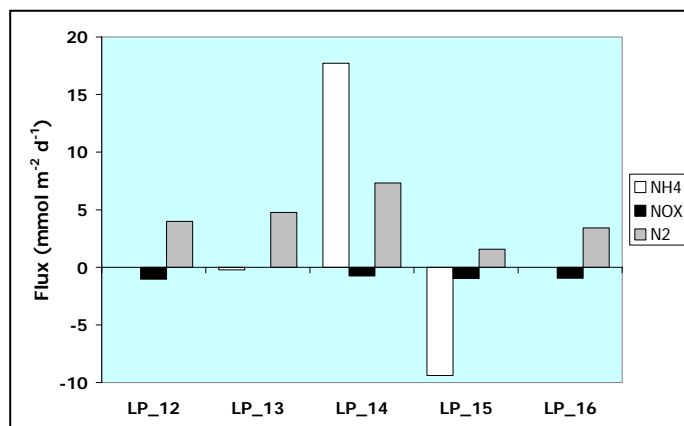
Figure 3-5.  $\text{NH}_4^+$ ,  $\text{NO}_x$ , and  $\text{N}_2$  fluxes from Lake Powell

Site LP\_14 had a large  $\text{NH}_4^+$  release ( $17.7 \text{ mmol m}^{-2} \text{ day}^{-1}$ ) while site LP\_15 had a significant  $\text{NH}_4^+$  uptake ( $-9.4 \text{ mmol m}^{-2} \text{ day}^{-1}$ ). All other sites had negligible  $\text{NH}_4$  fluxes.  $\text{NO}_x$  fluxes were small and negative at all sites. All sites had positive  $\text{N}_2$  fluxes ranging from  $1.6 \text{ mmol m}^{-2} \text{ day}^{-1}$  at site LP\_15 to  $7.3 \text{ mmol m}^{-2} \text{ day}^{-1}$  at site LP\_14

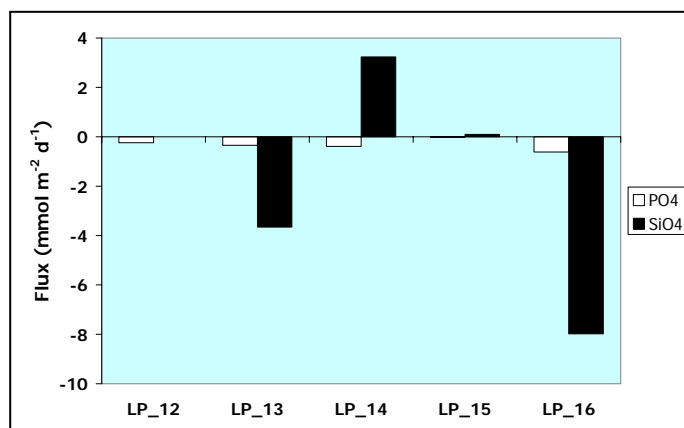
Figure 3-6.  $\text{PO}_4^{3-}$  and  $\text{SiO}_4^{4-}$  fluxes from Lake Powell

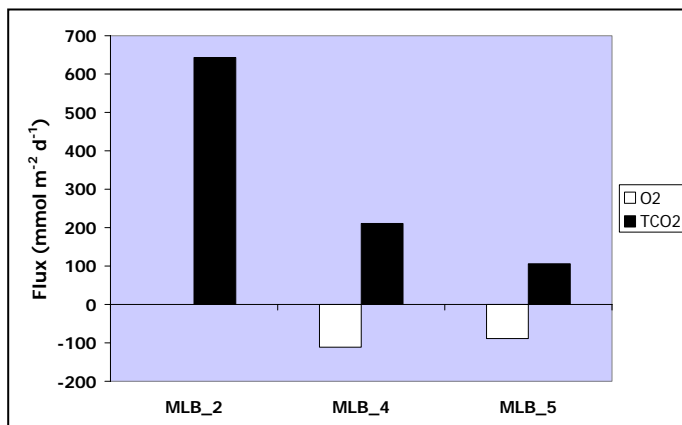
Figure 3-7. O<sub>2</sub> and TCO<sub>2</sub> fluxes from Marbelup Brook

No O<sub>2</sub> flux was recorded at site MLB\_2 due to a failure of the oxygen probe. O<sub>2</sub> uptake rates at sites MLB\_4 and MLB\_5 were very high (-111.4 and -88.9 mmol m<sup>-2</sup> day<sup>-1</sup> respectively). TCO<sub>2</sub> fluxes were also very high, ranging from 106.1 mmol m<sup>-2</sup> day<sup>-1</sup> at site MLB\_5 to 643.3 mmol m<sup>-2</sup> day<sup>-1</sup> at site MLB\_2.

Figures 3-7 to 3-9 show the benthic nutrient fluxes for Marbelup Brook. The benthic chambers deployed at sites MLB\_1 and MLB\_3 failed to seal adequately, therefore, no data is shown for these sites. Sites MLB\_4 and MLB\_5 were located together with MLB\_5 being a light chamber. However, due to the water clarity, no light would have reached this chamber (see  $K_d$  values in Table 3-1 and results in Section 3A3).

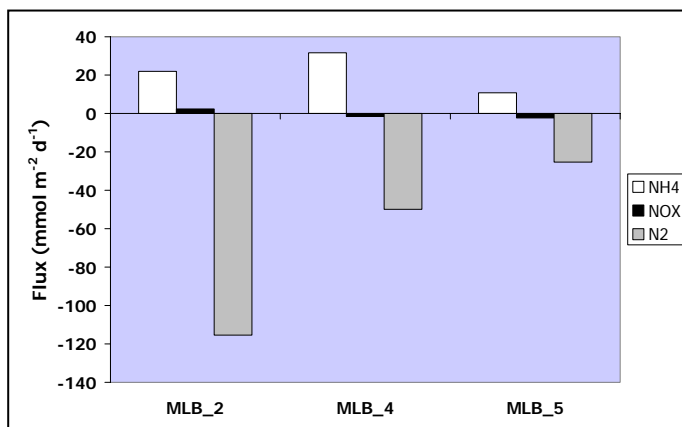
Figure 3-8. NH<sub>4</sub><sup>+</sup>, NO<sub>x</sub>, and N<sub>2</sub> fluxes from Marbelup Brook

NH<sub>4</sub><sup>+</sup> fluxes were high at all sites, ranging from 10.8 mmol m<sup>-2</sup> day<sup>-1</sup> at site MLB\_5 to 31.6 mmol m<sup>-2</sup> day<sup>-1</sup> at site MLB\_4. NO<sub>x</sub> fluxes are either very small or negative at all sites. N<sub>2</sub> uptake rates were extremely high at all sites and exceeded -100 mmol m<sup>-2</sup> day<sup>-1</sup> at site MLB\_2.

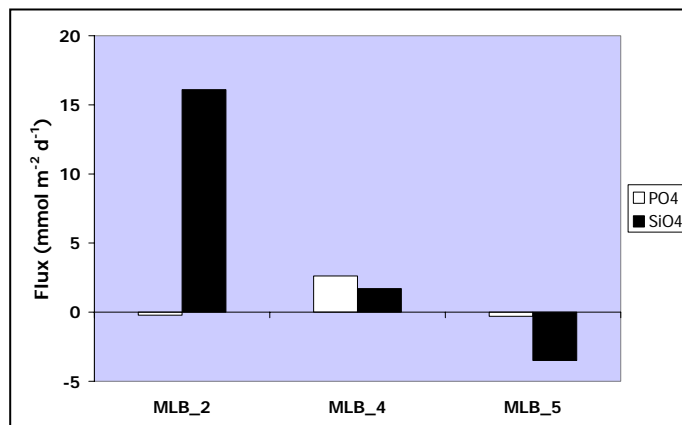
Figure 3-9. PO<sub>4</sub><sup>3-</sup> and SiO<sub>4</sub><sup>4-</sup> fluxes from Marbelup Brook

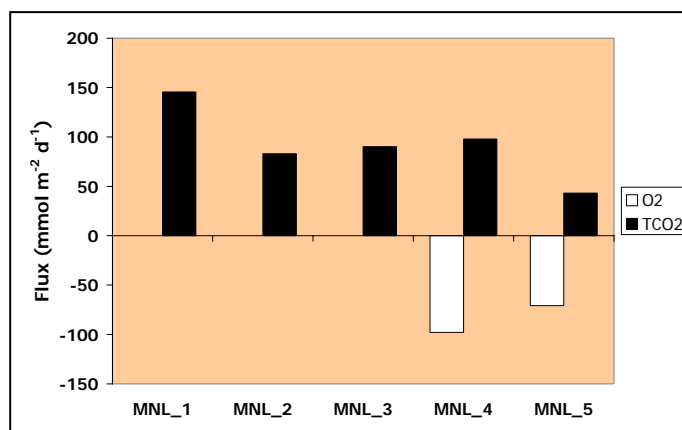
Figure 3-10. O<sub>2</sub> and TCO<sub>2</sub> fluxes from Lake Manarup

No O<sub>2</sub> fluxes were recorded at sites MNL\_1, MNL\_2 and MNL\_3 due to a failure of the oxygen probe. O<sub>2</sub> consumption and TCO<sub>2</sub> release were greater at MNL\_4 than at MNL\_5 possible due to some photosynthetic activity in the light chamber. TCO<sub>2</sub> release rates in the dark chambers ranged from 83.0 to 145.4 mmol m<sup>-2</sup> day<sup>-1</sup>.

Figures 3-10 to 3-12 show the benthic nutrient fluxes for Lake Manarup. All fluxes were derived from dark benthic chambers except for site MNL\_5, which was a light chamber and located at the same site as MNL\_4. Fluxes at all sites were generally similar and relatively small.

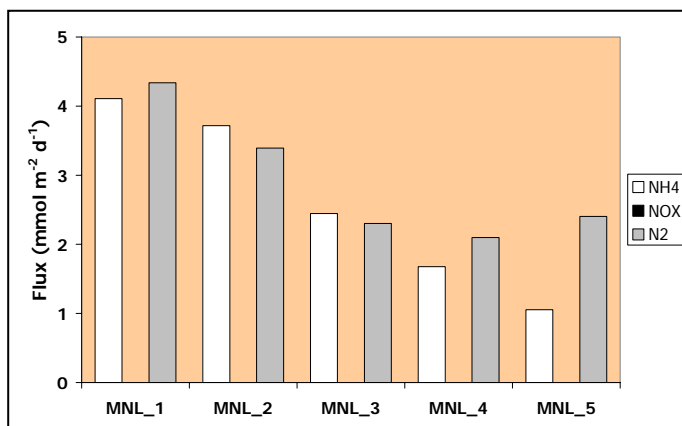
Figure 3-11.  $\text{NH}_4^+$ ,  $\text{NO}_x$ , and  $\text{N}_2$  fluxes from Lake Manarup

$\text{NH}_4^+$  fluxes were low at all sites ranging from  $1.1 \text{ mmol m}^{-2} \text{ day}^{-1}$  at site MNL\_5 to  $4.1 \text{ mmol m}^{-2} \text{ day}^{-1}$  at site MNL\_1.  $\text{NO}_x$  was below detection limits at all sites.  $\text{N}_2$  fluxes followed a similar trend to the  $\text{NH}_4^+$  fluxes with site MNL\_1 having the highest release ( $4.3 \text{ mmol m}^{-2} \text{ day}^{-1}$ ).

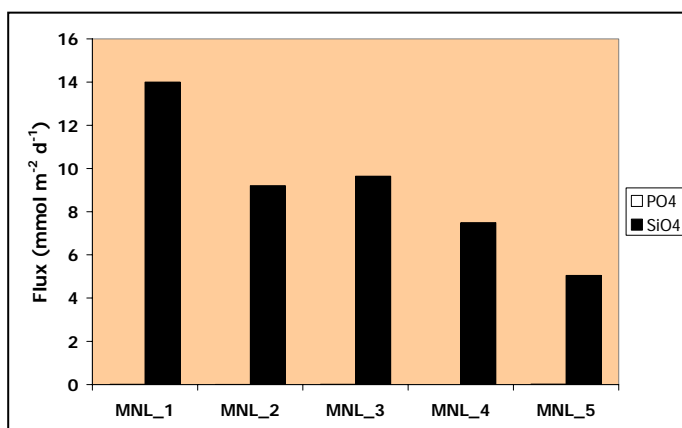
Figure 3-12.  $\text{PO}_4^{3-}$  and  $\text{SiO}_4^{4-}$  fluxes from Lake Manarup

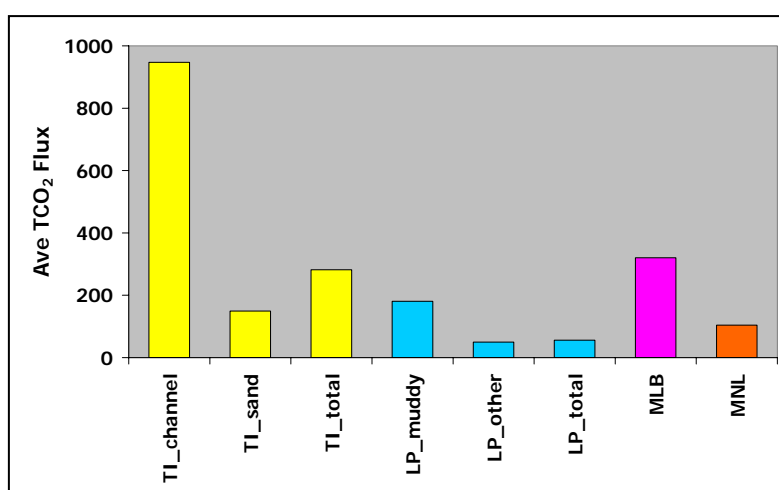
Figure 4-1. Average  $\text{TCO}_2$  fluxes for the study sites ( $\text{mmol m}^{-2} \text{ day}^{-1}$ )

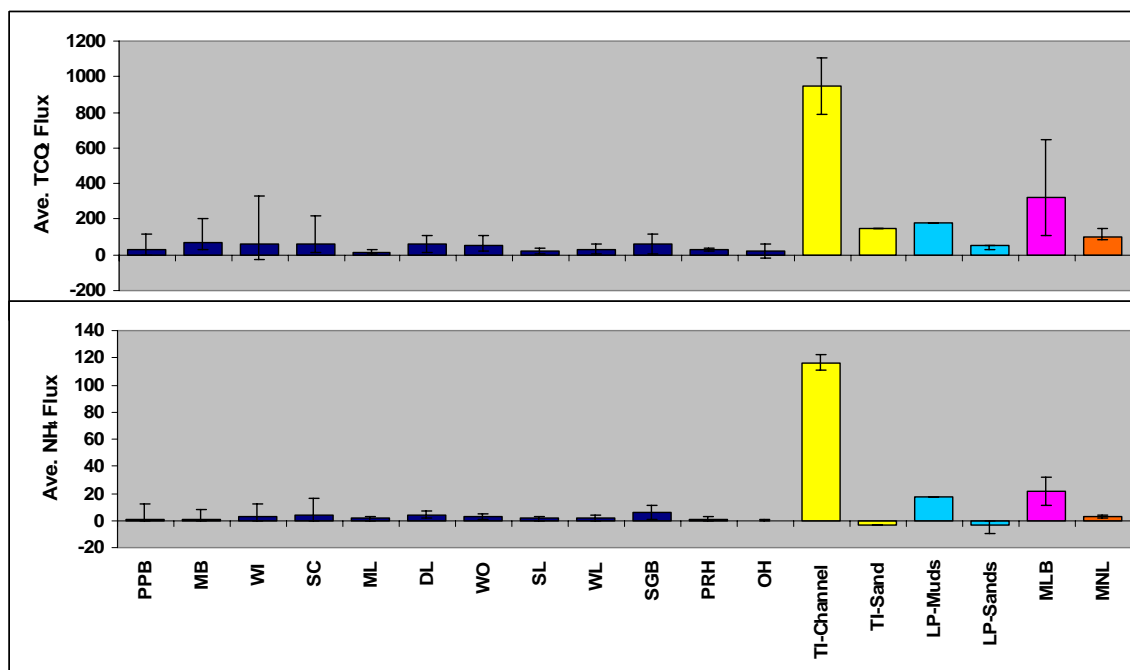
Figure 4-2. Average TCO<sub>2</sub> and NH<sub>4</sub><sup>+</sup> fluxes from temperate Australian estuaries (PPB=Port Phillip Bay, VIC; MB=Morton Bay, QLD; WI=Wilson Inlet, WA; SC=Swan River/Canning River, WA; ML=Myall Lake, NSW; DL=Durras Lake, NSW; WO=Lake Wollumboola, NSW; SL=Smiths Lake, NSW; WL=Wallis Lake, NSW; SGB=St Georges Basin, NSW; PRH=Princess Royal Harbour, WA; OH=Oyster Harbour, WA; Range Bars show maximum and minimum values)

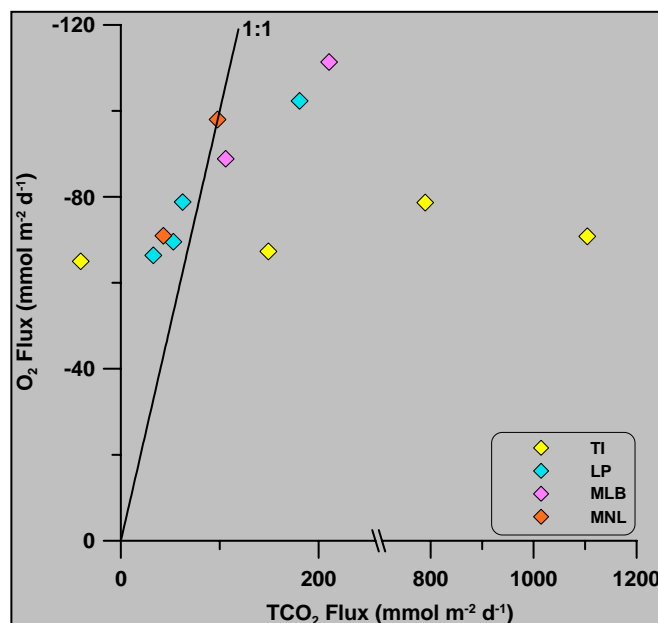
The  $\text{TCO}_2$  fluxes in Torbay Inlet are highly variable whereas the corresponding  $\text{O}_2$  fluxes are quite similar, indicating that the same amount of oxygen is being consumed no matter the amount of carbon decomposed. Data for Lake Powell, Marbelup Brook and Lake Manarup all show a similar trend to each other; shallower slope than the 1:1 line and an apparent y-intercept at about  $-60 \text{ mmol m}^{-2} \text{ day}^{-1} \text{ O}_2$ . These results suggest that there is a demand for oxygen even at very low  $\text{TCO}_2$  fluxes. Furthermore, it becomes clear that other processes than aerobic carbon oxidation affect the  $\text{O}_2$  and  $\text{TCO}_2$  fluxes. These processes include anaerobic pathways of organic matter breakdown, e.g. sulphate reduction, nitrogen (and carbon) fixation utilizing  $\text{O}_2$  as energy source, and reoxidation of reduced species such as sulphide.

Figure 4-3.  $\text{TCO}_2$  flux versus  $\text{O}_2$  flux (dark chambers only; note break in x-axis)

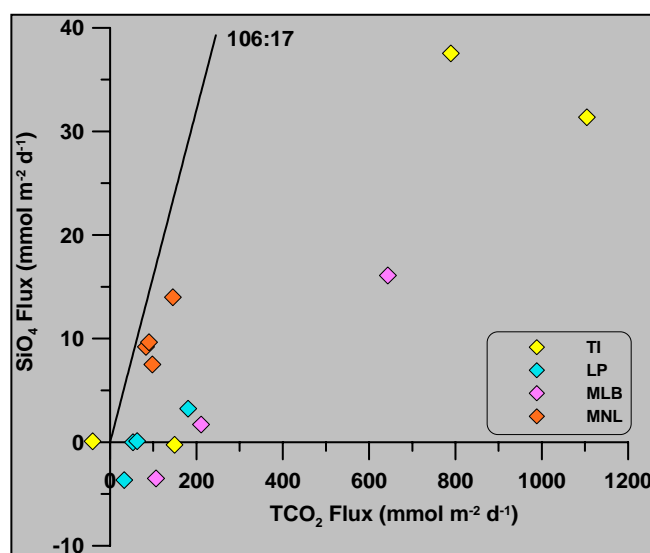
macroalgae, or at the sediment surface. The plot of  $\text{TCO}_2$  flux against  $\text{SiO}_4^{4-}$  flux (Figure 4-4) can indicate if diatoms are the major source of organic matter undergoing degradation in the sediments. If diatoms were the major source of organic matter, data would plot close to the 106:17 line (Brzezinski, 1985).

Figure 4-4.  $\text{TCO}_2$  flux versus  $\text{SiO}_4^{4-}$  flux (dark chambers only)

In Marbelup Brook, only MLB\_2 was found to have a diatomaceous component to its organic matter, but this was only about 15 %. Sites MLB\_4 and MB\_5 showed a non-diatomaceous source of organic matter. Lake Manarup was the only waterway in which diatoms formed a major component of the organic matter source. 50 to 70 % of the organic matter source in Lake Manarup could be attributed to diatoms. Other possible sources of organic matter could be estuarine-derived non-diatomaceous or catchment-derived terrestrial organic matter.

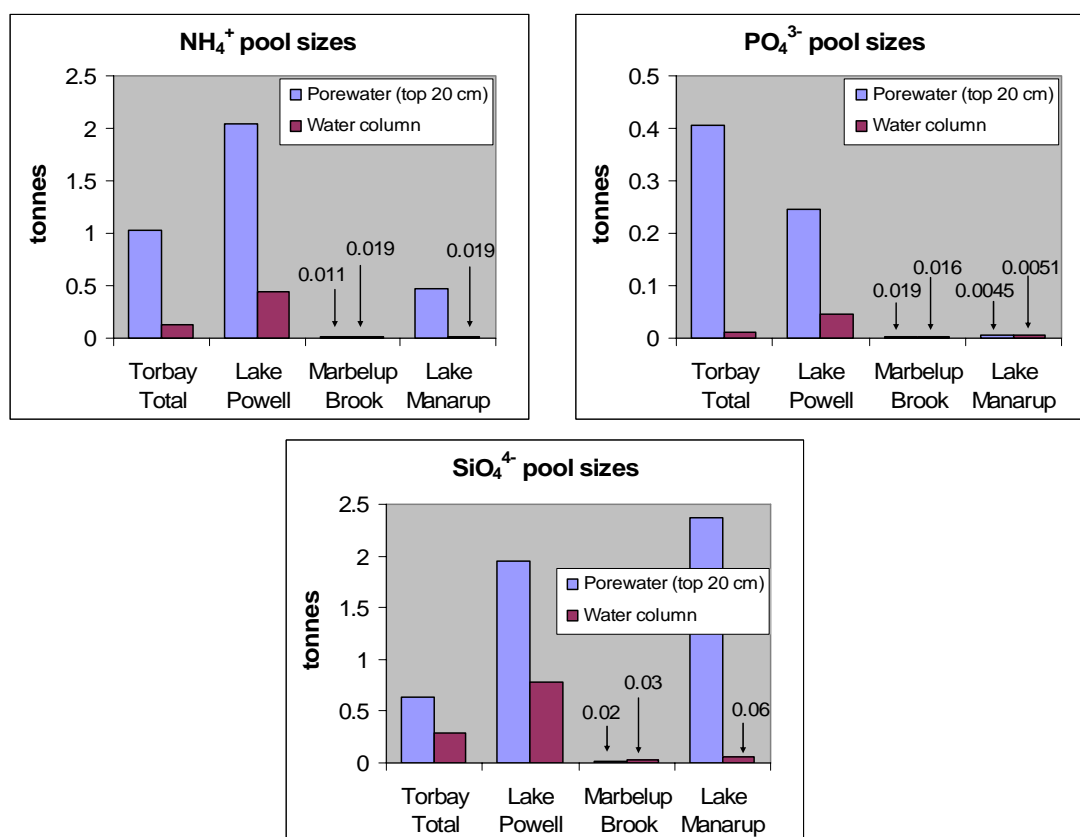
It was found that  $\text{NH}_4^+$ ,  $\text{PO}_4^{3-}$ , and  $\text{SiO}_4^{4-}$  pool sizes of the porewater in the top 20 cm of sediment by far exceed the nutrient pool sizes in the water column (Figure 4-5). Only Marbelup Brook represents an exception having similar surface sediment and water column nutrient pool sizes. In Marbelup Brook water column nutrient concentrations are by far the highest with average concentrations of 138, 5.3, and 105  $\mu\text{mol/l}$  for  $\text{NH}_4^+$ ,  $\text{PO}_4^{3-}$ , and  $\text{SiO}_4^{4-}$ , respectively, while porewater nutrient concentrations were relatively low (see Section 3C3). The importance and the impact of the Torbay Inlet channel facies is revealed by its nutrient pool size compared to the pool size of the shallow basin facies. Although the channel area only constitutes about 20 % of the total Torbay Inlet area, the N- and P-pool sizes of the channel are 10- and 20-fold larger than the shallow basin pool size (Appendix 7). Similarly, the depth integrated N- and P-mass of the muddy site of Lake Powell (site LP\_14) was more than 10-fold higher than at the sandy sites.

Figure 4-5. Nutrient pool sizes in surface sediments (top 20 cm) and in the water column of Torbay Inlet, Lake Powell, Marbelup Brook and Lake Manarup.

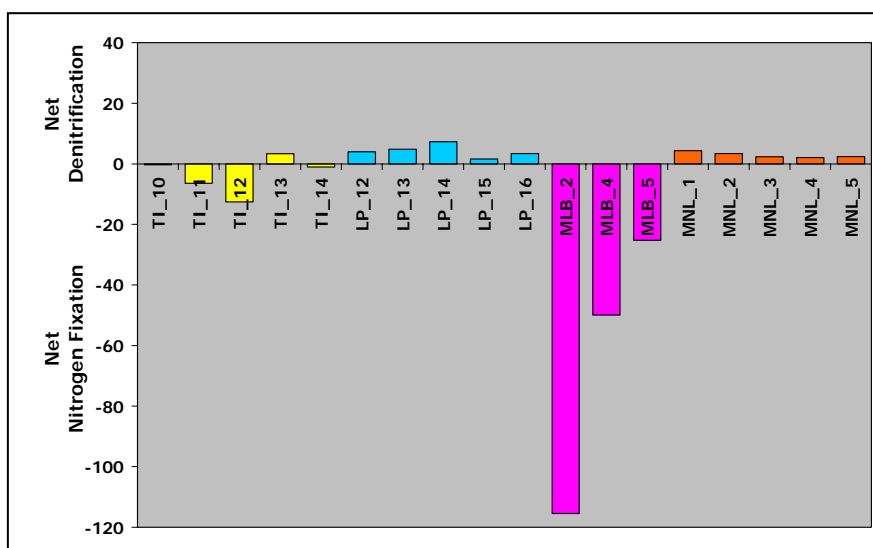
Positive fluxes represent net denitrification, whilst negative fluxes represent overall net nitrogen fixation. As both denitrification and nitrogen fixation may occur simultaneously, these results do not give us actual rates of each process. The channel sites in Torbay Inlet and all sites within Marbelup Brook were found to be net nitrogen fixing (Figure 4-6). The degree of nitrogen fixation appears to be significantly higher in Marbelup Brook compared to the channel sites in Torbay Inlet. The shallow sandy site in Torbay Inlet, Lake Powell and Lake Manarup were all found to be net denitrifying.

Figure 4-6.  $N_2$  fluxes for the study sites ( $\text{mmol m}^{-2} \text{ day}^{-1}$ ; positive  $N_2$  flux indicates net denitrification and a negative  $N_2$  flux indicates net N-fixation)

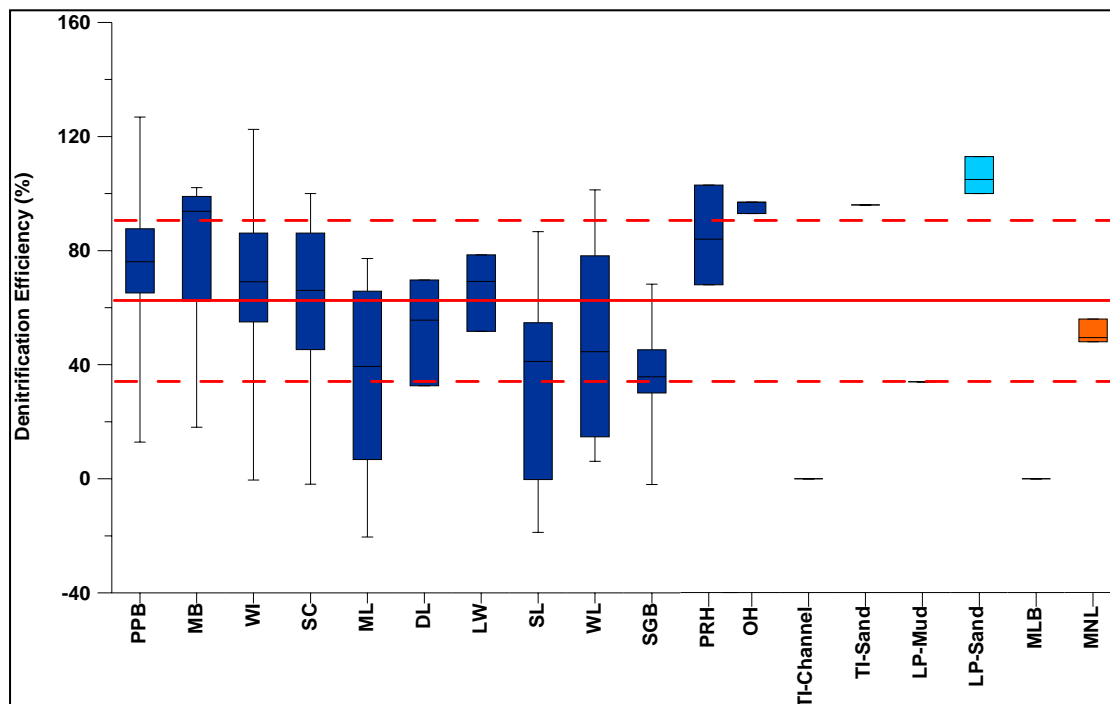
Compared to other temperate Australian estuaries (Figure 4-7), the sandy sediments in Torbay Inlet and Lake Powell had high denitrification efficiencies, whereas Lake Manarup and the muddy sediments in Lake Powell had lower than average denitrification efficiencies. Denitrification efficiencies in the muddy sediments of Torbay Inlet channel and Marbelup Brook are presumably zero, as mentioned above.

Figure 4-7. Box and whisker diagrams showing denitrification efficiencies for temperate Australian estuaries compared to waterbodies of the Torbay drainage system. The median is the horizontal line within the boxes, the bottom end of each box is the 25<sup>th</sup> percentile and the top end is the 75<sup>th</sup> percentile, and the vertical lines show the range of the outliers. Only the median is shown for TI-Channel, TI-Sand, LP-Mud, and MLB because there are only one or two measurements for these locations. The solid red line represents the average of all denitrification efficiencies and the dashed red lines represent  $\pm$  one standard deviation. (PPB=Port Phillip Bay, VIC; MB=Morton Bay, QLD; WI=Wilson Inlet, WA; SC=Swan River/Canning River, WA; ML=Myall Lake, NSW; DL=Durras Lake, NSW; WO=Lake Wollumboola, NSW; SL=Smiths Lake, NSW; WL=Wallis Lake, NSW; SGB=St Georges Basin, NSW; PRH=Princess Royal Harbour, WA; OH=Oyster Harbour, WA).

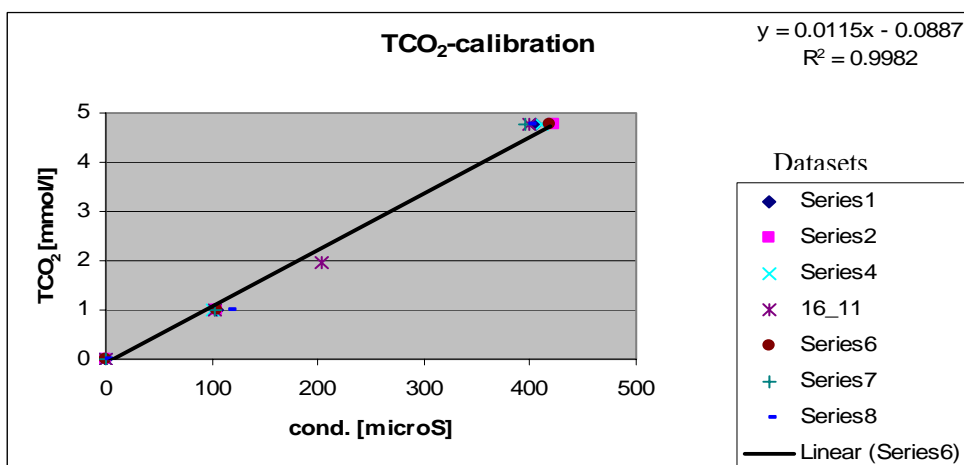
Sample: yellow-white; acid (HCl): orange –white; and base (NaOH): blue-white. A conductivity cell with  $k=0.117$  was used, but the instrument was set to  $k=0.351$ . Standard solutions (1, 2, 5 mM) were prepared from a 100 mM stock solution, of  $\text{Na}_2\text{CO}_3$  and purged demineralized water. They were kept gas-tight in small bottles with septa. We used a 30 mM HCl acid solution and 5-10 mM NaOH base solution. The conductivity meter was linked to a computer for continuous recording. The conductivity of the carbonate-free base flow gave a signal of ~ 1000 mV and standard sea water (2.1 mM  $\text{TCO}_2$ ) mixed with the acid resulted in a drop of ~200 mV. The signal was stable with  $\pm 2$  mV resulting in an analytical precision of  $\pm 20 \mu\text{M}$ . Calibration was highly reproducible over several days (Figure 3A).

Figure 3A. Calibration results of the direct  $\text{TCO}_2$  method over several days.

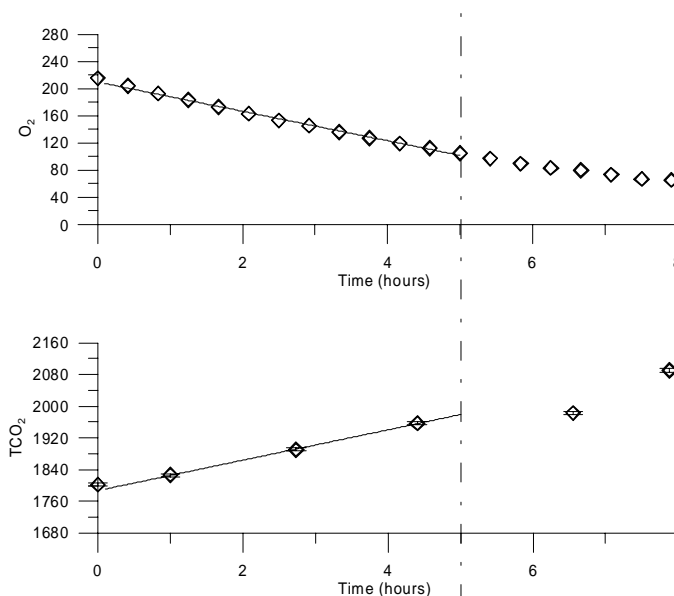
Figure 4A.  $O_2$  and  $TCO_2$  in  $\mu M$ . Fluxes were determined only from data points that fell within the time that  $O_2$  uptake was linear. In this example,  $O_2$  uptake was linear for the first 5 hours; indicating that, during this time, the chamber was not significantly perturbing the nutrient dynamics of the system. Therefore, solute fluxes ( $TCO_2$  in this particular example) were determined using only data points from the first 5 hours of the incubation.
