# Antarctic Geodesy Field Report 2008/09

GEOSCIENCE AUSTRALIA  
RECORD 2009/33

Ryan Ruddick, Alex Woods and Nick Brown<sup>1</sup>

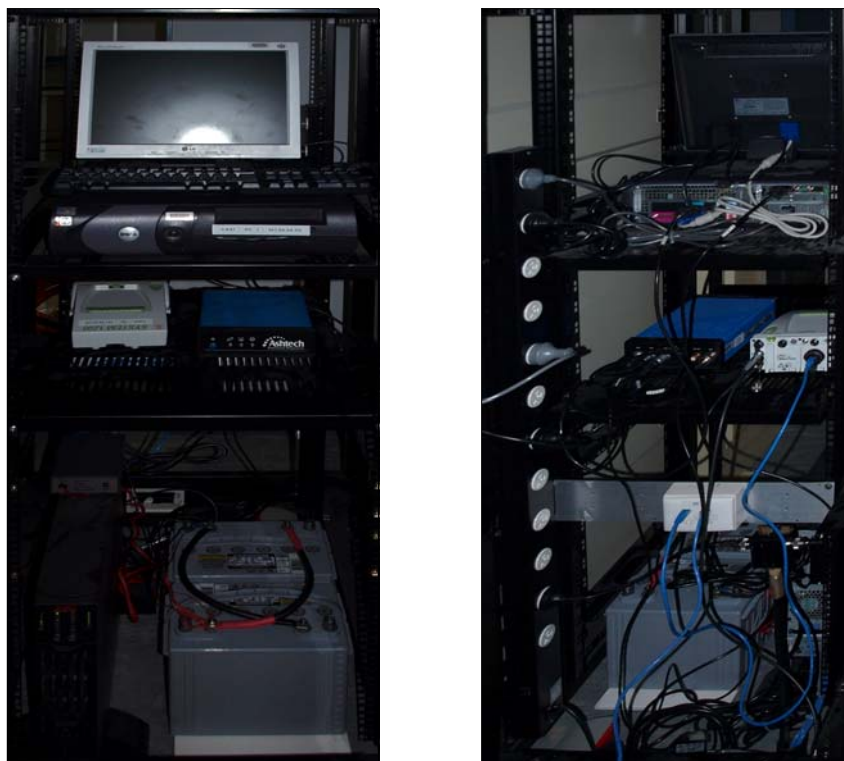
*Figure 2: Casey GNSS Equipment Rack from the front (left) and back (right) (December 2008).*

The Casey ARGN equipment is located in the Summer Logistics Room of the Operations Building and the GPS antenna is approximately 200m to the south west. The stations communication and technical officer is the local contact and routinely monitors the state of the equipment. The 2009 winter contact is Ian Phillips ([ian\\_phi@casey.aad.gov.au](mailto:ian_phi@casey.aad.gov.au) or ext. 8809). A request has been made to move the ARGN equipment from the Summer Logistics Room into the main communications rack – this request has been approved and should occur during the 2009 winter. Ryan Ruddick and Alex Woods undertook the equipment upgrade on the 3<sup>rd</sup> of December 2008, with the major change being the installation of a *Leica* GRX1200GG Pro receiver. Details of the Casey installation are provided in Figures 2 and 3.

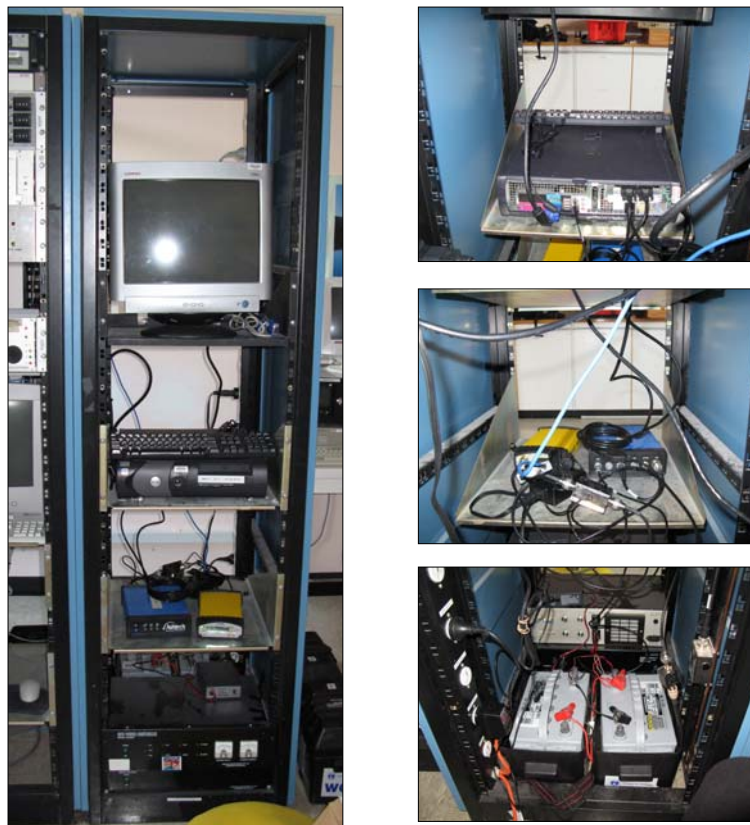
**Figure 6:** Macquaire Island GNSS Equipment Rack (Front and Back) (March 2009)

The Macquarie Island ARGN equipment is located in the Science Building and the GPS antenna is approximately 25m to the north on a large rock. The station communication and technical officer is the local contact and routinely monitors the state of the equipment. The 2009 winter contact is Brett ([macca\\_comms@macca.aad.gov.au](mailto:macca_comms@macca.aad.gov.au)). The equipment upgrade was undertaken on the 21<sup>st</sup> March 2009, with the major change being the installation of a *Trimble NetR5* receiver. Macquarie Island installation specifics are detailed in the setup diagram provided in Figures 6 and 7.

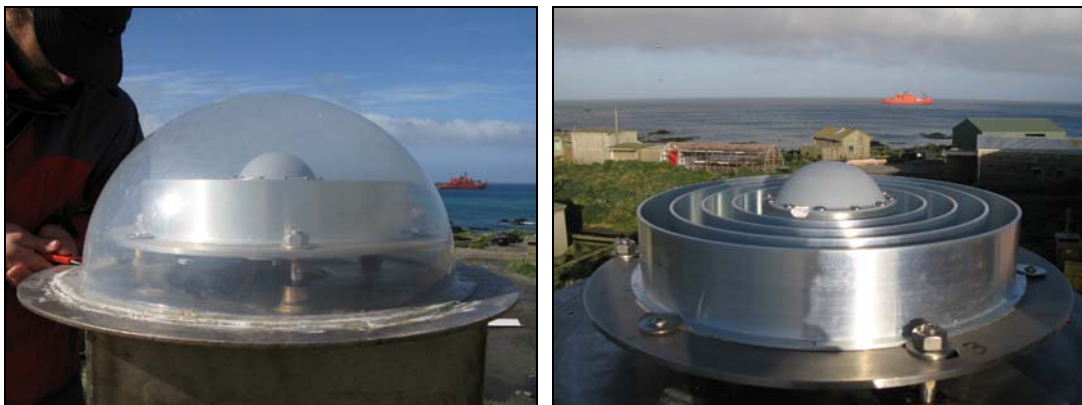
To directly observe the survey marks on the AUS211 GPS pillar the antenna and dome had to be removed (Figure 8). The dome was unscrewed from its connection onto the survey plate and set aside. A small allen key and knife were required to unscrew the connections and remove the silicon at the base of the dome. The height of the GPS antenna was observed before removal and again when re-attached to ensure there was no change in antenna height after moving the antenna. The GPS antenna orientation was also noted before the antenna was disconnected and unscrewed from the plate. A shifter was used to disconnect the antenna and holding mount from the bracing rods. After the survey the antenna was repositioned and the antenna was directed on the same alignment. The dome was refitted and sealed with silicon.

*Figure 8: Macquarie Island ARGN GPS antenna, dome and bracing mount*

The GPS antenna had to be removed to perform the reference mark survey. Due to the design of the GPS pillar, care had to be taken to ensure the height of the GPS antenna reference point (ARP) did not change. The height of the GPS antenna was observed before and after movement of the antenna, to monitor for any height displacement (Table 8).

The height of the antenna has not changed and the difference of 0.1 mm is within the leveling errors.

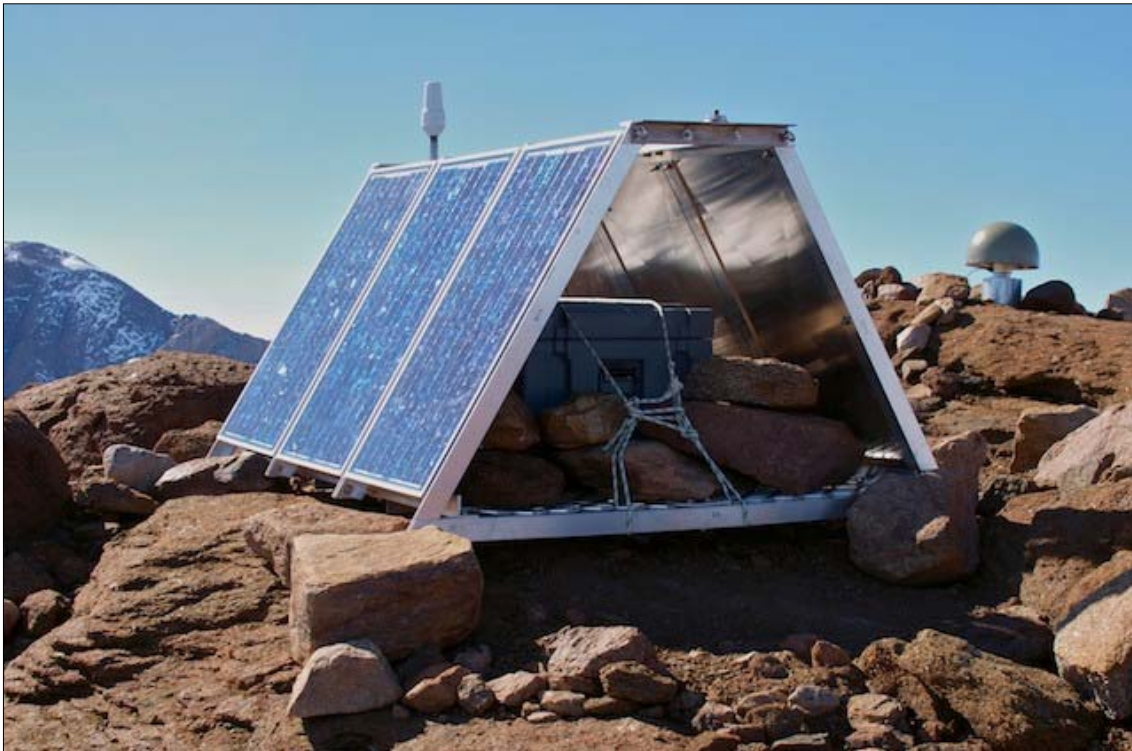
During the winter months the remote sites experience strong winds, which have at times blown over or snapped the structures that house the equipment boxes and support the solar panels. To overcome this, a new structure was designed and built by *Baxter Engineering* in Canberra. The structure was designed with a stable footprint of 1.6 x 1.6m and enclosed on the windward side (south) by aluminium panels angled at 60 degrees the leeward side (north) holds three solar panels also at 60 degrees to pick up sunlight low on the horizon. The base is slightly elevated to reduce snow build-up. Mounts on either side of the structure allow for the addition of an iridium antenna or vertical axis wind turbine (5/8" spigot). A large insulated space-case contains all of the equipment, including the batteries and rests on a mesh grid within the frame. The structure weighs 55kg and can be put together with a 13mm ratchet spanner.

*Figure 11: Solar panel frame structure, as installed at the Grove Mountains (December 2009).*

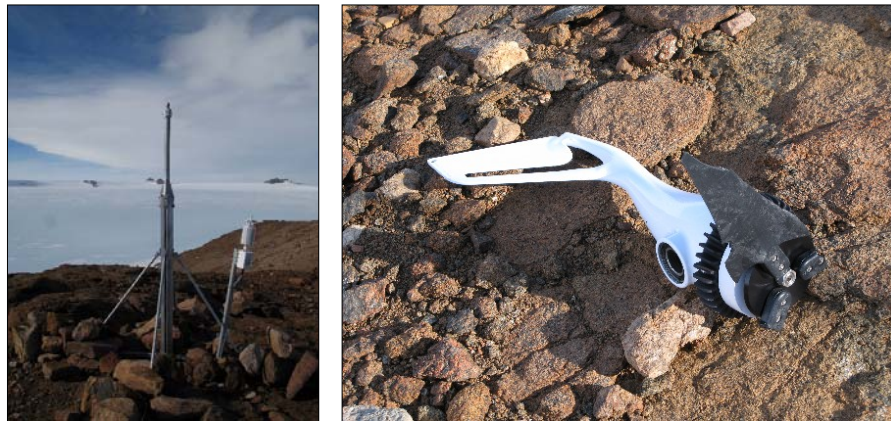
- Turbine broken off frame and found on the ground several metres away with blades shattered and missing. These wind turbines seem insufficient for the environment;
- Frame not disturbed, rocks in place over supports and still rigid, nuts and bolts still attached and tight;
- Positive and negative cables still running into battery box, earth cable still buried under rocks and earth, alongside wind turbine stand.

*Figure 16: Wind turbine stand (left) and damaged wind turbine (right).*

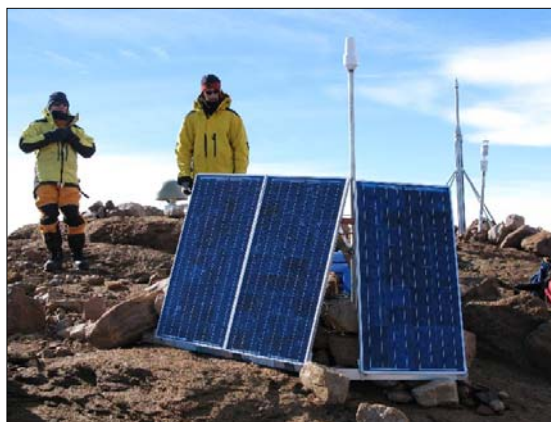
- Frame still upright with receiver and modem box still attached and rocks piled on top;
- Frame still in relatively good condition;
- Three solar panels attached to frame and in good condition;
- Solar panel cables all operational and in good condition;
- Junction box still in good condition, junction box cable to battery box in good condition;
- Iridium modem antenna and pole support still firmly attached to solar panel frame with stainless steel cable ties;
- Cables and connection into and within box all in good condition.

*Figure 17: Solar panel frame on arrival at the site.*

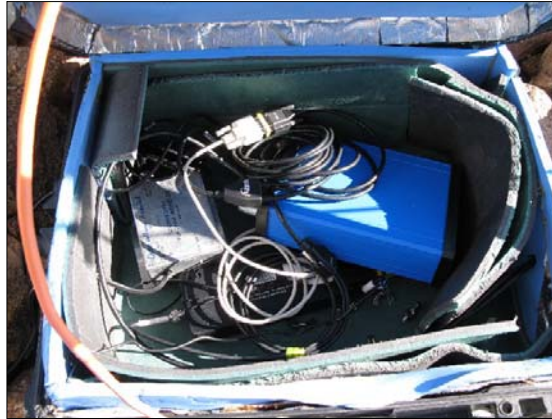
- Pelican case still secured to solar panel frame with rope;
- All GPS receiver and modem cables connected within box;
- *Ashtech* Micro-Z UZCGRS receiver (s/n: UC2200524009) still connected to over/under voltage protection, no lights flashing on receiver. Receiver found to be 65% full of data.

**Figure 18:** Modem and Receiver on arrival at the site.

The *Ashtech* Micro-Z UZCGRS receiver (s/n: UC2200524009) was removed from the station and returned to Australia. The data on the GPS receiver was downloaded successfully and RINEX'd for later processing. It should be noted that the observation interval in the *Ashtech* receiver was set to 90 second epochs, as opposed to the standard 30 second epochs. This was done in 2007 in order to reduce the daily file size, allowing the receiver to store more data.

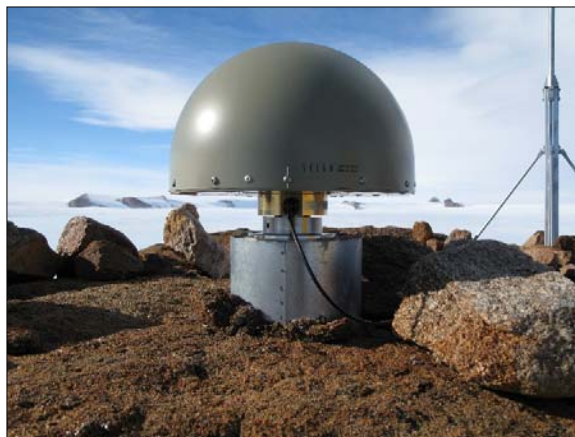
- Survey monument stable, not disturbed;
- Shim flush with survey plate and tight;
- GPS antenna (*Thales* 701945-02 Rev E1, s/n: CR6200327018) attached to 30mm shim, tightly and orientated north;
- SCIGN snow dome still in good condition, firmly attached to choke ring antenna with all bolts connected tightly.

**Figure 19:** Survey Monument (AUS351) and GPS antenna

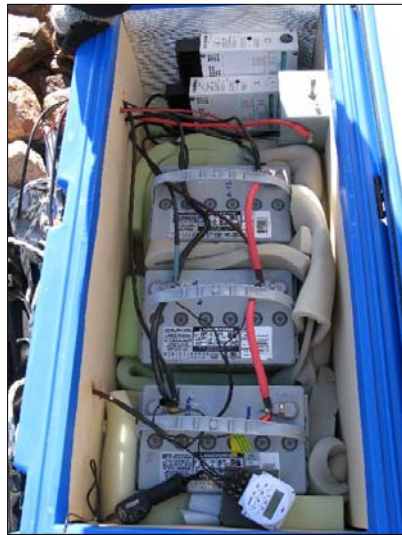
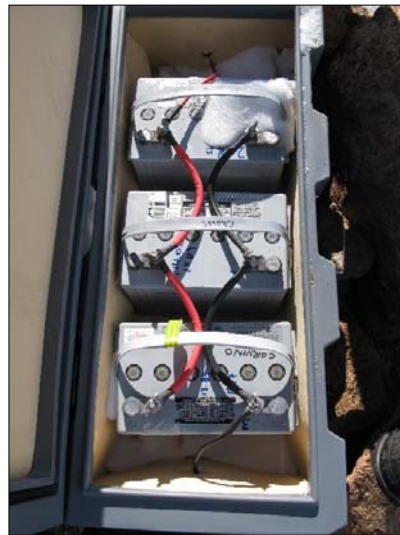
- Stable with rocks stacked on top;
- Turbine switch toggled to charge;
- Batteries leaked with bulged and busted sides;
- Connections within box still attached although cables discoloured due to battery leak;
- All cable entries into box in good condition;
- No signs of snow drift or moisture build up within box;
- *Xantrex* power regulator off;
- Direct power connection to Iridium modem on;
- Dump box connected with cables in good condition and dump box not disturbed a few metres away from site.

**Figure 20:** Inside the primary battery box. **Figure 21:** Inside the secondary battery box.

- Stable with rocks still stacked on top;
- Snow drift build up within box;
- Batteries leaked with bulged and busted sides;
- Connections within box still attached although cables discoloured due to battery leak.

After analysis of the site condition, all the old equipment, excluding the GPS antenna and antenna cable, was set aside for RTA. Tasks performed in the site upgrade between 20 and 21 December 2008 are detailed below.

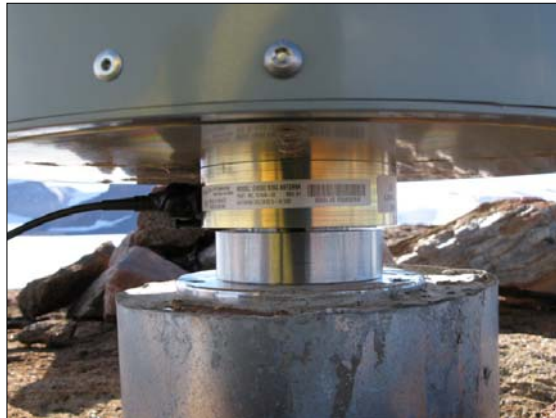
The stainless steel survey plate, concrete pillar, shim and *Thales* antenna (ASH701945E\_M S/N: CR6200327018) with SCIGN snow dome were not disturbed and noted to be stable and in good condition. The 10m long GPS antenna cable attached to the antenna with self-amalgamation tape to form a watertight seal was noted to be in good condition and was maintained in the site setup.

**Figure 22:** Survey monument (AUS351) and GPS antenna.

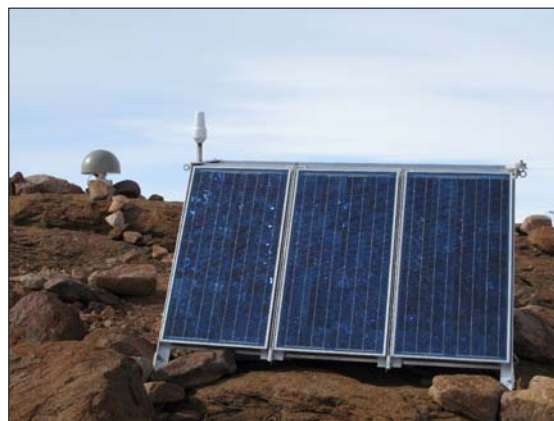
A new solar panel frame was erected in the same position as the previous frame, approximately five metres west of the GPS antenna on a relatively flat area of rock. The frame supports three 50W BP solar panels, an iridium modem antenna and equipment box. Rocks were piled on top of the frame before leaving the site; to ensure wind forces would not disturb it.

**Figure 23:** Groves new solar panel frame).

Three 50W *BP* solar panels (500mm x 1000mm x 50mm) all connect to a simple, closed solar junction box, which sits on the base of the solar frame with a connection entering the equipment box. The solar panel cables are protected from the weather with flexible conduit. The Iridium antenna screws directly onto a threaded pipe section attached to the solar panel frame. The antenna cable passes through the pipe, along part of the solar frame (attached with steel cable ties) and into the equipment box. The GPS antenna cable runs along the ground between the antenna and equipment box and was covered with rocks to keep it secure. All cable connections into the equipment box glands were wrapped with self-amalgamation tape.

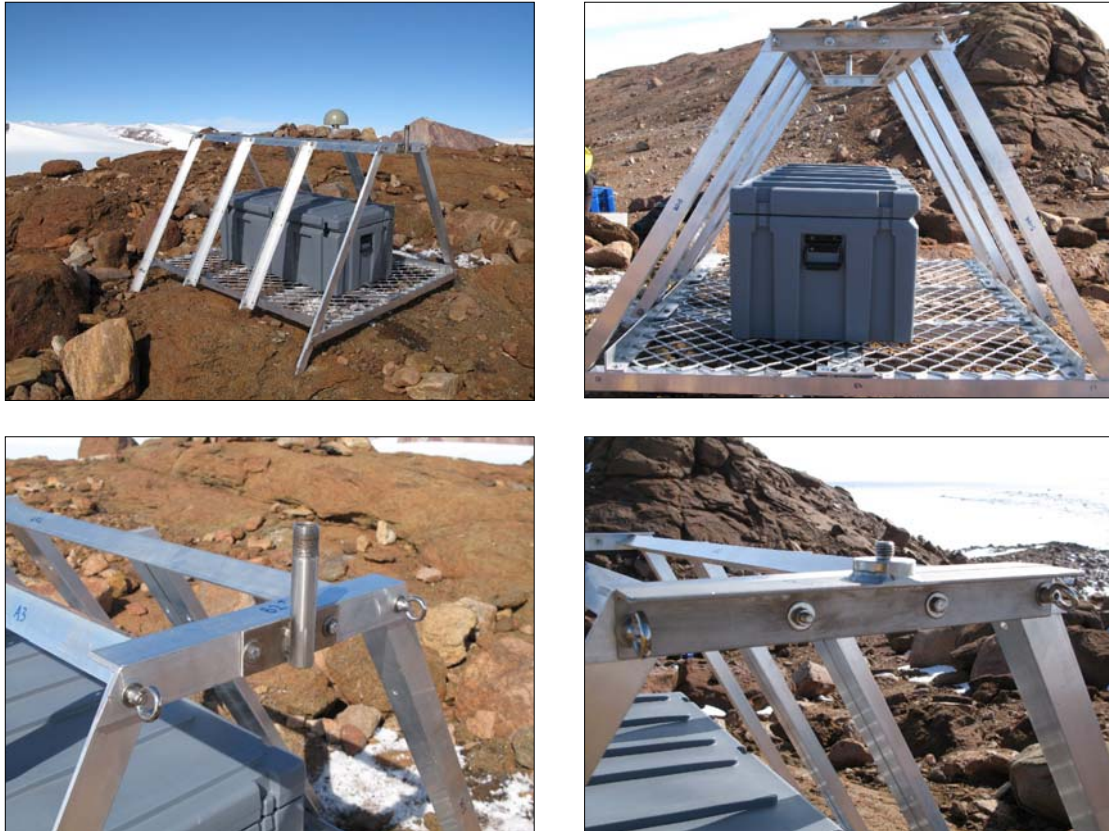
**Figure 24:** Top Left and right: Solar panel frame and equipment box; Bottom Left: Iridium antenna support and connection; Bottom Right: Wind turbine connection, with adjustable support.

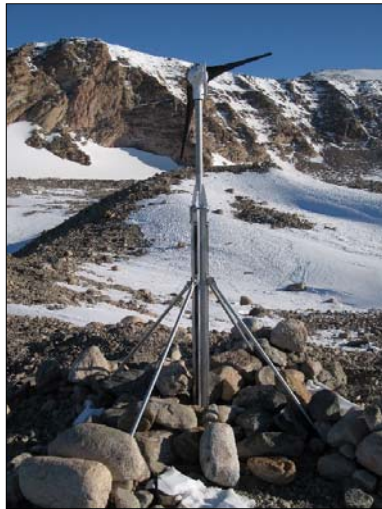
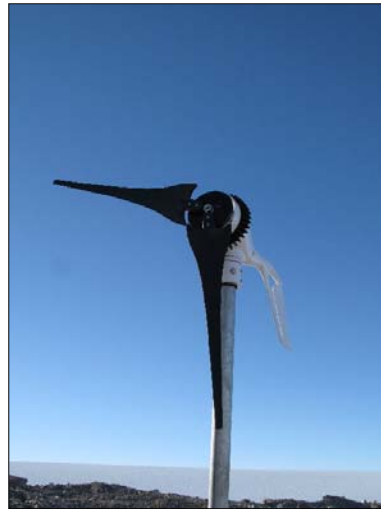
- Turbine still attached to frame, though bearings failed and rotation was restricted. Two blades attached, but unable to turn. These wind turbines seem insufficient for the environment;
- Frame not disturbed, rocks in place over supports and still rigid, nuts and bolts still attached and tight;
- Positive and negative cables still running into battery box, earth cable still buried under rocks alongside wind turbine stand.

**Figures 29:** Wind turbine stand (left) and damaged wind turbine (right).

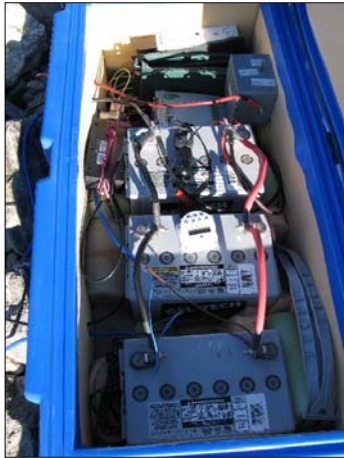
- Box stable with rocks stacked on top;
- All cable entries into box in good condition, no signs of snow drift or moisture within box;
- Turbine switch toggled to charge;
- Batteries leaked with bulged and busted sides;
- Connections within box still attached although cables discoloured due to battery leak;
- All GPS receiver and modem cables connected within box;
- *Leica* GRX1200 GPS receiver (s/n: 462980) on and tracking satellites. Receiver found to be full of GPS data and no longer logging;
- *Xantrex* power regulator not on;
- Direct power connection to *Iridium* modem on;

**Figure 30:** Primary equipment box.

The Leica GRX1200 GPS receiver (s/n: 462980) was replaced and returned to Australia. The data on the GPS receiver was downloaded successfully and RINEX'd for later processing.

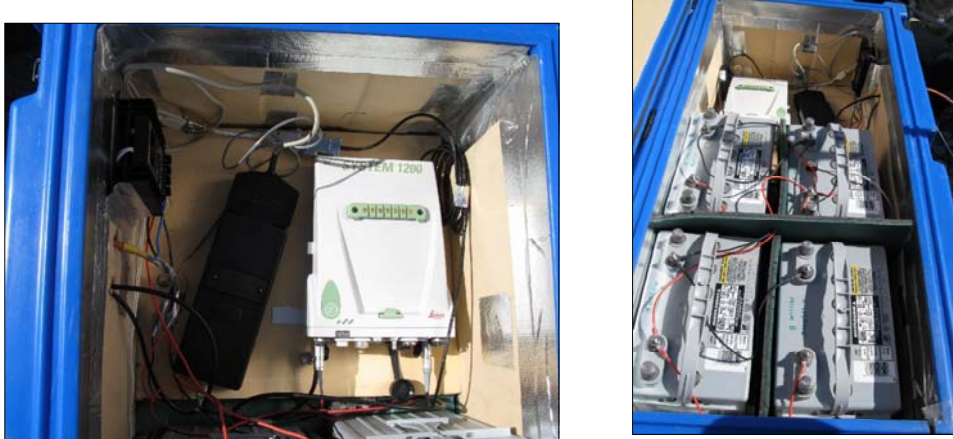
**Figure 33:** Receiver and Iridium Data Modem (left) and equipment box after equipment upgrade (right).

Upon installation, the receiver made a successful communication link to the *Iridium* modem and short text messages were successfully sent out. It was not possible to check communication back to Geoscience Australia in Canberra over the New Year break. Prior to leaving the site, all appropriate lights were flashing and three days of data were downloaded from the receiver.

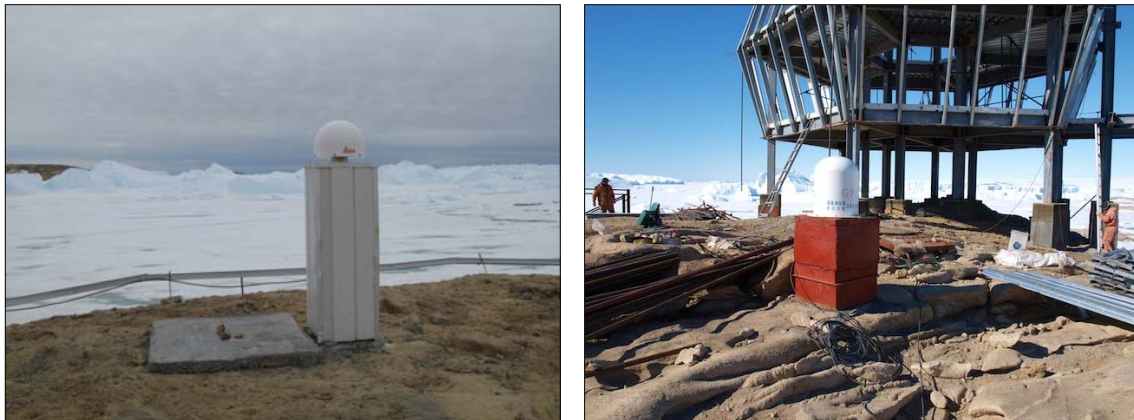
*Figure 36: New CHINARE CORS ZHON at Zhong Shan (left) and old Zhong Shan CORS, it was moved due to the obstruction of the new atmospheric physics building (right).*

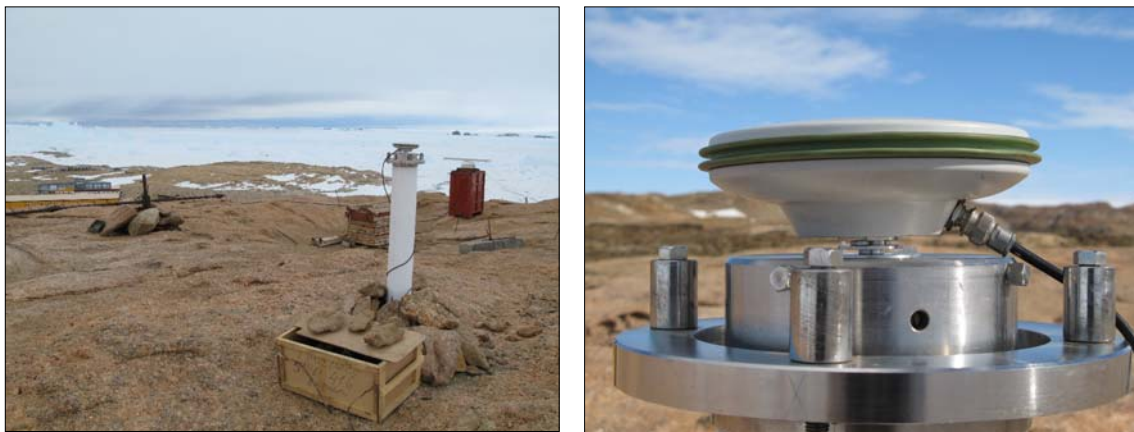
*Figure 37: New Russian CORS at Progress II (left) and close up view (bottom right).*

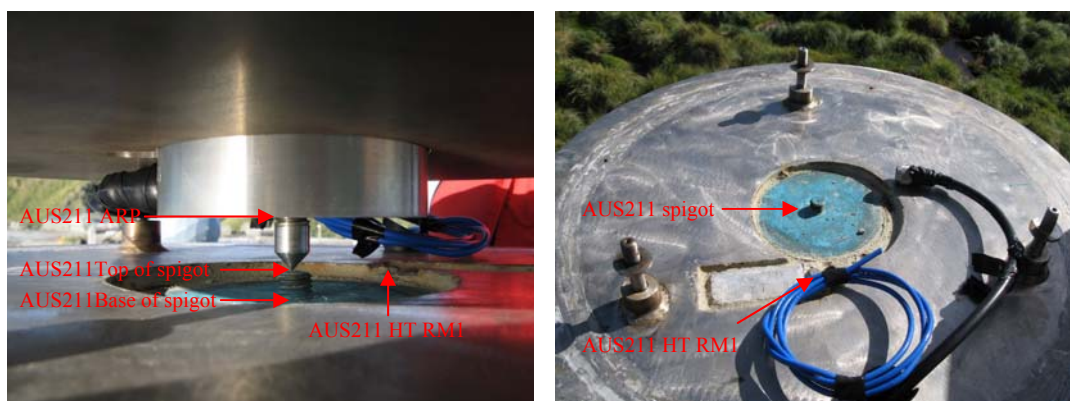
AUS211 HT RM2 to ...	Change in Height	MSL
AUS211 HT RM1	+1.1993	12.8810
AUS211 ARP	+1.2270	12.9087
AUS211 Top of threaded spigot	+1.2036	12.8854
AUS211 Base of threaded spigot	+1.1925	12.8743

Note: The AUS211 ARP was determined by observing the height at the top of the antenna choke ring and subtracting 0.102m (the value shown in the MAC1 log file antenna diagram).

**Figure 42:** Macquarie Island ARGN pillar height reference points, plan and profile view.

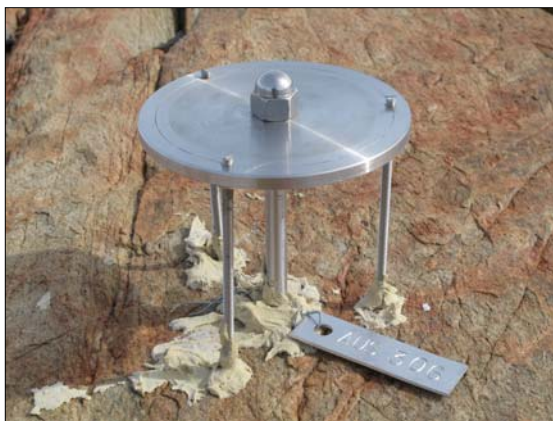
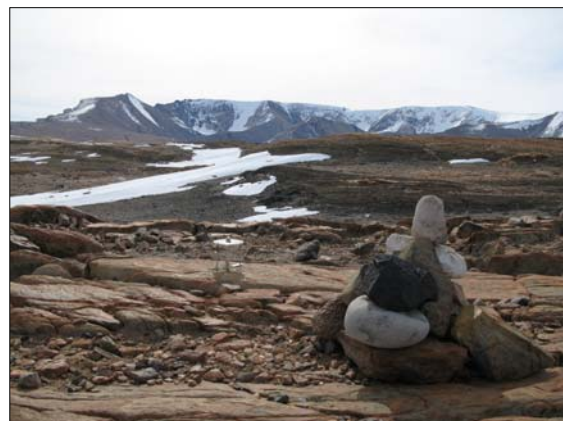
*Figure 46: AUS306 survey monument remaining at site (left); Small rock cairn indicates the location of the Dalton Corner site (right).*

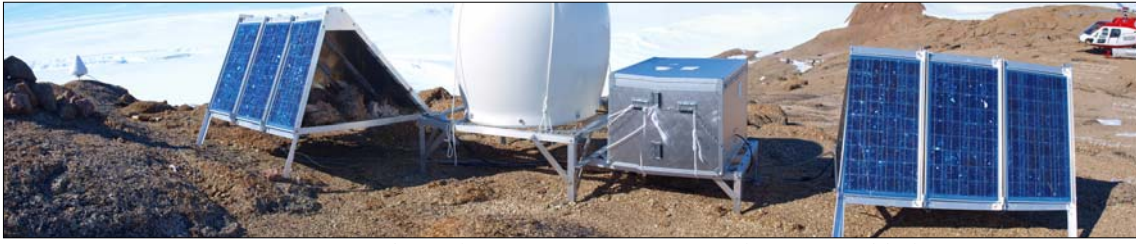
*Figure 47: Landing Bluff GPS prior to retrieval (Ryan Ruddick).*

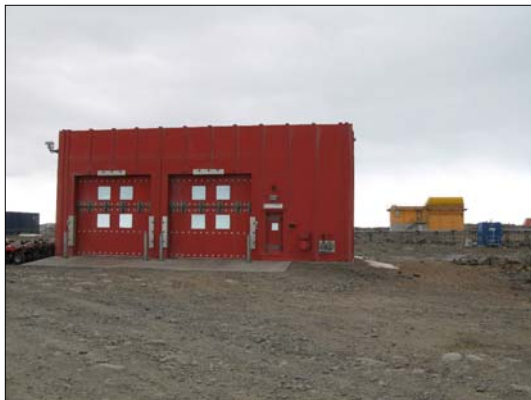
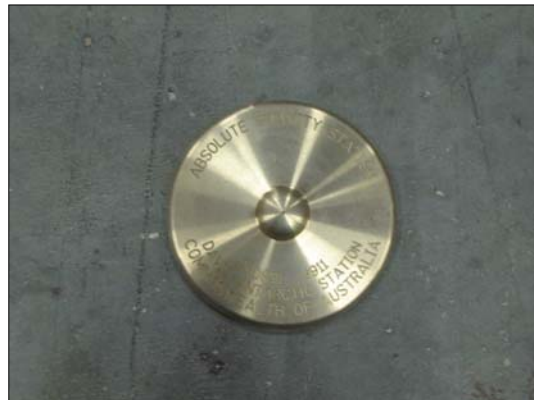
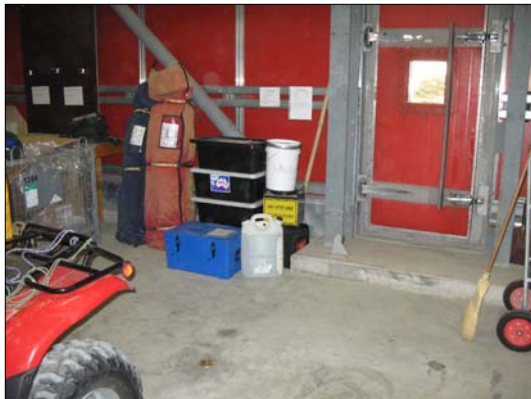
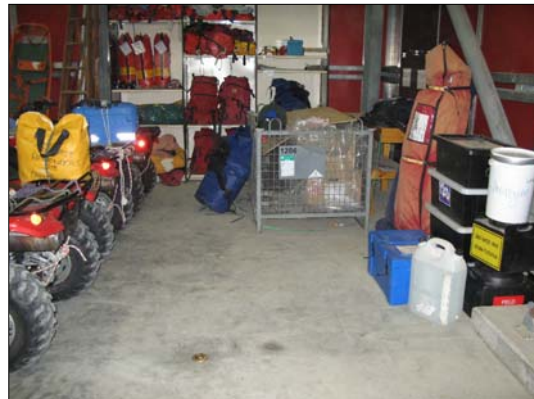
On the 25<sup>th</sup> of February 2009 an absolute gravity benchmark was installed in the Emergency Vehicle Shelter (EVS) at Davis. The benchmark was placed in the EVS after discussion with the engineering supervisor and consideration of several locations around station. Building drawings for the EVS were unavailable, although the floor in the EVS is a floating slab on columns that extend to bedrock. The EVS was identified as the optimal location as the building is rarely used and has sufficient floor space for the FG5 absolute gravimeter. There is 1.5m of vacant floor space around the monument which is located on the slab, along the line between two wall columns, in the Eastern corner of the building (Figure 48). This area is usually allocated for storage of search and rescue equipment. In placing the monument a 12mm diameter hole was drilled approximately 100mm into the slab and the mark was fixed using *Ramset Ultrafix Plus* polyester anchoring adhesive. The monument is identified as 200891.9911. A precise level connection was made on 2 March 2009 from PSM D3 to the new BM, incorporating it into the Davis level network with a 1983 Davis MSL height of 22.2437m.

**Figure 48:** EVS (top left); Absolute gravity benchmark (top right); Installed BM and rear wall and doorway (bottom left); Installed BM and SAR equipment (bottom right).

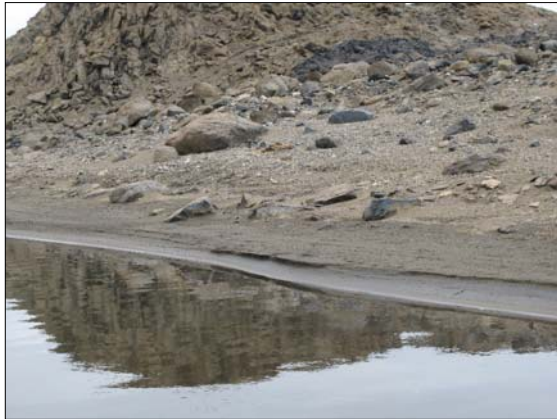
Many of the lakes (15) have shown a significant decrease in water level (greater than -100mm) between 2009 and 2007. Figure 50 and 51 show the shorelines of lakes which have dropped in the last two years, Ekho Lake (fell by 0.177m) and Lake McNeill (fell by 0.413m). In contrast, Lake Druzhby (+0.218m), Pauk Lake (+0.165m) and Lake Zvezda (+0.005m) have shown an increase in

**Figure 50:** *North East bank of Ekho Lake*

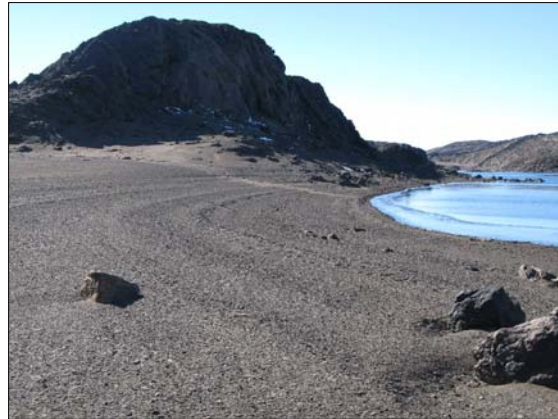
**Figure 51:** *North West bank of Lake McNeil.*
