# The Aitape PNG Earthquake/Tsunami - 1998

Just before 7 pm on Friday 17 July 1998, a magnitude 7.0 earthquake rocked the north coast region of Papua New Guinea (PNG). The Aitape tsunami took over 2000 lives, caused extensive damage to houses and public infrastructure, and altered the environment around the village.

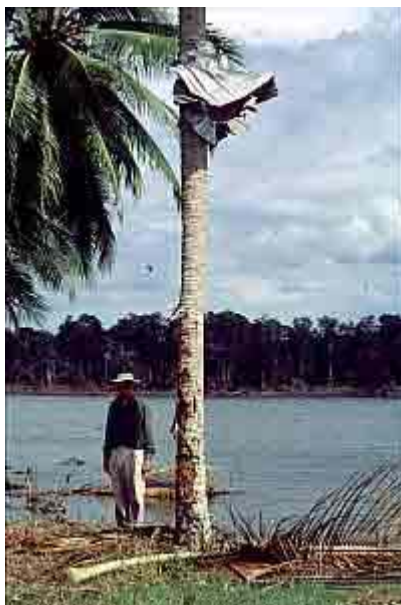
**Evidence of the height of the wave, roof sheeting wrapped around a coconut palm.**

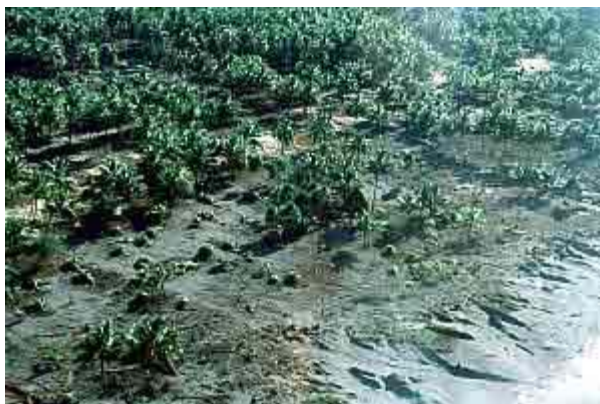
**Destruction of coconut palms and village.**

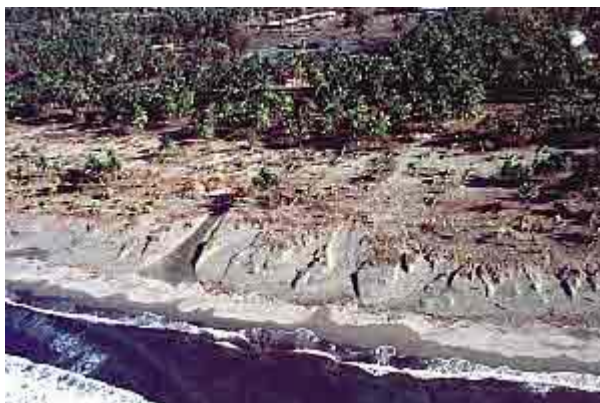
**Scouring of the shore line.**

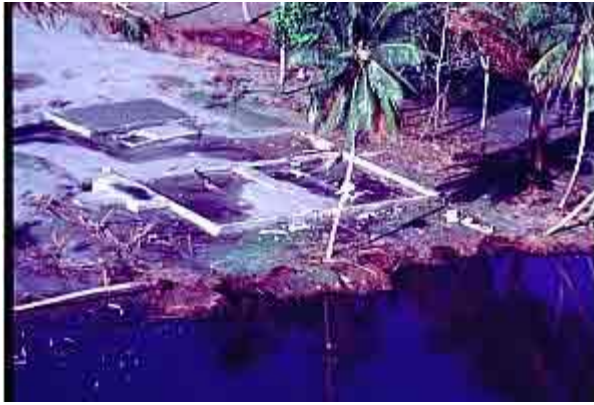
**Building foundation remnants.**

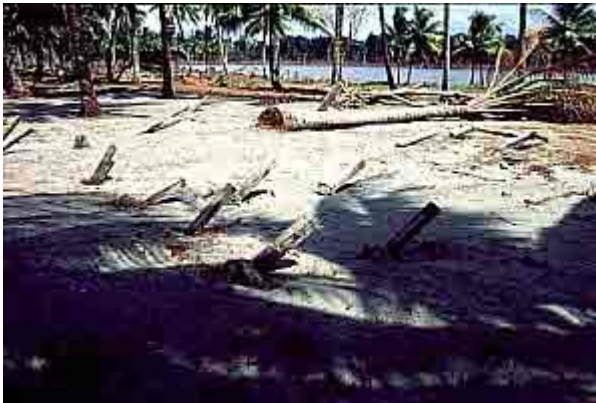
**Building stumps and fallen palm trees.**
