# **TECHNICAL REPORT 8**

## **Antarctic Geodesy**

### **Casey 2001**

Gary Johnston  
Paul Digney  
Australian Surveying and Land Information Group

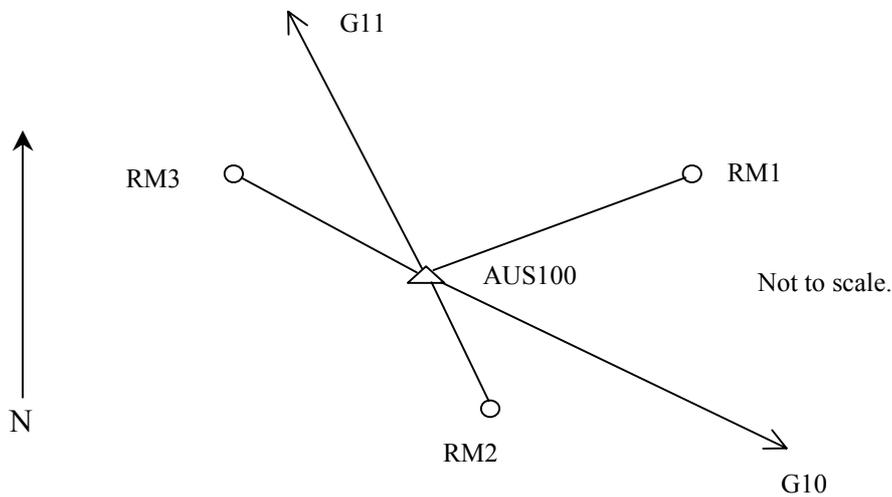
Ex AUSLIG surveyor John Hyslop last completed the reference mark survey in 1993. This survey was at the time of establishment of AUS100 and the placement of the reference marks (RMs). Figure 2.1 shows the general layout of the RMs and the existing stations used for network orientation.

*Figure 2.1 Network layout at AUS100 Casey*

For this survey the coordinates of AUS100 and G10 were taken from the most recent adjustment of the Australian Antarctic Geodetic Network (known as ANT2001 – see [www.auslig.gov.au/geodesy/antarc/antmarks.htm](http://www.auslig.gov.au/geodesy/antarc/antmarks.htm)) and used as datum. The coordinates listed in Table 2.1 for G11 are based on a distance derived from the ANT2001 adjustment and an azimuth determined from this survey. As such they should only be used for computing azimuth between AUS100 and G11. The distance between AUS100 and G10 was not observed.

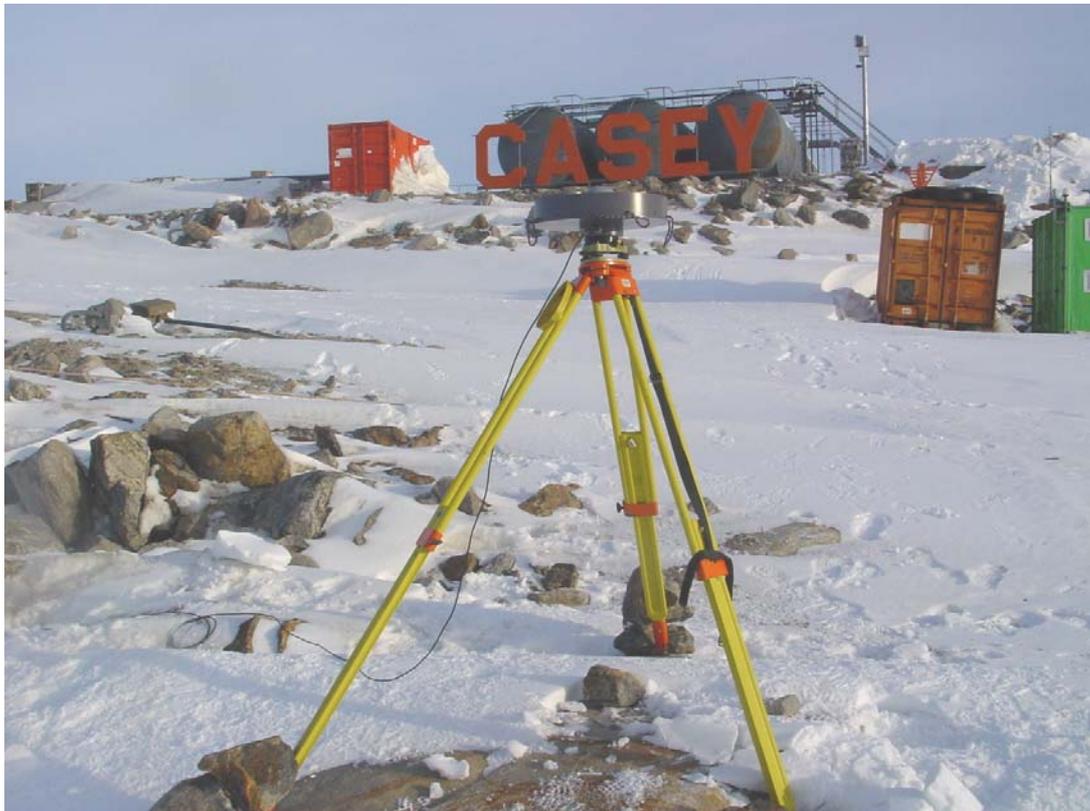
Historically HBM3 has been referred to as the tide gauge benchmark (TGBM) at Casey. This mark has been disturbed and is no longer suitable for this purpose. Not more than two metres away from HBM3 a new mark was placed by surveyor John Hyslop in 1993 to measure timed water measurements. This mark consists of a stainless steel bolt in rock with an aluminium tag inscribed with AUS299. This mark was centre punched and used for the GPS observations for this season. It is recommended that this mark be considered the TGBM for future works. It has been connected vertically to a variety of other marks in the vicinity as detailed in section four of this report.

*Figure 4.1. GPS antenna over the TGBM (AUS299)*

Three sessions were observed as detailed in Table 4.1. The antenna was removed between sessions two and three to allow a level connection, thus explaining the change of antenna height.
