# EDM Height Traversing Levelling Survey Report

Manus Island, Papua New Guinea, September 2012

GEOSCIENCE AUSTRALIA  
RECORD 2014/19

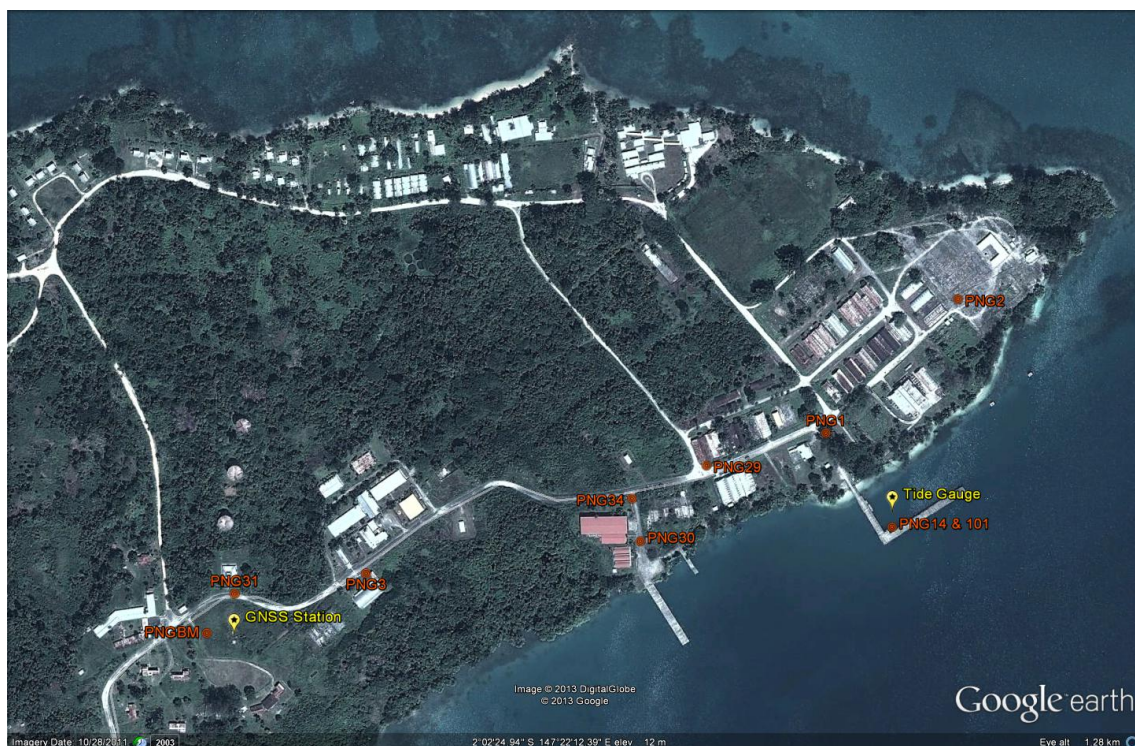
## 2.1 Bench Mark Locality Diagram

The EDM height traversing levelling survey was carried out between the SEAFRAME tide gauge sensor, continuous CGNSS station and the deep driven bench marks:

All the deep bench marks were located and found in good order and undisturbed. Also included in the survey were temporary holding marks PNG26, PNG28, PNG34 and PNG100. The benchmark, PNG20 (Iron bolt adjacent to the Tide Gauge Hut) was found disturbed therefore it was replaced with PNG101 (stainless steel bolt in concrete – radar sensor bolt)
