The Lithgow earthquake of 13 February 1985: macroseismic effects

Marion O. Michael-Leiba¹ & David Denham¹

The Lithgow earthquake of magnitude ML 4.3, which took place on 13 February 1985, was the largest earthquake to have occurred in the Blue Mountains region of New South Wales since the Kurrajong earthquake of 1919. It caused minor damage in Lithgow and Wallerawang and was felt as far away as Parkes and Dubbo, 200 km

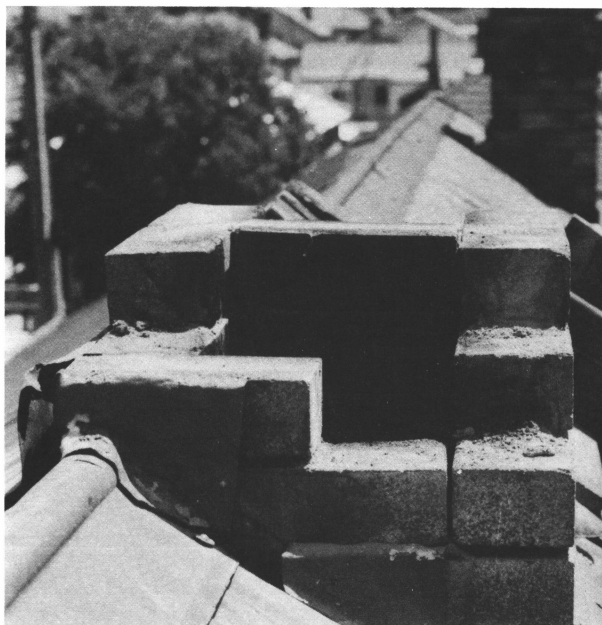
Figure 2. Chimney in Lithgow, collapsed at the roofline because of the earthquake.

It used to be the same height as the chimney in the background (A. Churchill—personal communication). Photograph by A. Churchill, Rembrandt Photographics, Lithgow—commissioned by BMR.

Sheryl Taylor of television station Channel 9 (Sydney) inspected the damage in Lithgow the day after the earthquake. She saw several partly demolished chimneys and broken windows, a shop in which beams 25 cm thick had shifted, a house in which the footings and front step had moved, and fresh cracks in walls and the widening of existing cracks in some buildings. Don Kipp of the *Lithgow Mercury* said that the earthquake had been felt severely all over Lithgow, bringing people running out into the streets. Objects fell off shelves in many parts of the city. The intensity was less in the underground mines than on the surface, because the amplitudes of both body and surface waves are greater at a free surface.

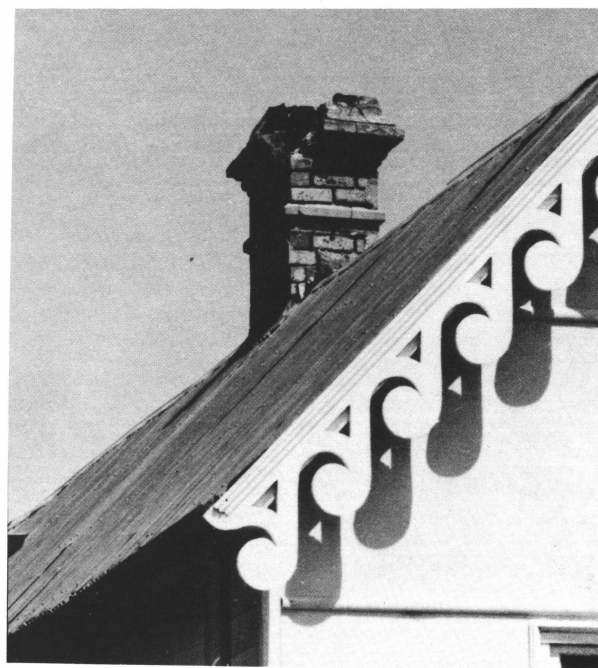
Figure 3. Earthquake-damaged chimney in Lithgow.

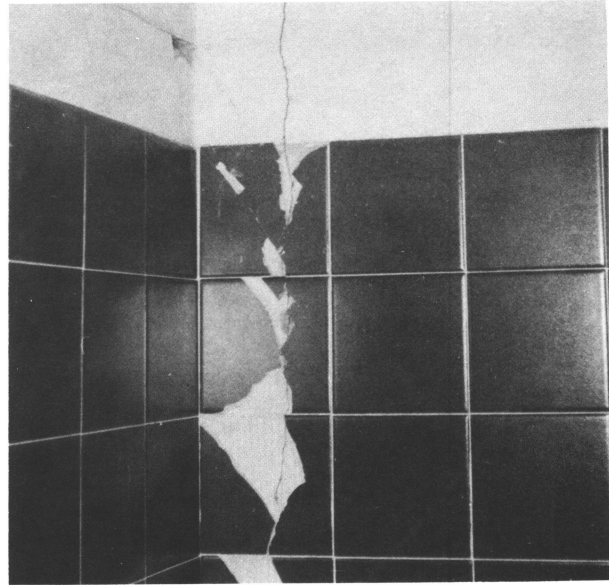
Figure 6. The vertical crack in Figure 5 continues down into the tiles in the lower part of the wall.

In Wallerawang power station, the earthquake caused new cracks in a previously cracked wall on the first floor. The new cracks were in a part of the wall that was not already cracked (John Forest, personal communication). Both vertical and diagonal cracking occurred (Figs. 5, 6). A diagonal crack also occurred in the well-built brick external wall of the power station at ground floor level. The crack is 2.5–3.0 m long and decreases from about 1.5 mm wide at the top to approximately 0.5 mm at the lower end, petering out about 1.3 m above ground level. It generally follows the mortar, but passes diagonally through several bricks. The main generator at the power station tripped, owing to physical shaking of the float-type switch (Bucholtz relay) on the transformer.
