3.4.2 Case Study 2 – Emerald Estate

3.4.3 Case Study 3 - Bernard Rd South

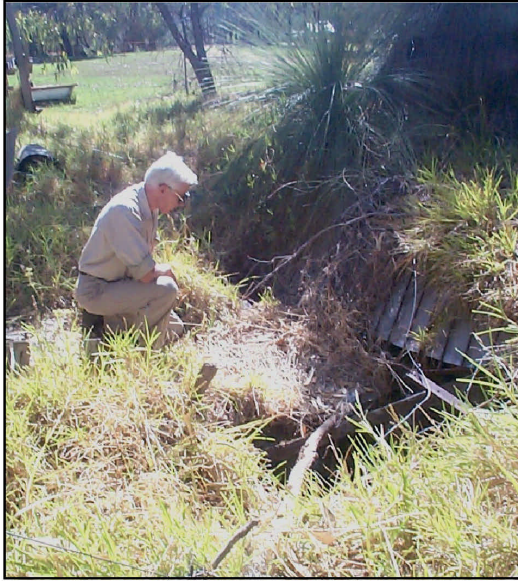
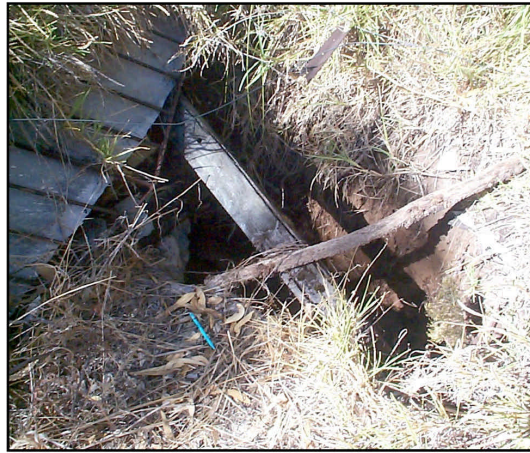
Figure 3.5a Cave on Tintara with broken covering **Figure 3.5b** Current covering is inefficient and shrubs

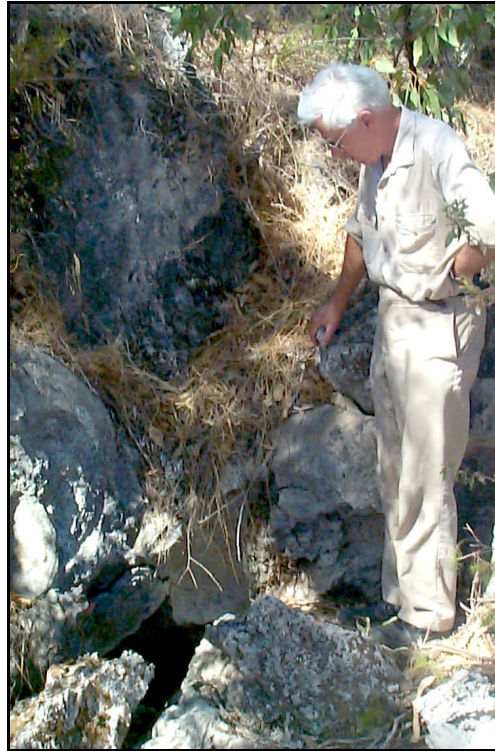
A small sinkhole at Emerald, roughly 2m in diameter was filled with rubble. Within the sinkhole a cave approximately 8m in depth exists (Figure 3.7). The entrance hole to the cave was originally small (child size), sloping into the cave. However, by tipping rubble into the sinkhole, the cave entrance increased in size and currently an adult can fit through the hole (Bastian, 2003). The rubble has also caused the cave entrance to now be vertical. This feature has now been left in a more dangerous condition due to the partial filling of the hole and changing the size and gradient of the cave entrance.

Figure 3.7 Sinkhole with limestone rubble and vertical cave entrance
