#### **3.4.4 Case Study 4 – Mining lease land**

### **3.5 GROUND SUBSIDENCE**

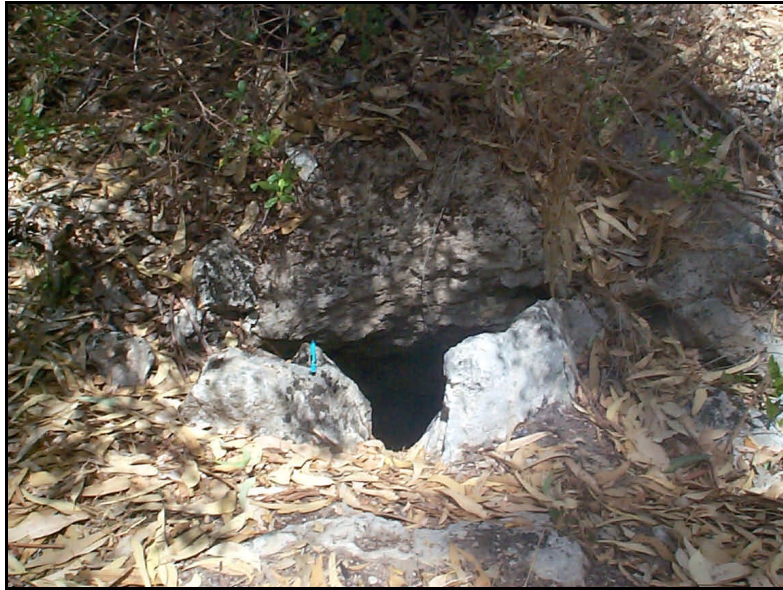
**Figure 3.8** Fissure type cave beside Bernard Rd South

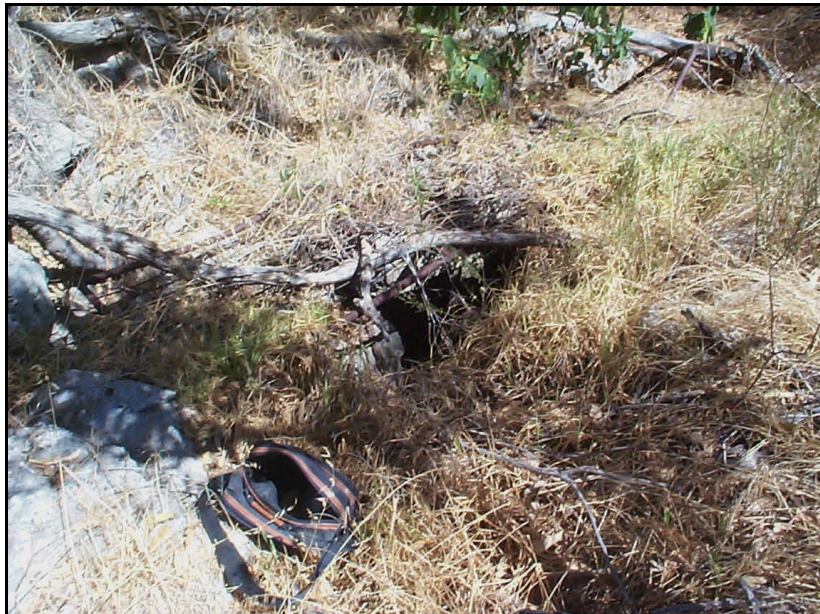
The block of land adjacent to Emerald Estate is currently controlled by a mining lease. Numerous small caves occur on this land and most are partially concealed due to a covering of grass (Figure 3.9).

**Figure 3.9** Typical exposure of a discreet caves

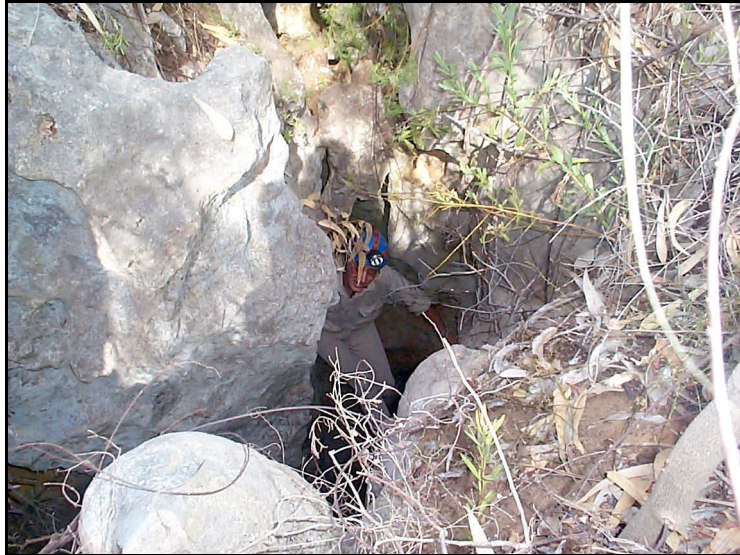
This block of land is highly vegetated and contains caves with numerous openings. Figure 3.10 shows one of the eight entrances to Tuarts cave. These vertical openings are fissure type and are up to 5m in depth. As this land is adjacent to Emerald Estate, it may be hazardous if members of the community explore the land as no signs or barriers exist around caves.

**Figure 3.10** One of the eight entrances to Tuarts Cave

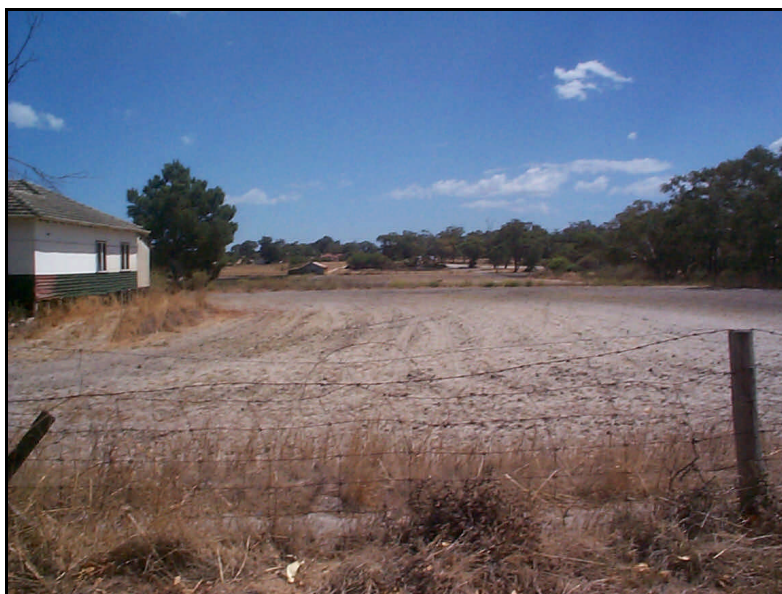
There are many hobby farms within Wanneroo and land use plays an important role in karst hazard prevention. Vegetated land holds soil together as well as increases soil structure. When the ground is bare, there is nothing holding the soil together and with increased rain or floods (natural or human made), the soil has a greater potential to be washed down a pre-existing cavity. This could lead to holes forming in the ground, similar to those described in Section 3.2. During parts of the year, the soil within the hobby farms is bare (Figure 3.12).

**Figure 3.12** Un-vegetated land between plantings in hobby farms within Wanneroo

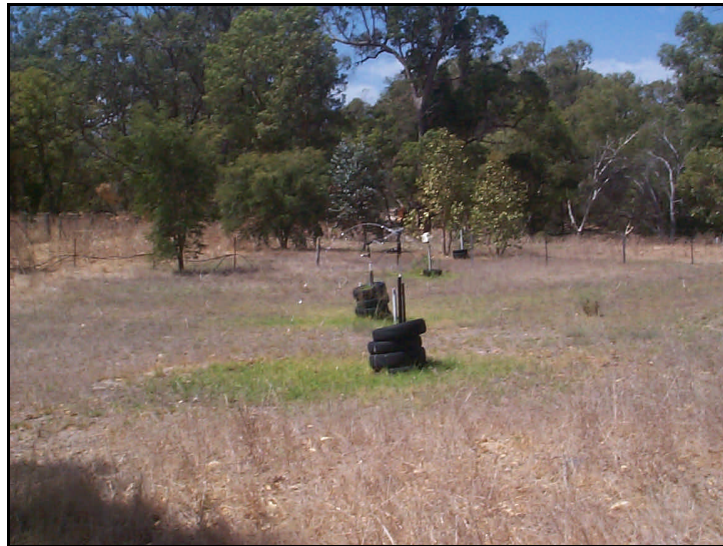
The holes that formed on the rural properties in Section 3.2 occurred due to an increase in water, concentrating on a small area of land. These case studies demonstrate that water should not be concentrated to one spot on karstic land. Figure 3.13 shows an inefficient sprinkler system off Bernard Rd South. The green grass shows that water is concentrated in these areas. With increased watering, subsidence may occur. However, this can only happen if a pre-existing cavity is below.

**Figure 3.13** Inefficient sprinkler system concentrating water within a small zone

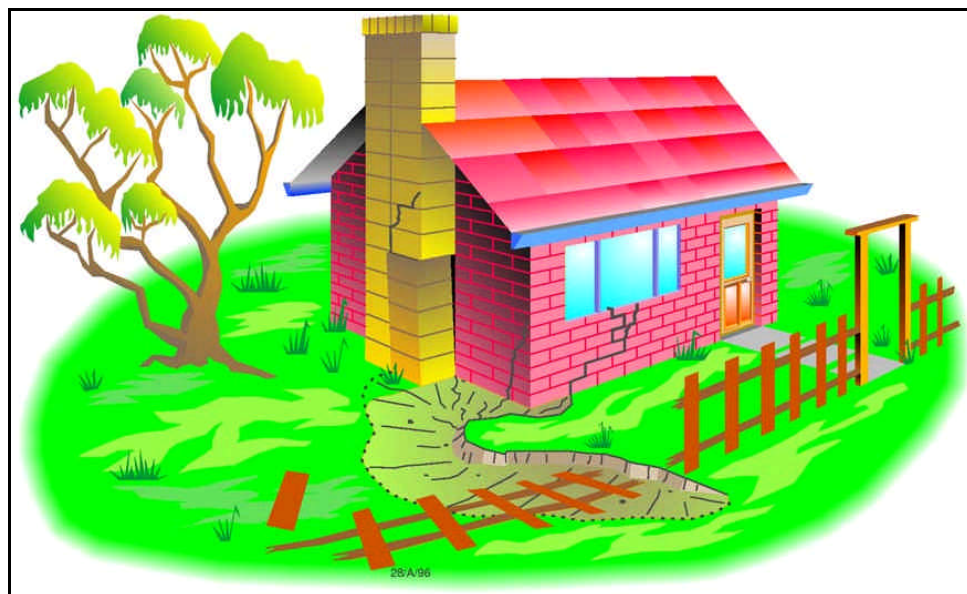
Ground subsidence can cause structural damage to roads and houses. The tilting of fence posts as well as cracks along mortar joints and in pavements are indicators for ground subsidence (Figure 3.14).

**Figure 3.14** Schematic diagram representing cracks in masonry and tilting fences due to ground subsidence.

Within Emerald Estate, a house was built over a fissure type cave (Bastion, 2003). Although the surface of the cave was filled in, movement down the fissure may occur. If the caves structural integrity is reduced then structural damage to the house will possibly occur, similar to Figure 3.13. However, more damage may occur if the cave collapses as the structural foundations to the house will be removed.

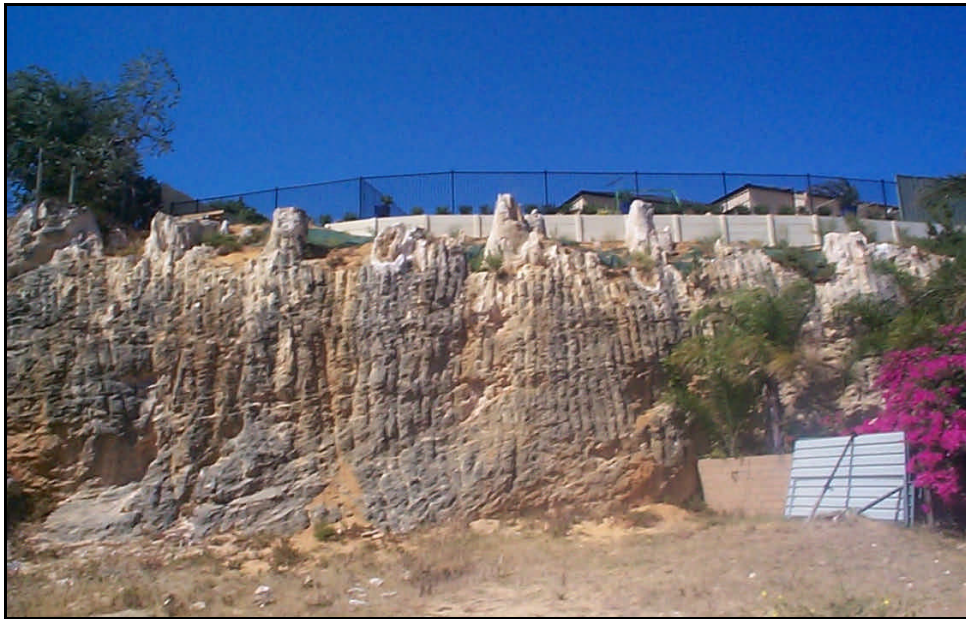
The limestone within the Wanneroo area contains an abundance of pinnacles. When developing infrastructure it is important that these pinnacles are identified. With increased rain or erosion, the soil between the pinnacles can be removed causing a cavity. Figure 3.15 depicts how pinnacles are situated in the ground. The lines down the cutting are solution flutes which provide a method for transporting water and soil. Building over pinnacled ground, can cause structural damage from subsidence.

**Figure 3.15** Most pinnacles in Wanneroo and below ground level. This photo depicts how pinnacle are situated in the ground with solution flutes running down the cutting.

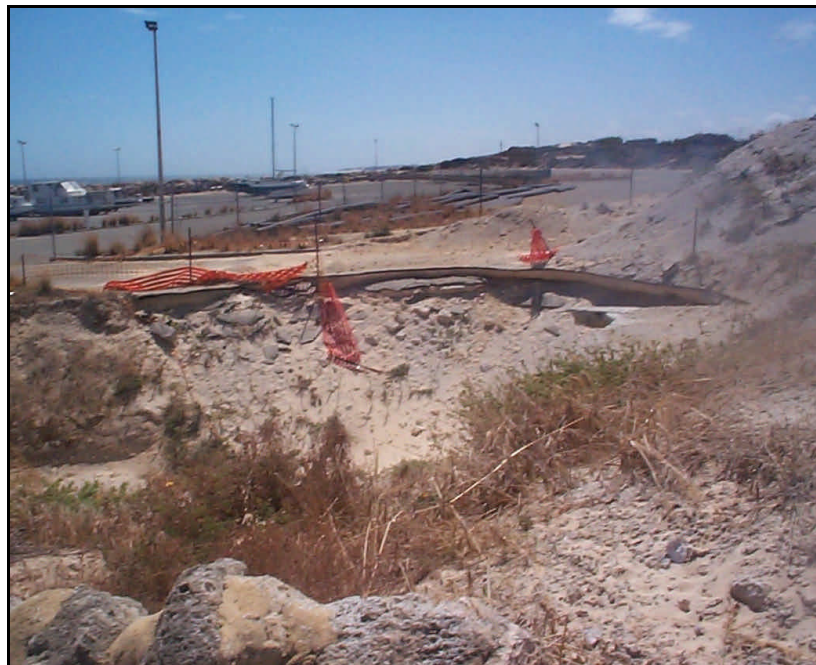
Figure 3.16 is a photo of a road collapse in Two Rocks. This site is on Holocene Limestone which is a lot more friable than the Pleistocene limestone within the karst belt. Nevertheless, it depicts the hazards associated with road collapse and potential social, economic and environmental disruption.

**Figure 3.16** Road collapse in Holocene limestone at Two Rocks
