CHAPTER 2: GENERAL GEOLOGY OF THE COAST

2.1 INTRODUCTION

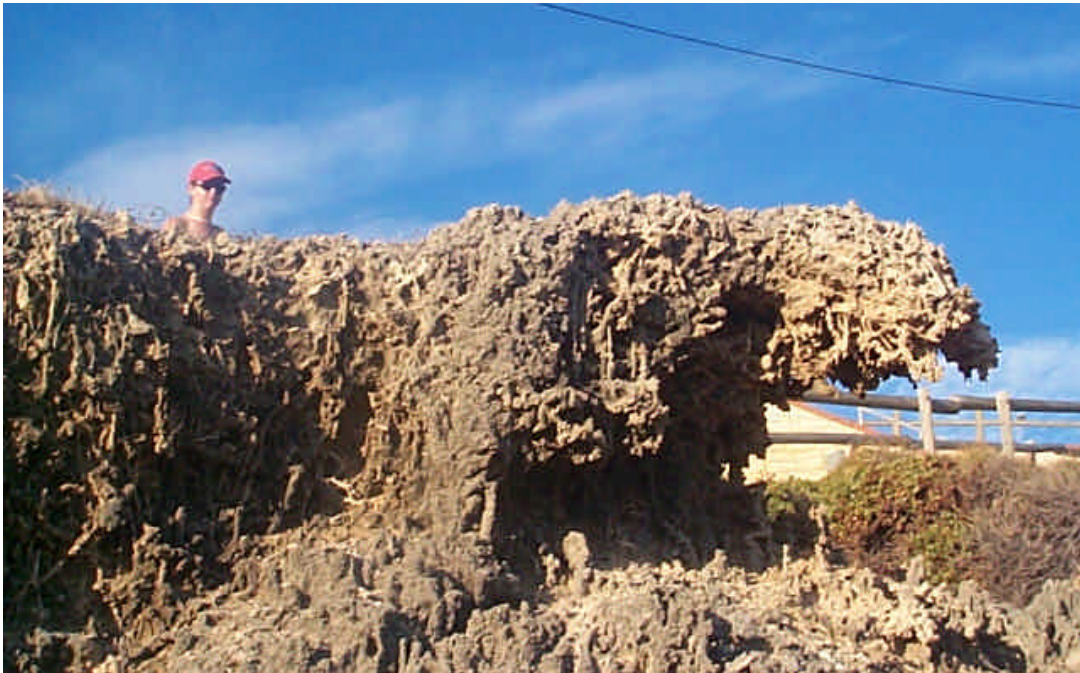
Figure 2.2 Hard calcrete casts and moulds of fossil roots can be seen in this outcrop of Tamala Limestone at site 6 (see Appendix A).

Calcrete duricrust formation is a common feature of carbonate weathering and also forms during a hiatus in the dune building process. The duricrust forms when calcium carbonate from shells, is leached from the underlying layers of limestone and redeposited at the surface. The surface deposition of calcium carbonate forms a hard indurated caprock above the fossil soil layer, leaving the underlying limestone weak and friable. This calcium carbonate depleted layer weathers rapidly under the indurated caprock leaving hard calcrete casts and moulds of fossil roots as prominent features. This is known as the Zone of Roots (Gordon, 1999) and can be seen in extensive outcrops along the coastal fringe (Figure 2.2).

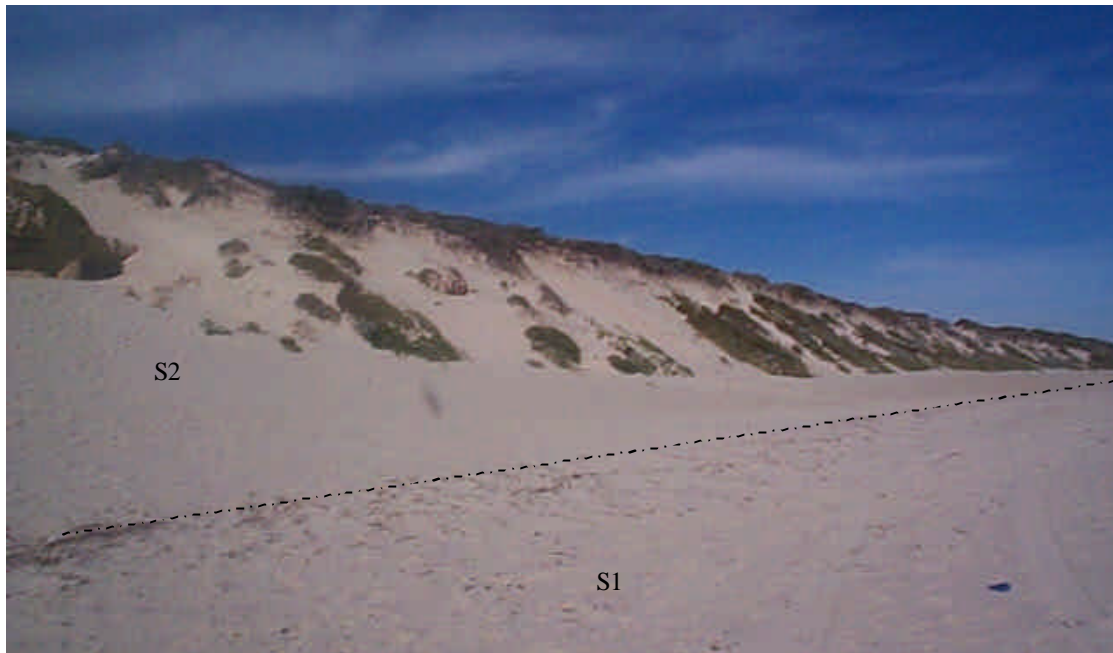
Figure 2.3 Profile of Mindarie Beach in the City of Wanneroo. This beach is a typical example of the relationship between S1 and S2 Safety Bay Sands. S2 forms large dunes backing the gently sloping S1 beach.

S1 is most commonly found forming flat to gently sloping sandy beaches along the coast (Figure 2.3). The sand is calcareous fine to medium-grained, sub-rounded quartz and shell debris of eolian origin. This unit is not vegetated and has an elevation ranging from 0 – 25 m ASL (above sea level).

S2 also consists of fine to medium-grained, sub-rounded quartz and calcareous shell debris of eolian origin. This unit however, is most commonly found forming large undulating dunes with moderate to steep slopes ranging from $\sim 10^\circ$ to $>20^\circ$ (Figure 2.3). These vegetated dunes have an average elevation between 20 – 60 m but can reach heights of 140 m along the Naturalise coast.

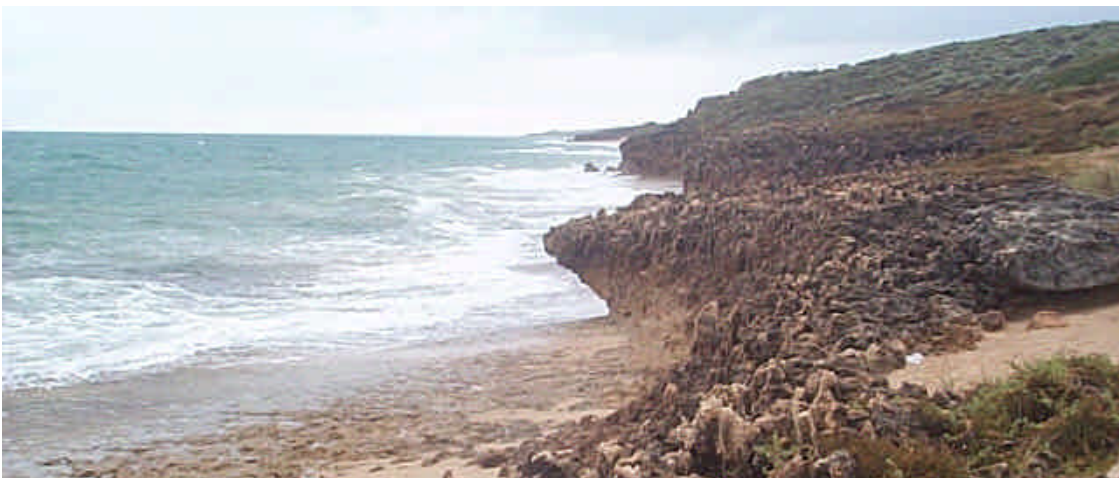
Figure 2.4 Wave action at the base of this cliff has initiated the development of an overhang.

In conjunction with Karst weathering, which diminishes the structural integrity of the limestone, the unit is also vulnerable to mechanical weathering from wind and wave action. Wave action at the base of a cliff gradually erodes the limestone, undermining the cliff and developing an overhang (Figure 2.4). This process of erosion continues until the overhang becomes sufficiently undermined and collapses.
