## APPENDIX A: SITE DESCRIPTIONS

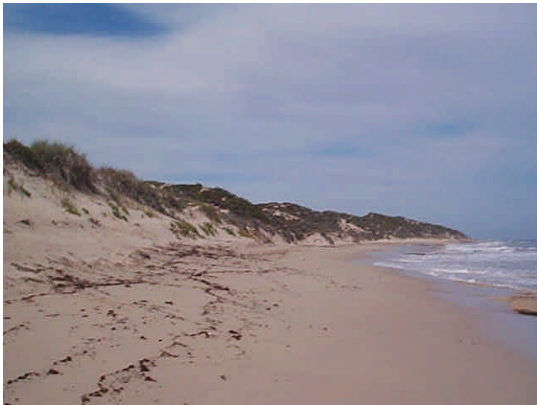
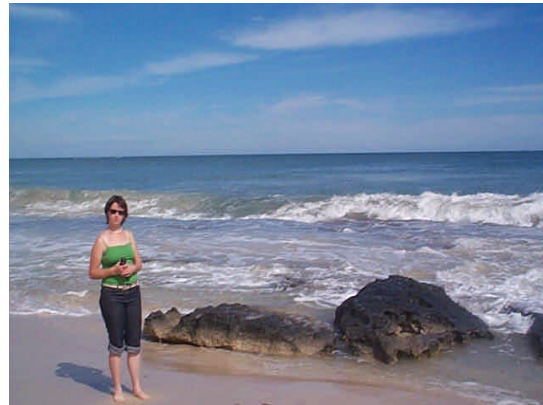
**Site number:** 1  
**Location:** 1.5 km south of Yanchep Lagoon  
**GPS:** 0370544 / 6506865  
**Geological unit:** Safety Bay Sand, S1 backed by S2

*Description:* Narrow (<10m) sandy beach backed by large extensive dunes characterises this area. Foredunes are well-vegetated approx 5-8 m tall. Scattered along the waters edge are limestone outcrops ~ 50cm high and of varying diameter.

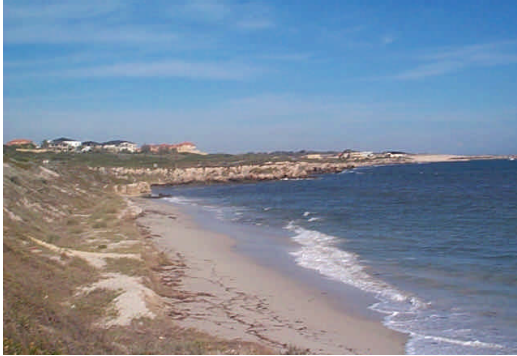
**Site number:** 4  
**Location:** Quinns Rock Beach  
**GPS:** 0376504 / 6494237  
**Geological unit:** Tamala Limestone (LS1)

*Description:* There is a very narrow (<10m wide) sandy beach, backed by low (~5 m) dunes. At the southern end of the beach, vertical limestone cliffs approx. 3-4 m tall

form a series of headlands along coast. Access to the cliff areas is limited as they front straight on to the water. There is evidence of wave undercutting and the development of small overhangs. There are several large ( $>1\text{m}^3$ ) blocks of limestone scattered around the base of the limestone which provide evidence for collapse. There is a large sign at the top of the car park warning visitors that this is a rock fall risk area.

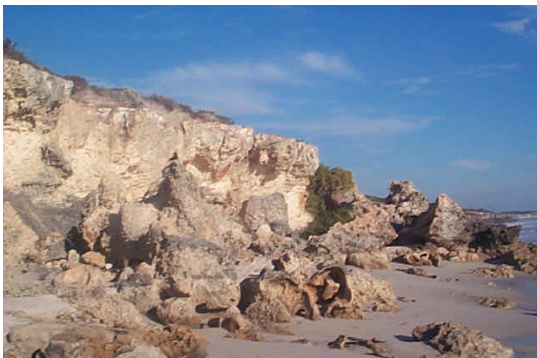
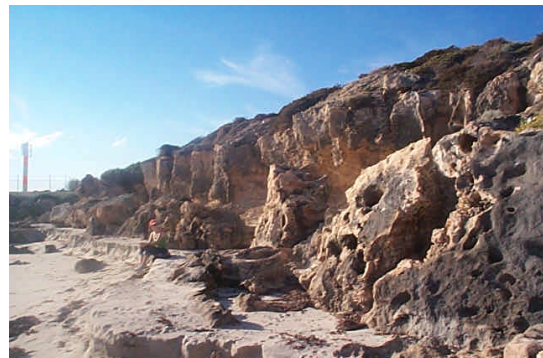
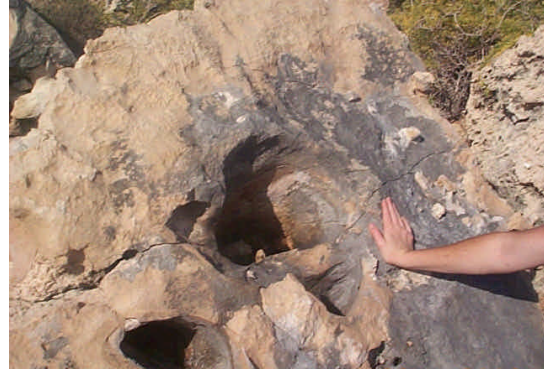
**Site number:** 5  
**Location:** Immediately south of Ocean Reef Boat Harbour  
**GPS:** 0379629 / 6485055  
**Geological unit:** Tamala Limestone (LS1)

*Description:* This site is characterised by a small sandy beach backed by highly weathered limestone cliffs (~5 m tall). The beach is littered with very large ( $1\text{-}2\text{ m}^3$ ) blocks of limestone derived from collapse. The cliff face appears to be quite fresh in a number of places which is evidence for recent topples. The limestone is extremely porous exhibiting large solution tubes  $<60\text{ cm}$  in diameter. A fence has been erected part way around this area, but does not surround it, making the beach easily accessible. There are no warning signs in the immediate vicinity identifying the cliff as a hazard.

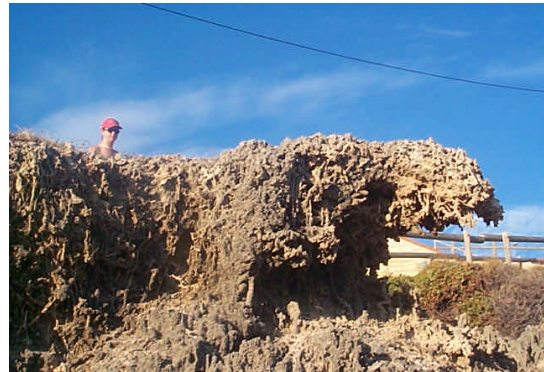
**Site number:** 6

*Description:* Some of the limestone cliffs within this area appear to have crumbling rock faces. Pitting caused by dissolution is evident in some outcrops, along with overhang development and loosened blocks of limestone. Calcified root structures can be seen quite clearly in one outcrop, and is an excellent example of the Zone of Roots. Fences have been erected around dangerous areas and warning signs are displayed.

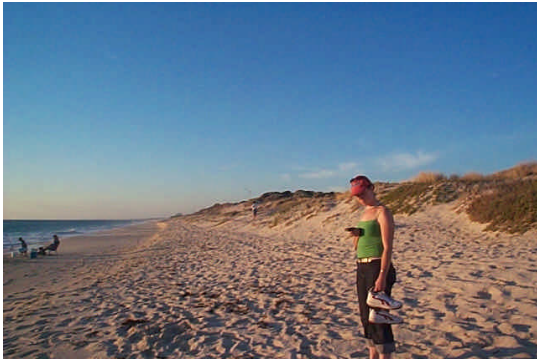
Photo of site 7

*Description:* This site is characterised by a long narrow (~10-15m wide) beach backed by low (< 5m tall) vegetated dunes with a slope of approximately 30°.

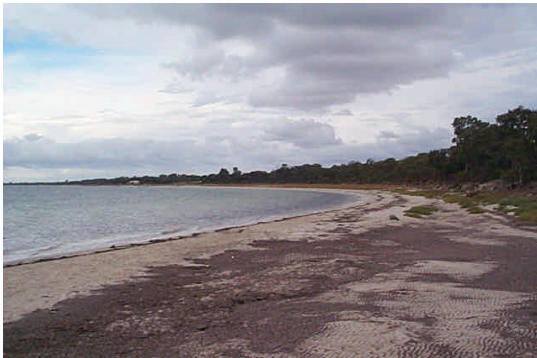
Photo of site 10

*Description:* The beach at this site is quite narrow (10–15 m) and very flat. Backing the sandy beach are some well vegetated low dunes, no more than 2 m high. The dunes are well stabilised by trees and grasses and do not present a threat to the community.

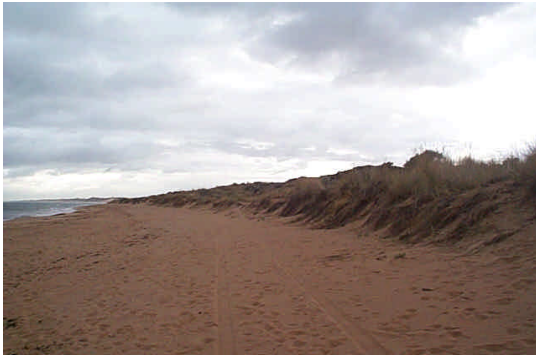
Photo of site 12

*Description:* Long, narrow sandy beach with shore parallel foredunes 3-5 m in height. Dunes are moderately vegetated and are quite steep with an angle of repose around 45°.
